Effects of High-Temperature Annealing in Air on Hi-Nicalon Fiber-Reinforced Celsian Matrix Composites

Narottam P. Bansal
Glenn Research Center, Cleveland, Ohio

NASA/TM—2008-215221

BN/SiC-coated Hi-Nicalon fiber-reinforced celsian matrix composites (CMC) were annealed for 100 h in air at various temperatures to 1200 °C, followed by flexural strength measurements at room temperature. Values of yield stress and strain, ultimate strength, and composite modulus remain almost unchanged for samples annealed up to 1100 °C. A thin porous layer formed on the surface of the 1100 °C annealed sample and its density decreased from 3.09 to 2.90 g/cm³. The specimen annealed at 1200 °C gained 0.43 wt%, was severely deformed, and was covered with a porous layer of thick shiny glaze which could be easily peeled off. Some gas bubbles were also present on the surface. This surface layer consisted of elongated crystals of monoclinic celsian and some amorphous phase(s). The fibers in this surface ply of the CMC had broken into small pieces. The fiber-matrix interface strength was characterized through fiber push-in technique. Values of debond stress, σ_d , and frictional sliding stress, τ_f , for the

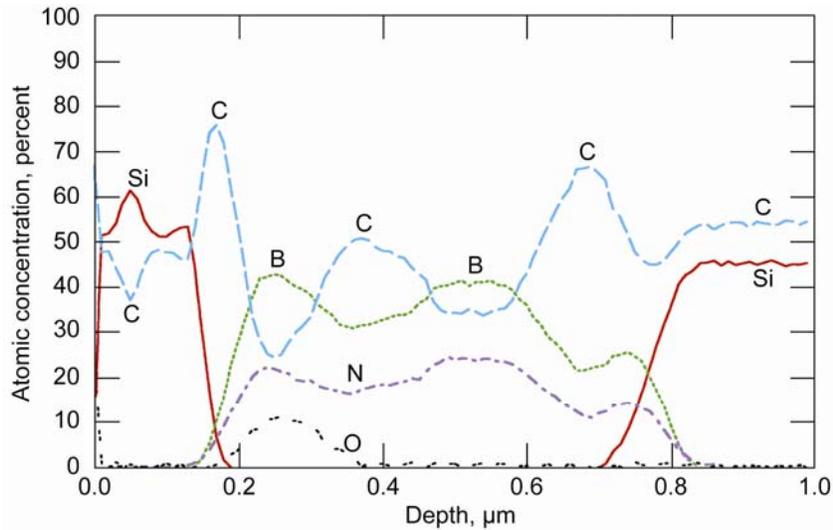
Figure 1.—Scanning Auger microprobe depth profiles of various elements for Hi-Nicalon fibers having a duplex “BN/SiC” surface coating deposited by CVD.

Elemental composition depth profiles obtained from scanning Auger microprobe analysis for the BN/SiC coatings on Hi-Nicalon fibers are shown in figure 1. The coating consists of ~0.15 μm thick Si-rich SiC followed by ~0.6 μm of carbon rich “BN”. In addition, unintentionally deposited carbon layer is also present between the SiC and “BN” coatings. Another predominantly carbon layer is also seen between the “BN” coating and the fiber surface. Presence of free Si has also been detected (ref. 13) in the SiC coating layer by Raman microspectroscopy. This is consistent with the results of another study (ref. 22) which found the SiC layer to be rich in Si from scanning Auger analysis.

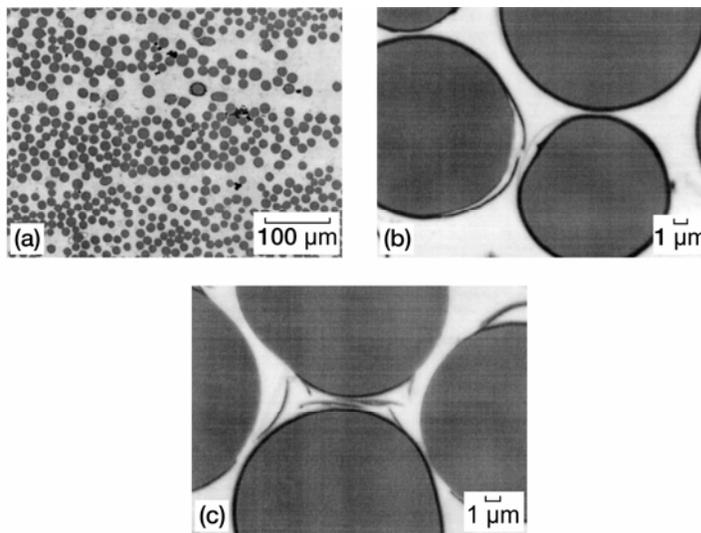
Figure 2.—SEM micrographs at different magnifications showing polished cross-section of a unidirectional Hi-Nicalon/BN/SiC/BSAS composite.

SEM micrographs taken from the polished cross-section of the unidirectional hot pressed composite are shown in figure 2. Uniform fiber distribution and good matrix infiltration within the fiber tows is evident. Some matrix porosity is also present. Some of the filaments are of irregular shape rather than having circular cross-section. The manufacturer reports an average fiber diameter of ~14 μm, but a large variation in the diameter of the filaments within a fiber tow can be seen. The BN/SiC surface coating has been detached from some of the fibers during metallography or composite processing. Debonding or loss of the fiber coating may lead to adverse reactions between the fibers and the oxide matrix at high temperature resulting in strong fiber-matrix bonding.

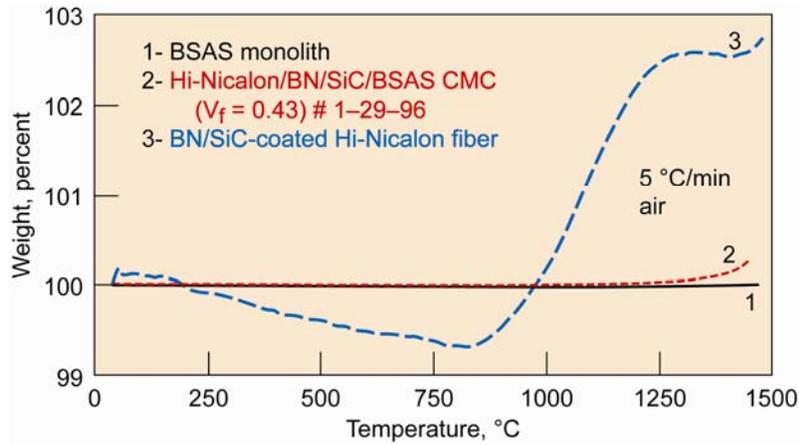
Figure 3.—TGA curves for BSAS monolith, BN/SiC-coated Hi-Nicalon fiber and Hi-Nicalon/BN/SiC/BSAS composite recorded at a heating rate of 5° C/min in air.

The TGA curve for the Hi-Nicalon/BN/SiC/BSAS composite with a fiber volume fraction of 0.43 is given in figure 3. Also shown for comparison are the curves for the BN/SiC coated Hi-Nicalon fibers and a BSAS monolithic sample hot pressed at 1300 °C for 2 h at 4 ksi. The monolithic ceramic exhibits hardly any weight change and appears to be stable up to 1500 °C in air. The composite shows a negligible weight change up to ~1150 °C. The total weight gain at 1450 °C is also small (~0.3 percent). In contrast, the fibers initially lose ~0.5 wt% up to ~850 °C, probably due to the loss of absorbed moisture. This is followed by a large weight increase, possibly due to the oxidation of BN into B₂O₃ and also SiC to SiO₂, particularly at higher temperatures. The total weight gain is found to be ~3 percent.

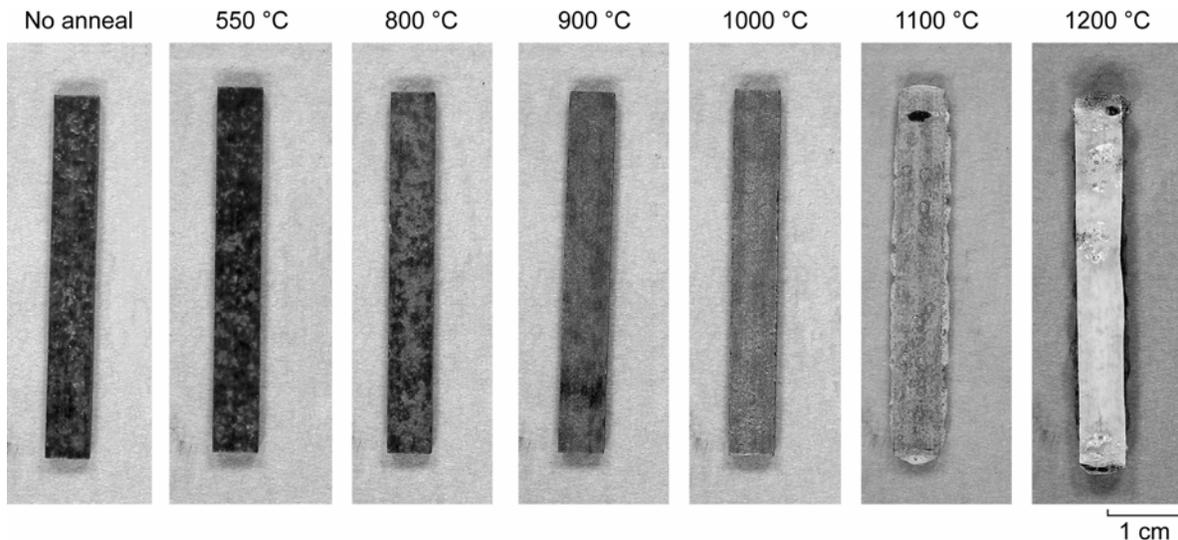
Figure 4.—Optical photographs showing Hi-Nicalon/BN/SiC/BSAS composite bars annealed for 100 h in air at various temperatures.

CMC bars were heat treated in ambient air for 100 h at various temperatures. Optical photographs showing the physical appearance of the CMC bars before and after annealing at various temperatures are shown in figure 4. No changes in physical appearance were observed in samples annealed at 1000 °C or lower. However, the specimen annealed at 1100 °C was covered with a thin porous white layer that could be easily removed by polishing with a fine emery paper. The samples aged at 1200 °C were deformed and developed a thick shiny white layer on the exposed surfaces. Pores were present in the surface layer. Signs of partial melting and gas bubble formation during heat treatment were also observed. From XRD analysis, both amorphous and Celsian phases were detected in the surface layer. Since such a behavior was not observed (ref. 23) in monolithic BSAS material even after heat treatment for 20 h in air at 1500 °C, it is assumed to be caused by the presence of Hi-Nicalon fibers and the BN/SiC coating. In the presence of air, BN is probably oxidized to B₂O₃ which reacts with the matrix and/or silica formed from

the oxidation of silicon carbide fibers, resulting in low-melting glassy phase which migrates to the sample surface. The bubble formation may be related to the oxidation of Hi-Nicalon fibers producing amorphous silica and volatile CO and CO₂ gases.

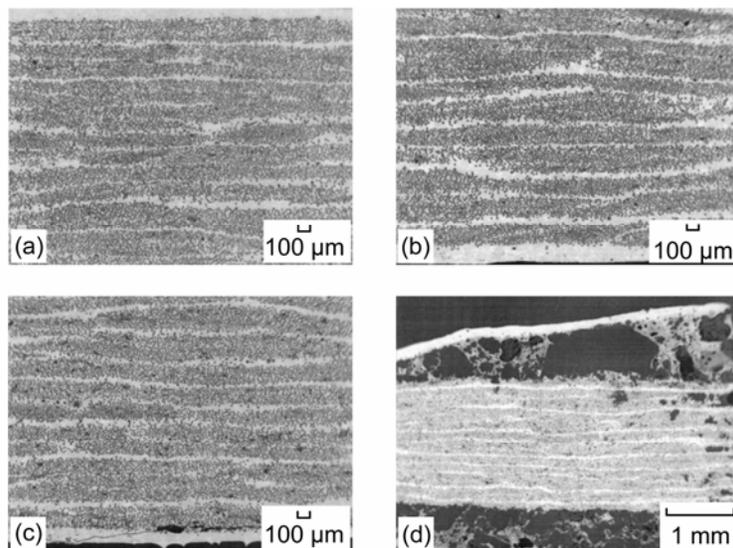
Figure 5.—SEM micrographs of polished cross-sections of unidirectional Hi-Nicalon/BN/SiC/BSAS composites annealed in air for 100 h at various temperatures. (a) As-fabricated. (b) 1000 °C. (c) 1100 °C. (d) 1200 °C.

The matrix layers on the surface of CMC specimens annealed at 1100 and 1200 °C appear to have cracked and delaminated, respectively as seen in the SEM micrographs (fig. 5) taken from the polished cross-sections. A large difference in the coefficients of thermal expansion (CTE) of Hi-Nicalon fiber (~3.5×10⁻⁶/°C) and the oxide matrix (ref. 20) (~5.28×10⁻⁶/°C) may be responsible for the observed cracking and delamination. This would provide an easy path for the ingress of oxygen to the fiber bundles and accelerate the degradation of fibers from oxidation. No such cracking or delamination was observed in samples annealed at lower temperatures. Higher magnification SEM micrographs (fig. 6) from the 1200 °C annealed specimens show the presence of gas bubbles on its surface. Severe damage is also observed underneath the top debonded layer where damaged broken pieces of the fibers are also present.

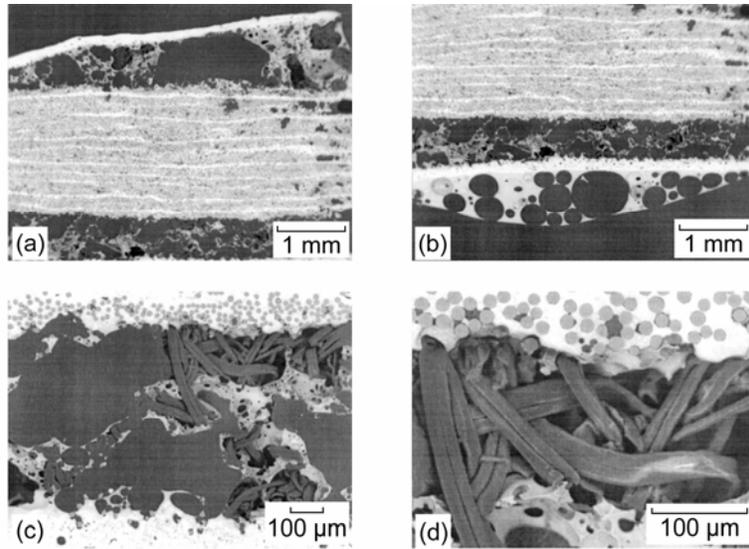
Figure 6.—SEM micrographs of polished cross-sections of unidirectional Hi-Nicalon/BN/SiC/BSAS composites annealed at 1200 °C for 100 h in air.

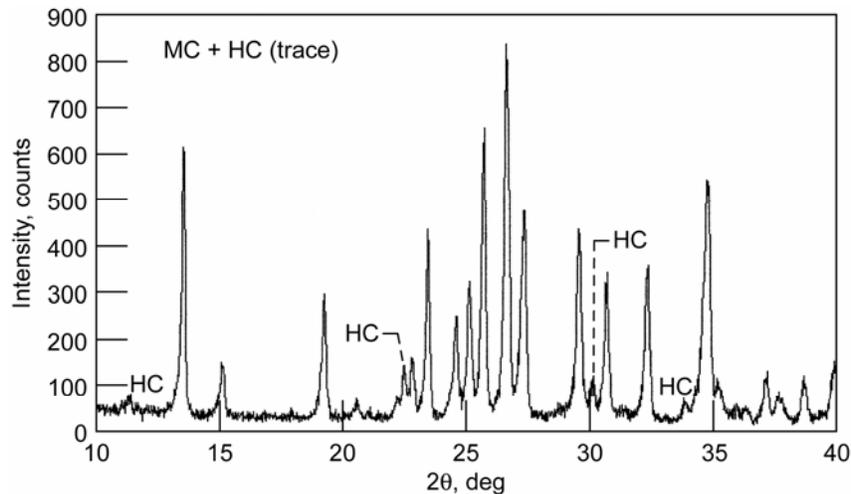
Figure 7.—X-ray diffraction pattern taken from the surface of as hot-pressed Hi-Nicalon/BN/SiC/BSAS composite.

XRD pattern recorded from surface of the as fabricated CMC panel is given presented in (fig. 7). It shows the presence of only monoclinic celsian along with a trace amount of hexacelsian. Additional diffraction peaks at d values of 0.504 nm ($2\theta = 17.5^\circ$) and 0.312 nm ($2\theta = 28.5^\circ$) were detected in samples annealed at 900, 1000, and 1100 °C. The peak at $d = 0.312$ nm was much stronger than the one at $d = 0.504$ nm in the 900 °C annealed specimen where as the reverse was true for the CMC annealed at 1000 and 1100 °C. The phase corresponding to these peaks could not be identified. A white shiny and glassy layer was formed on the surface of the sample annealed at 1200 °C. The surface layer was found to contain monoclinic celsian and an unidentified amorphous phase from XRD analysis.

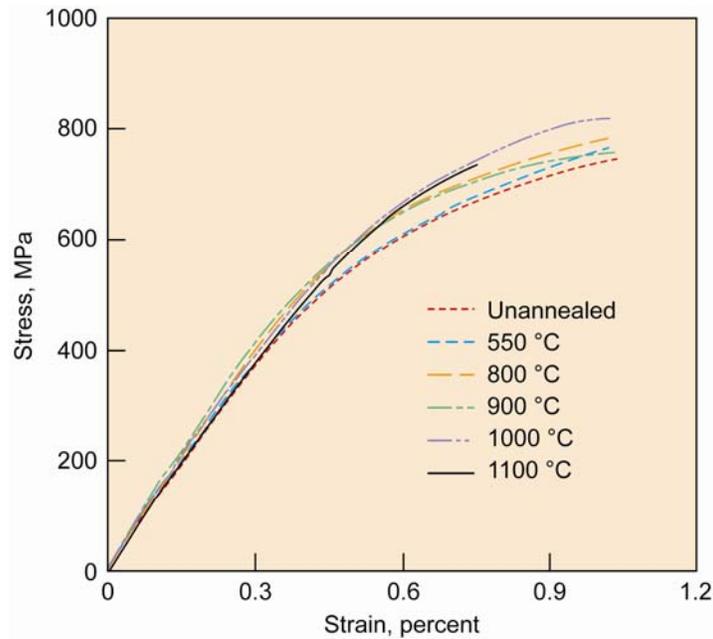
Figure 8.—Apparent stress-strain curves recorded in three-point flexure for BN/SiC-coated Hi-Nicalon fiber reinforced celsian matrix composites annealed in air for 100 h at various temperatures.

Apparent stress-strain curves recorded in three-point flexure for the unidirectional BSAS matrix composite reinforced with BN/SiC-coated Hi-Nicalon fibers, before and after thermal aging in air at various temperatures to 1100 °C, are presented in figure 8. In earlier studies (refs. 11 and 20), hot pressed BSAS monolithic material showed flexural strength of 130 MPa, elastic modulus of 96 GPa, and failed in a brittle mode, as expected. In contrast, the composites show initial linear elastic behavior followed by an extended region of load carrying capability beyond the initial deviation from linearity. This indicates load transfer to the fibers beyond the proportional limit indicating graceful failure and true composite behavior. Various room temperature mechanical properties of the composites, before and after thermal aging in air at various temperatures, are summarized in table 1. The measured elastic modulus of the CMC is in good agreement with a value of 150 GPa, calculated from the rule-of-mixtures ($E_c = V_m E_m + V_f E_f$ where V is the volume fraction and the subscripts c, m, and f refer to the composite, matrix, and fiber, respectively) using $E_m = 96$ GPa (ref. 20) and $E_f = 270$ GPa. (refs. 18 and 19) There is no effect of thermal annealing in air up to 1100 °C on the values of elastic modulus, yield stress, yield strain, and ultimate stress of the composites. Mechanical behavior of the CMC annealed at 1200 °C could not be recorded as this specimen had badly deformed.

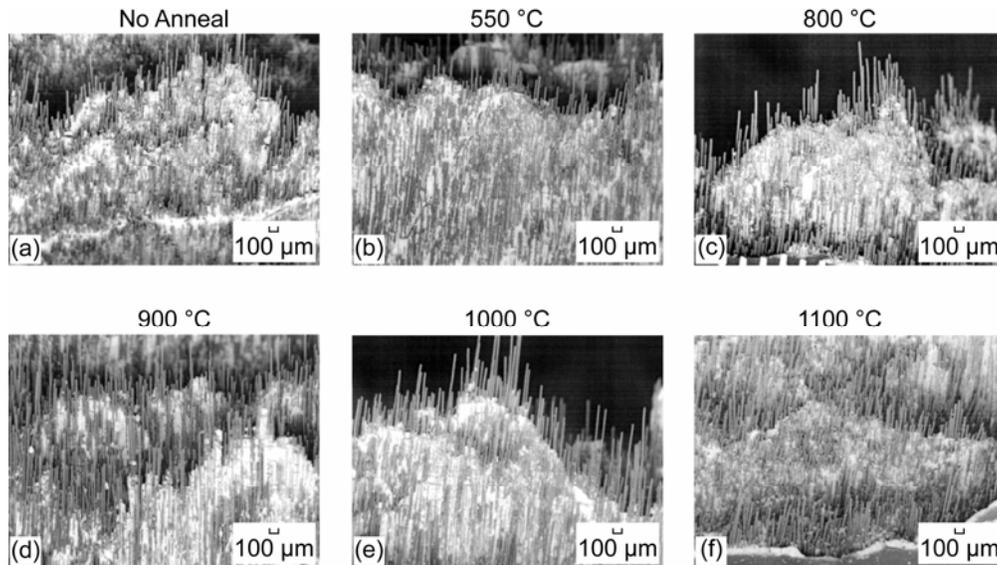
Figure 9.—SEM micrographs showing fracture surfaces of BN/SiC-coated Hi-Nicalon fiber reinforced celsian matrix composites annealed in air for 100 h at various temperatures.

SEM micrographs of fracture surfaces of the composites, annealed for 100 h in air at various temperatures up to 1100 °C, after the room temperature flexure test, are shown in figure 9. Extensive long lengths of fiber pullout are observed indicating toughening behavior for all the annealed CMC samples. Typical higher magnification SEM pictures showing fracture surfaces of the as-fabricated CMC and the one air-annealed at 1100 °C are presented in figure 10. Debonding occurs primarily between the fiber and the innermost coating in both specimens. In some instances, the coating appears to stay with the fibers, particularly in the un-annealed sample. Surface of the debonded fibers appear to be smooth indicating no fiber degradation or chemical reaction with the matrix during high temperature annealing at 1100 °C.

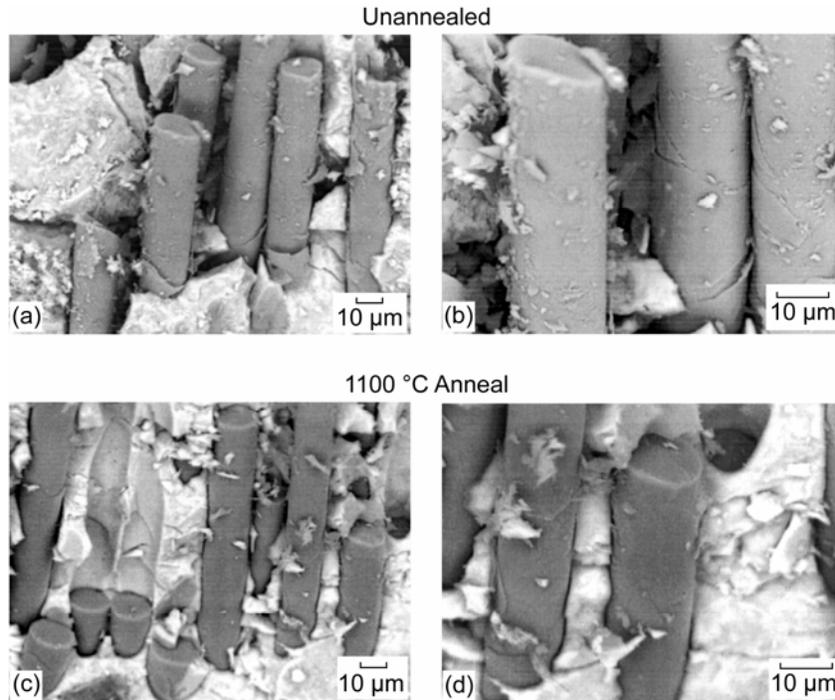
Figure 10.—SEM micrographs showing fracture surfaces of BN/SiC-coated Hi-Nicalon fiber reinforced celsian matrix composites: as-fabricated and those annealed at 1200 °C for 100 h in air.

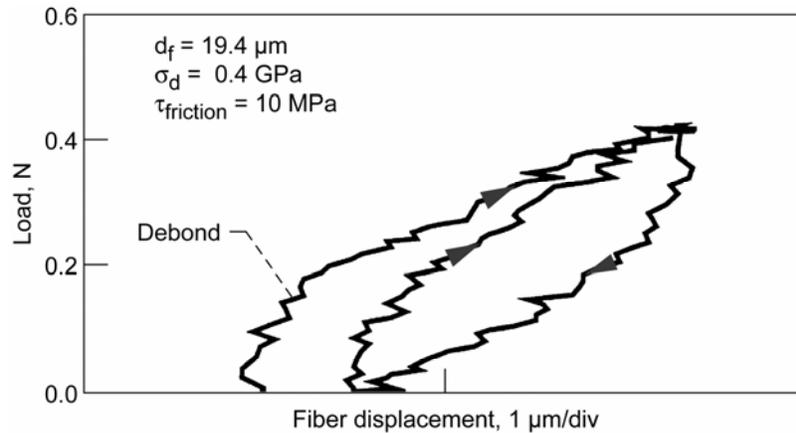
Figure 11.—Load versus fiber displacement curve recorded during fiber push-in test of as-fabricated celsian matrix composite reinforced with BN/SiC-coated Hi-Nicalon fibers.

For strong and particularly tough CMCs, the fiber-matrix interface must be sufficiently weak to allow debonding at the interface, yet strong enough for effective load transfer from the matrix to the fiber. Fiber-matrix debonding and frictional sliding stresses at the fiber-matrix interface were evaluated from fiber push-in tests. About 12 to 15 fibers per coupon were individually pushed in for the air annealed and as-fabricated composites. A typical cyclic push-in curve at room temperature for the as-received composite, along with reloading part of the second cycle, is given in figure 11. The data were analyzed by first subtracting the appropriate load-train compliance correction from the measured displacements. An estimate of frictional sliding stress, τ_{friction} , was obtained using the constant τ_{friction} model of Marshall and Oliver (ref. 25) which includes effects of residual stresses, but does not consider fiber roughness or Poisson expansion. Value of τ_{friction} was determined by fitting the compliance corrected data from each reloading curve to the relationship

where u is the fiber end displacement, u_0 is the residual fiber end displacement after the previous unloading, F is the applied load, r_f is the fiber radius, and E_f is the fiber modulus. While neglecting Poisson expansion of the fibers leads to an overestimation of τ_{friction} values, the relative changes in τ_{friction} with load cycling could be followed using equation (2). In addition, a debond initiation stress, σ_d , could be calculated from the debond initiation load, F_d , (load at which fiber end begins to move during first loading cycle) by the relation

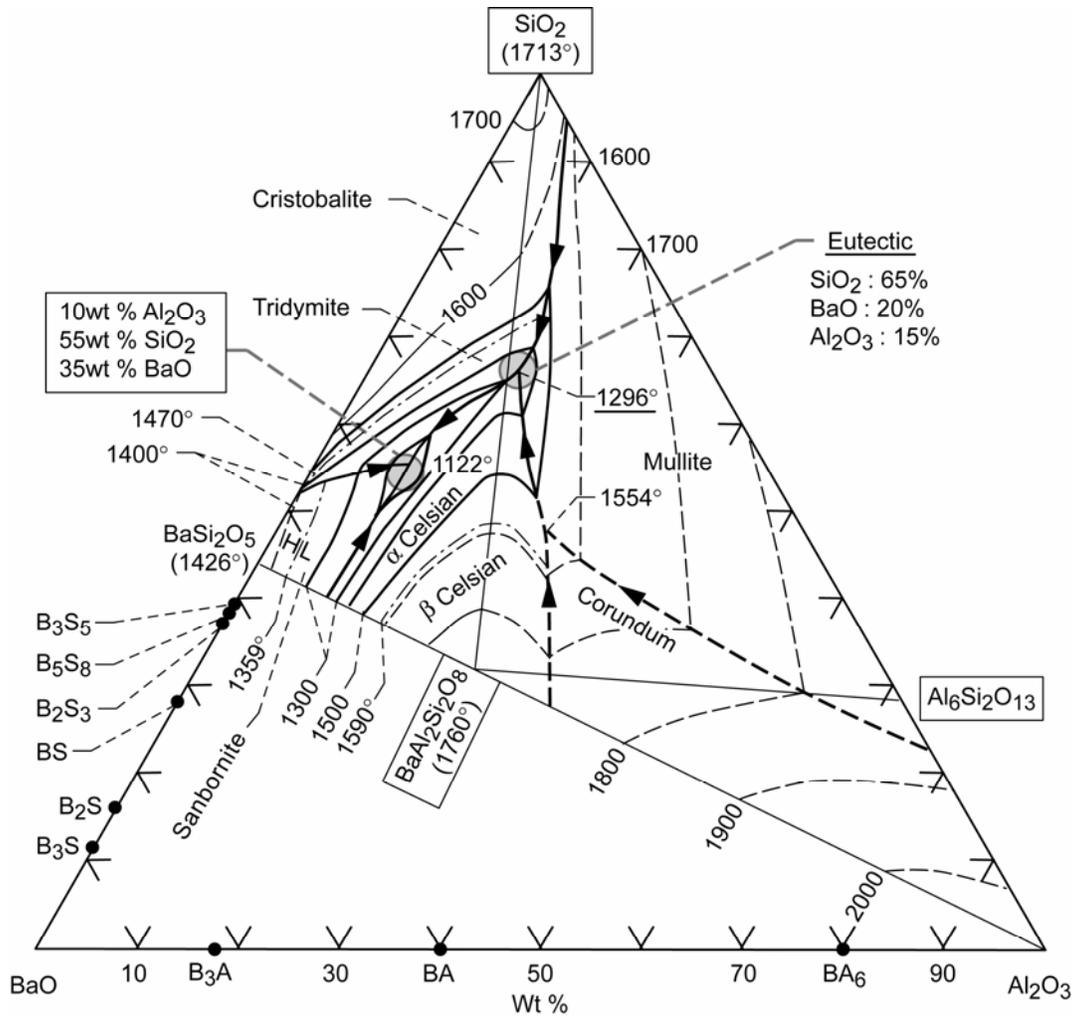
Figure 13.—Phase diagram of BaO-Al₂O₃-SiO₂ system showing the presence of low-melting ternary eutectics.

The silica formed reacts with celsian resulting in the formation of a low melting phase. The phase diagram of BaO-Al₂O₃-SiO₂ ternary system (ref. 30) is given in figure 13. It does show the presence of a ternary phase with a melting point of 1122 °C. This phase is richer in SiO₂ but poorer in BaO and Al₂O₃ than celsian. Formation of gaseous by-products CO and CO₂ during reaction (4) results in the evolution of bubbles as observed in SEM micrograph of figure 6. On cooling, celsian crystals precipitate from the melt leaving behind a glassy matrix which is richer in SiO₂ and poorer in BaO and Al₂O₃ than celsian. SEM micrograph (fig. 14) taken from the surface of 1200 °C annealed CMC shows the presence of elongated crystals in some glassy matrix. From qualitative EDS analysis, these crystals are seen to be celsian and the glassy matrix is found to be richer in SiO₂ but poorer in BaO and Al₂O₃ than celsian. The XRD patterns taken from the as fabricated CMC and that annealed for 100 h in air at 1200 °C are given in figure 15. Only celsian phase is detected in the as-fabricated sample whereas celsian and some amorphous phase are present in the 1200 °C-annealed CMC. Formation of a low-melting glass phase has also been reported (ref. 31) earlier during the study of BSAS environmental barrier coating (EBC) on Si-based ceramic substrates such as CVD SiC and SiC_f/SiC composite. On heat treatment, the plasma sprayed BSAS coating reacted with the silica layer, formed from oxidation of the Si-based ceramic substrate, resulting in low melting ternary glass phase which was found to be richer in SiO₂ but poorer in BaO and Al₂O₃ than celsian. Formation of amorphous silica, due to the oxidation of SiC whiskers, has also been reported during oxidation study of SiC whisker reinforced mullite/zirconia composites (ref. 32) at 1000 to 1350 °C. At 1200 °C or higher temperatures, formation of zircon was observed from the reaction between ZrO₂ and SiO₂. Secondary mullite grains were also formed through a solution-precipitation mechanism.

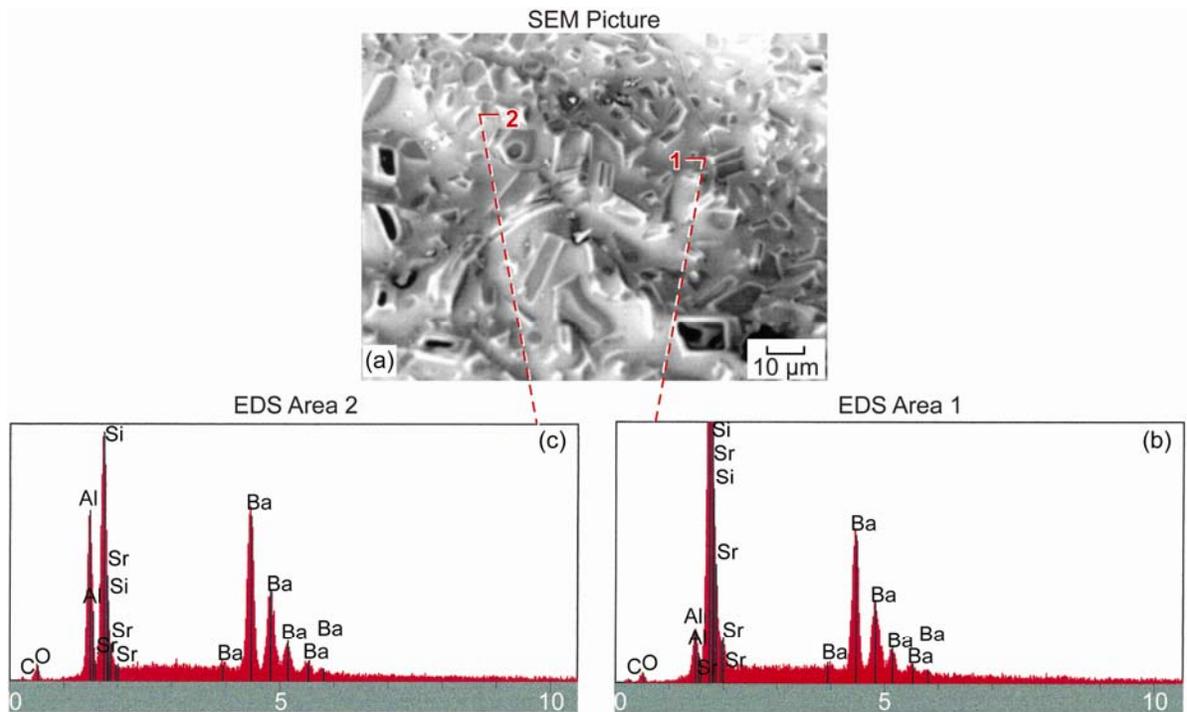
Figure 14.—SEM micrograph showing surface of Hi-Nicalon/BN/SiC/BSAS composite annealed at 1200 °C for 100 h in air. Also shown are the EDS analyses of two different areas, labeled as 1 and 2, of the CMC surface.

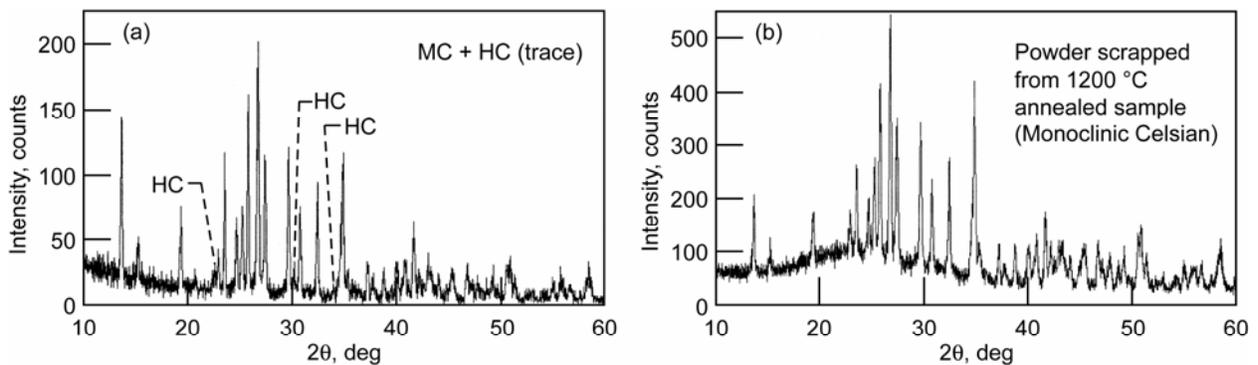
Figure 15.—X-ray diffraction spectra from surfaces of Hi-Nicalon/BN/SiC/BSAS composites. (a) As-fabricated. (b) Annealed at 1200 °C for 100 h in air.
