Development of a Spacecraft Antenna Pointing Gimbal

Abstract

The development of the pointing gimbal in the high-gain antenna system (HGAS) of the Solar Dynamics Observatory spacecraft is described. The gimbal was designed for 5 years of service in Geo-Synchronous orbit. The hardware incorporates multiple levels of redundancy, allows harnessing and waveguide along its full length across its two axes of rotation and points with an accuracy of better than 0.065° . Significant issues with actuator alignment, Electrical Contact Ring noise, pointing budget, and waveguide failures are described, along with their respective resolutions.

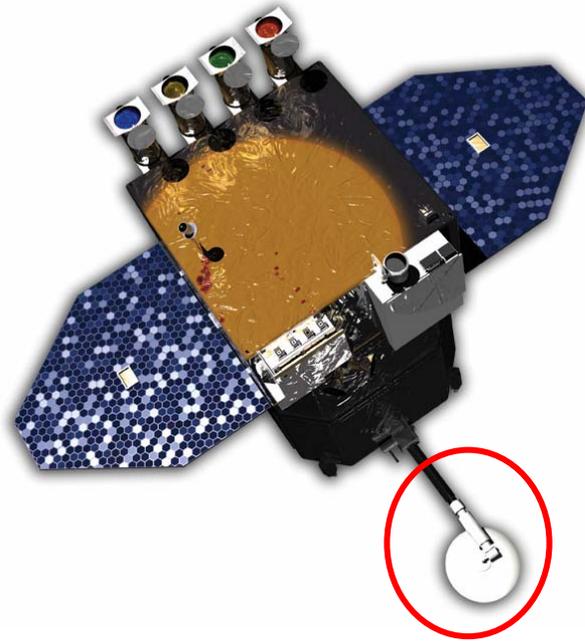
The Solar Dynamics Observatory (SDO), shown in Figure 1, is a NASA spacecraft that will collect data from the Sun during its 5-year life. The spacecraft was designed by and is being integrated at NASA Goddard Space Flight Center in Greenbelt, MD. Universities and industry provide its science instruments.

Figure 1. Solar Dynamics Observatory with One of Two High-Gain Antennas and Gimbals Circled

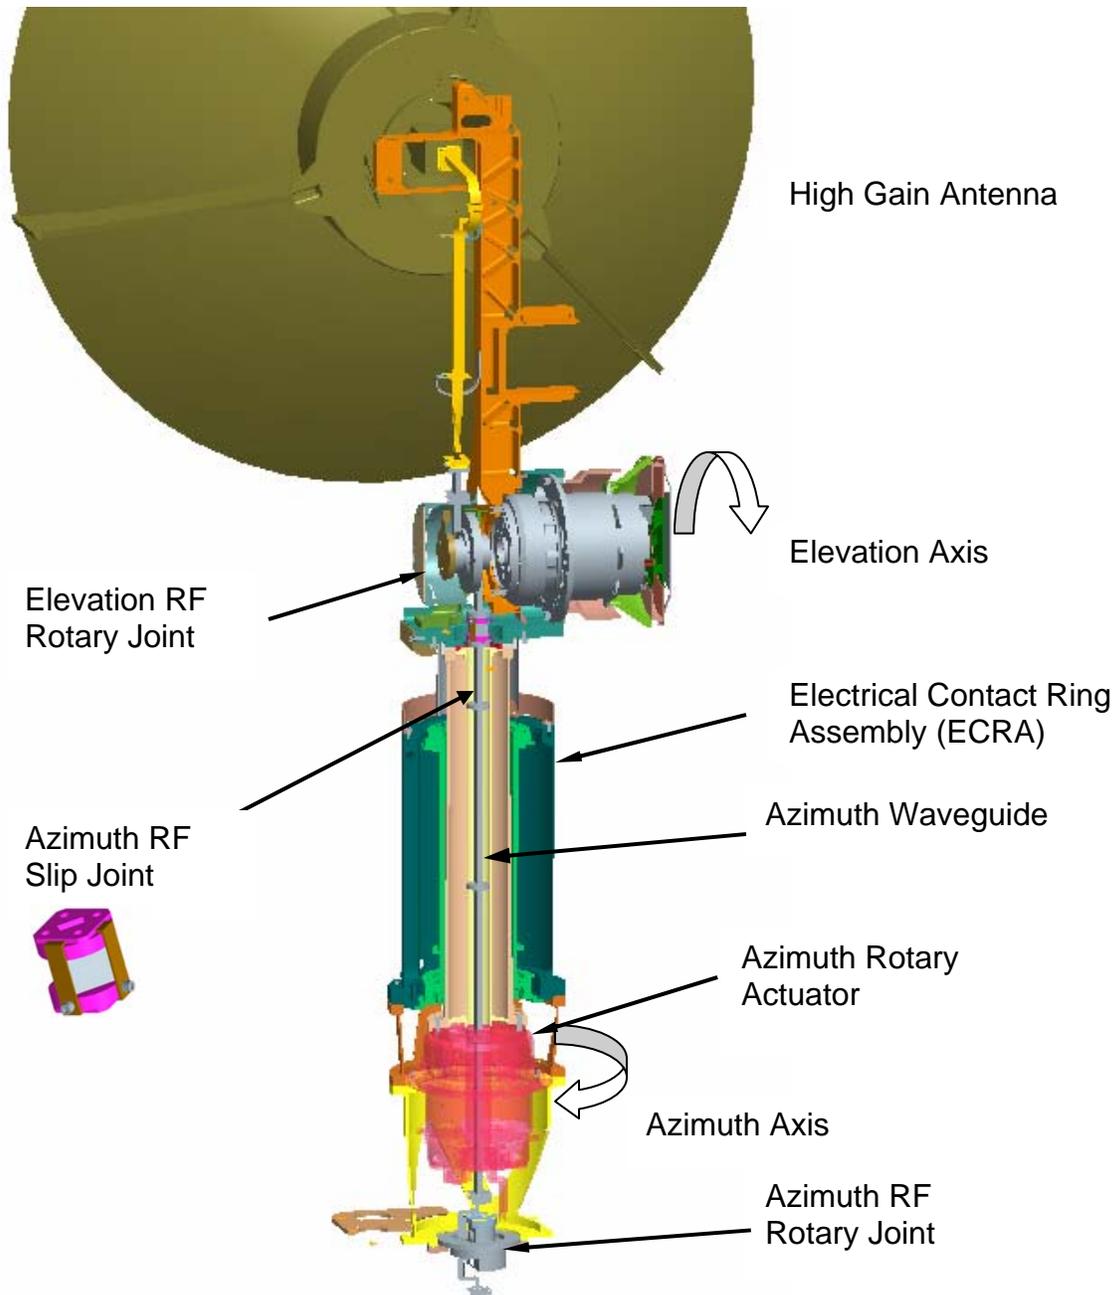
The overall configuration is shown in Figure 2. The azimuth axis has unlimited rotation and the elevation axis has a $\pm 69^\circ$ range. The continuous azimuth rotation is made possible by having the power and signal transferred through the ECRA. For the elevation rotation, a rotary cable wrap wherein the cable is carefully spiraled through the center of the elevation actuator manages the harness.

There are two rotating sections of waveguide on this two-axis gimbal. An azimuth section rotates with the azimuth axis and extends from the azimuth actuator up to the elevation axis. An elevation section rotates with the elevation axis and extends from the elevation actuator up to the antenna.

Figure 2. Gimbal Cross-section

The second solution, shown in Figure 2, was to replace the flexible section of waveguide with a slip-joint section. This was also developed and tested, and it was found to work well. Ultimately this slip-joint approach was determined to be more robust with no discernible failure mode, and it was selected for use in the azimuth Waveguide.

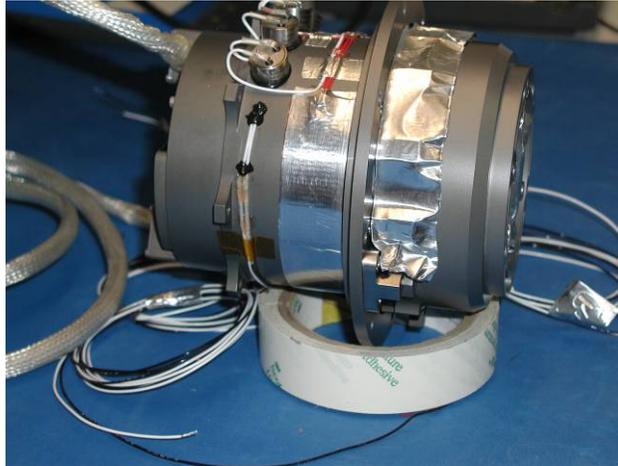
The rotary actuators for azimuth and elevation are identical except for hard stops on the elevation actuators limiting travel to ± 69 degrees. Each commercial actuator consists of a stepper motor, hybrid optical encoder, and harmonic drive gear reducer in a titanium housing. Once delivered, the units were tested for compatibility with the GSFC-designed control electronics, and characterized for settling time, torque margin, encoder output and alignment. Then thermal hardware was applied, as shown in Figure 3, and the harnessing prepared for integration to flight hardware.

Figure 3. Rotary Actuator Shown During Thermal Hardware Application

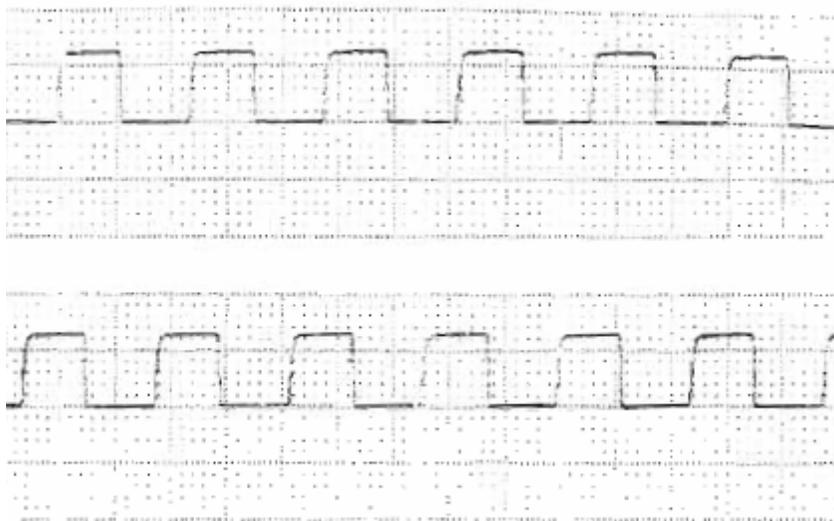
alignment of their encoder discs to the step detents. The easiest way to test for alignment is by the quality of the encoder output during settling in its detent. A well-aligned encoder disc would have its Light-Emitting Diode (LED) centered in the disc aperture. Even at the beginning of settle, when the oscillations are highest, little or no light would be occulted by either edge, as shown in Figure 4a (each window is two steps wide). Encoders that are not optimally aligned would shadow a portion of the light while settling in a step detent. Of 10 potential flight actuators, 6 were aligned with less than optimal performance, as shown in Figure 4b by the encoder light output “hash” during characterization testing. The actuator specification called out static alignment only; as a result, all 10 flight actuators satisfied the specification requirements.

Figure 4a. Good Encoder Alignment – Two-Step Window

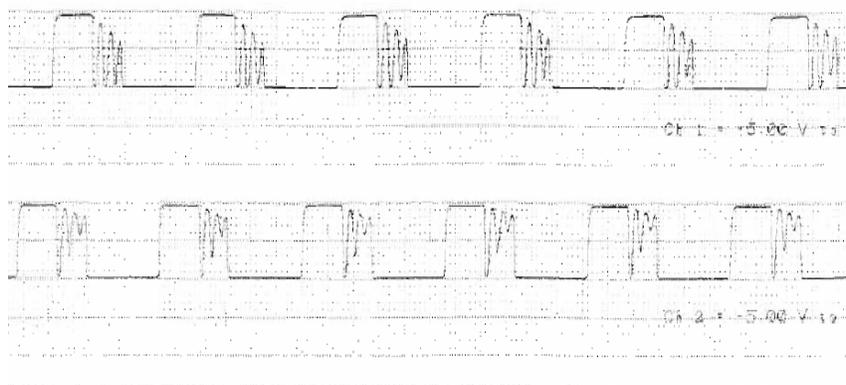
Just prior to delivery to the spacecraft, two of the flight actuators were damaged beyond repair by excessive heat in a Goddard thermal vacuum chamber. Two of the less-than-optimal actuators were brought to flight status. These passed the static alignment specification but during a high-rate slew operation could incur positioning errors of one step. This error is reset in the control electronics when the actuator passes through the “home” position, so the condition is tolerable during slews. Under normal tracking, there is adequate time for the encoder output to settle and the output to be verified. The only remaining issue is diode output over the mission life. As the diode response decays due to radiation effects and the normal degradation due to operation, the partial occulting could reduce margin on the encoder output.

Figure 4b. Less than Optimal Encoder Alignment

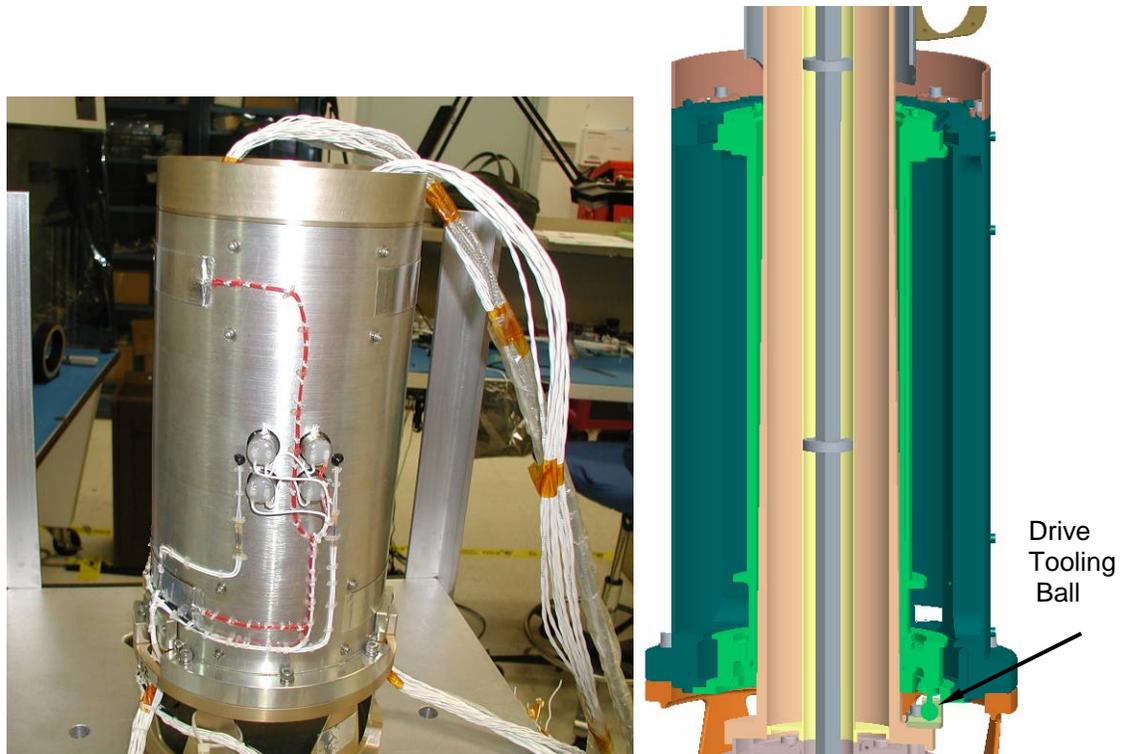
The elevation axis harness, which consists of 14 power circuits and 26 signal circuits, is routed through the ECRA. The outer structure of the ECRA, shown in Figure 5, is stationary and is hard-mounted to the same bracketry as the azimuth actuator stator. The inner structure of the ECRA is fully supported in the stationary section by a duplex set of angular contact bearings as well as a trailer bearing. A tooling ball mounted in the base of the rotating portion of the ECRA mates with a slot in the azimuth output shaft allowing the gimbal to transmit the rotary motion while permitting slight angular misalignment between the ECRA and the output shaft.

Figure 5. ECRA with Thermal Hardware Attached (prior to lead tape over wrap)

The structure consists primarily of aluminum and titanium components. The ECRA uses gold/silver/nickel alloy mono-filament brushes in gold-plated brass grooves. Two outer brush blocks that are part of the stator support brushes that span the gap between the stationary and rotary portions of the assembly. Each groove accommodates two brushes, one leading and the other trailing. The power circuits utilize a three-groove design while the lower-powered signal brushes utilize a two-groove design. The final result is a current-carrying margin in the power and signal circuits of three and four times respectively. This is in addition to the electrical redundancy in the gimbal itself.

During component thermal testing, the ECRA exhibited higher than expected noise in the lines. While the ECRA exhibited acceptable noise performance at temperatures greater than 0°C, the noise levels on several circuits increased considerably at sub-zero temperatures. The primary cause was determined to be water contamination of the brush-groove lubricant. It was determined that the nitrogen environment in the thermal chamber was insufficient to purge the assembly of all water vapor. The primary solution was to perform the thermal testing in vacuum. Additional steps that were taken included a vacuum bakeout without the external housing installed before final assembly, a run-in before testing, and efforts to improve

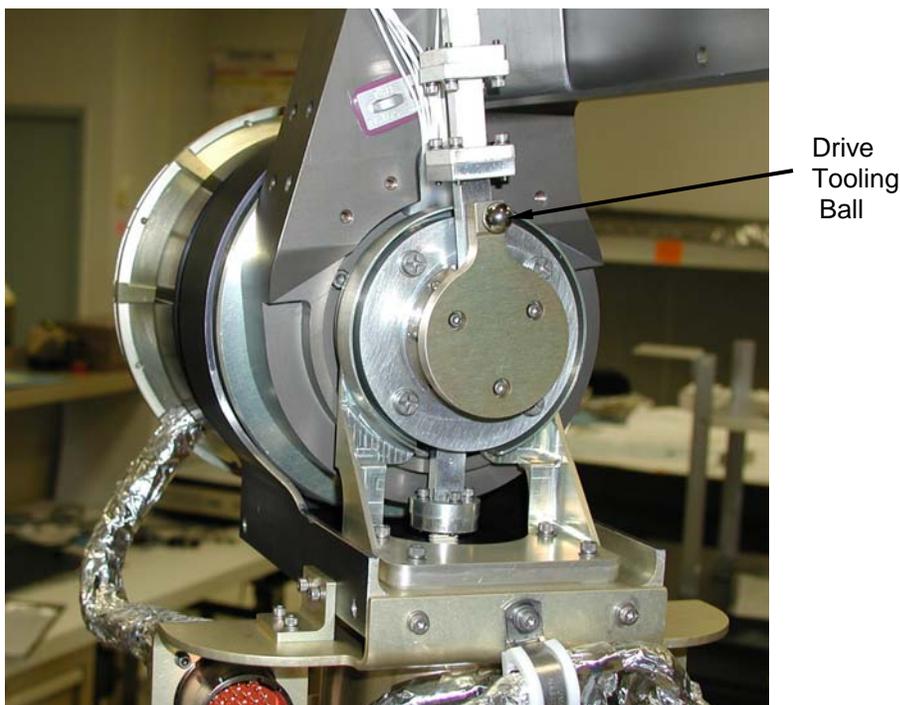
SDO's data downlink is carried out by a Ka-band RF transmission of 26.5 GHz from a ¾-meter (30 in) High-Gain Antenna to one of two 18-meter (60-ft) ground station antennas. WR-34 waveguides are used to transfer the signal from the transmitter to the HGA. They are aluminum, plated with silver. An anti-tarnish coating was applied over the silver plate. Rotary joints, shown in Figure 6, pass the RF signal with budgeted 0.2-dB insertion loss and allow rotations about the two axes. The stationary and rotating sections of each rotary joint are aligned by a duplex set of ball bearings. The rotating portion of the joint is driven similarly to the ECRA. A ball drives the movement through a slot arrangement, using a tooling ball and a clevis with a close-tolerance gap.

Figure 6 RF Rotary Joint with Drive Tooling Ball (Elevation Axis Shown)

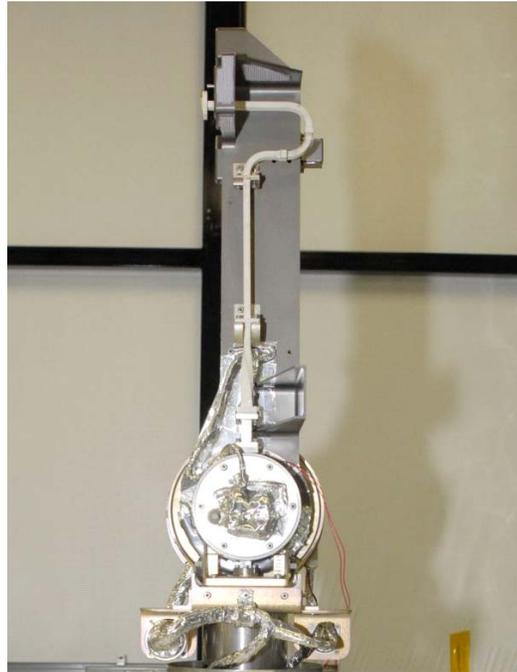
Figure 7. Waveguide Resolution - Elevation Waveguide with “P-Trap” section

For the elevation waveguide, analysis confirmed that the 90° bend in flex could be replaced with rigid waveguide in a slightly longer, convoluted path. The addition of two more 90° bends created a shape similar to a plumbing expansion section or a P-Trap, shown in Figure 7. The extra path mitigated misalignment and thermal effects. Tolerance stack-up in the axial direction away from the P-Trap was accommodated through the use of aluminum shims.

Originally, there were two 7- to 11-cm sections of corrugated flexible beryllium copper waveguide on the gimbal—one in the azimuth section and one in the elevation section. The design intent was that the accordion-style flexibility would compensate for tolerance stack-up and for slight variations in temperature or CTE mismatches. During initial Qualification Unit vibration testing, both of the flexible sections broke completely due to low-cycle fatigue.

One cause for this failure was insufficient waveguide support. Some rigid waveguide spans were 25 cm or more, while the manufacturer recommended 15 cm or less. During vibration, it was shown by analysis that the flex waveguide saw deflections well above the yield stress point.

The main cause for failure was improper heat treatment and fabrication steps of the delicate 100- μ m thick corrugated sections. Metallographic analysis of the failed waveguide revealed a larger grain size than that associated with the certified heat treatment. There are multiple conditions that can result in excessive grain size. Regardless of its cause, this condition was a primary contributor to the low cycle fatigue failure

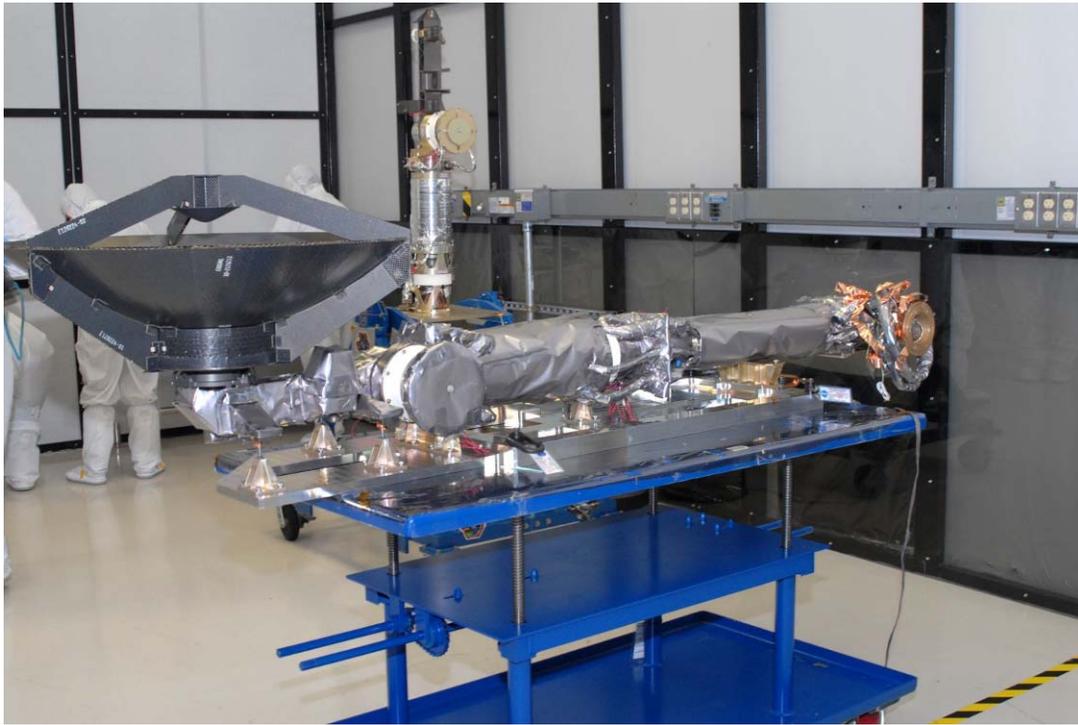
The first flight gimbal, shown in Figure 8, has been tested and delivered to the spacecraft. The second gimbal will be replaced by a spare after being subjected to damaging temperatures during the post-thermal vacuum bake-out. Integration and testing of the re-built gimbal is scheduled to be complete in March 2008. Launch is scheduled for late 2008.

**Figure 8. SDO Gimbal Mated to Deploy Boom and High Gain Antenna, with MLI installed
Second Unit Shown Vertical in Background**
