Failures in Hybrid Microcircuits during Environmental Testing. History cases.

Alexander Teverovsky

Perot Systems/NASA GSFC, code 562, Parts, Packaging,
and Assembly Technologies Office
Alexander.A.Teverovsky.1@gscf.nasa.gov

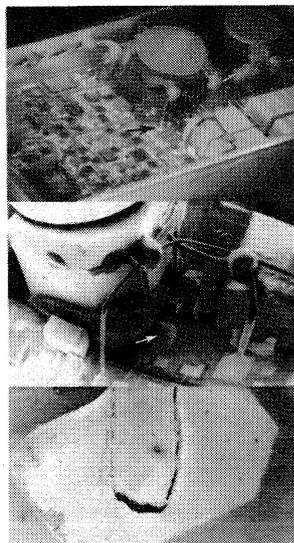
- A DC-DC converter failed during box-level testing in a thermo-vacuum chamber.
- The failure was due to a soldered joint fracture.
- Failed wire was secured to the transformer fixed to the lid with silicone.
- Mechanism of failure: low-cycling fatigue caused by deformation of the lid and shifts of the transformer and wire.

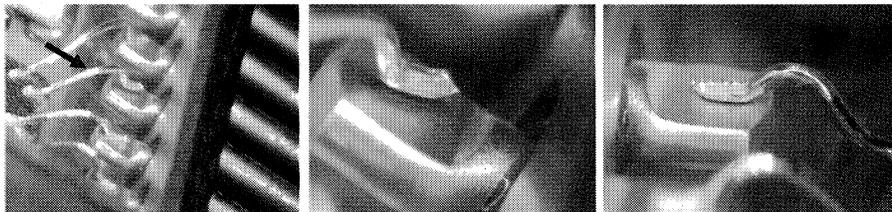
- Five hybrid solid state power controllers successfully passed life testing at 125 °C during 1000 hours.
- Additional electrical measurements after testing unexpectedly revealed open pins in two parts.
- The failures were caused by lifted 10-mil Al wires.
- Although Al wires are annealed, they are stiff and have built-in mechanical stresses, which might result in failures in bonds with weakened adhesion under minor mechanical disturbances.
