## **Long-term Lunar Radiation Degradation Effects on Materials**

National Space and Missile Materials Symposium

# Long-Term Lunar Radiation Degradation Effects on Materials

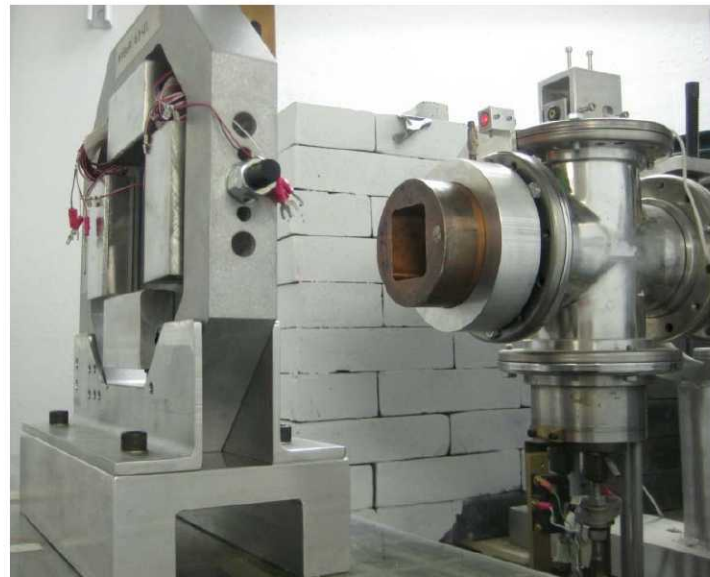
↑  
Sample in Test  
Stand

↑  
Beam Exit

Radiation Beam

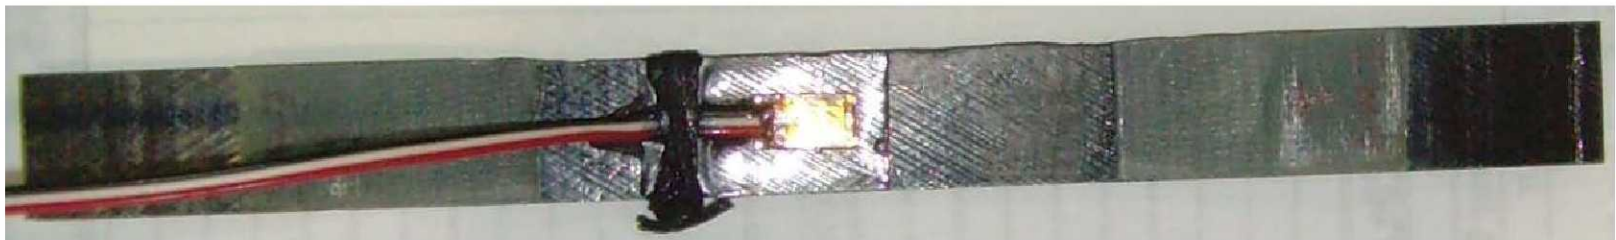
# Tensile Test Procedure

- 3 coupons made from one sample
- coupons were cut perpendicular to  $0^\circ$  plys
  - to highlight any matrix sensitivities in tensile properties
- Each tensile coupon included
  - tabs to protect the material during test
  - single strain gauge in the center to collect tensile data
