Chapter Four

Rocketdyne - SE-7 & SE-8 Engines

Tim Harmon's SE-7 & SE-8 Presentation Viewgraphs

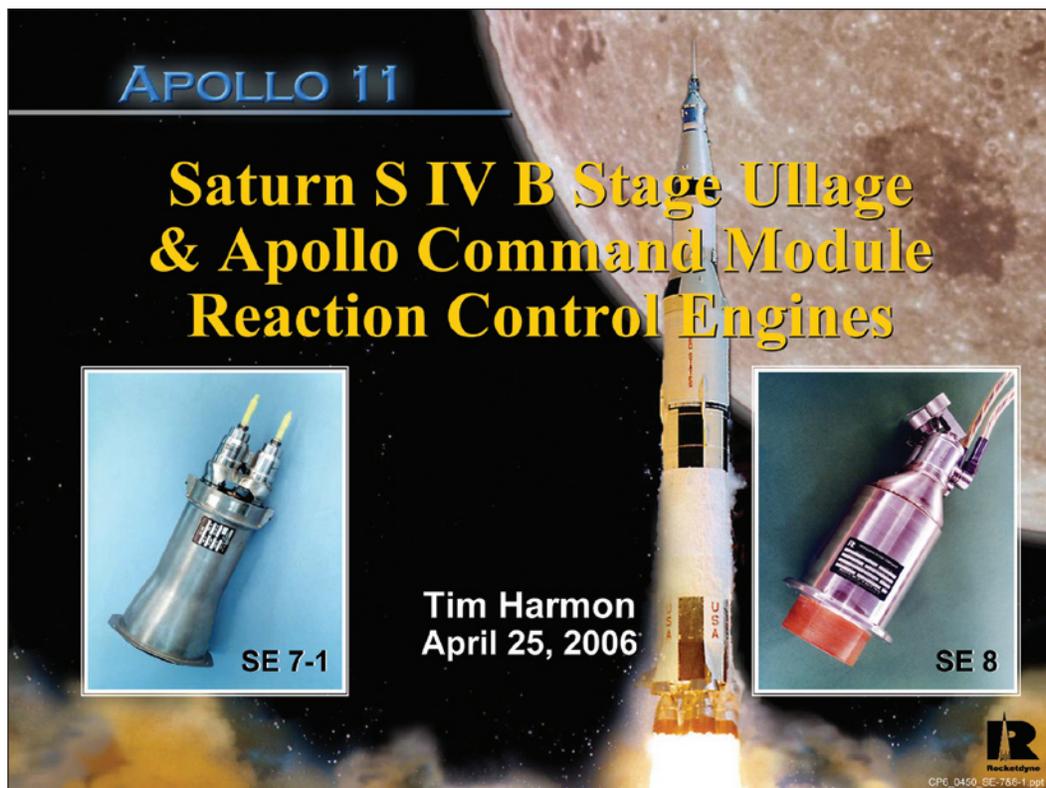
Apollo/Saturn V

Launch Escape System
Twelve SE-8 reaction control engines guided Columbia safely through reentry on her way to splashdown and the crew's appointment with history.

Apollo Command and Service Modules
One RS-18 lunar ascent module engine lifted Eagle off the lunar surface for a safe rendezvous with Columbia.

Lunar Module and Spacecraft LM Adapter
Two SE 7-1 ullage engines settled propellant after first J-2 Burn and during restart chilldown prior to second J-2 Burn.

Instrumentation Unit
One third stage J-2 engine put Apollo 11 into Earth orbit... and then boosted Neil Armstrong, Buzz Aldrin and Michael Collins toward the moon.

Third Stage
Four S-II ullage engines settled Stage II propellants before Stage II ignition.

Second Stage
Five J-2 engines boosted Stage II with over a million pounds of thrust.

First Stage
Five F-1 booster engines provided 7.6 million pounds of first stage thrust for Saturn V.

Now, let's talk about off-the-shelf technology and lessons learned with the Apollo Program. There were a dozen SE-8 engines in the Apollo capsule; in the S-IV-B Stage, there were two SE-7 engines. These engines were similar in design and function. They were based on the Gemini Program vehicle attitude control engines. The Gemini Program used small engines that Rocketdyne built. These were buried engines. One of the technical issues with buried engines is keeping engine heat from soaking into the Gemini capsule. The solution was ablative-cooled engines that insulate the vehicle from engine-firing heat. The Gemini Program success was the basis that Rocketdyne used to win the contract to develop the engines for the Apollo Program's Saturn vehicle. (See Slide 2, Appendix F)

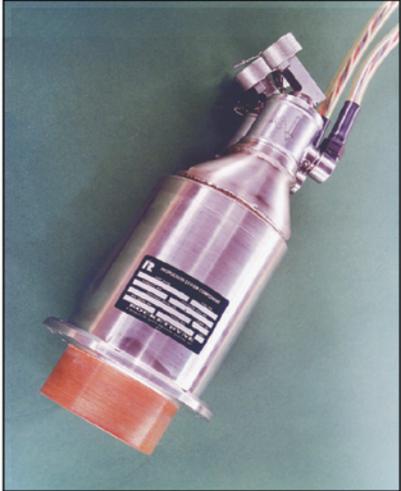
SE-8 Apollo Command Module Reaction Control

Type:	Pressure-Fed
Thrust:	93 lb vac
Specific Impulse:	274 sec vac
Propellants:	NTO/MMH
Design Year:	1964

The Rocketdyne solutions were to replace silicon carbide material with a more forgiving ceramic material. Also, due to the multiple locations within the vehicle, the shape of the nozzles varied. Some nozzles were long, and some nozzles were short. We came up with a single engine design with variable nozzle extensions and configurations to fit particular vehicle locations. (See Slides 10 and 11, Appendix F)

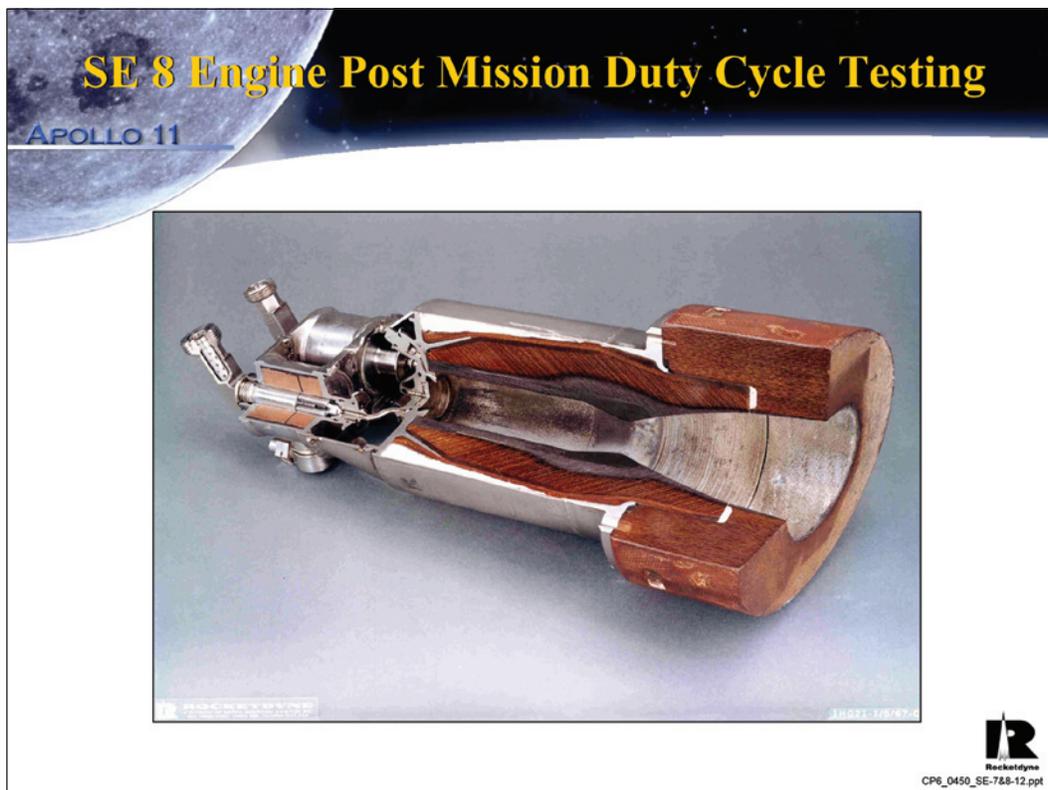
Each Injector Hot Fire Certified

- Issue – Some engines experienced uneven material ablation & throat insert erosion
- 12 Engines per vehicle...12 injector hot fire calibration cycles
- Subjective (visual) appearance required for approval
- Devised a tactile aid for inspectors to approve/disapprove throat wear

We also had an uneven throat erosion issue caused by uneven injector performance. When we went away from the silicon carbide throat material, the substitute material we chose was not as sturdy. The SE-8 program was still schedule driven. We could identify injectors that caused high erosion problems by hot-fire testing each injector in a specially built thrust chamber that used steel throat inserts. A poorly performing injector would erode the steel throats quickly. The plan was to devise some sort of tool for inspecting throat erosion post-test to identify samples with good erosion characteristics and samples with bad erosion characteristics.

By this time, we probably had a database of fifty or so injector tests on steel throats of various discolorations or erosion patterns. I made up a board that basically consisted of samples that were good and samples that were bad. We put them on a metal strip. To do that, and do it in a hurry because we were in production, I went into the shop, found a welder, and said, "This is a 'G job.'" In those days, a G job was special. It took no paperwork, and you could get anything done you wanted. So, we would weld a throat on a strip of metal. Now, it was hot. You had to wait for the first weld to cool down before you could weld the next one. Again, we had injectors at the Rocketdyne test site we were trying to inspect and show were acceptable. This tool was needed in a hurry. We would weld one on, then wait for the thing to cool. It was time-consuming, and I needed to solve the problem. There was a men's bathroom right next to welding station. The welder would weld one strip, and I would run and flush it in the urinal and cool the metal weld immediately. We would then complete the next weld, flush it in the urinal, cool it right down, and repeat the process. (See Slides 12 and 13, Appendix F)

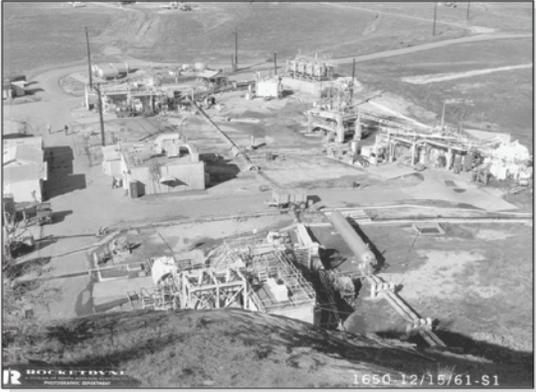
Component Test Lab IV, Santa Su

- Santa Su site of early B-movie westerns
- Two shift test operations
- Intense test slot competition
- Major data reduction effort

Our test facility, Santa Susana (California), had an interesting history. A lot of B Western movies were made there before it became a test facility. If you see a 1920s or 1930s Western, there was a good chance it had been filmed at Santa Susana. Rocketdyne purchased the area for testing rocket engines and built many facilities. This was the facility that tested most small engines. It had four or five small engine test stands. It was a very active facility. Engineers were pushing for their test slots and trying to get things done. We had to test our engine at altitude conditions. We had a very limited capability in terms of altitude simulation testing. It could run approximately fifteen minutes before needing to be reloaded with propellants. To hot-fire calibrate an engine or run development tests, we conducted a test, analyzed our data, and determined our next test condition. If we wanted to change the mixture ratio and the various tank pressures to get another test, we tried to do that as fast as we could with our handy, dandy slide rule calculators. Times were different for testing in the 1960s than they are now. It was fairly frantic because we tried to get as many test conditions as possible in the shortest time span. What we did have were Datelink Independent Gateway Retrofit (DIGR) data recorders - we called them diggers - for instrumentation, which was interesting. The DIGR was a circular plot with an ink pen that showed the test data. A development engineer would run a test, go over and look at the DIGR, and it would tell the value of pressure or thrust or whatever. But, it wouldn't tell right away because there was a hysteresis (or lag time) in the pen. We would have to go over and tap the DIGR to get our values. As soon as we ran a test - we had probably ten DIGRs we had to pay attention to - we were going along tapping every DIGR to get our value. It looked like we were doing some sort of comedy because we would tap all the DIGR, use our slide rules, do all the calculations, and then yell new test values to the test conductor. We would yell, "Change the tank pressures to this." Then, we would do the next test, and start all over again. It was very frantic and very challenging. (See Slides 14 and 15, Appendix F)
