Chapter Two

Paul Coffman

Rocketdyne - J-2 Saturn V 2nd & 3rd Stage Engine

Paul Coffman's Presentation Viewgraphs

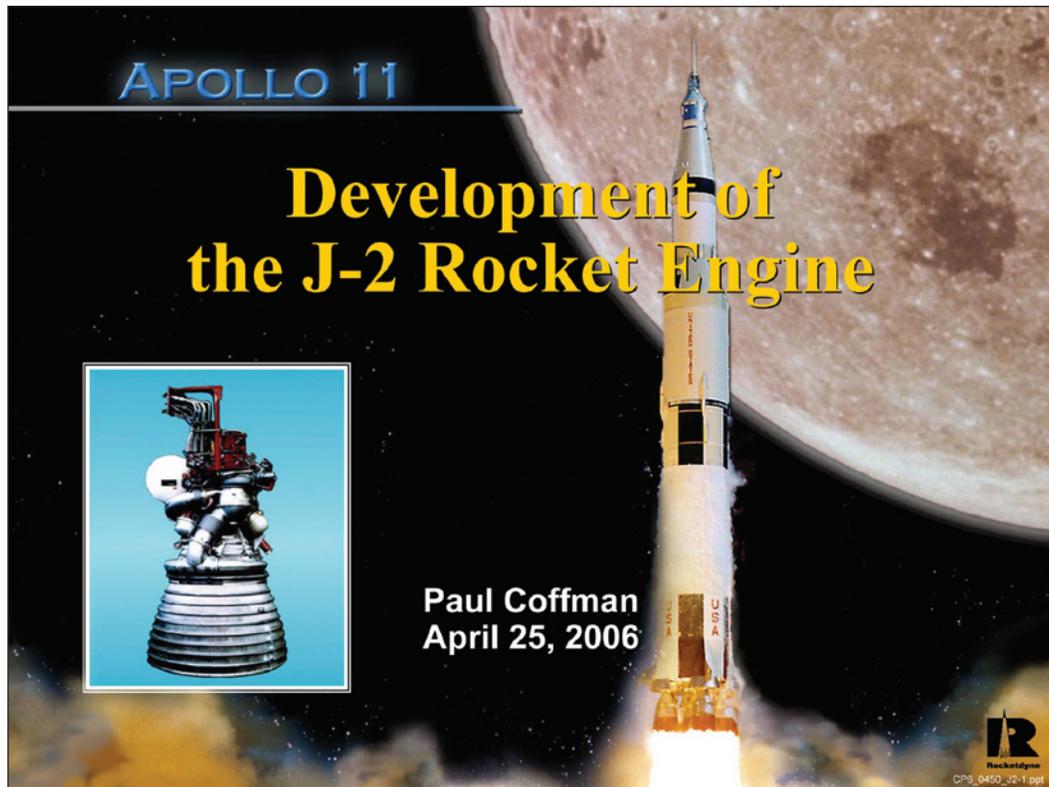
The J-2 Engine

The J-2 engine was unique in many respects. Technology was not nearly as well-developed in oxygen/hydrogen engines at the start of the J-2 project. As a result, it experienced a number of "teething" problems. It was used in two stages on the Saturn V vehicle in the Apollo Program, as well as on the later Skylab and Apollo/Soyuz programs. In the Apollo Program, it was used on the S-II stage, which was the second stage of the Saturn V vehicle. There were five J-2 engines at the back end of the S-II Stage. In the S-IV-B stage, it was a single engine, but that single engine had to restart. The Apollo mission called for the entire vehicle to reach orbital velocity in low Earth orbit after the first firing of the Saturn-IV-B stage and, subsequently, to fire a second time to go on to the moon. The engine had to be man-rated (worthy of transporting humans). It had to have a high thrust rate and performance associated with oxygen/hydrogen engines, although there were some compromises there. It had to gimbal for thrust vector control. It was an open-cycle gas generator engine delivering up to 230,000 pounds of thrust.

We delivered 152 production engines. The specific impulse of 425 seconds did represent a small compromise. Chamber pressure was relatively modest, a little over 700 pounds per square inch absolute (psia), and the mixture ratio was 5.5:1 at that chamber pressure. It also had the capability of operating at a mixture ratio 4.5:1. Basic engine weight was relatively light, and if you make the numbers, you will come out a little bit over 80 percent for thrust-to-weight ratio. Propellants were liquid oxygen and liquid hydrogen. Nozzle area ratio was 27.5:1. Because of the difference in densities, there was a requirement for two different turbopumps. They were separate and located, as conventional wisdom would have it, on opposite sides of the engines just for safety sake. The bearing lubrications were liquid oxygen and liquid hydrogen, so there was no separate lubrication system. The gas generator burned main propellants. (See Slides 2 and 3, Appendix D)
