NASA/TM—2011–216455

# **Direct Visualization of Shock Waves in Supersonic Space Shuttle Flight**

## TECHNICAL MEMORANDUM

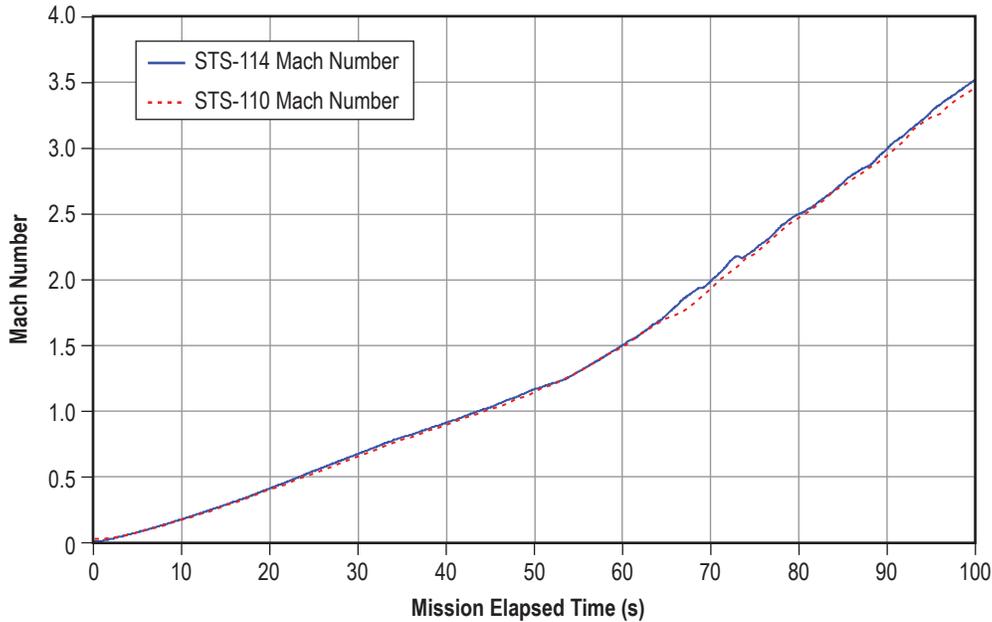
Figure 1. STS-114 and STS-110 SSV Mach number profiles during ascent.

The SSV Mach number can be plotted against mission elapsed time (MET) for a specific mission by using the wind relative Mach number profile acquired from the National Space Transportation System (NSTS) database, as is done for STS-114 and STS-110 in figure 1. Imagery from STS-114 of the shock boundary formation over an elapsed period of time is shown in figures 2–9. Using MET obtained directly from imagery and the plot provided in figure 1, the Mach number of the vehicle can then be determined.

The view angle, the angle from the SSV trajectory to the tracking camera’s principal axis, can be calculated using the BET data from the NSTS database. The shock cone angle, the angle between the vehicle and the shock boundary, is calculated using the oblique shock relations for a Mach 1.45 airflow. The relationship between the view angle and the shock cone angle versus the MET is shown in figure 20. When the shock cone angle is equal to the view angle, an observer at the camera site would be looking directly at the shock boundary. At  $\approx 55$  s MET, the shock cone angle and the view angle are nearly equal. It is during this time that the LODs become visible. The Mach number for STS-110 is shown in figure 1 for reference (dotted line).

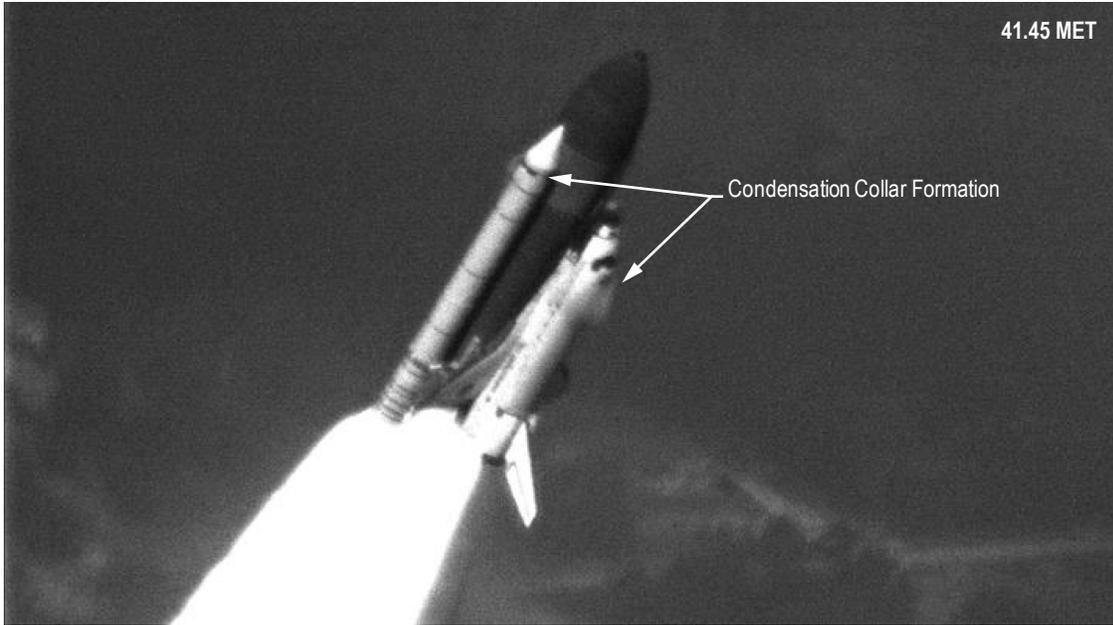
Figure 2. STS-114 condensation collar formation at 41.45 s MET.

A condensation collar is first observed to form at the forward areas of the solid rocket boosters (SRBs), external tank (ET), and orbiter at  $\approx 41$  s MET (fig. 2). The condensation collar is a result of the pressure change at the shock boundary. Given sufficient humidity, condensation of the available moisture provides a visible counterpart to the acoustic shock wave being generated. Depending on atmospheric conditions, the condensation collars typically form just prior to the vehicle attaining Mach 1.0. For STS-114, the Mach number was  $\approx 0.95$  when the condensation collars were first observed to form.

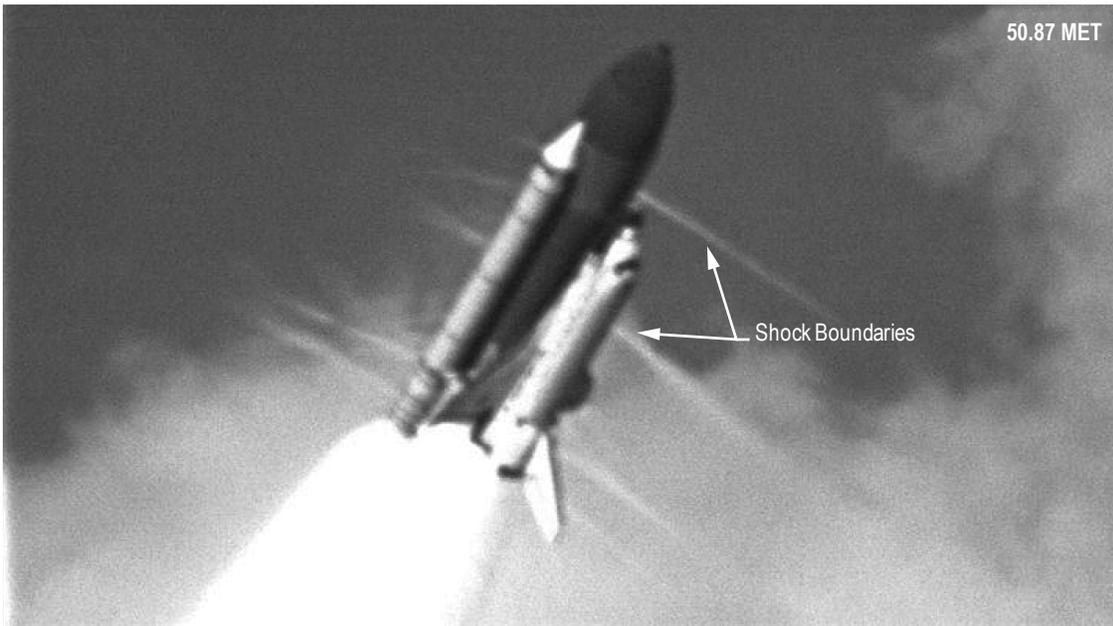
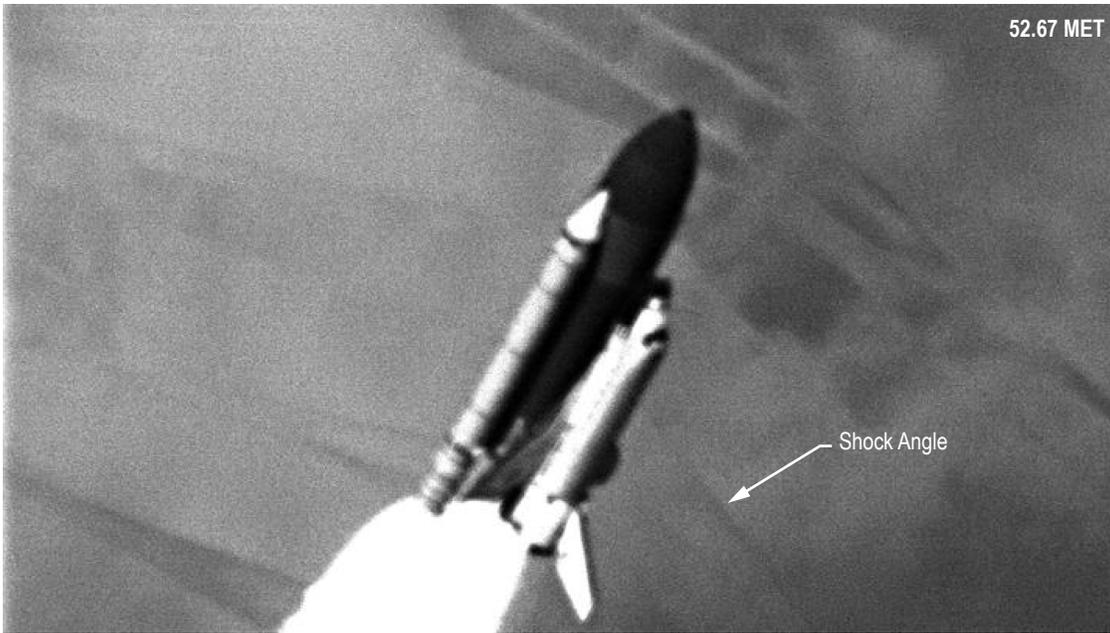
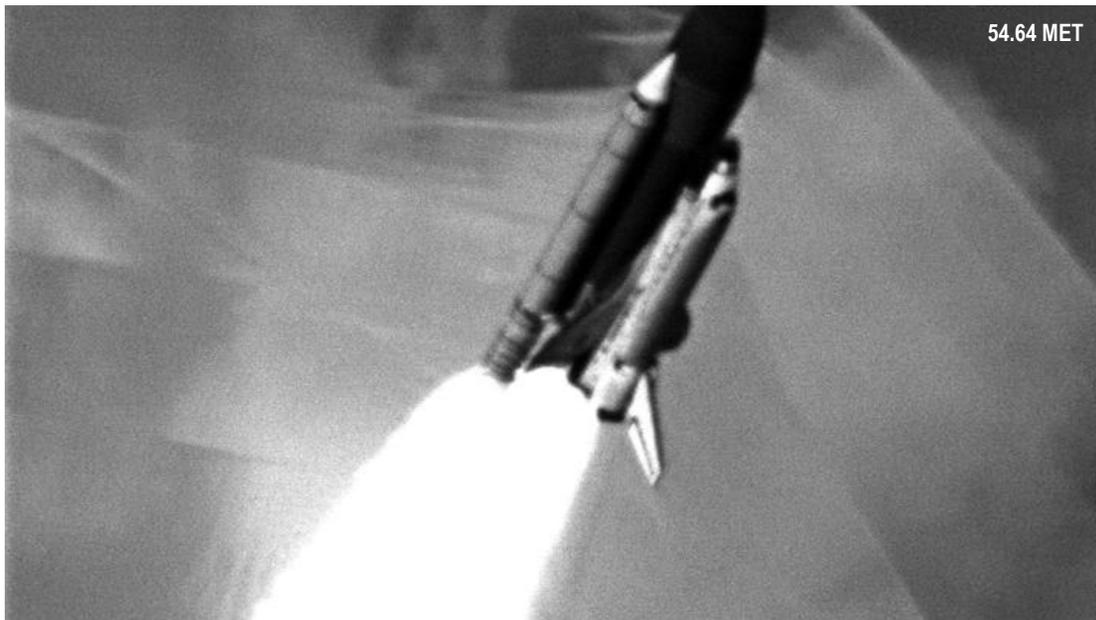
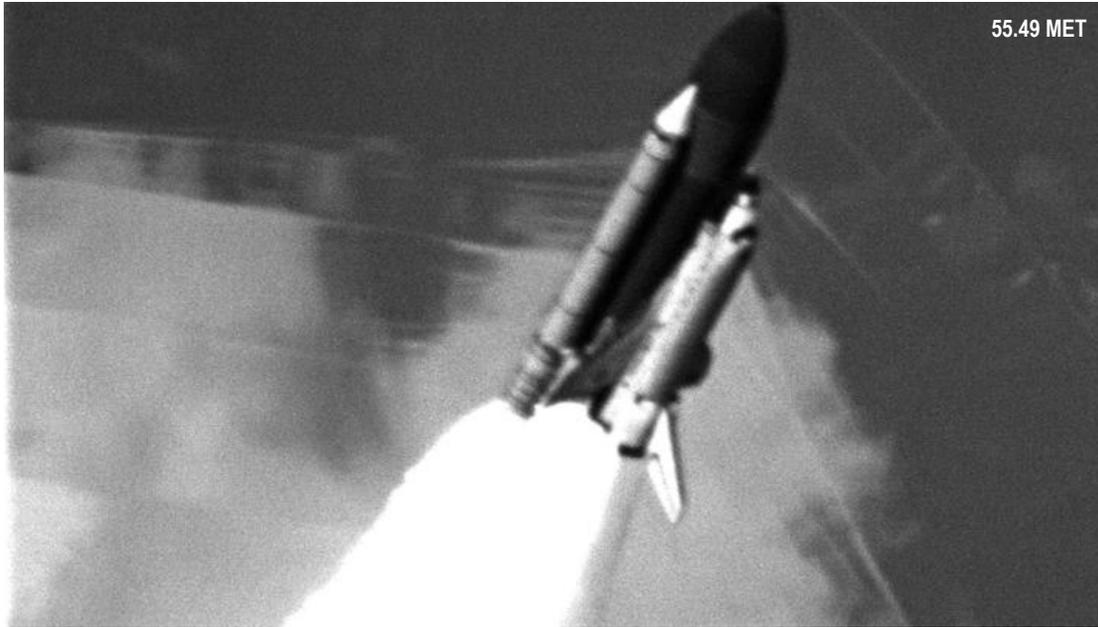
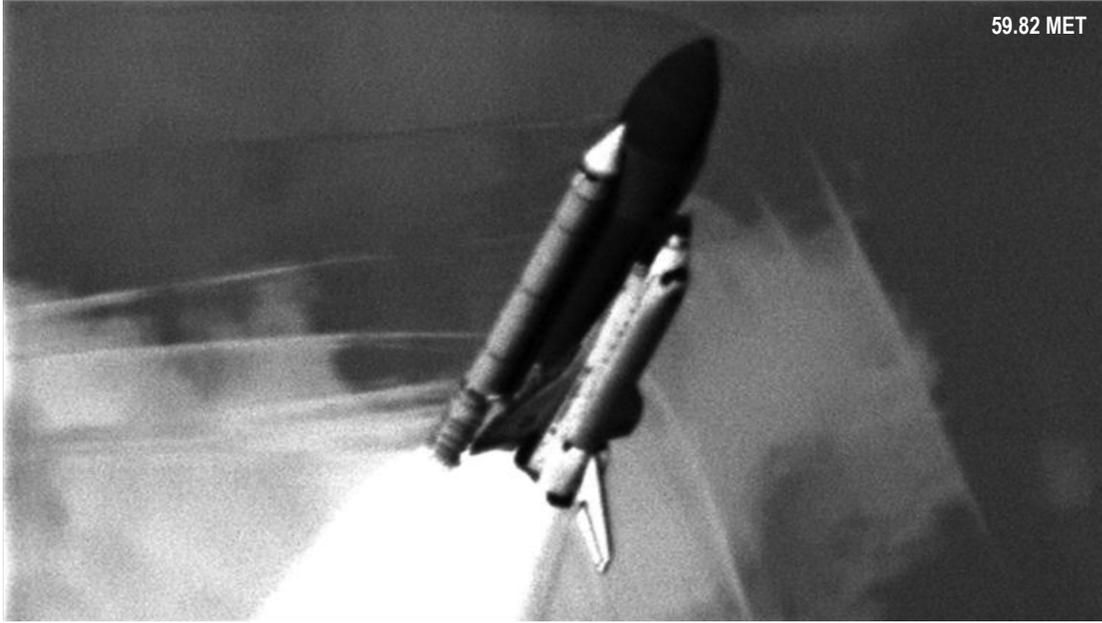
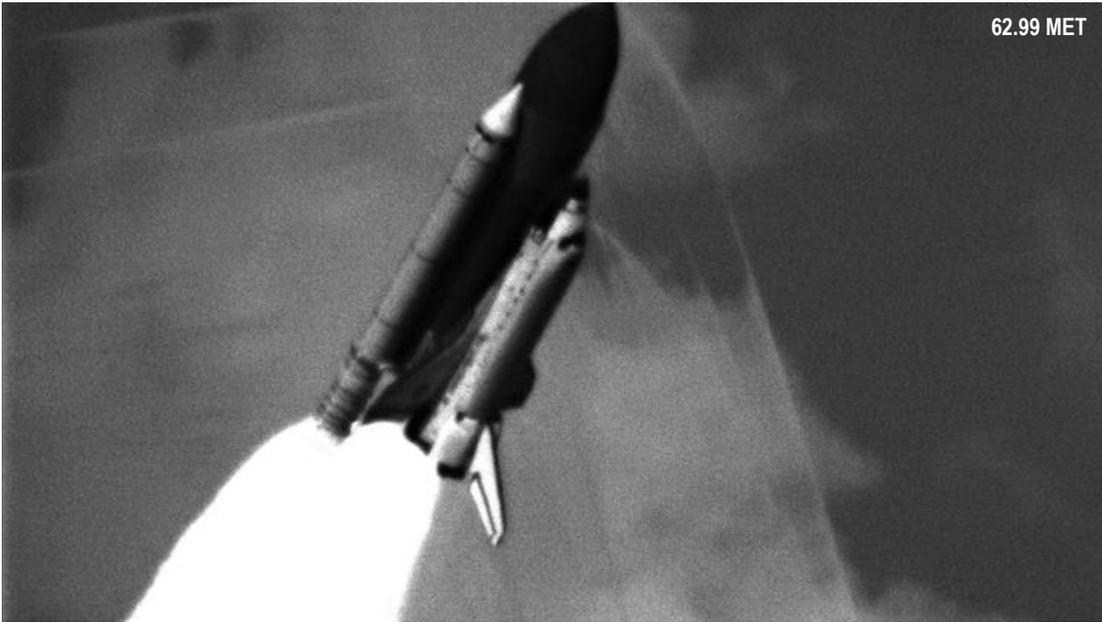
Figure 3. STS-114 shock structure at 50.87 s MET.

Figure 4. STS-114 shock structure at 52.67 s MET.

Figure 5. STS-114 shock structure at 54.64 s MET.

Figure 6. STS-114 shock structure at 55.49 s MET.

Figure 8. STS-114 shock structure at 59.82 s MET.

Figure 9. STS-114 shock structure at 62.99 s MET.

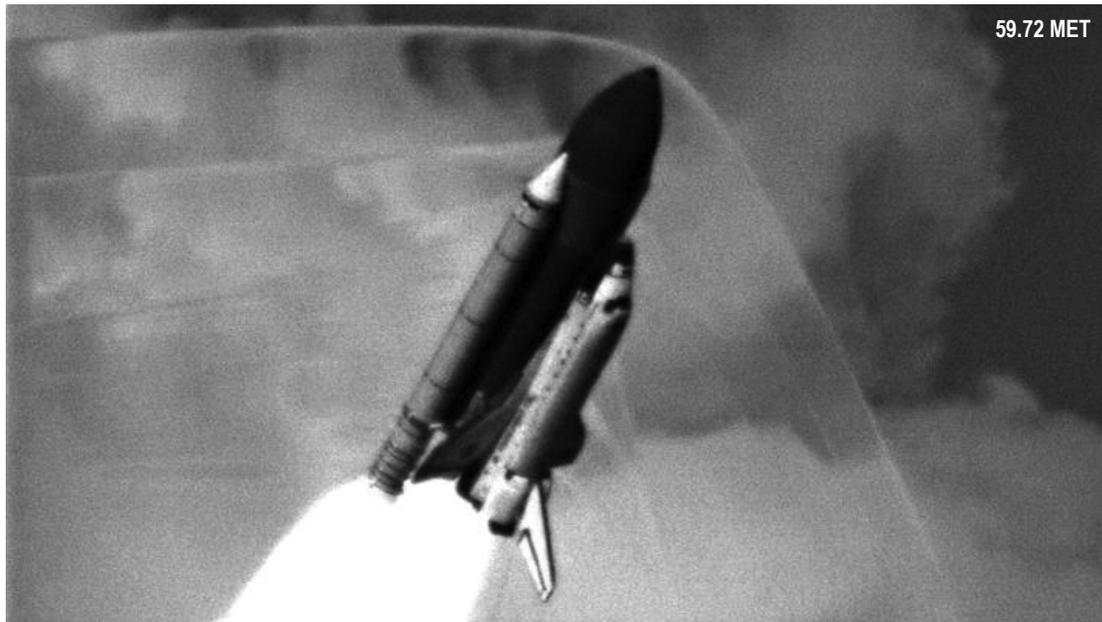
Figure 7. STS-114 shock structure at 59.72 s MET.

As the Mach number increases, the shock angle to the vehicle becomes more acute. The bow shock and the structure of the secondary shocks from vehicle protuberances are clearly visible (fig. 7).

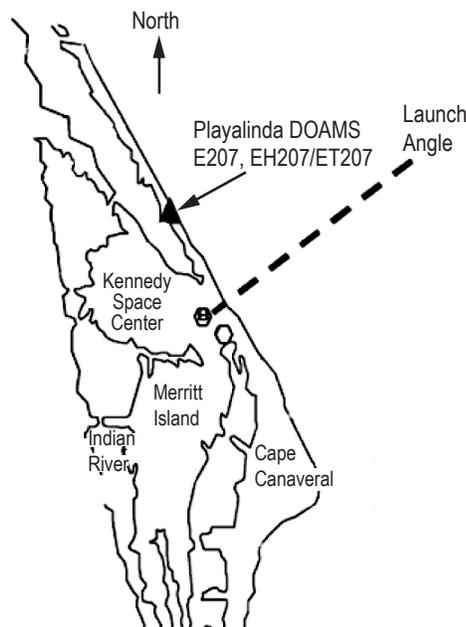
Figure 10. Camera E207 location.

Long-range tracking camera E207, located at Universal Camera Site-10, is  $\approx 5$  mi to the north and 2 mi to the west of the space shuttle launch site on pad 39-B (fig. 10). This 35-mm film camera is equipped with a 400-in focal length lens, which provides a close-up view of the aft area of the orbiter through SRB separation.

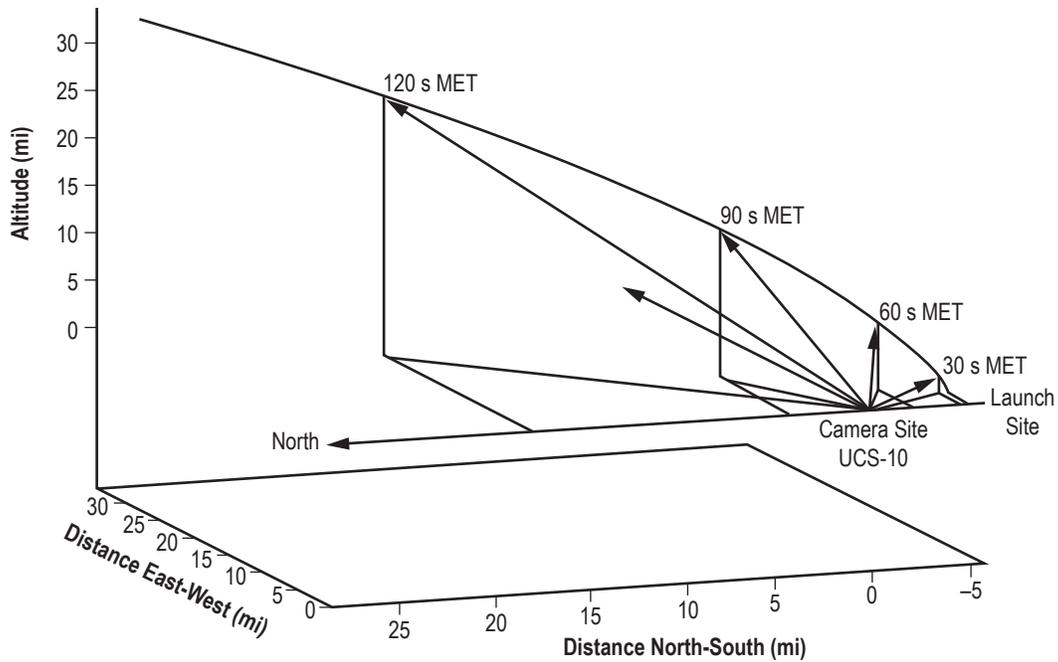
Figure 11. STS-110 trajectory from BET data.

During STS-110, long-range ground cameras tracked the SSV from lift-off through separation of the SRBs from the orbiter and ET. Separation of the SRBs occurs  $\approx 2$  min after lift-off. For this particular mission, the sky was clear, providing excellent conditions for viewing the SSV during ascent. The vehicle traversed a trajectory determined from best estimated trajectory (BET) data as shown in figure 11.

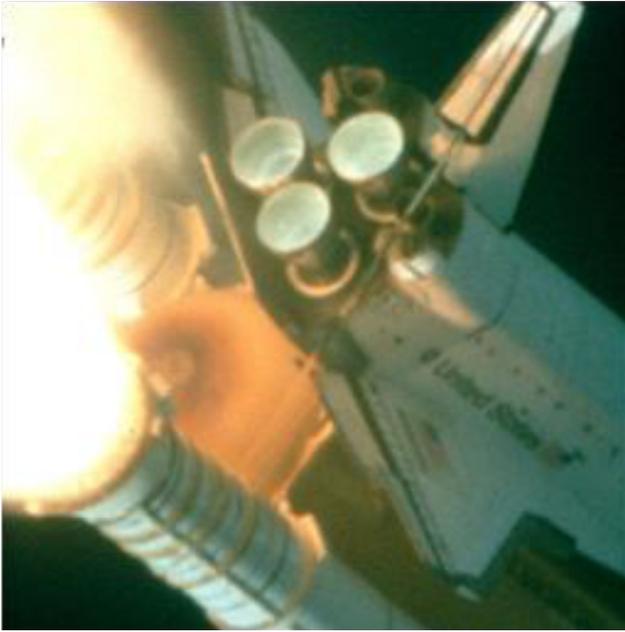
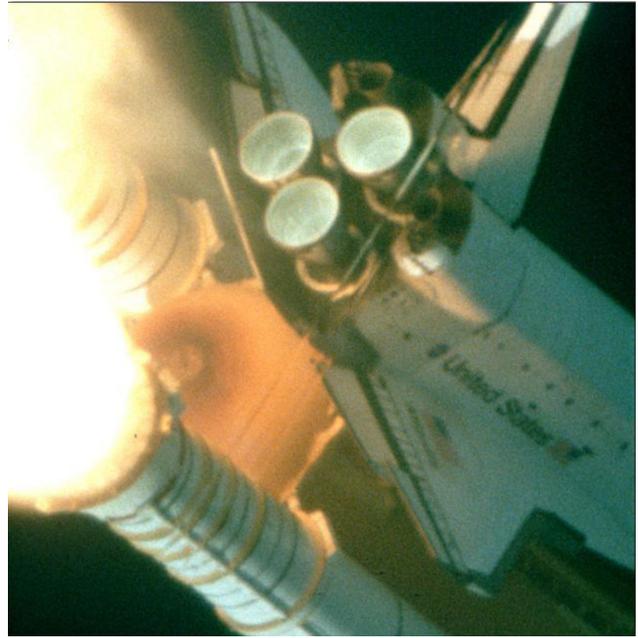
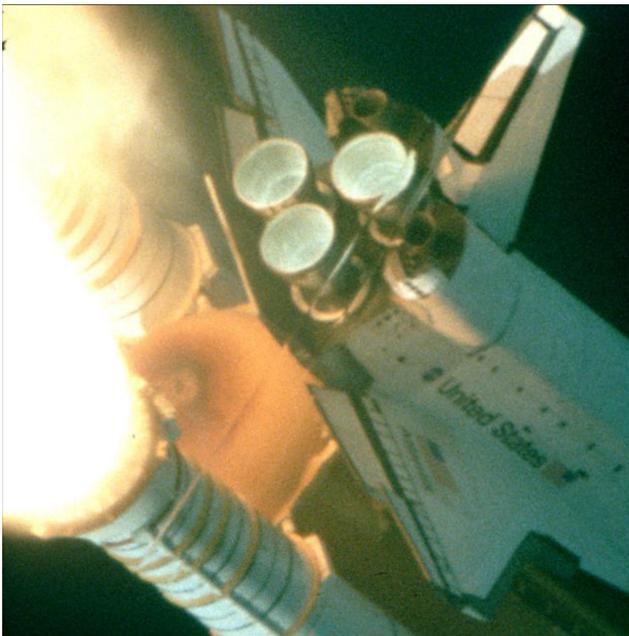
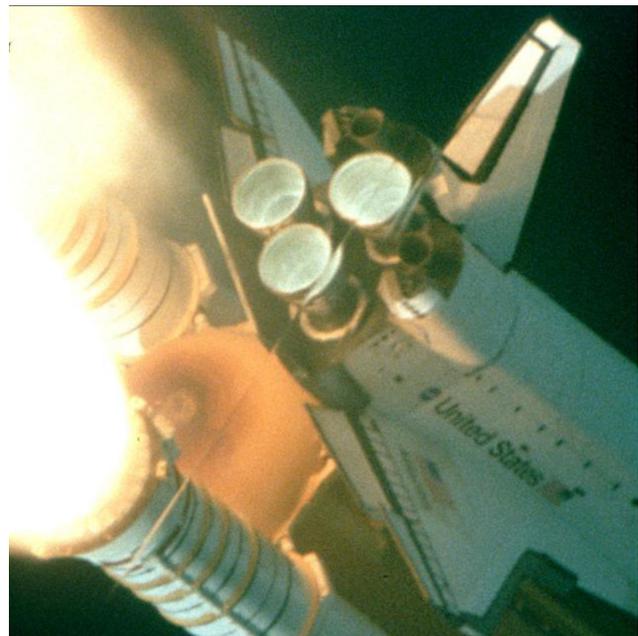
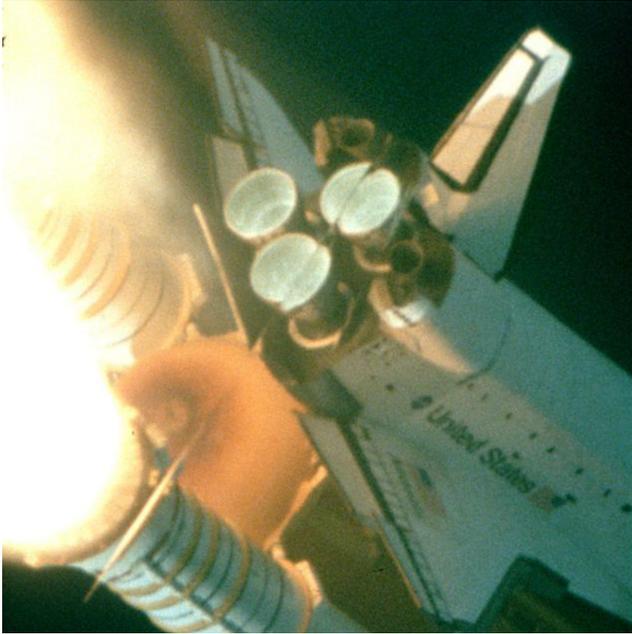
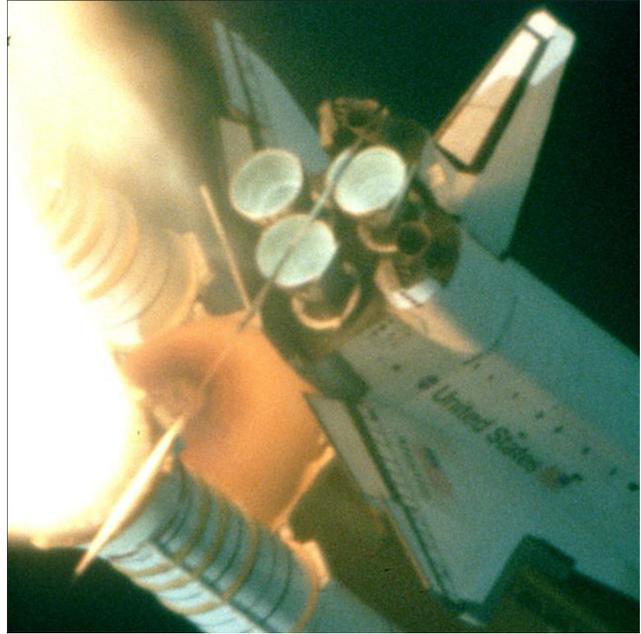
Figure 12. STS-110 shock at 59 s MET.

Figure 13. STS-110 shock at 59.002 s MET.

Figure 14. STS-110 shock at 59.005 s MET.

Figure 15. STS-110 shock at 59.007 s MET.

Figure 16. STS-110 shock at 59.010 s MET.

Figure 17. STS-110 shock at 59.012 s MET.

In figures 12–19, a shock appeared approximately midway along the orbiter body and traveled nearly perpendicular to the axial direction of the vehicle in the image. The shock boundary moved aft of the SSV in the field of view, disappearing from camera view in the SRB plumes. Figure 13 clearly shows ripples in the shock boundary. All of the images show the bending of light due to refraction through the high-density shock layer. It is interesting to note that the shock boundaries that are visible are the same color as the original area of refracted light.

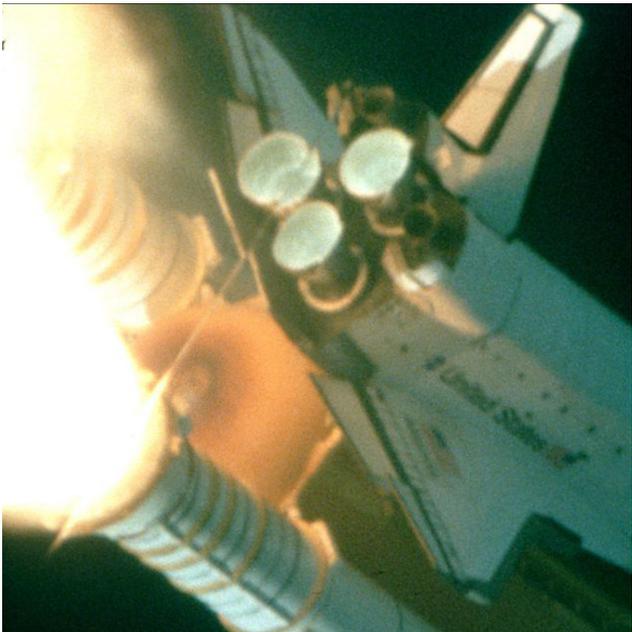
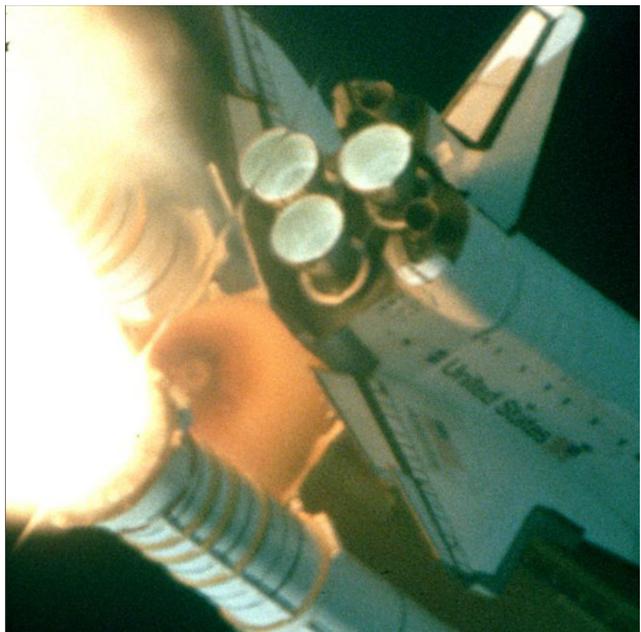
Figure 18. STS-110 shock at 59.015 s MET.

Figure 19. STS-110 shock at 59.017 s MET.

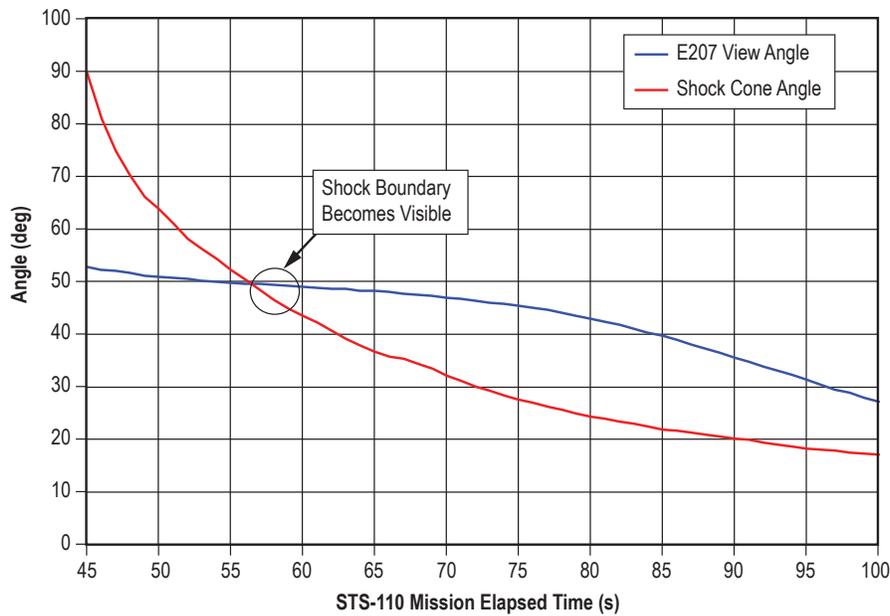
Figure 20. Camera E207 view angle versus chock cone angle.

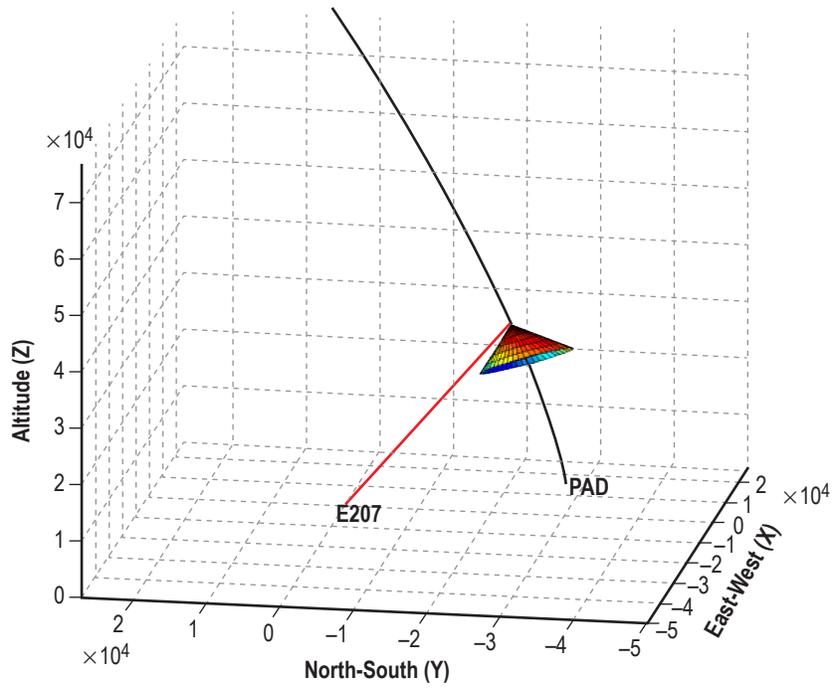
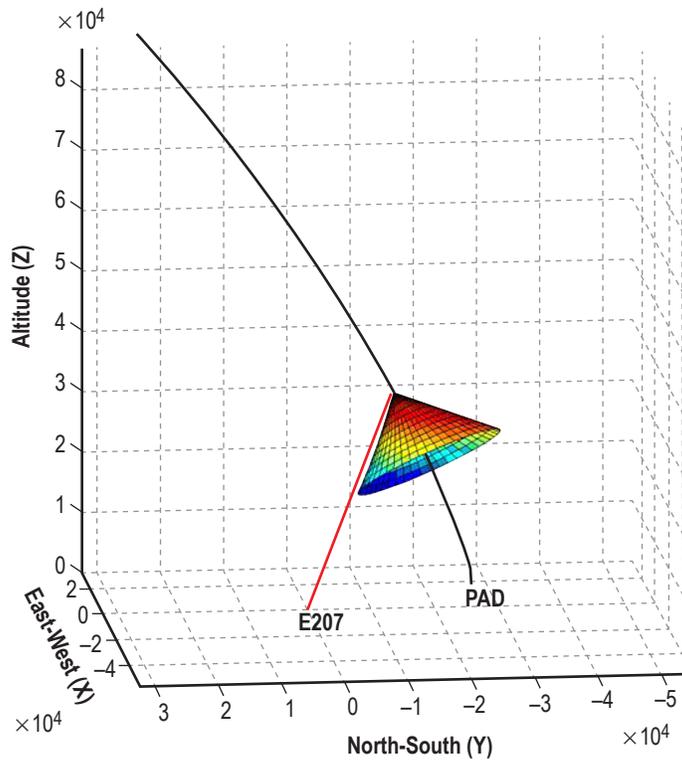
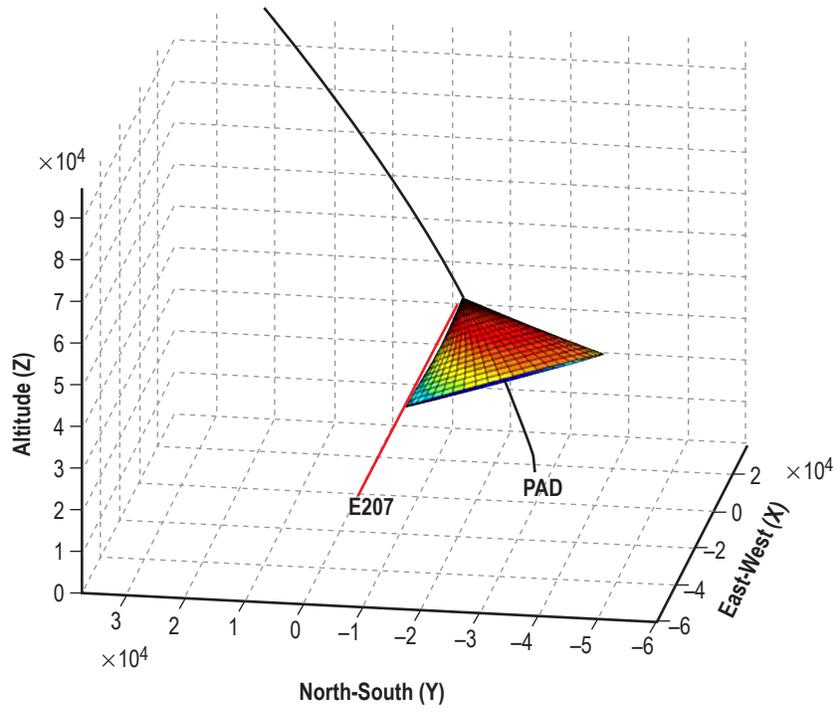
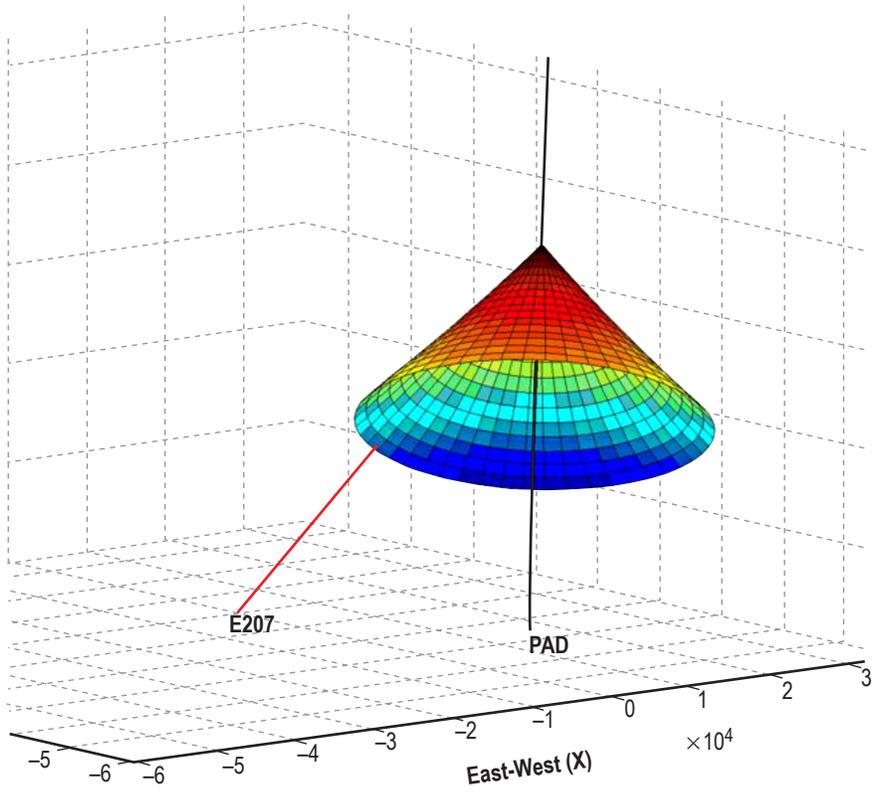
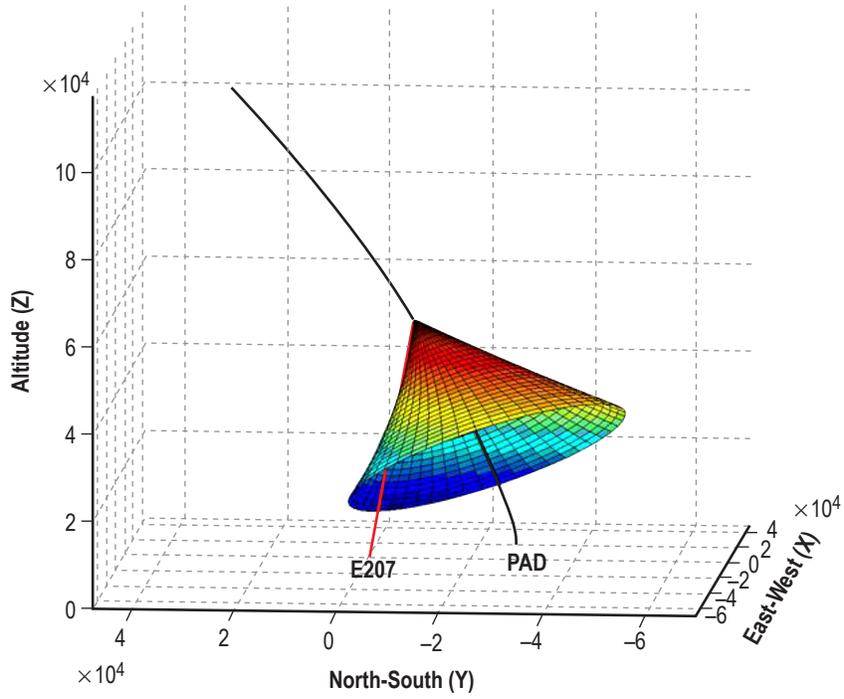
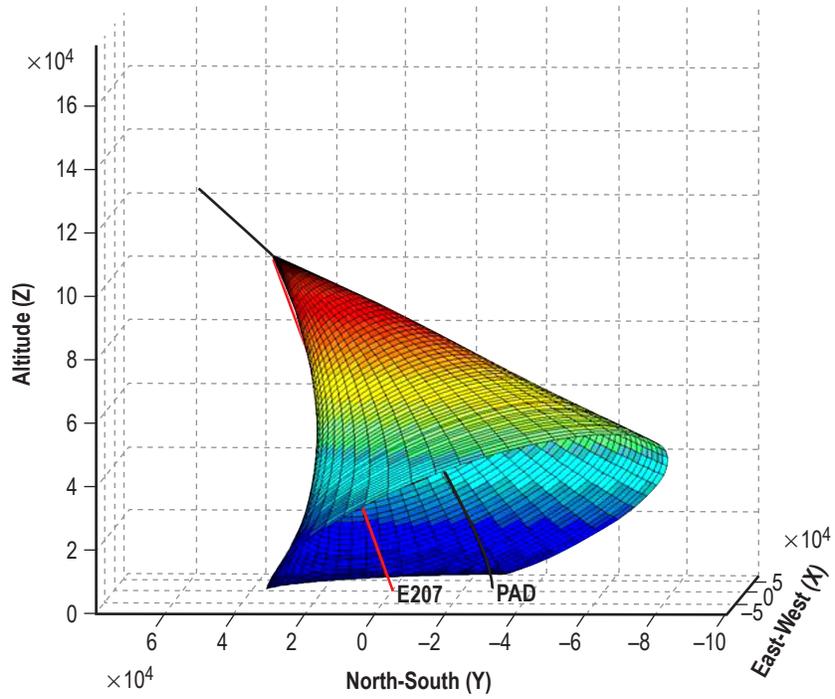
Figure 21. STS-110 shock sheath at 50 s MET.

Figure 22. STS-10 shock sheath at 55 s MET.

Figure 23. STS-110 shock sheath at 60 s MET.

Figure 24. STS-110 shock sheath at 60 s MET.

Figure 25. STS-110 shock sheath at 70 s MET.

Figure 26. STS-110 shock sheath at 100 s MET.

As the SSV ascends and attains Mach 1.0, shock waves form and travel away from the vehicle at the speed of sound. During that time, LODs are observed as shock waves passing through the view of the long-range ground tracking camera. At several instances in time, the geometry of the shock cone and the line of sight were modeled in MATLAB using the STS-110 trajectory and theoretical sound speed at the corresponding altitude and are shown in progression in figures 21–26.

In the following graphs, the black curve is the trajectory of the SSV, the red line is the line of sight from camera E207 to the SSV at the time indicated, and the conical structure is the spread of the sonic shock boundary. In the early MET images (figs. 21 and 22), the conical shock sheath has grown little and the line of sight from the camera to the orbiter does not intersect the shock sheath. At 60 s MET, the simulation estimates that the shock sheath has intersected the camera line of sight as shown in figures 23 and 24.

The MATLAB simulation uses theoretical data for atmospheric parameters determining the speed of sound at the corresponding altitude; therefore, the model will not give precise intersection data for missions when the line of sight intersects the sheath boundary. However, the simulation places the intersection in approximately the correct timeframe. Typically, the LODs are first observed around 55–60 s MET. Prior to 55 s MET, the line of sight precedes the growing shock sheath and after 60 s MET, the line of sight clearly intersects the shock sheath.

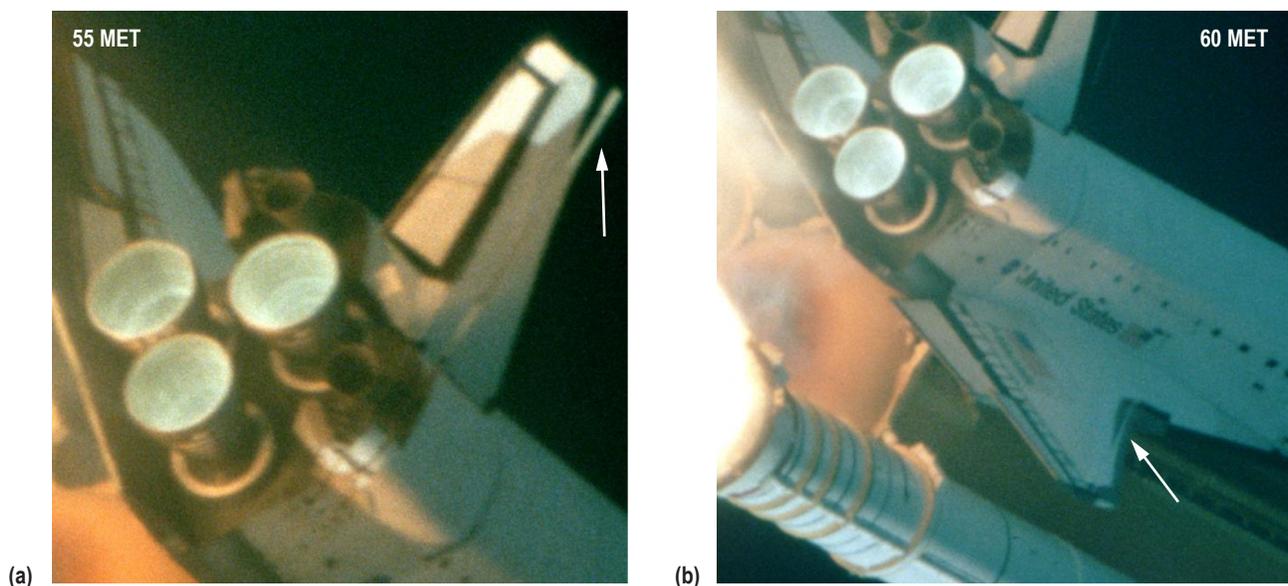
Figure 27. STS-110 LODs at (a) 55 s and (b) 60 s MET.

Often several LODs are observed during ascent and many times there are several visible at once. LODs typically appear on the vehicle body and move aft. The first LOD is noted at  $\approx 55$  s MET. A late occurring LOD often appears and travels aft at  $\approx 60$  s. The time of appearance is thought to be related to a particular shock boundary. It is thought that the 55 s MET LOD is probably related to the aft shock from the tail of the vehicle and the 60 s MET LOD could be related to the bow shock of the vehicle. These two shocks are illustrated in figure 27.

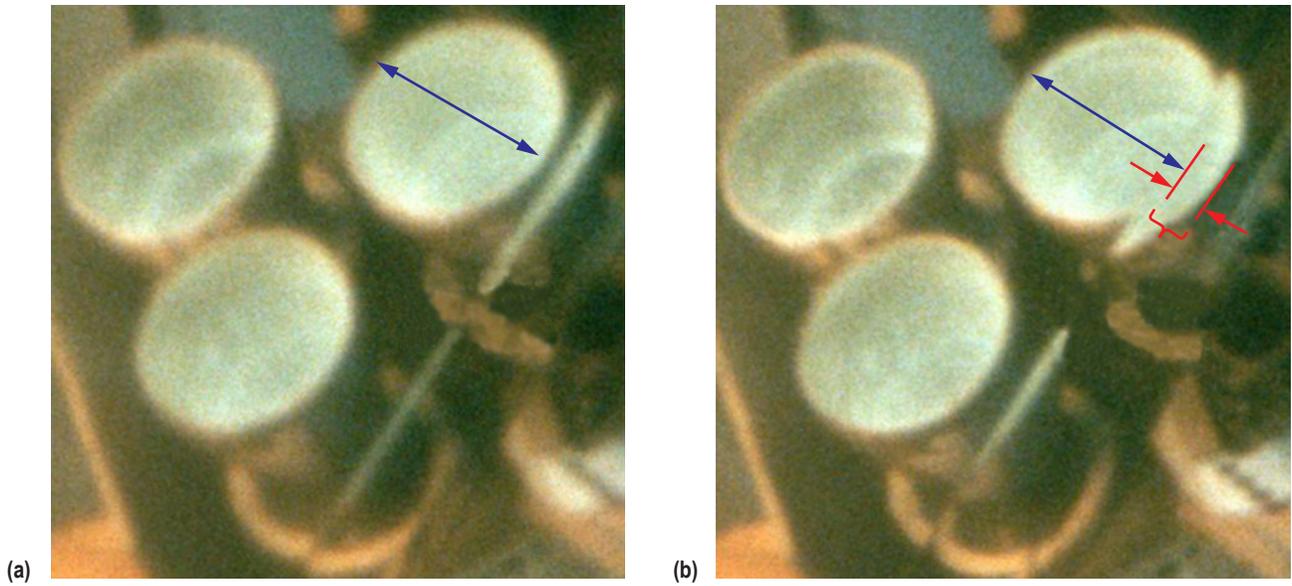
Figure 28. STS-110 SSME No. 1 nozzle refracted through shock boundary layer: (a) Actual SSME diameter (blue arrow) and (b) bending due to refraction (red arrow).

Due to the density differences on opposite sides of the shock boundary, refraction of light will occur. When utilizing imagery for object measurement and/or identification, care must be taken to account for the shift in object location due to refraction at the shock boundary. Measurement errors across shock boundaries may be quite significant. In STS-110 imagery from camera E207, as shown in figure 28, the position of one edge of the space shuttle main engine (SSME) nozzle

No. 1 has shifted by nearly 20% of the actual diameter or about 20 in. This gives an indication of the amount of pixel shift necessary to make measurements across the shock boundary at the particular time the image was obtained.

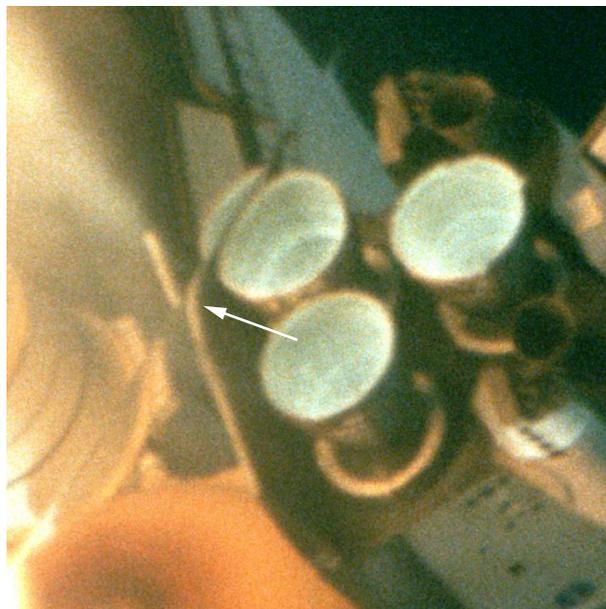
Figure 29. View angle effect on LOD.

The view angle to the vehicle also shifts the observed position through a shock boundary. This may be observed as a discontinuity in the continuous orbiter body flap structure (fig. 29).

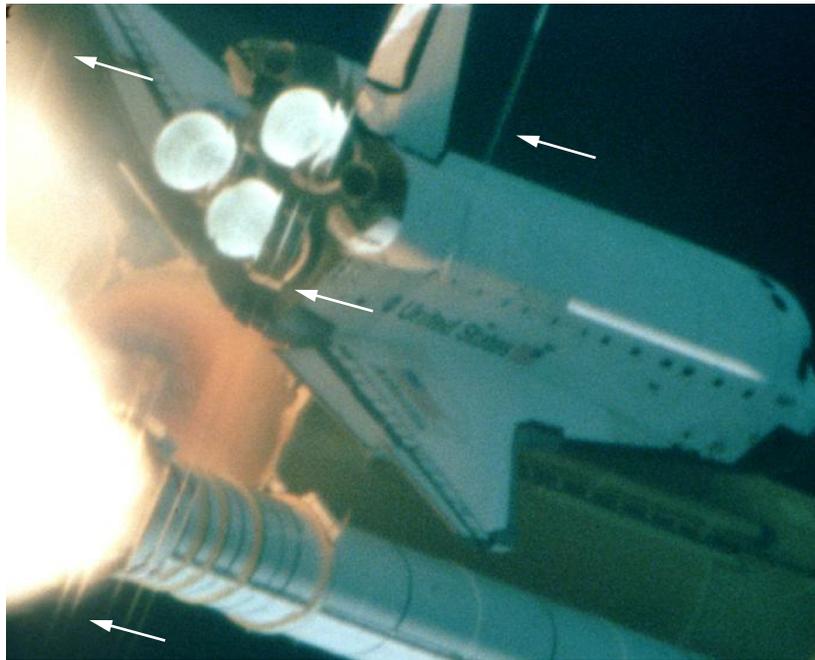
Figure 30. Multiple LODs visible.

Often multiple LODs are visible. Typically, a particular shock boundary may be distinguished by a group of LODs that travel together. Four groups were noted in figure 30. Although the LODs in each group move together, it is unknown whether separately these groups are associated with one shock or with multiple shock boundaries. The LODs are often difficult to track for extended periods since they become washed out by the brightness of the SRB plumes or indistinct from the background as they travel forward where the amount of light reflected from the vehicle is insufficient to illuminate the shock boundary.

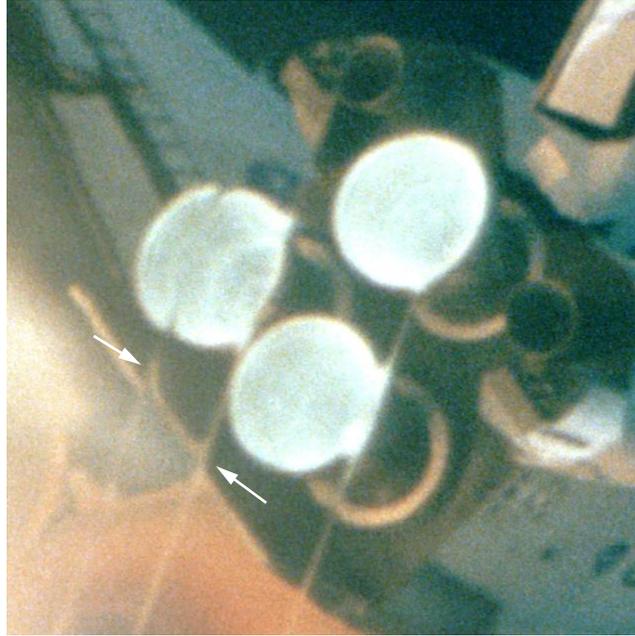
Figure 31. Refraction direction illustrates ripples in the shock boundary.

Along the body flap (fig. 31), the refraction due to a shock boundary may be observed to be deflected toward the top of the image. The leftmost arrow points to a LOD where the body flap is deflected upward from the right side of the boundary. The right arrow points to a LOD where the body flap is deflected upward from the left side of the boundary. In this particular example, the two LODs noted are associated with a group that moves together and may be correlated to one particular shock boundary. However, there are also LODs that move in opposite directions that also exhibit this phenomenon and it is suspected, but unknown, whether these LODs are associated with separate shock boundaries.

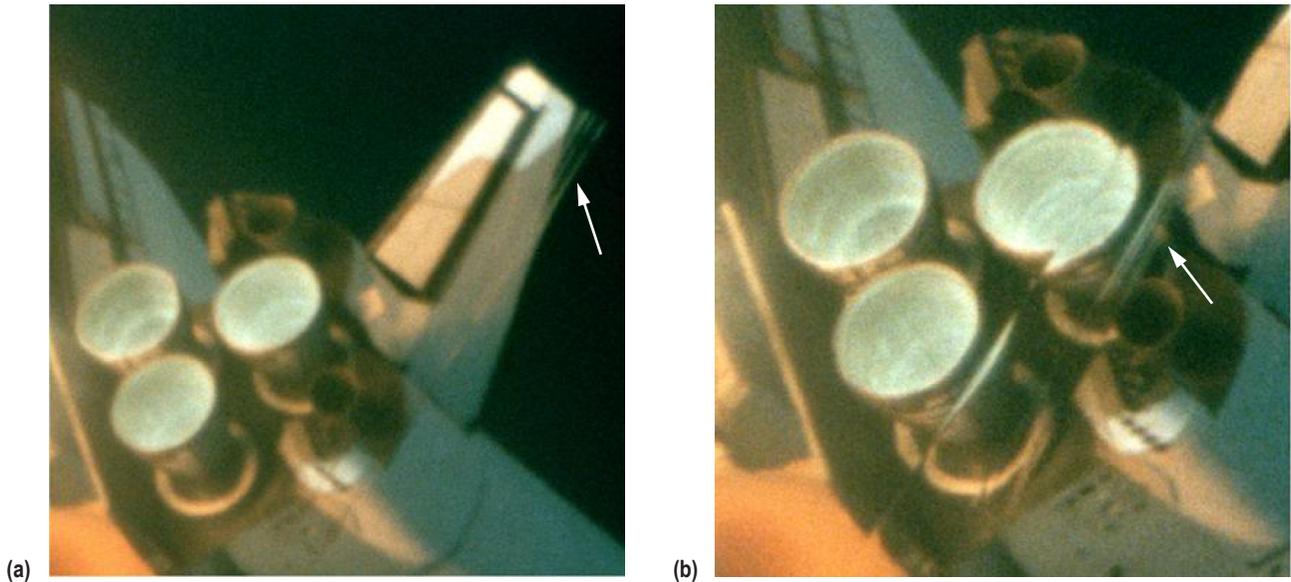
Figure 32. Minor ripples in the shock boundary: (a) Noted at a time prior to the time for (b).

Also at the edge of a shock boundary, a spread of minor ripples is observed (fig. 32). These two images are from the same LOD group and ostensibly from the same shock boundary. (The LOD group travels aft.) The cause of these minor ripples is unknown. Larger ripples of this same LOD group are noted at the SSME nozzle in (a).

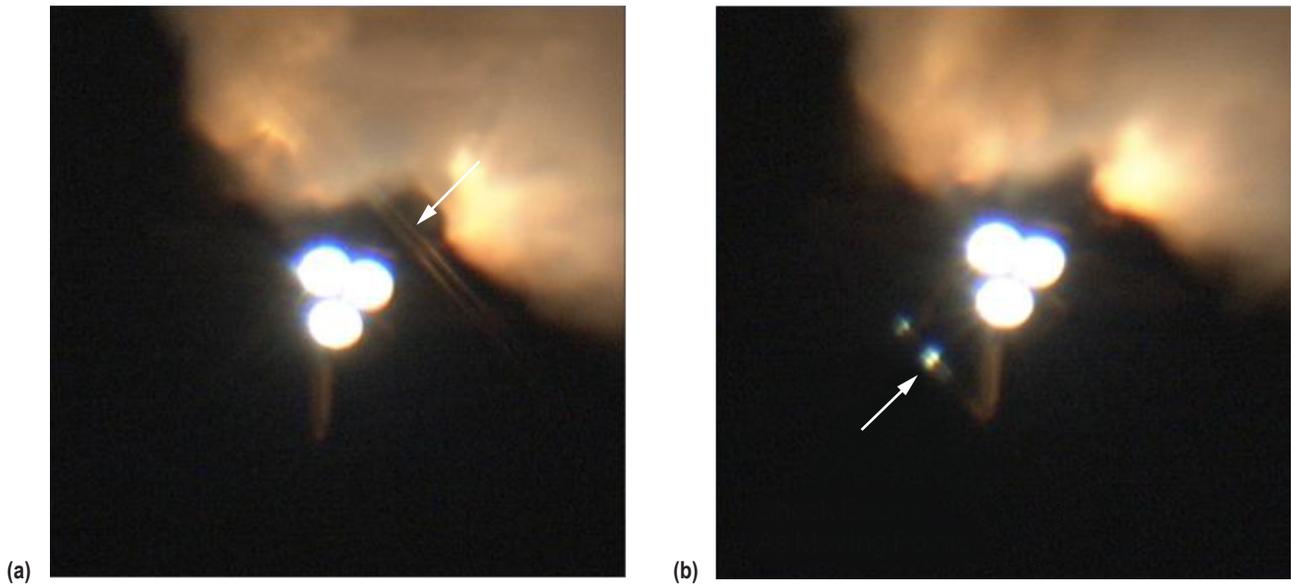
Figure 33. STS-116 SSME refraction: (a) Shock boundary visible in SRB plumes and (b) shock boundary visible as moving points of light.

Often during post-launch imagery evaluation, debris that falls aft of the vehicle during ascent can only be described as a light-colored object. When the vehicle is near SRB separation, only a few of the long-range tracking cameras have a resolution capable of distinguishing debris from the refractive effects of LODs. In figure 33, imagery from camera E207 during STS-116 captures the refractive effects of a shock boundary in the SRB plumes. Light from the SSMEs was also refracted and appeared as light-colored objects moving aft of the vehicle. Identification of shock boundaries helped to eliminate this observation as debris from the vehicle.

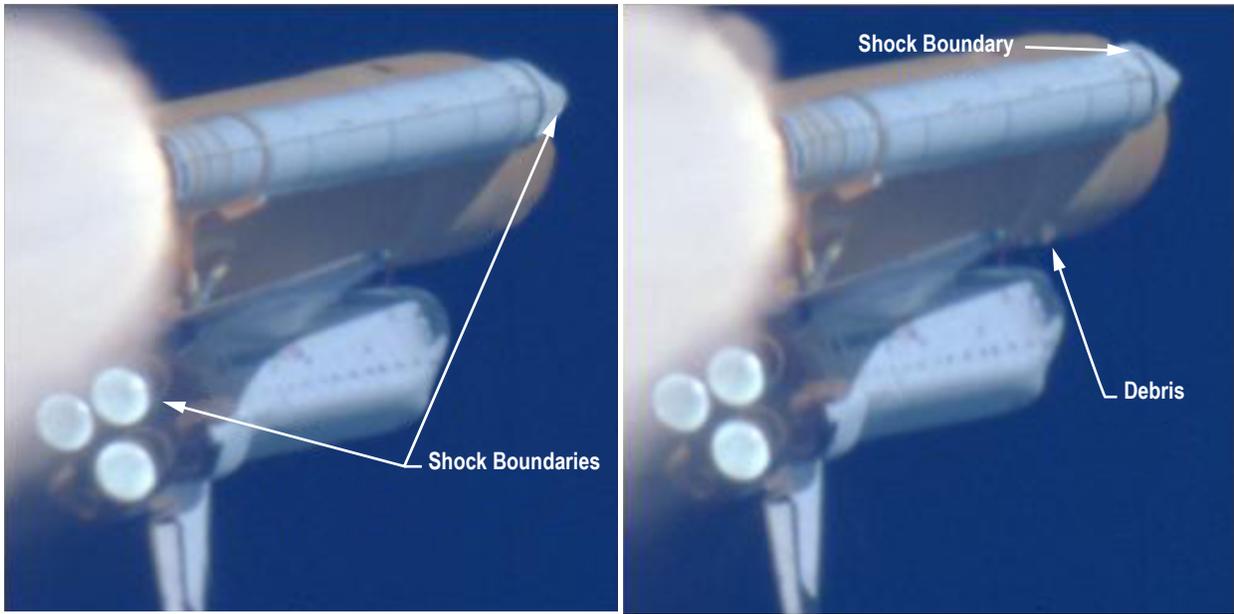
Figure 34. STS-107 shock boundaries (LODs).

Another example of this occurred on STS-107. As debris impacted the reinforced carbon-carbon (RCC) panels, there were multiple shock boundaries visible in the imagery from long-range tracking camera E212 (fig. 34). The shock boundaries were faint in the imagery due to the ambient lighting and resolution of the camera at that distance.
