NASA/TP—2011–216300R

## Evaluation of Cable Harness Post-Installation Testing: Part B

### EVALUATION OF CABLE HARNESS POST-INSTALLATION TESTING: PART B

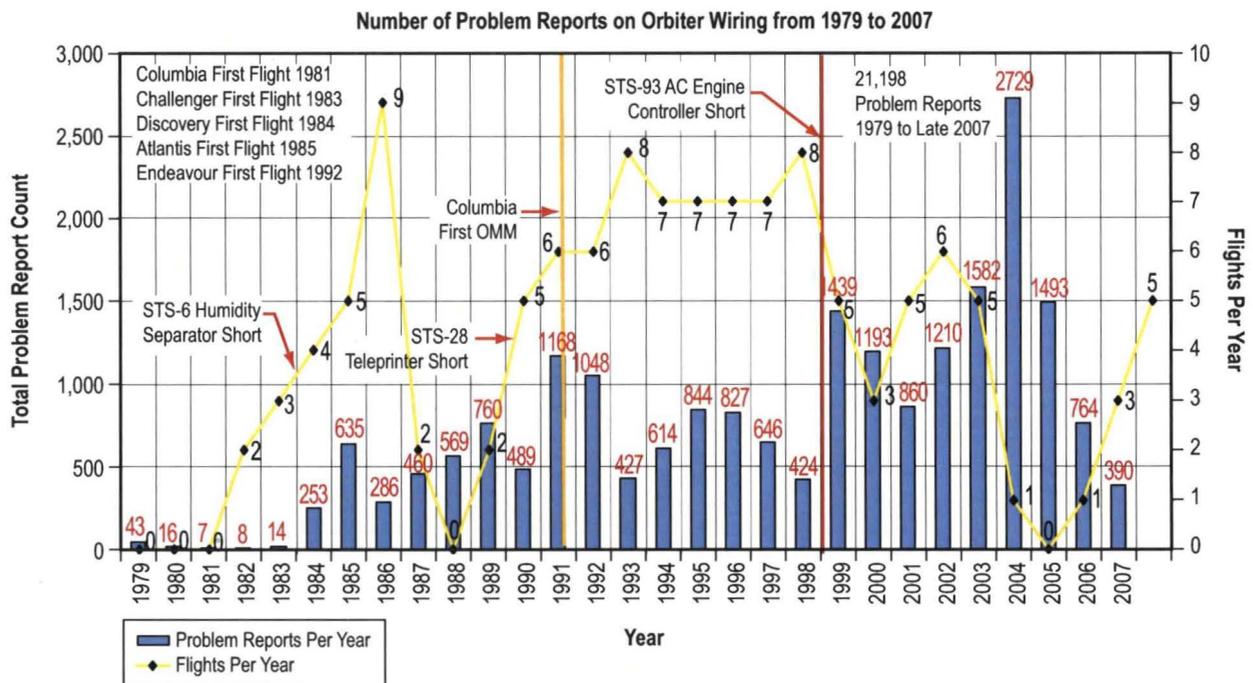
Figure 2 shows the relationship between the number of wire problem reports (PRs) per year and flights per year. Note that the flight rate data are erroneously shifted to the right one year. From the data, there is no indication that wiring PRs decrease with vehicle maturity in the case of the Orbiter (although Ares' single-use, ship-and-shoot strategy makes this not directly comparable to Ares). Also, per the Orbiter electrical team, there are two major reasons that Orbiter wiring PRs increase during low flight-rate years: First, inspections of wiring go up during those years. Second, as the flight rate decreases, there is more traffic in the ship resulting in an increase in collateral damage.

Figure 2. Shuttle (Orbiter) wiring problem reports and flight rate from 1979–2000.

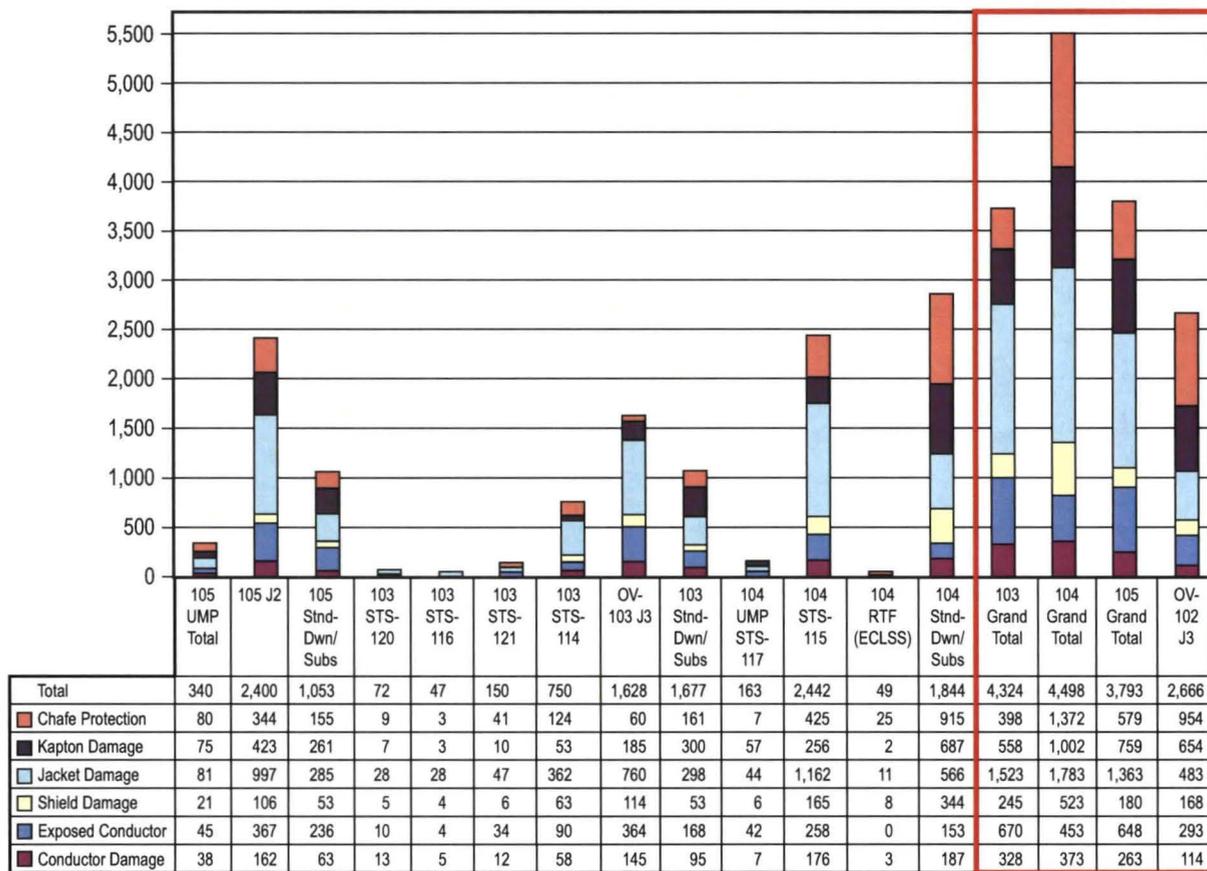
Figure 3 shows a breakdown of the types of wire-related problems encountered in the Orbiter fleet. Note that some of the most significant categories include damaged conductor and exposed conductor.

Figure 3. Orbiter wiring problem breakdown.

Clearly, handling-induced damage or damage resulting from work in close proximity is a primary source of wiring anomalies. The question is: Of the total set of wiring problems, how many, if any, can the post-installation testing in question screen? To answer this question, the team took a different approach on data collection. The idea was to generate a very narrow search criteria with the intent of finding instances where the post-installation testing described in this report uncovered

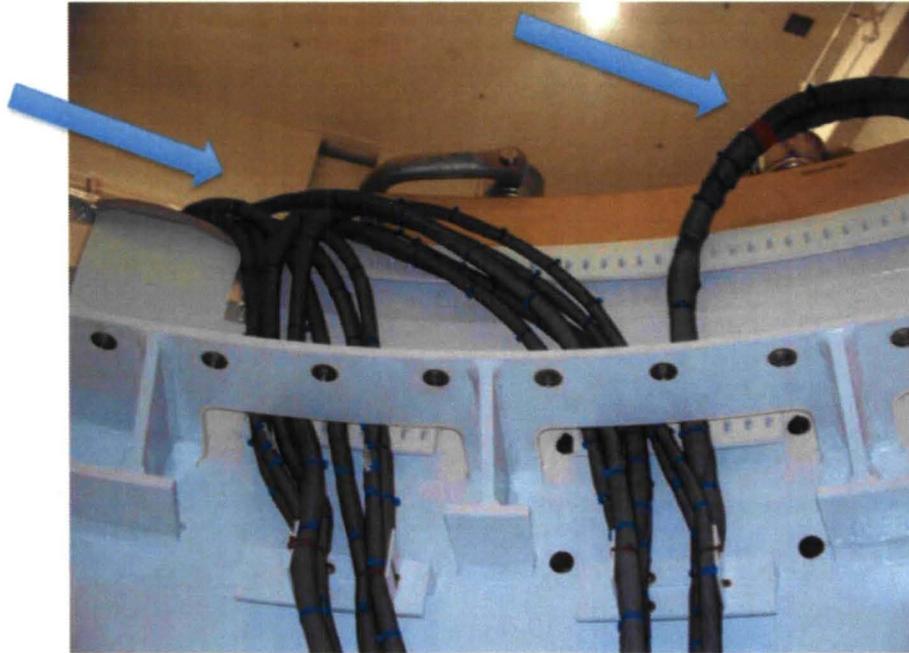
In figure 4, the harnesses are draped over the cylinder to allow the technicians to connect to the harness. Given most of the failures have occurred in the last 12 inches, and those last 12 inches are being manipulated after the test, in addition to when the cables are finally mated, this design is not optimal with respect to cable testing.

Figure 4. Ares I-X cable harness test configuration.

- Selecting easily mated/demated connectors.
- Designing for special test connectors that allow technicians to leave the harness in the near final location for testing.
- Considering a common connector.
- Developing a common method to hold the test connectors and harness in place during the testing process.

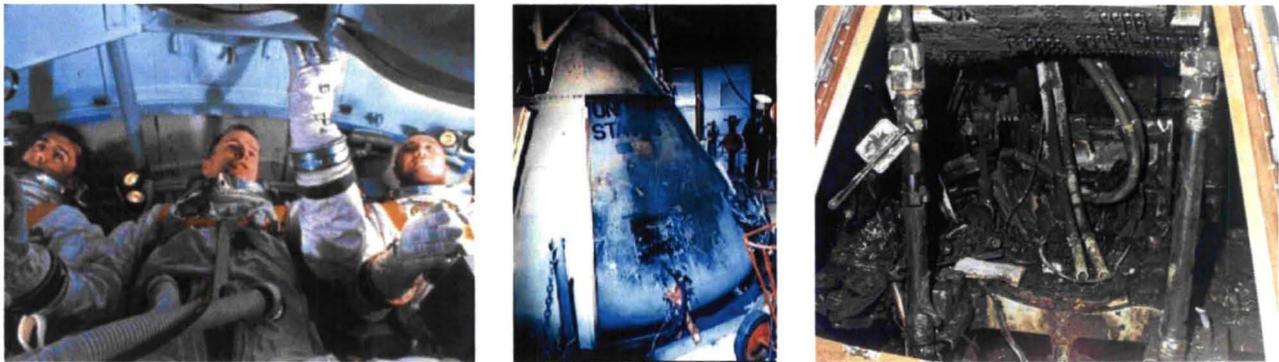
Figure 5. Apollo 1 fire (crew, capsule, and damage).

Listed in the Apollo 1 findings was that it is most probable that the fire was initiated by an electric arc and was most probably brought about by some minor malfunction or failure of equipment or wire insulation. Components of the Environmental Control System installed in Command Module 012 had a history of many removals and of technical difficulties that included regulator failures, line failures, and environmental control unit failures. The design and installation features of the environmental control unit made removal or repair difficult. In addition, deficiencies in design, manufacture, installation, rework, and quality control existed in the Teflon® electrical wiring. The report conclusion included a recommendation that rigid inspection at all stages of wiring design, manufacture, and installation be enforced.

Finally, it should be noted that a number of high-profile failures in NASA history have listed wiring faults and handling-induced damage as related causes. Included in these are the Apollo 1 and Apollo 13 incidents and a number of Shuttle anomalies. The Apollo 1 fire shown in figure 5 (as excerpted from The Apollo 204 Report) occurred during a full-up launch simulation on January 28, 1967. A momentary increase in alternating current (AC) Bus 2 voltage on all three phases was noted at  $\approx 9$  seconds before the report of fire, and at the same time telemetry data from equipment powered from AC Bus 2 showed abnormalities. All communications were lost 18 seconds later. The rapid spread of fire within the pure oxygen atmosphere caused an increase in pressure and temperature that resulted in rupture of the Command Module and creation of a toxic atmosphere. Death of the crew was from asphyxia due to inhalation of toxic gases due to fire.

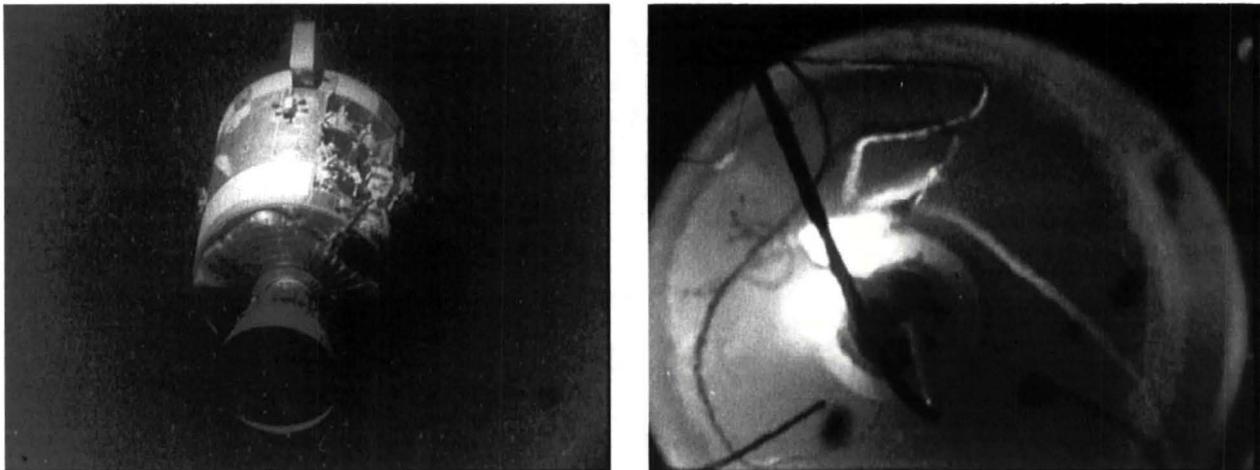
Similarly, on Apollo 13 (fig. 6), as excerpted from the Apollo 13 Review Board Cortright Commission's report, the No. 2 oxygen tank had been previously installed in the service module of Apollo 10, but was removed for modification (and was damaged in the process of removal). At 55 hours, 55 minutes, oxygen tank No. 2 exploded, causing No. 1 tank also to fail. The Apollo 13 command module's normal supply of electricity, light, and water was lost, at a distance of 200,000 miles from Earth. Subsequent investigation of the accident determined the cause of the combustion was most probably the ignition of Teflon wire insulation on the fan motors' wires, caused by electric arcs in this wiring. In both cases, handling-induced damage and wire insulation failure were contributors.

Figure 6. Apollo 13.

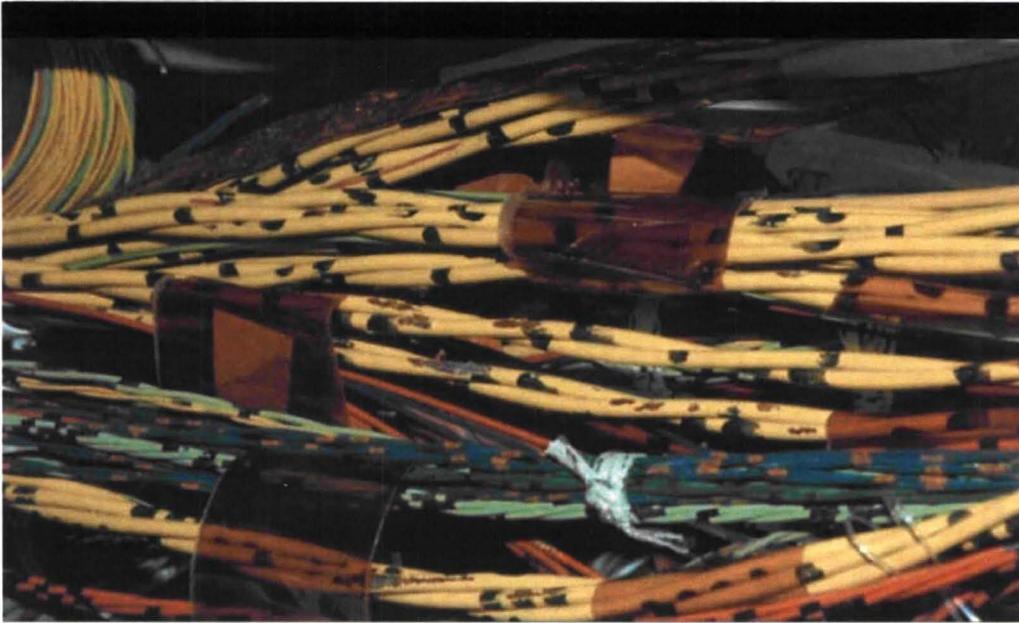
Other examples of notable failures within the Space Shuttle Program are depicted in figures 7 through 10. Figure 7 shows damage to Orbiter wiring caused by work in close proximity to the wire bundle shown. Note that the outer color coating is damaged in several areas, exposing the Kapton® insulation layer. Also note that in several areas, the outer Kapton layer has also been damaged. This type of damage can exist undetected with no outward indication that the system function can be compromised. In these cases, ascent thermal and/or vibration environments can move the harness, increasing the potential for bare conductor to short to chassis or other exposed wires. Figures 8 and 9 show a closeup of the insulation damage and figure 10 shows a closeup of the teleprinter short.

Figure 7. Orbiter wiring damage.

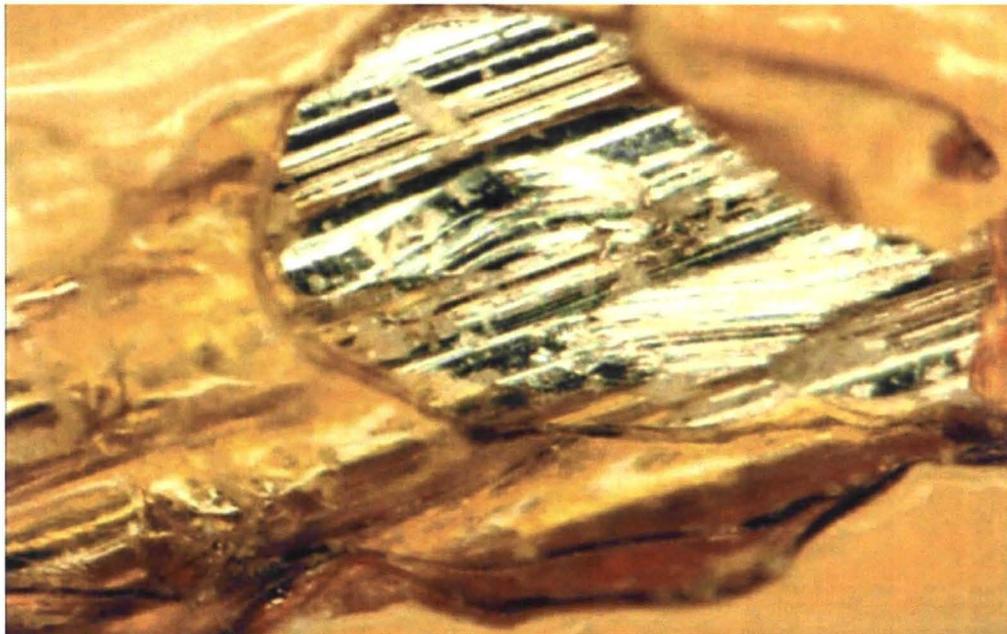
Figure 8. Closeup of Orbiter wiring damage.

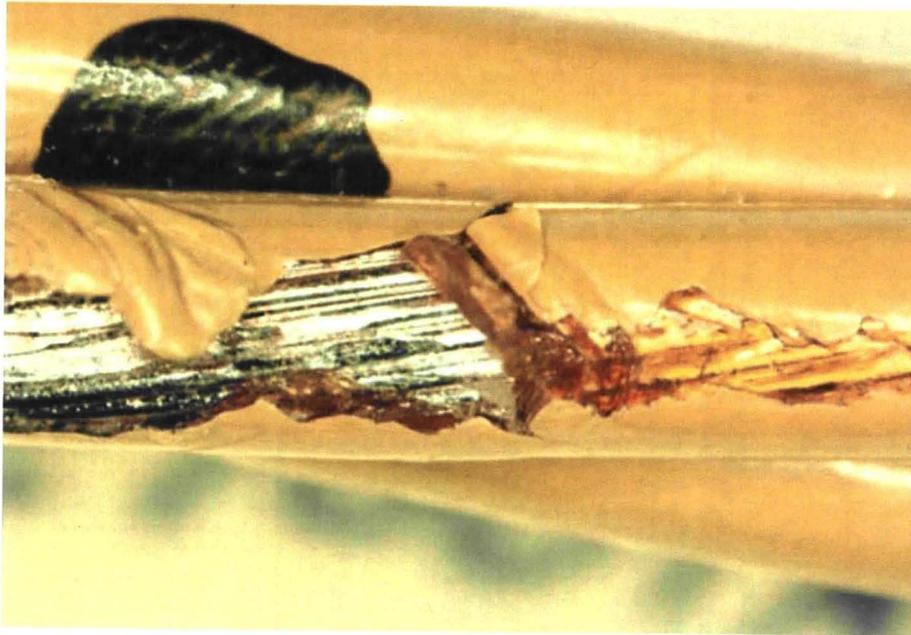
Figure 9. Closeup of Orbiter wiring damage.

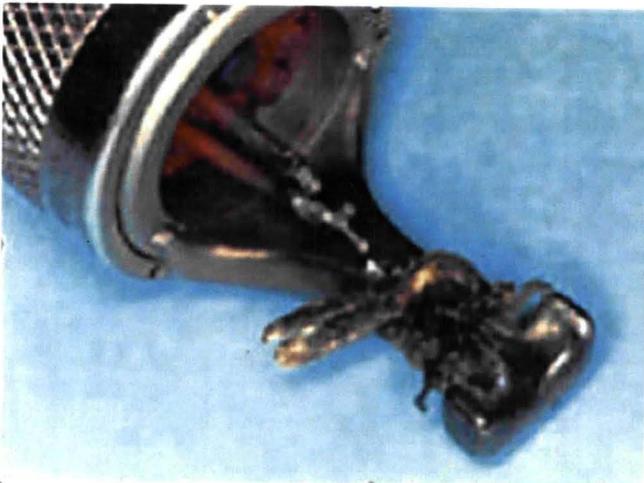
During Space Transportation System (STS)-28, a short circuit occurred between the +28V and return wire segments inside a power cable for a teleprinter (fig. 10). Suspect Cause: Kapton wiring was subjected to a severe bend over the top of the straight backshell when routed during use. The design was changed to incorporate the use of Teflon wiring and a 90-degree backshell.

Figure 10. Closeup of Orbiter teleprinter short. Figure 11. STS-93 AC Bus short to structure.

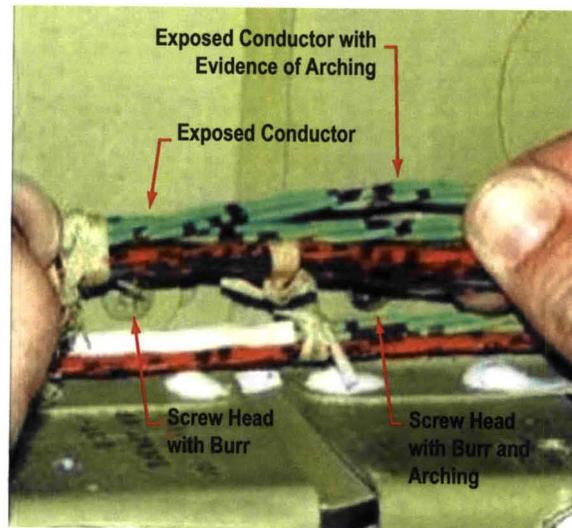
During STS-93, an electrical short circuit on AC Bus-1 (AC-1), Phase-A (fig. 11), resulted in loss of the primary controller for Space Shuttle Main Engine (SSME)-1 and the secondary controller for SSME-3. The suspected cause was that a torque set screw head with burred edges likely damaged the wire insulation before launch, resulting in the exposed conductor, which made contact during the vibration environment of launch, resulting in the short.

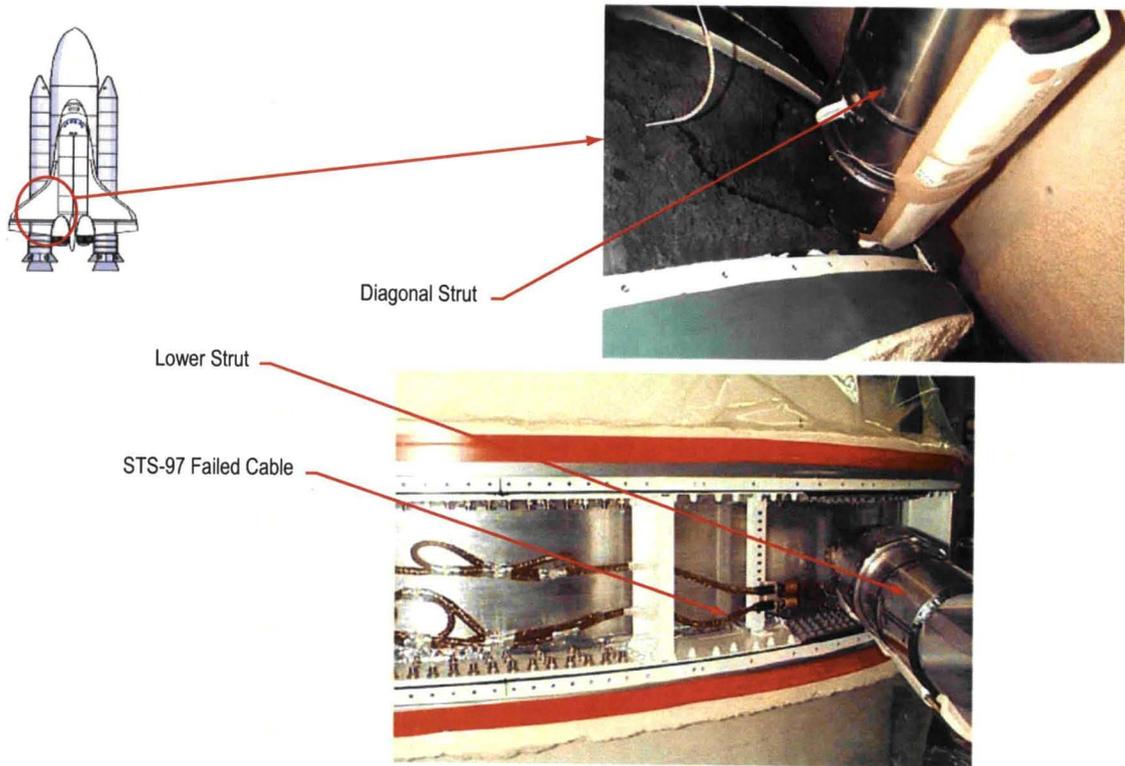
Another anomaly occurred during STS-97 that, after postflight analysis, drove a rollback of STS-98 for assessment. The anomaly was that System "A" NASA Standard Initiator (NSI) Pressure Cartridge in the left aft lower strut did not fire, resulting in a Criticality 1R failure of the SRB separation system, shown in figures 12 and 13. The assessment team confirmed that the Orbiter and external tank (ET) cabling performed nominally as did the pyrotechnic NSI. The failure was attributed to the watertight reusable strut ordnance cable. Gross shield damage was noted. The most probable cause was identified as handling damage unique to the ET attach-ring strut reusable strut cables.

Figure 12. STS-97 NSI cable failure.

Technicians performed xray inspection and electrical tests of the STS-98 reusable strut ordnance cables and replaced one suspect upper strut reusable ordnance cable and also reterminated one suspect lower strut reusable ordnance cable. The team replaced one suspect forward separation bolt ordnance cable. An effort was also kicked off to perform xray inspections and electrical tests of additional cables from inventory. The xray inspection and electrical tests of 223 flight cables from inventory was completed and four cables were identified with a break in a conductor. Analyses concluded conductor breaks were not recent occurrences. Corrective actions were implemented for the STS-98 mission, which entailed rollback to the Vehicle Assembly Building (VAB) for inspection and testing of system tunnel cables. The team completed xray inspections and electrical tests of 36 of the 38 system tunnel cables with no anomalies noted. This anomaly shows the impact that problems like these can have when discovered late in the flow.

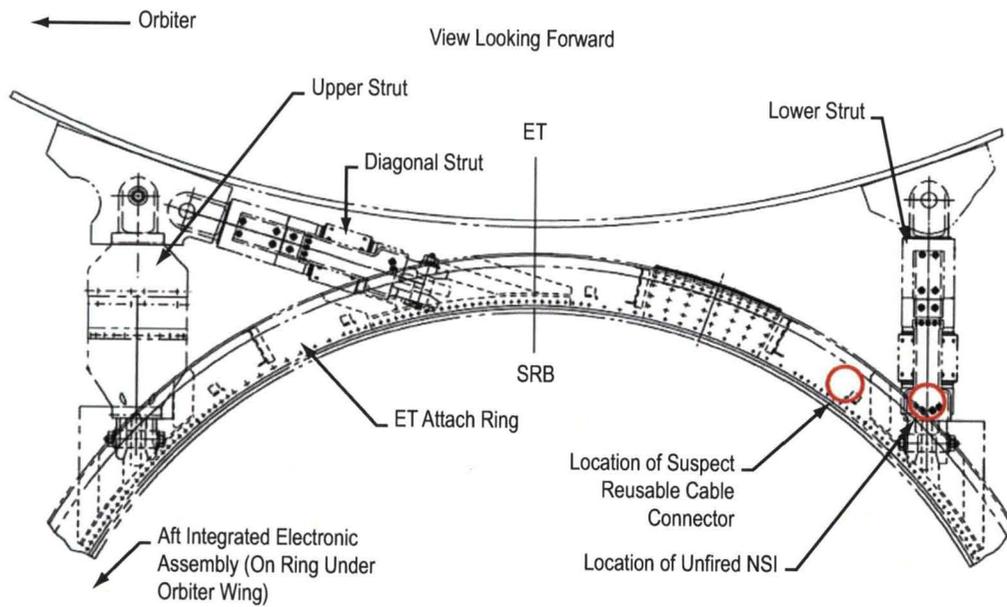
Figure 13. STS-97 failure location.
