CHALLENGES OF COLD CONDITIONING AND STATIC TESTING THE SECOND ARES DEMONSTRATION MOTOR (DM-2)

Shyla Quinn
ATK Aerospace Systems
Brigham City, Utah

Larry C. Davis
NASA
Huntsville, Alabama

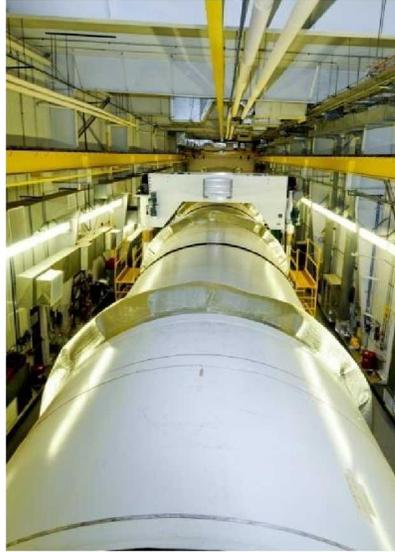
Figure 1. Motor Conditioning in the T-97 Test Bay

This first stage motor contains over 1.3 million pounds of solid propellant, and thousands of pounds of insulation surrounded by a steel case. The entire mass needed to be cooled so that the propellant mean bulk temperature (PMBT) was 40 ± 5 °F. For this effort it was imperative to have a thermal model that could accurately predict the temperature and time required to cool the motor to meet the schedule timeline.

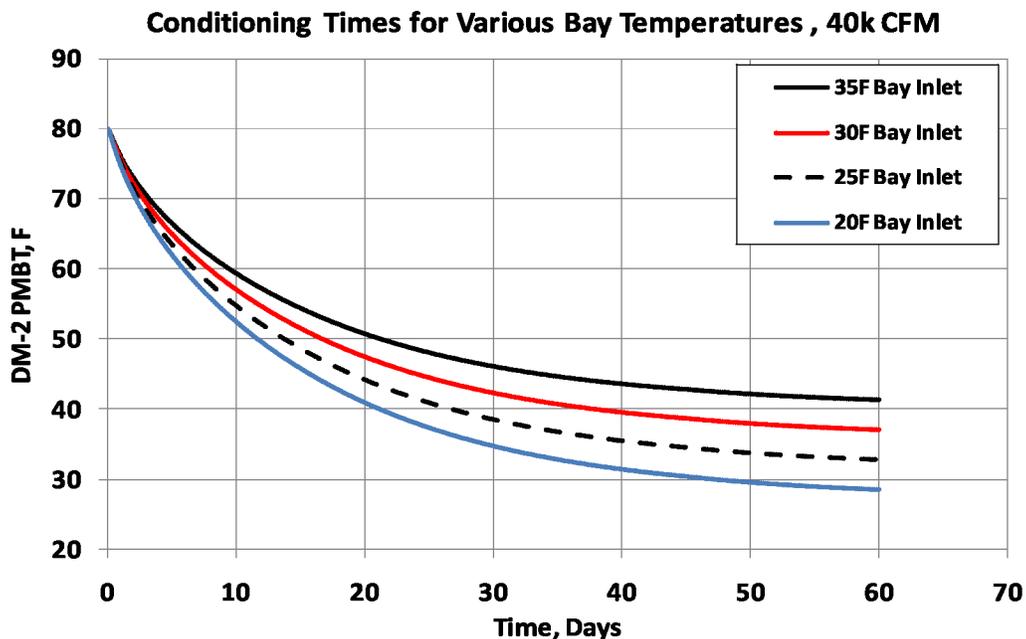
The model assumed a constant 40,000 cfm flow into the building. The model showed that it would take approximately 40 days at 30 °F and over 60 days at 35 °F to reach the PMBT goal. The model turned out to be a good conservative predictor of motor reaction, which can be seen below in the conditioning section.

Figure 2. Predictive PMBT Model

A new thermal model was developed. This new model accounted for all the above factors as well as the solar radiation on the building and thrust block. It also accounted for the radiation exchange from the surrounding terrain and sky. The model assumed a uniform thickness of the cement floor of 10 feet, where in fact the floor depth varied. A 3-D thermal "Predictive" model was generated and run in Thermal Desktop modeling code. The model looked at four input temperatures: 20, 25, 30, and 35 °F as seen below in Figure 2. However, there was a temperature limit restriction on the case being 22 °F. Another 2 °F was added to the restriction due to thermocouple error. The 30 °F and 35 °F were the most heavily weighted.

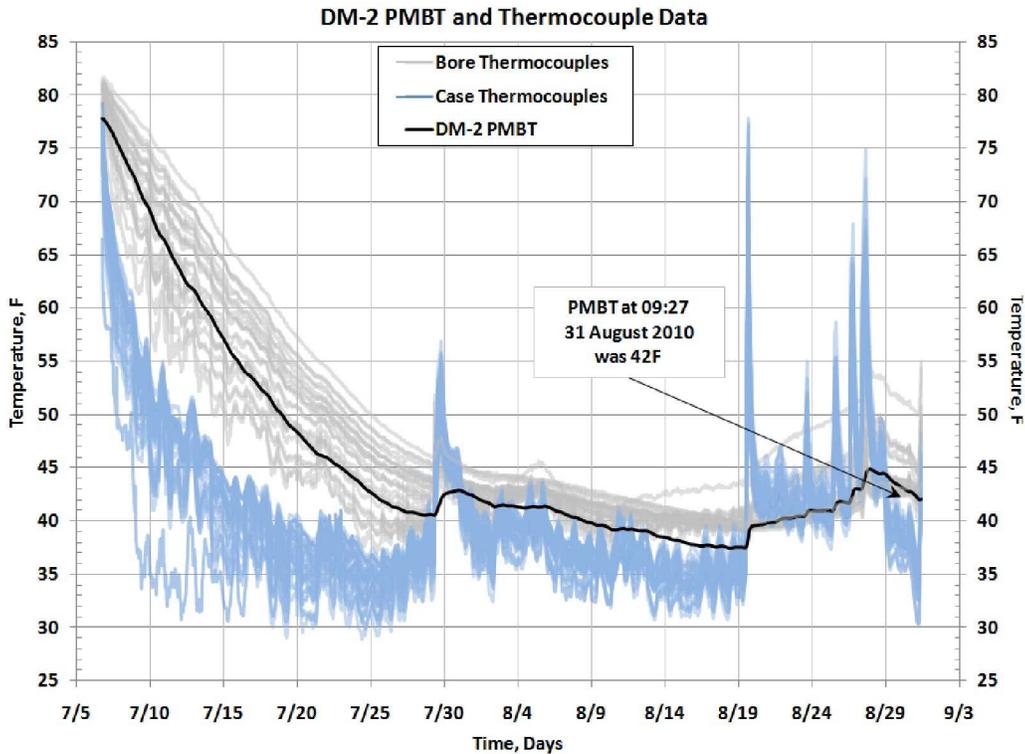
A second model known as the operational PMBT model was simpler in its design. It took the real time data collected from the 32 thermocouples adhered to various locations along the external surface and 24 thermocouples along the internal diameter on the propellant surfaces of the motor. This model captured the thermal effects along the surfaces of the motor. This model was much more accurate than the predictive model and it could be run every day to provide real-time updates. With these updates, the conditioning in the bay would be adjusted. This model was used to calculate the final PMBT at time of static test. The results of the conditioning using the operational model can be seen in Figure 3 below.

Figure 3. Actual PMBT Calculated Using Thermocouple Data

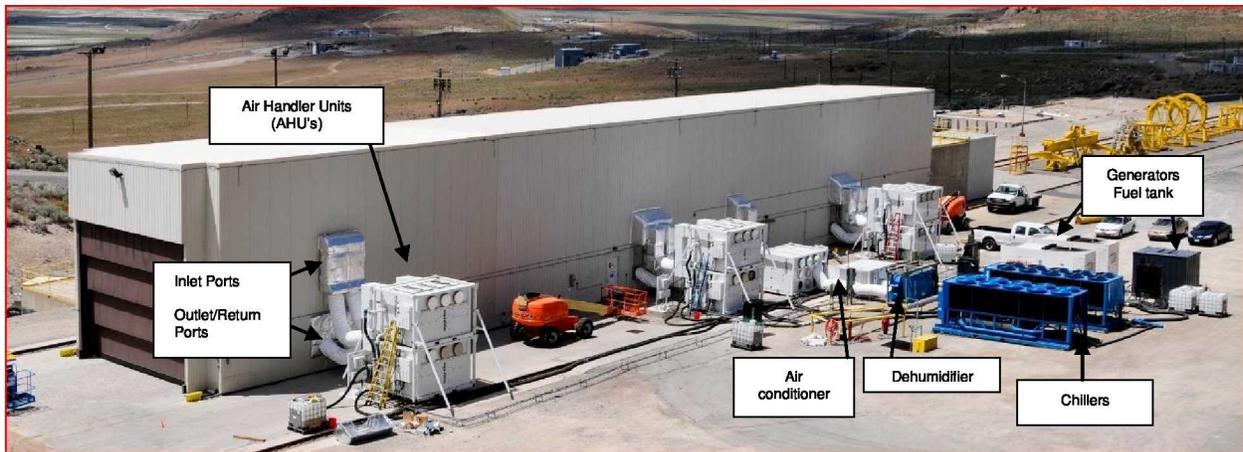
The conditioning equipment setup seen below in Figure 4 consisted of: two 200 ton chillers filled with a 50% propylene glycol solution called “brine”. This brine solution could go to -10 °F if needed. When the brine solution was cooled to this temperature it lowered the capacity of the chillers to approximately 85 effective tons. The original setup had only one chiller running with the other acting as a backup. However, because of the heating throughout the day and the building’s response, both chillers were run throughout the full two months. The brine solution was pumped through 6 inch hoses using two 1000 gallon per minute pumps.

Figure 4. Conditioning Equipment Set-up at T-97

The cold air was blown into the building by seven 120 ton Air Handler Units (AHU). The building was separated into three segments with inlet and return ports. Six AHUs were configured in a double stack configuration. The AHUs are essentially huge fans that pull in air and moisture from the building. The air is then blown over coils containing the chilled “brine” solution. The air is blown back into the building via the inlet ducts. As conditioning efforts progressed, it was determined that the best and easiest way to modify the inlet temperatures was to adjust the airflow rate of the AHUs. The slower the rate, the longer the time the air had to be chilled over the coils and thus the colder the air. Inversely the faster the airflow rate the warmer the air would be. This way the three sections of the building could be adjusted to ensure an even cooling of the motor. The motor cooled down at different rates, the subtle adjustments of the inlet temperature were vital. The last air handler was for the fresh air supply to the building. It was connected to a 5000 cfm dehumidifier and a 20 ton air conditioner. This set-up was later used to condition the joint shrouds discussed later in this paper.

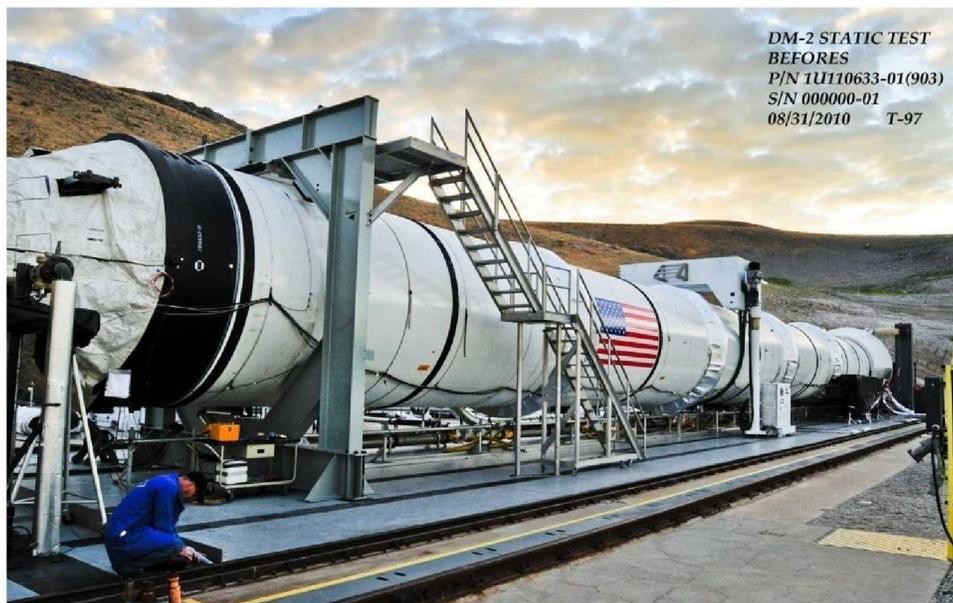
The various temperature restrictions combined with the need to roll the bay back to perform essential activities near the end of conditioning meant the motor’s PMBT was slightly out of the program’s goal range. Because the nozzle heating corrective actions had proven successful, the inlet set point temperature was dropped to 25 °F and later to 22 °F for the last three days. The TCs on the motor case never fell below the 24 °F. The three days of dedicated cooling did allow the PMBT of the motor to drop to just above 40 °F. The day of static test the building was pulled off just before sunrise. Once the building was pulled back the joint shroud conditioning was activated. Figure 5 shows the motor getting ready for static test approximately T-2 hours. At T-60 minutes the joint conditioning was turned off. At the time of test the PMBT was calculated to be 42 °F.

Figure 5. Pretest Picture

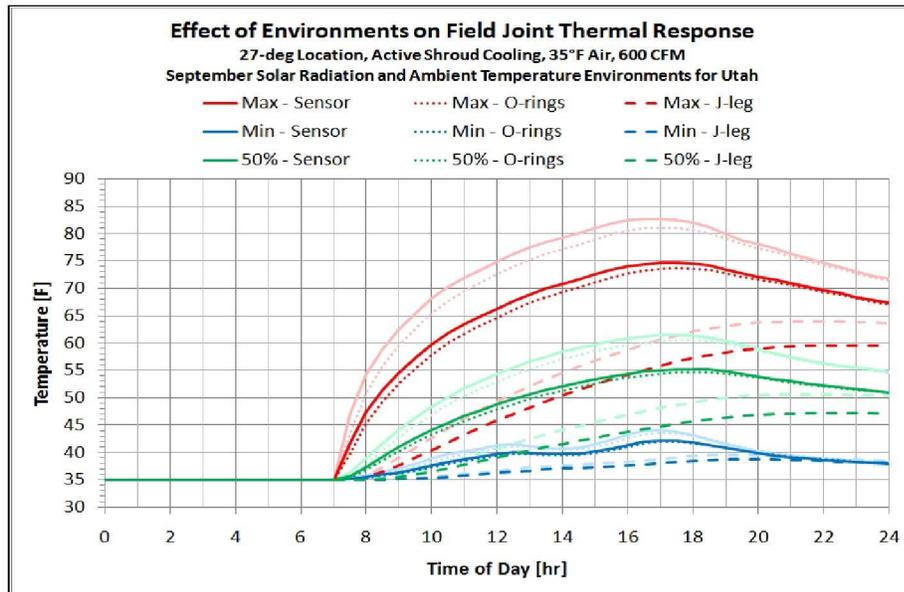
The four field joints needed to be conditioned so that the O-rings could be 32-38 °F at the time of test. However, the j-leg feature and insulation inboard of the O-rings should not go below 35 °F. A thermal analysis was conducted to predict the reaction of joints once the motor was exposed to the environment. Figure 6 below shows the prediction of how quickly the joints would heat up once the sun came up and radiant heating began. The analysis shows that even with active conditioning, the warming of the motor outside of the shrouds would eventually warm the joints beyond the temperature limits. Figure 6 shows the predictive thermal analysis of the joint shrouds for the day of test.

Figure 6: Joint Shroud Thermal Analysis Under Active Conditioning

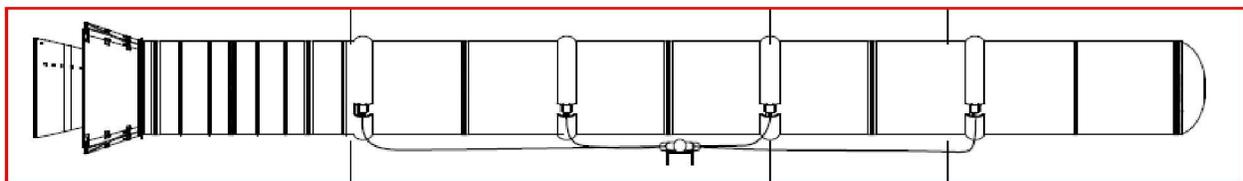
The new shrouds were designed to be easily applied, lightweight, and flexible. The shroud components were bonded to the case so no damage would occur during test. The shrouds consisted of five simple elements: aluminum braces, shrouding material, inlets, electrostatic dissipative ducting, and the air flow manifold. A simple schematic of the joint shroud set-up can be seen in Figure 7.

Figure 7: Drawing Schematic of Joint Shroud Set-up

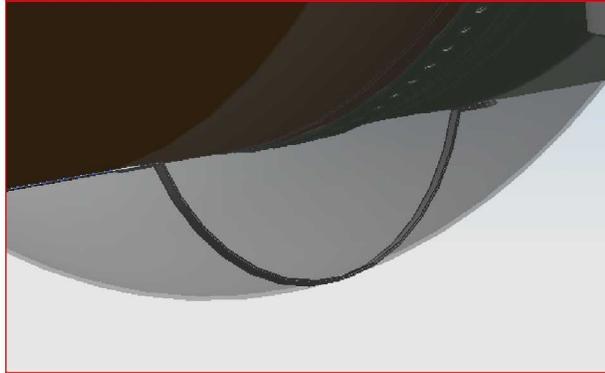
The aluminum braces are seen in Figure 8 below. The braces acted like ribs providing structure for the shrouds. They were bent to form a semi-circle with flanges on the end. The braces were designed to span a minimum of 13 inches on each side of the field joint. Strong 139 lb magnets were bolted to each of the legs and secured to the motor.

Figure 8: Representation of Internal Shroud View

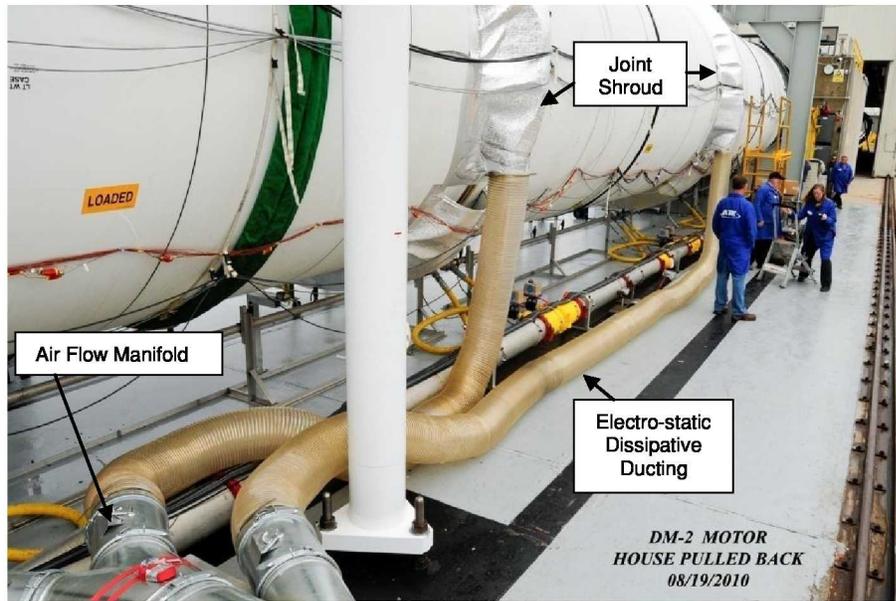
The static dissipative ducting was connected to an aluminum air flow manifold. The manifold was designed to take in the conditioned air from the Aggreko air handler unit and flow it out to the four joints. The manifold had air flow regulators that could be manually adjusted to control the amount of air to each joint. Since the joints were at varying distances from the manifold, the air flow had to be manually balanced using an air flow manometer. An example of this can be seen in Figure 9 below.

Figure 9: Joint Shrouds Operational Dry-Run

The joint shrouds functioned extremely well. The conditioning was terminated T-60 minutes prior to test per the countdown script. The thermocouples imbedded in the joints reported O-ring temperatures between 32.5-36 °F at the time of static test.
