Solid Rocket Booster (SRB) - Evolution and Lessons Learned During the Shuttle Program

Howard S. Kanner¹, Donna M. Freeland² and Derek T. Olson³
United Space Alliance, LLC, Titusville, FL 32780

T. David Wood⁴ and Mark V. Vaccaro⁵
NASA MSFC Space Flight Center, Huntsville, AL 35812

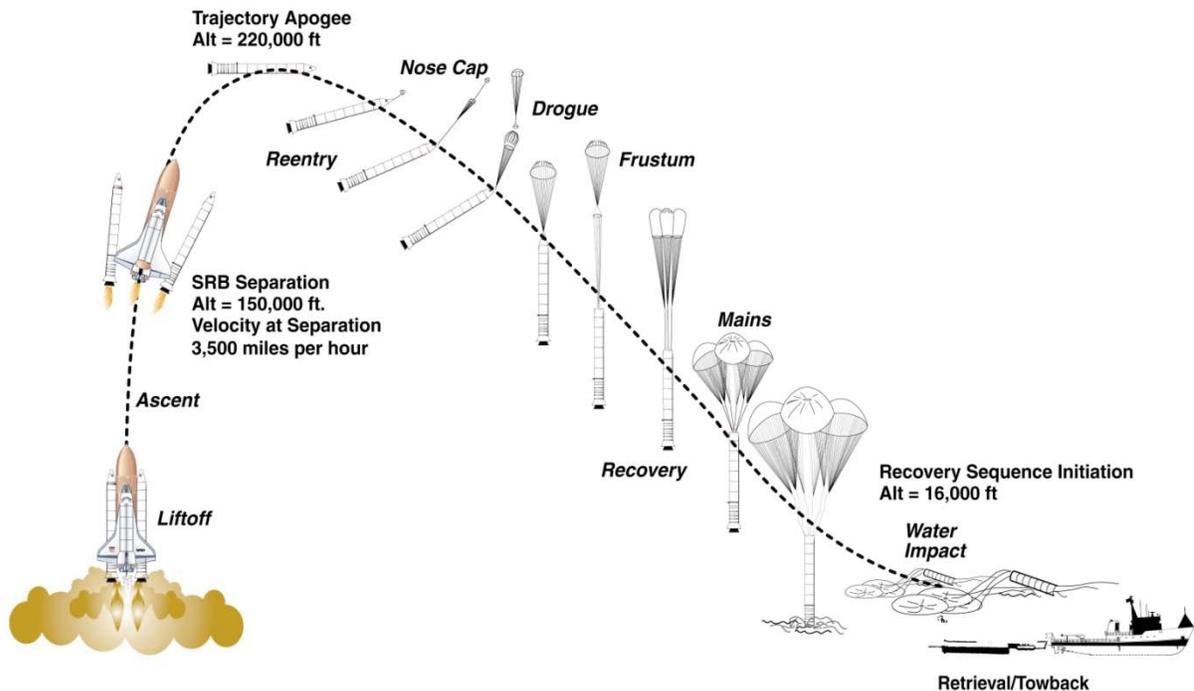
Figure 1. SRB Flight Sequence

The SRBs are the largest solid propellant rocket motors ever flown, and the first designed for reuse. The two SRBs provide the main thrust to lift the Space Shuttle off the launch pad to an altitude of ~150,000 feet (28 miles) and burn for 123 seconds during ascent. Each SRB is 149.16 feet long, 12.17 feet in diameter and weighs ~1,300,000 pounds at launch. During flight, each SRB burns ~1,100,000 pounds of propellant, with a final weight of ~192,000 pounds. The flight sequence for the SRBs can be seen in [Figure 1](#), from lift-off through retrieval.

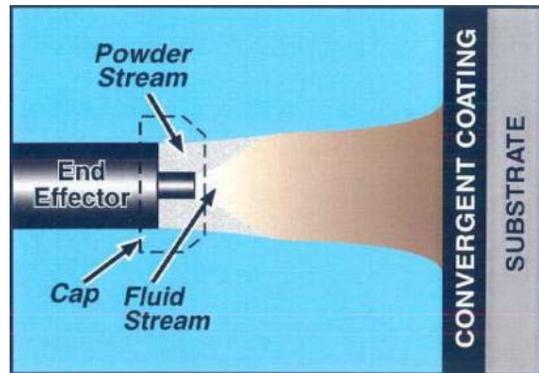
Figure 3. Convergent Spray Technology™ mixes solids and liquids during application process.

Marshall Convergent Coating (MCC-1) was developed to address Environmental Protection Agency (EPA) mandates, eliminating solvents and the classification as hazardous waste. Processing and the overall material capability for MCC-1 were also significant improvements over MSA-2 due to the use of Convergent Spray Technology™ (CST™). This application method was developed in-house to apply the coating by mixing multiple streams of materials at the application surface (Figure 3). CST™ is what eliminated the need for solvents. MCC-1 was first flown on the left-hand SRB during STS-79 (September 1996), and fully implemented for STS-80 (November 1996). In addition to Space Shuttle SRB applications, MCC-1 was used for the Air Force Titan program, eliminating its non-environmentally-compliant TPS.

The incorporation of MCC-1 resulted in significant process improvements, such as reduced setup time, mixing on demand and consistent surface finish. MCC-1 reduced the constituents required, from eleven to five, reducing material storage and handling requirements (MCC-1 constituents later increased to six, adding an accelerator to the epoxy). In addition, MCC-1 had superior strength over its predecessors, with flat-wise tensile capabilities in excess of 200 psi, vs. 50 psi for MSA-1 and 75 psi for MSA-2. MCC-1 also had improved thermal properties, indicated by improved recession characteristics (when exposed to the combination of heating and aerodynamic shear). MCC-1 was qualified to be applied over more substrates than previous sprayable ablators, thus further reducing hardware processing time. The only trade-off from MSA-2 was that MCC-1, despite allowing thinner applications, had a higher density, and thus resulted in a slight increase in TPS weight for the vehicle. However, the latest incarnation of the sprayable acreage TPS (with its associated top-coat of Hypalon) has been demonstrated as being very robust in the flight environment. It is tolerant of impacts from in-flight debris sources, and it has minimal propensity to self-liberate debris.

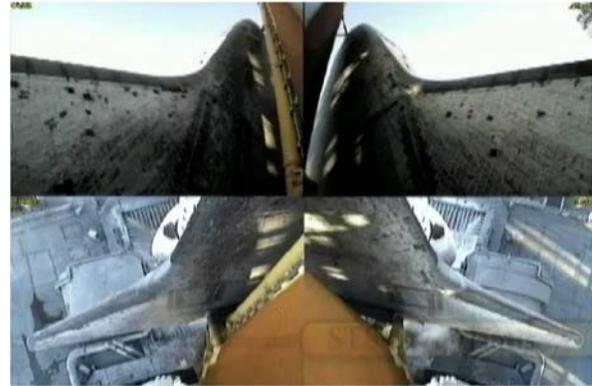
Figure 4. STS-114 (July 26, 2005) Views from SRB Forward and Aft Pointing Cameras.

In addition to data acquisition systems, in-flight imagery was acquired, starting with video from tracking ships as well as Air Force Starcast and Navy Castglance aircraft. STS-41G (October 1984) incorporated a 16mm camera to capture parachute deployment, and it was used periodically on subsequent flights. Camcorders were implemented into the DAS system starting on STS-77 (May 1996). A second flight camera was installed on STS-95 (October 1998), and utilized for five flights to observe External Tank (ET) foam performance on the Intertank (the region between the liquid oxygen and liquid hydrogen tanks), and was permanently implemented on STS-114 (July 2005). On STS-121 (July 2006), two more in-flight video cameras were added to the SRBs to evaluate ascent debris concerns, with one camera on the forward skirt of the SRBs looking aft, and another on the ET Attach Ring looking forward (Figure 4). All of these cameras, in addition to the ground-based imagery, ET Feedline Camera and Orbiter imagery, were tools that provided the Mission Management Team (MMT) valuable data to assist in evaluating the on-orbit condition of the Orbiter. In addition, the cameras provided details of in-flight anomalies, such as parachute failures (Figure 5) and material liberation that could strike the Orbiter (Figure 6).

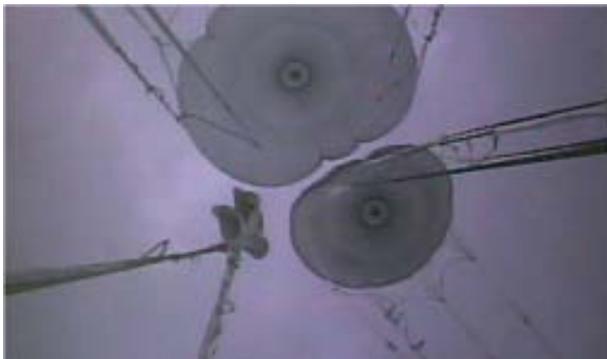
Figure 5. STS-122 Parachute Failure Observed With Parachute Forward Skirt Dome Camera.

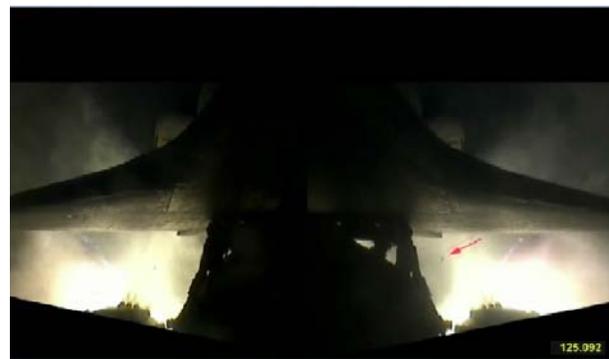
Figure 6. STS-116 In-Flight Anomaly of TPS Striking the Orbiter during SRB Separation.

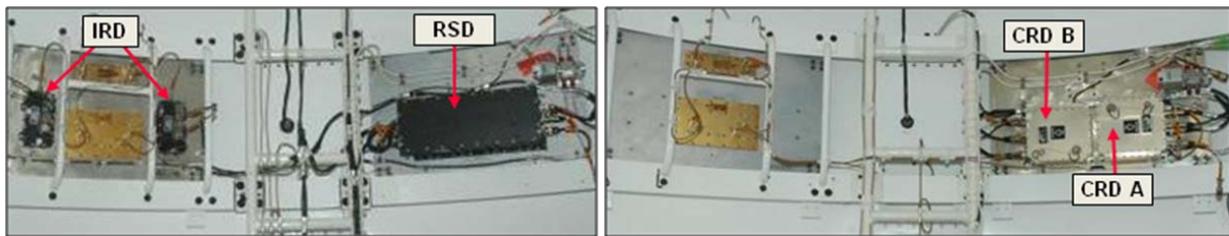
Figure 7. Previous IRD/RSD Configuration vs. New CRD Configuration.

The CRD implementation was originally developed for an RSS for the ET. However, an RSS for the ET was subsequently eliminated. Due to concerns of supportability and obsolescence, SRB evaluated the CRD design and determined it could be used to replace its aging RSS electronics boxes (Integrated Receiver/Decoder (IRD) and Range Safety Distributor (RSD)) (Figure 7).

The design configuration is such that there are redundant CRD A and B systems processing command signals independently. Unfortunately, it was not until integrated system level testing that a design deficiency was discovered. The CRD A and B electrical return paths for a particular command signal (Orbiter power) were not isolated from each other or the SRB structure. The consequence was a modification of the electrical circuit to separate the command signal return from the other paths. Subsequently, the redesigned CRD passed all qualification testing and successfully began flying on STS-118 (August 2007).

The design flaw could have been identified earlier in the development process. The root cause was identified as inconsistent terminology from the system to the component level. In this case, the Orbiter power was treated as a command signal during requirements development and design, and therefore the power isolation system requirement was not identified. System level testing was a key factor to identifying this design deficiency. For the CRD development, this occurred late into the cycle, which required additional efforts to bring the system into compliance with the design requirements. In addition, a strong involvement of systems engineering, particularly during the early development phase, would have greatly benefited the design, especially when dealing with multiple subsystems.

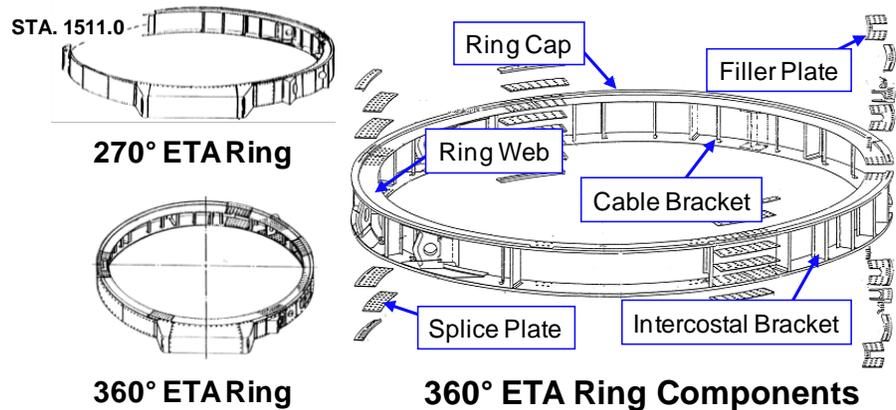
Figure 9. 270° vs. 360° ETA Ring.

Following the Challenger accident, detailed structural analyses were performed on critical structural elements of the SRB, focused on areas where anomalies were noted during postflight inspection of the recovered and refurbished hardware. As a result, it was noted that the region where fasteners attach the ETA Ring to the SRB motor case experienced high levels of distress during thrust buildup. As a consequence of these assessments, the ETA Ring was redesigned to completely encircle the motor case (360°), which provided higher strength margins throughout the SRB flight and water impact (Figure 9).

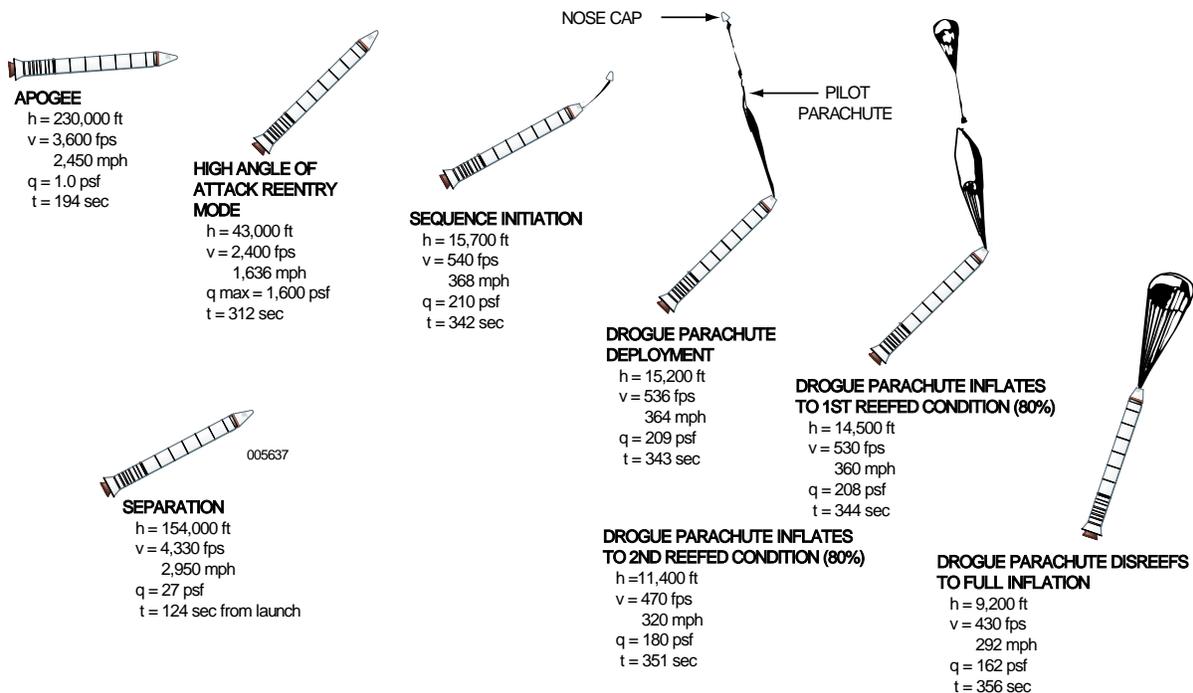
Figure 10. SRB Recovery Sequence Part 1: Descent through Drogue Parachute Disreef

The design requirement for reusability of the SRBs resulted in the development of a hardy recovery system. An Altitude Switch Assembly (ASA) located within the forward assembly initiates the parachute deployment process at the appropriate altitude as determined by pressure measurement (Figure 10, Figure 11). Then, through a series of hardware releases, parachute deployments and parachute disreefings, the SRBs are slowed down for a safe water landing, where retrieval ships recover the parachutes and flight structures, and bring them back to Kennedy Space Center for postflight inspection and refurbishment.

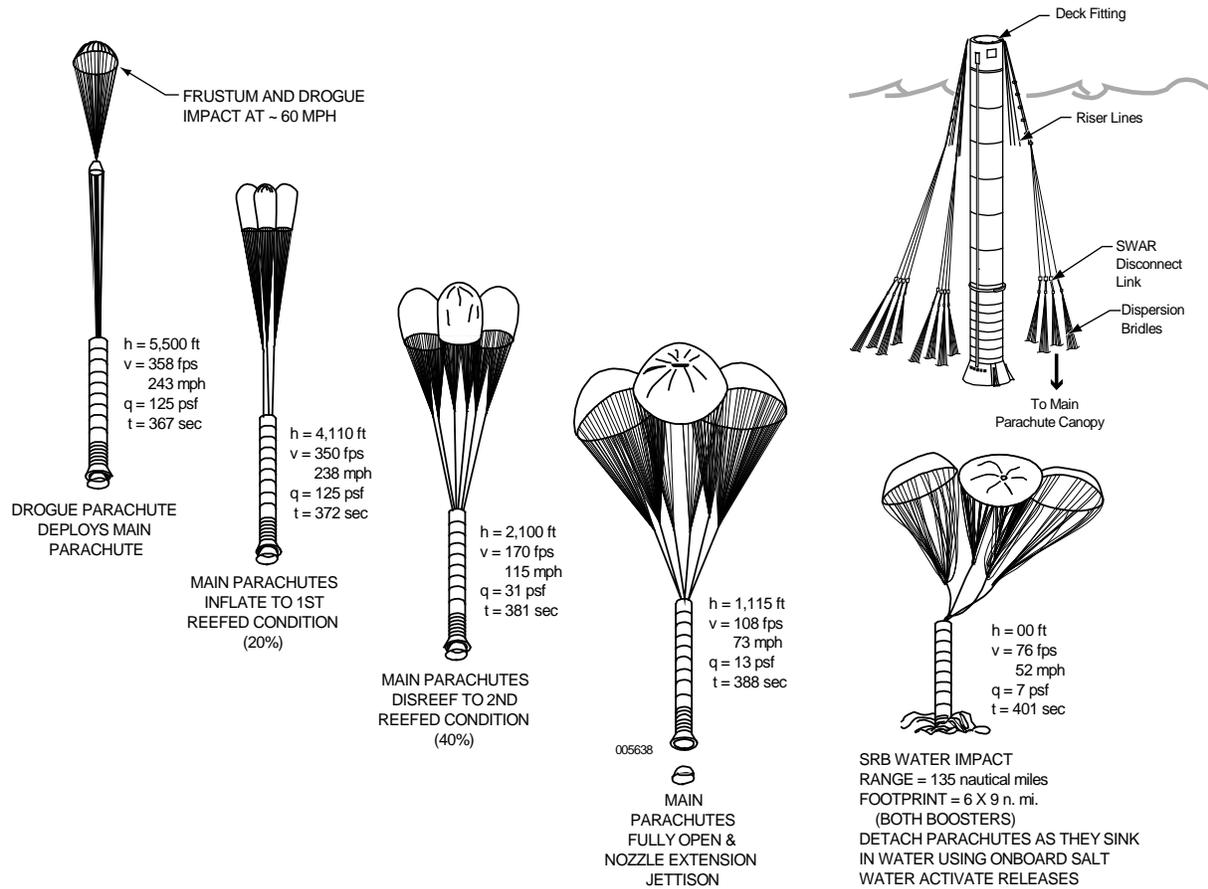
Figure 11. SRB Recovery Sequence Part 2: Main Parachute Deployment through Water Impact

The initial SRB main parachutes were called “Small Main Parachutes” (SMP). The SMP had a canopy diameter of 115 feet, and resulted in water impact velocities of approximately 90 feet per second. Starting with STS-41D (August 1984), larger parachutes, called the “Large Main Parachutes” (LMP), with a diameter of 136 feet and resultant water impact velocities of approximately 76 feet per second, were flown, and fully incorporated starting STS-51D (April 1985). The larger canopy parachutes provided a twofold benefit. First, they reduced the water impact velocity and consequently the impact loads and potential for structural damage. Second, they increased the SRB survivability from a single parachute failure, where the water impact velocity under two LMP would be comparable to that of three SMP, thus reducing the possibility of structural damage from a hard water impact.

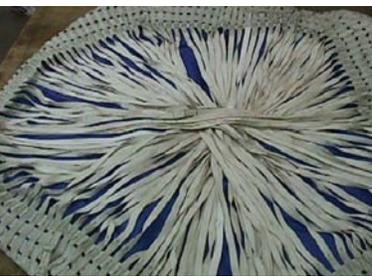
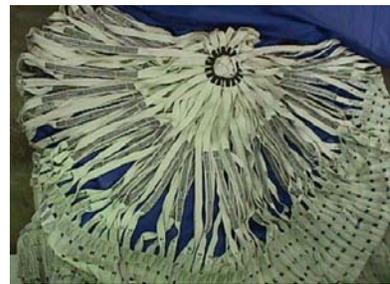
Figure 13. Sequential Stacking Design vs. Hengel Weave.

A third (iterative) improvement to the SRB parachutes occurred in the main parachute vent, which is the top of the canopy. Starting on STS-51F (July 1985), a vent cap (i.e. additional horizontal canopy members) was added, decreasing the vent diameter from 11.6 to 5.6 feet. This design modification allowed the canopy to inflate more reliably to the first reefed condition. However, there were intermittent cases of major damage that was eventually attributed to the lagging inflation of the parachute that led to vent line entanglement. The vent cap consisted of 80 vent lines stacked in a constant clockwise sequence that created large openings and a large mass at the center.

The openings allowed air to escape, slowing inflation, and the large mass of lines to tangle, causing parachute damage. The next improvement of the LMP vent occurred on STS-95 (October 1998), where the vent lines were woven together in an alternating stacking method called the Hengel Weave (Figure 13), which organized (eight groups of ten vent lines) and constrained the vent lines. This eliminated two large slots in the vent and prevented the concentration of a vent line mass, further helping the parachute inflate more reliably to its first reefed condition.

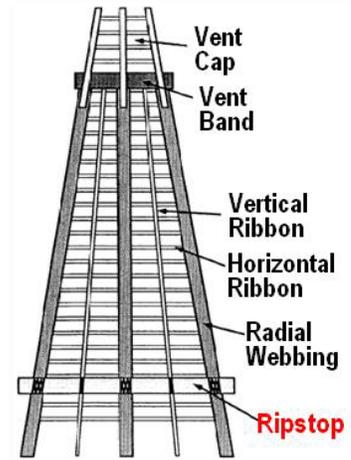
Figure 12. Rip Stop.

Another parachute system improvement first flown on STS-33R (November 1989) was the incorporation of ripstops within the canopy (Figure 12). These consisted of six horizontal bands of high-strength nylon added to the LMP to mitigate a tear from propagating completely through the parachute canopy, thereby allowing the parachute to remain inflated during descent. The spacing of the ripstops was defined by analytical models of the canopy loading. Since incorporation, ripstops have been determined to have prevented total failure of a parachute on seven occasions.

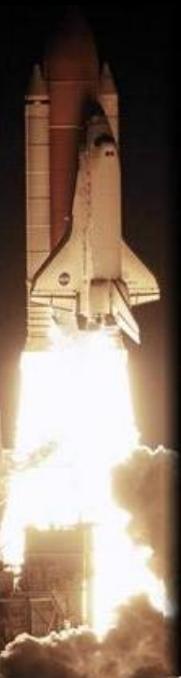
◆ Convergent Spray Technology™

- Apply coatings by converging multiple streams of different materials
- Deliver dry filler materials and fluid binder materials separately to spray gun
- Proprietary nozzle convergently mixes constituents external to gun tip as sprayed

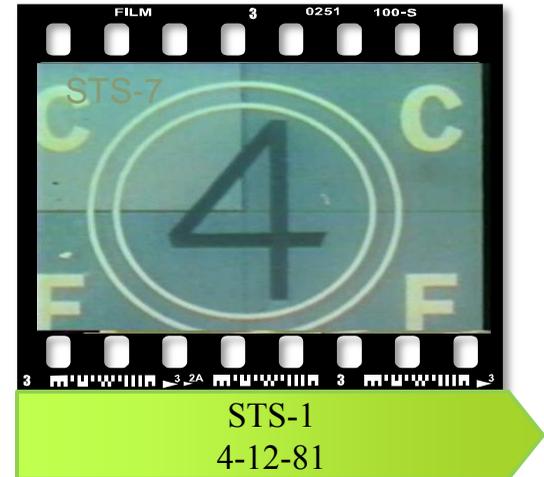
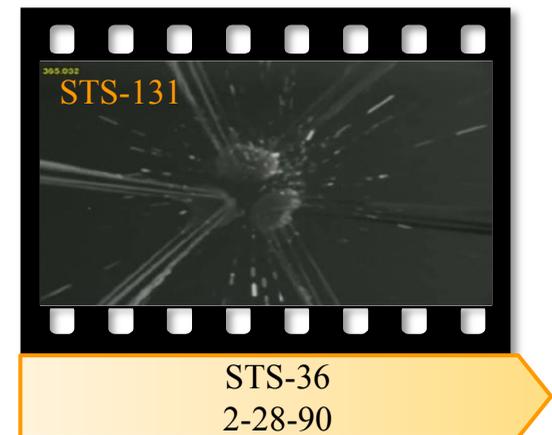
- ◆ **Photographic coverage of SRB descent and parachute deployment important at beginning of Shuttle Program**
 - Provided by ship and aircraft
 - Redstone/Vandenberg ships and Starcast/Castglance aircraft
 - Discontinued after STS-35 (12-2-90)
- ◆ **STS-51A (11-8-84) first installed 16 mm camera into forward skirt dome to capture parachute deployment**
 - Implemented permanently STS-36 (2-28-90)
 - Upgraded to Data Acquisition System (DAS) with video camera STS-72 (1-11-96)
 - Included recording accelerometers data

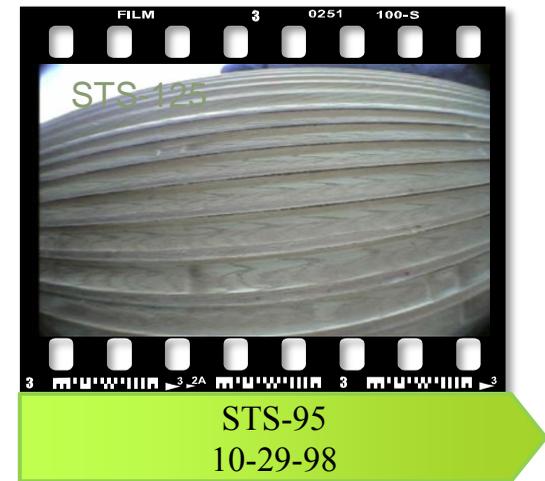
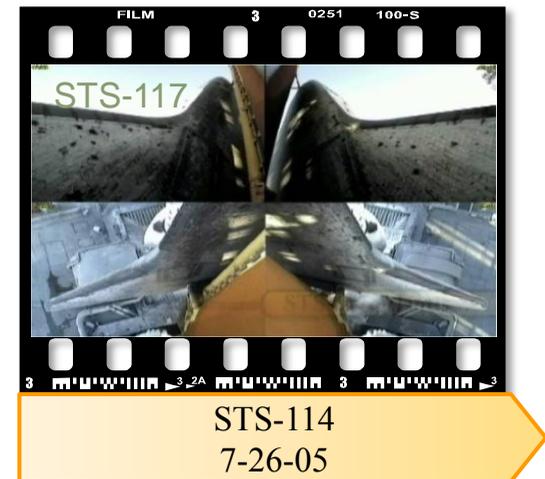
- ◆ **Second camera installed in forward skirt on STS-95 (10-29-98) to observe ET foam popcorning from intertank**
 - Utilized for five flights
 - Permanently implemented on STS-114 (7-26-05)
- ◆ **STS-121 implemented two additional standard SRB cameras to evaluate ascent debris conditions**
 - Forward skirt aft looking and ETA ring forward looking cameras
 - Refinements incorporated to improve camera settings and modify field of view

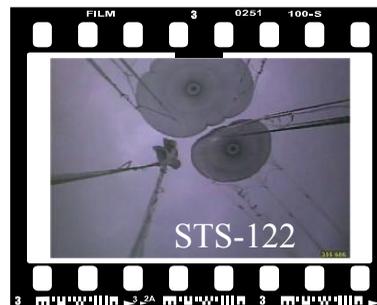
Parachute Failure

The first failure of the recovery system occurred on STS-3, where a main parachute failed due to entanglement with floats installed for assisting in retrieval of the parachutes. Next, on STS-4 (June 1982), the floats were removed. However, an unrelated failure occurred where the parachute lines released from the deck fittings prior to deployment. The parachute lines utilized g-load activated release mechanisms to sever the lines upon water impact, minimizing the possibility of underwater diver entanglement in the vicinity of the SRB during recovery. The root cause was deemed that during frustum separation (when the drogue parachute was released), the g-load switch initiated the deck fitting pyrotechnics; thus pre-maturely releasing one of the two deck fittings on each main parachute. In such a configuration, the parachutes provided no drag during the remaining SRB descent resulting in an SRB water impact velocity of six times the predicted value, and the SRBs sank into the ocean. As a result of this failure, the switch was deactivated (from STS-5, November 1982, to STS-61C, January 1986), until a timer mechanism was incorporated that released the deck fittings about the time of water impact. During this time period, the retrieval divers manually cut the lines. After the timers were implemented to release the deck fittings, the SRBs started exhibiting structural damage that was associated with the slap-down of the SRB into the ocean (the SRBs

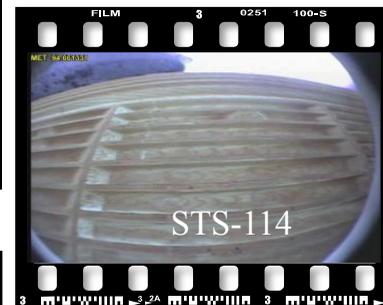
Hypalon Off Gassing

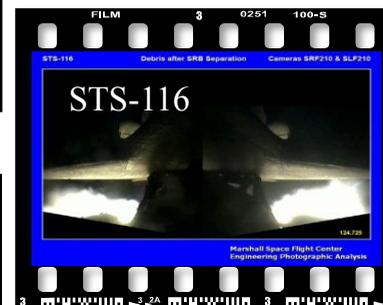
BTA from Aft BSM
Hits Orbiter

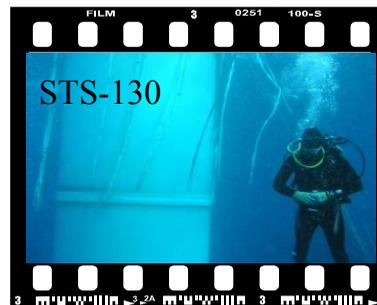
Riser Line Cut

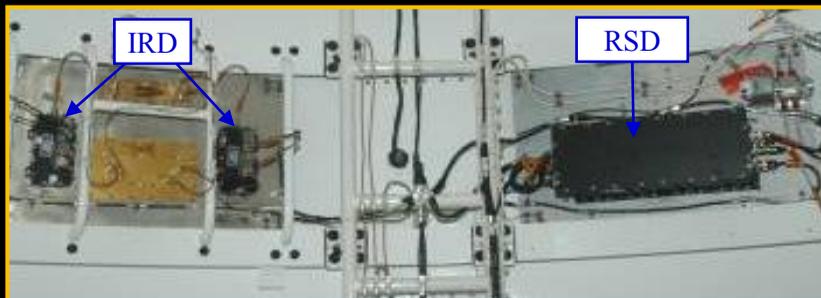
Previous IRD/RSD Configuration

- ◆ CRD initially developed for ET Range Safety System (RSS)
- ◆ ET subsequently eliminated RSS
- ◆ CRD design evaluated and implemented in SRB due to Integrated Receiver/Decoder (IRD) and Range Safety Distributor (RSD) supportability/obsolescence concerns
- ◆ CRD combined IRD/RSD functions into single design

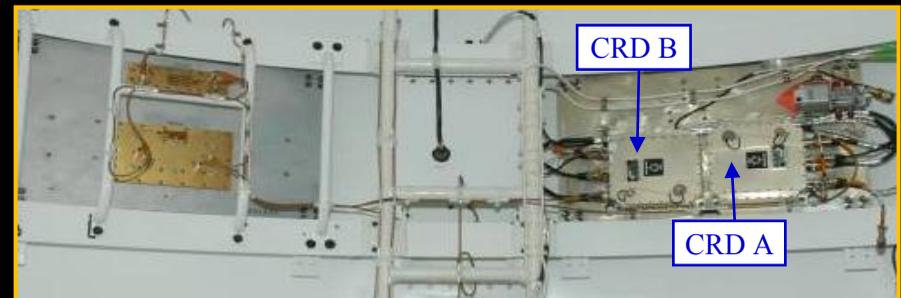
New CRD Configuration

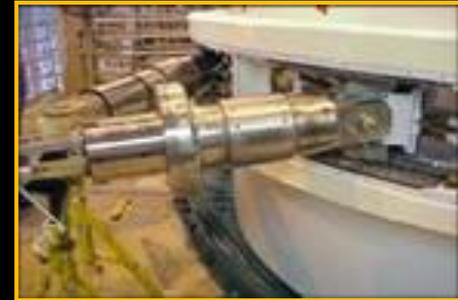
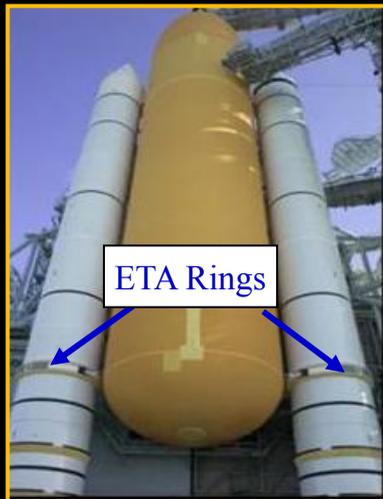
ETA Ring Location

- ◆ Initial 4130 steel ETA ring spanned 270°
- ◆ Redesigned ETA ring to 360° for STS-26
 - Modified existing hardware
 - Eliminated negative margins of safety during thrust build-up

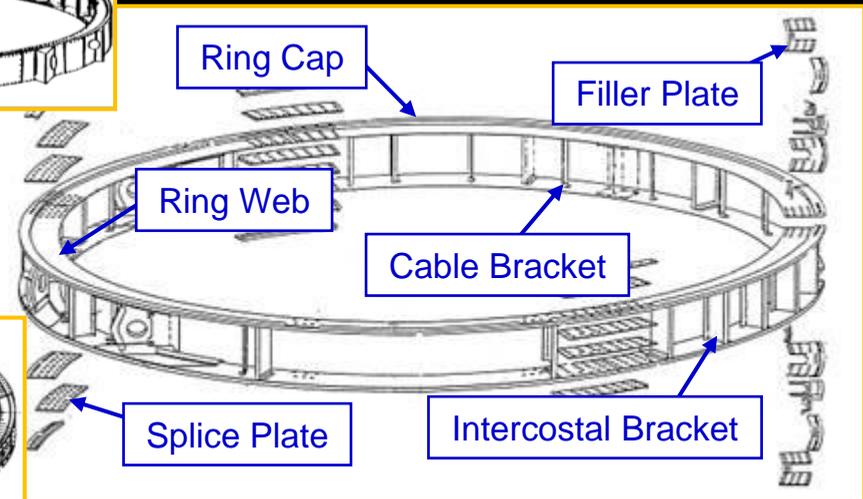
360 ETA Ring Components

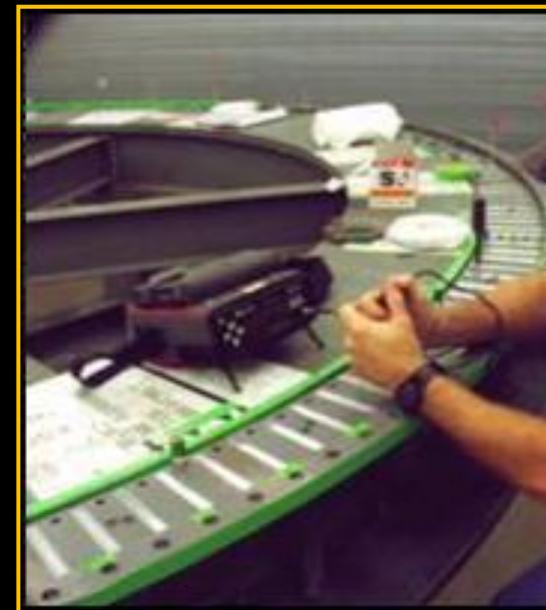
ETA Ring
Hardness Testing

ETA Ring Tensile Strength (ksi)		
	Yield	Ultimate
Test *	130-189	152-202
Requirement	163	180
* Performed on ETA Ring S/N 13

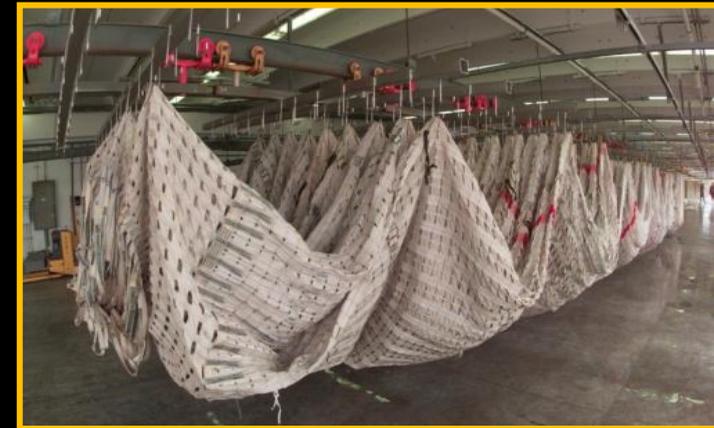
- ◆ **First 13 flights used Small Main Parachutes (SMP) – 115 ft diameter**
 - Observed damage during deployment due to reentry and parachute dynamics
 - Sometimes led to parachute failures
 - Resulted in significant splashdown damage and threatened booster retrieval
- ◆ **Large Main Parachutes (LMP) flew on STS-14RH – 136 ft diameter**
 - Sized for impact velocity of 2 LMP to be same as 3 SMP (~90 ft/sec)
 - Greatly decreased post flight damage on booster
 - Improved hardware survivability with one parachute failure

- ◆ **Implementation of Rip-stops began 17 flights after LMP**
 - Reinforced parachute in strategic locations
 - Reduced tear propagation and prevented total Gore failure
- ◆ **Incorporated Hengel Weave STS-95 at vent cap**
 - Design changed to organize and constrain vent lines
 - Reduced entanglement during deployment that led to parachute failure

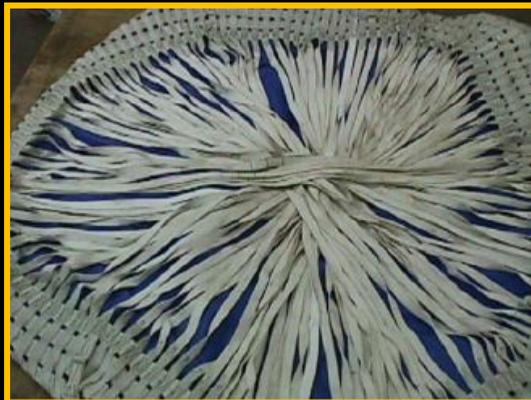
Stack Design

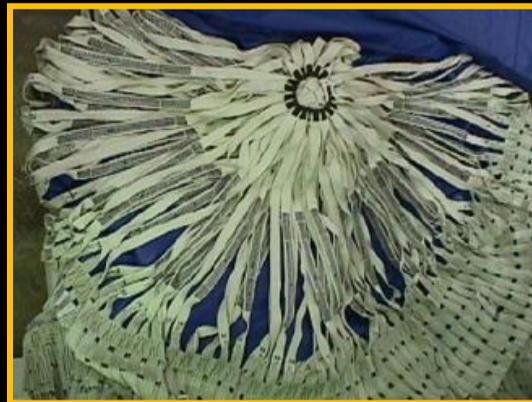
Hengel Weave
