# **Structural Element Testing in Support of the Design of the NASA Composite Crew Module**

## **Abstract**

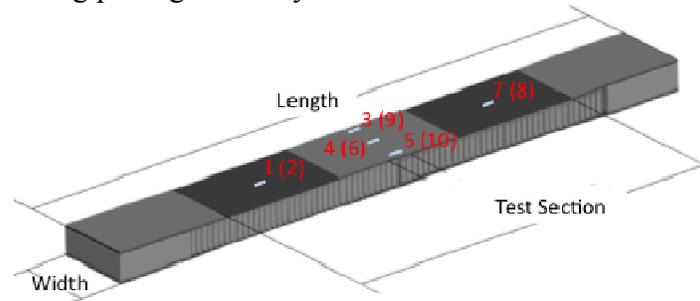
Figure 1. Specimen geometry and strain-gage positions. Gage numbers in parenthesis were located on the opposite surface.

Specimen dimensions, for both acreage and longeron samples, are summarized in Table 1. Test section is defined as the distance between the tab ends and is shown in Figure 1. For all samples, the aluminum core thickness was 25.4 mm.

In preliminary tests, also referred to as group 1 (G1), splice specimens were instrumented with ten strain gages as shown in Figure 1. Some specimens were also speckled to enable full-field strain measurements using photogrammetry.

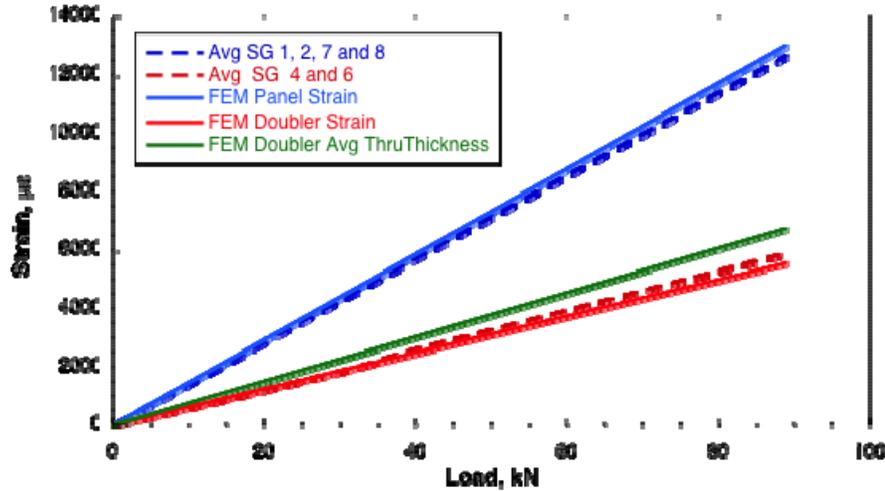
Figure 2. Comparison of post-test analytical and experimental strain-gage responses for the acreage splice sample 001

A typical strain response comparison between analysis and test are presented in Figure 2 for an acreage splice sample. Corrected stiffness values were used in these analytical predictions.

In general, strain predictions for the acreage splice correlated well with measured strain responses. The greatest deviations were for the strain gages located in the center of the doubler with a maximum difference of about 5.5 %. The difference between test and analysis for the center strains could be attributed partly to potting compound cracking at the edge of the facesheet. In the finite element models (FEM) this bond showed high stresses; however, since it is not a load-carrying bond the stresses were ignored. Figure 3 shows a FEA model of the test sample and a close up edge view of the deformed mesh around the broken bond.

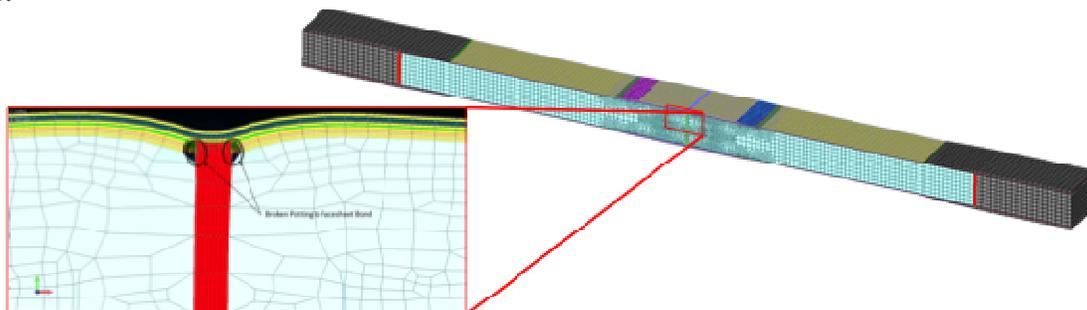
Figure 3. Close up view of the deformed mesh at the center section of the specimen. Deformations are not shown to scale.

As seen in Figure 3, the FEA model predicts localized bending in the center of the doubler as it bridges the gap between the facesheets. For the acreage splice, the magnitude of the analytical bending strain was  $2380 \mu\epsilon$ , or 33 % of the membrane strain. Bending in the doubler was found to depend on (a) the gap size between the two facesheets (shown in red), the smaller the gap the lower the doubler bending (b) the relative stiffness between the facesheets and splice laminates which controls the magnitude of the bending moment generated by the load eccentricity and (c) the thickness of the doubler which controlled the degree of eccentricity. Since maximum bending occurs at the center of the gap, it is anticipated that the measured strains also depend on the exact positioning of the strain gage – a higher strain is expected if the strain gage happened to be off center.

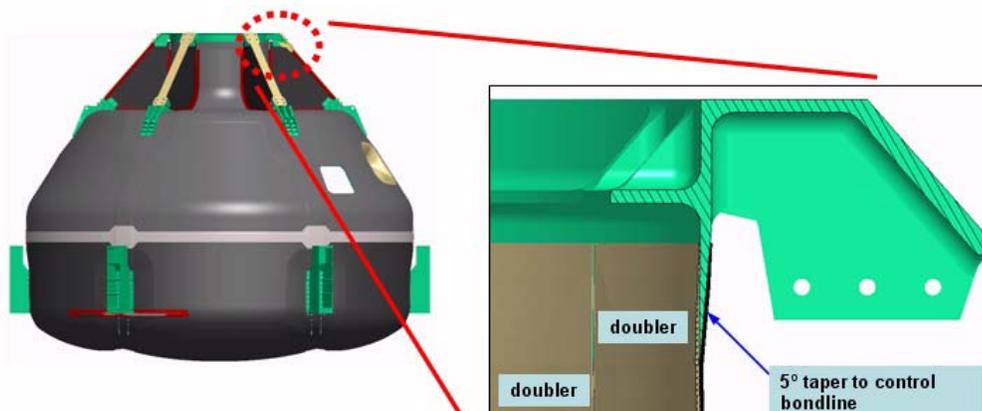
Figure 4. Schematic of LIDS ring/tunnel interface joint (LIDS ring is shown in green and the composite doubler is shown in light brown)

The Low Impact Docking System (LIDS) is a metallic interface ring. For the CCM, the LIDS ring was fabricated out of aluminum that was paste bonded to the cured CCM tunnel and further reinforced by the addition of a six-piece composite doubler. In essence, the addition of the doubler transformed the joint from a lap shear to a double shear joint. The location of the LIDS ring on the CCM and structural details of the joint are shown in the schematic of Figure 4.

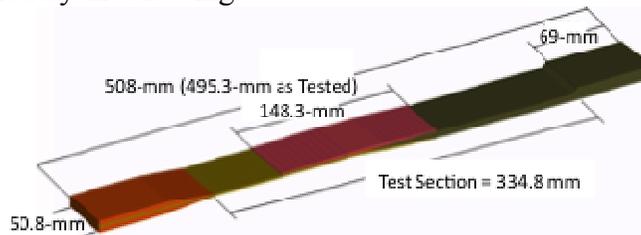
Figure 5. Specimen geometry. As built sample length was 12.7 mm shorter than drawing.

Specimen geometry is shown in Figure 5. The specimen consisted of an aluminum adherend representing a section of the LIDS ring, a composite adherend representing the solid laminate of the composite tunnel and a third laminate representing the composite doubler. Composite end-tabs were added to the composite end of the specimen to accommodate grip loads. The grip end of the aluminum adherend was machined eccentrically to minimize specimen bending.

The nominal thicknesses in the test gage section of the aluminum and composite adherends, were 6.35 mm and 2.06 mm, respectively. These thicknesses were tapered down to a knife-edge in the bonded joint region. The adhesive thickness was controlled to 0.38 mm. Due to material availability, the as-manufactured length of the aluminum adherend for the specimens was 12.7 mm shorter than specified by the drawings.

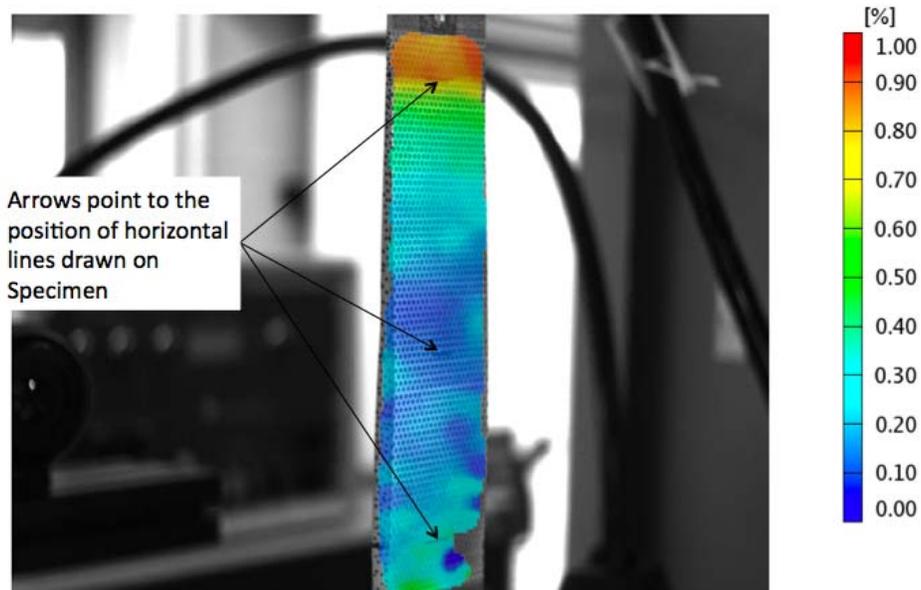
Figure 6. Typical full-field axial strains superimposed on actual specimen (image shown close to the failure load for specimen 2)

Except for one specimen where the composite doubler remained bonded to the aluminum part, all specimens failed in three separated pieces. Post-test inspection of the adherends and doubler revealed a typical pattern of adhesive failure along the adhesive-adherend interface. The aluminum adherends were generally fully covered on each bond surface with adhesive. All fully separated doublers were covered with adhesive on the part of the doubler that bonds to the composite adherend. At the aluminum knife-edge, the adhesive was observed to fracture normal to the load direction leaving the doubler completely free of adhesive on the surface that bonds to the aluminum adherend.

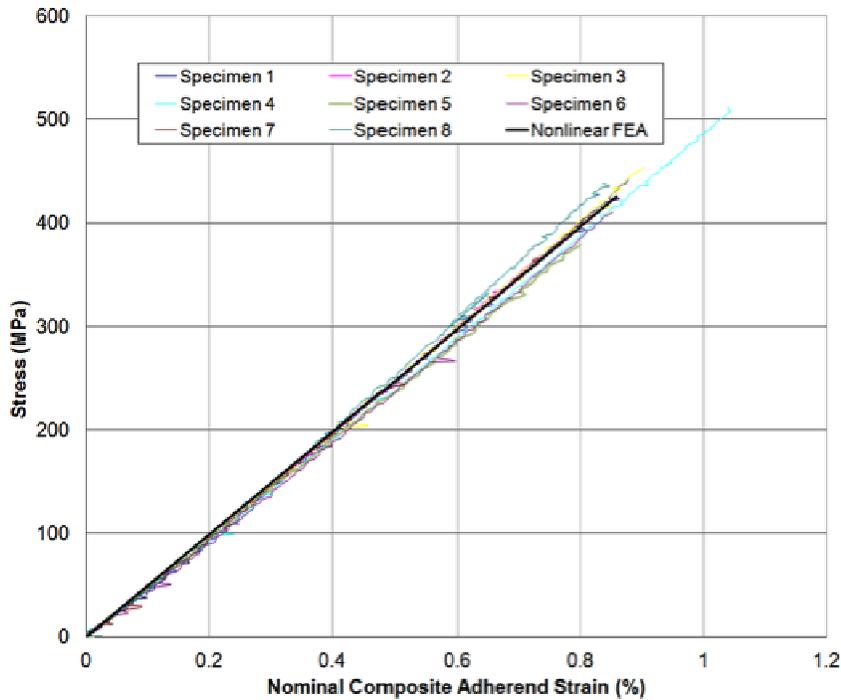
Figure 7. Comparison of experimental stress versus strain to nonlinear FEA response. To obtain stress, the applied load was divided by the cross-sectional area at the strain-gage location

A summary of the stress as a function of the nominal composite adherend strain is shown in Figure 7. The nominal composite adherend strain is the membrane strain found by taking the average to the back-to-back strain gages. The experimental responses are compared to the post-test nonlinear FE results. For the analysis, strains were extracted at the strain gage position. The results of Figure 7 demonstrate an excellent agreement between the FEA model and the far field stress/strain response. The effective modulus of the composite section of the specimen was found to be within 1.0 % of the average of the measured values reported in Table 5.

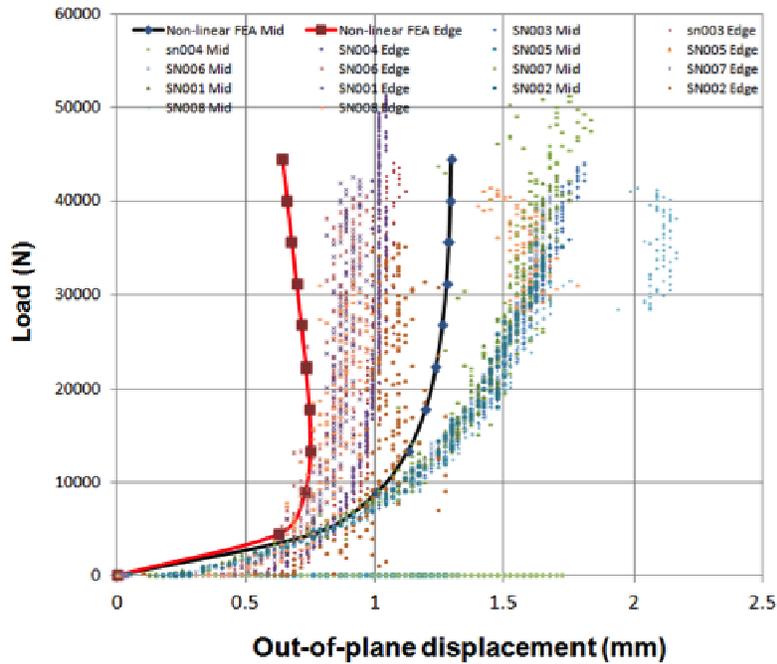
Figure 8. Measured versus analytical out-of-plane bending response.

In addition to strain measurement, photogrammetry provided out-of-plane displacements, which were used to examine the out-of-plane bending response relative to the nonlinear FE results. Figure 8 compares the nonlinear FEA results to the load as a function of the out-of-plane displacement results for two locations: doubler edge and midline of the doubler. The measured data show that the out-of-plane deflection at the doubler knife-edge asymptotically approaches a maximum of about 1.02 mm. This is greater than the nonlinear FEA result (red trace), which decreases in magnitude after reaching a maximum of about 0.74 mm.

With the exception of sample 8, the out-of-plane displacement measured at the midline, also appears to tend towards an asymptote at approximately 1.78 mm as compared to an approximate asymptotic value of 1.32 mm obtained from the nonlinear FEA results.

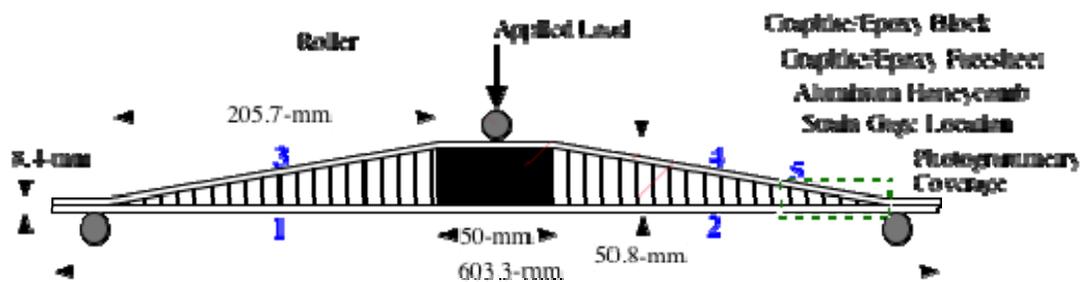
Figure 9. Sample geometry and location of instrumentation. (Strain gage locations are indicated by numbers 1–5)

The core-taper geometry was determined by the full-scale structure construction. The specimen's facesheet stacking sequence and thickness were tailored such that the core shear strength design allowable would be exceeded prior to facesheet/core debonding and/or fracture. Specimen width was 50.8 mm with nominal facesheet thickness of 3.92 mm. Each facesheet consisted of eleven 0.36 mm-thick fabric plies oriented at  $45^\circ/0^\circ/0^\circ/-45^\circ/0^\circ/0^\circ/0^\circ/-45^\circ//0^\circ/0^\circ/45^\circ$  with the  $0^\circ$  being along the beam length. The core was aluminum honeycomb with density of  $70.5 \text{ Kg/m}^3$ . The ribbon direction of the core was oriented along the specimen length. A solid block of graphite/epoxy was molded at the center of the coupon, as shown in Figure 9, to provide a hard point for load application and to preclude core failure outside of the core ramp.

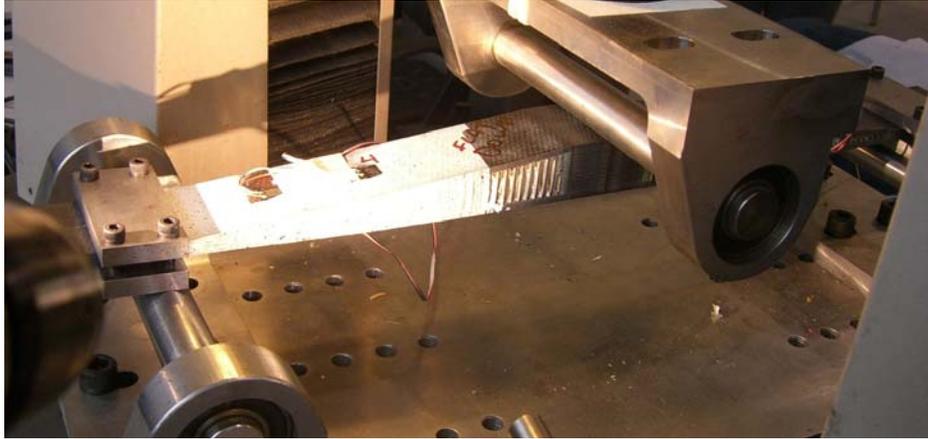
Figure 10. Photograph of sample tested with end tabs. (Also shown is the photogrammetry speckled pattern)

Preliminary tests were performed without end tabs, however, to better simulate the clamp-up pressure that the bolted fittings provide in the solid laminate of the panned down regions of the CCM, the remaining samples were tested with metal end-clamps as shown in Figure 10.

One specimen end was speckled for photogrammetric measurements. Prior to painting, the exposed honeycomb core edge was filled with a low modulus latex-based caulking material to provide an even surface. The painted end is shown in Figure 10.

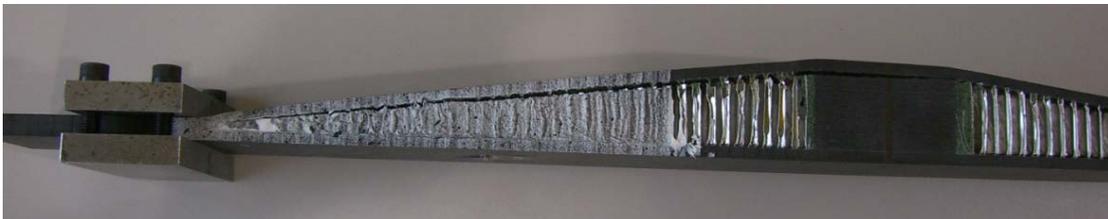
Figure 11. Photograph of the failed end of test coupon with clamped ends

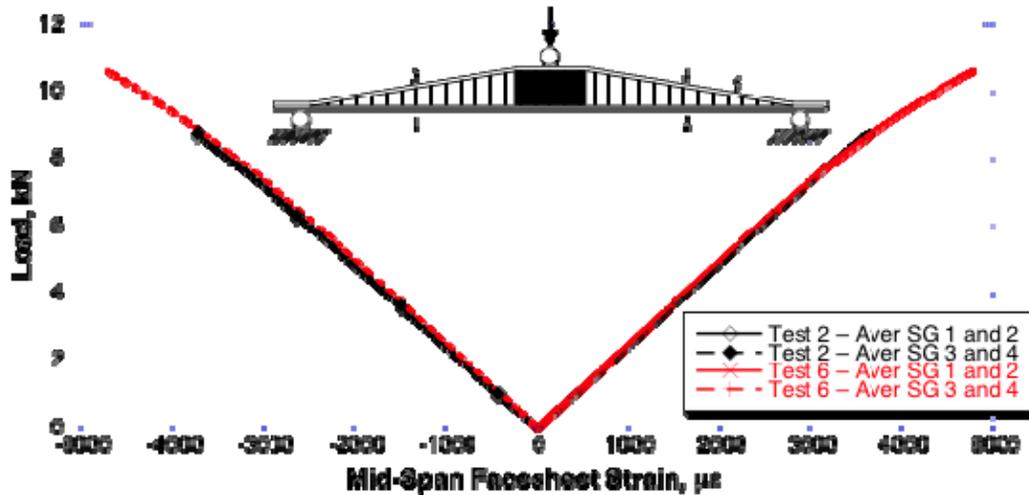
Figure 11. Facesheet strain versus applied load for specimens with and without clamped ends. Strains are the measured average values from top and bottom center span strain gages.

Average mid-span facesheet strains as a function of applied load are presented for the load case with and without end-tabs in Figure 11. For clarity, the response of sample 5, which was similar to that of sample 6, was omitted.

Figure 11 shows that the strain responses for the two loading cases (with and without end-tabs) are relatively linear and similar to each other in the range of load up to 8.76 kN—the failure load of sample 2.

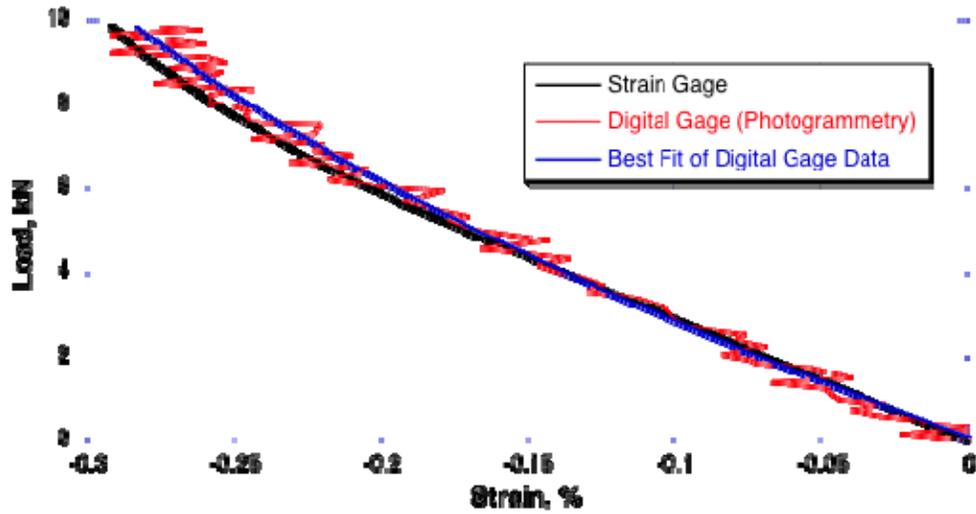
Figure 12. Strain gage versus photogrammetry based strain measurements for sample 5

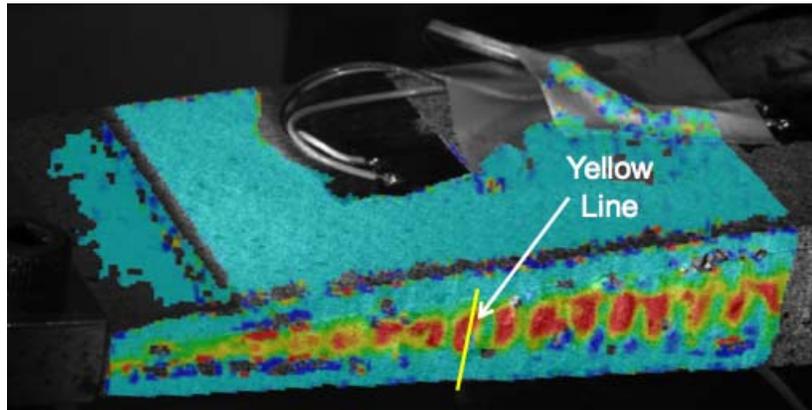
Figure 13. Typical example of full-field strain for Sample 5 at ultimate load (shear strain distributions were extracted along the yellow line and are presented in Figure 14).

An example of full-field shear strain is shown in Figure 13. From the strain field of Figure 13, shear strains at discrete points were extracted along a vertical line, shown in yellow, and plotted in the form of strain versus through-the-thickness position in Figure 14. The through thickness shear strain response resembles a parabola with the peak occurring roughly midway between the top and bottom facesheets as expected. However, accurate measurement of the shear strain magnitude in the core was complicated due to the uneven surface of the honeycomb and the uncertainty of the effect of core filler. Therefore, an indirect measurement of the average shear strain in the core was obtained based on the relative displacements of the facesheets.

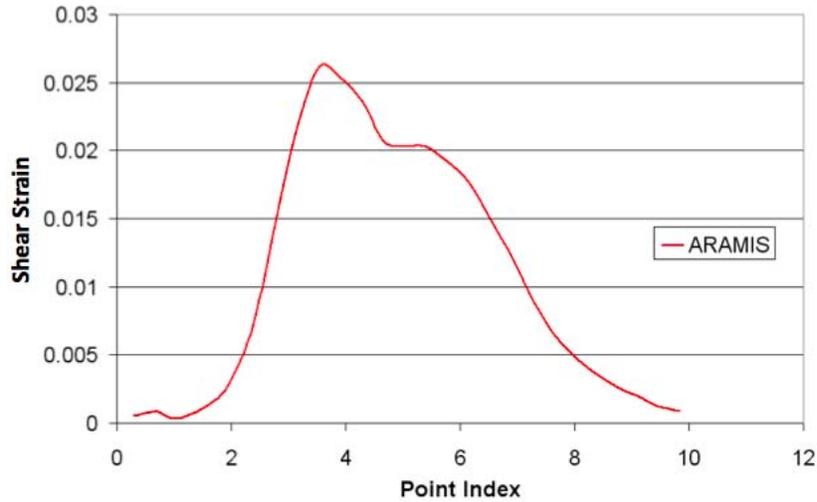
Figure 14. Shear strain versus through-the-thickness position for sample 5 at 9.84 kN

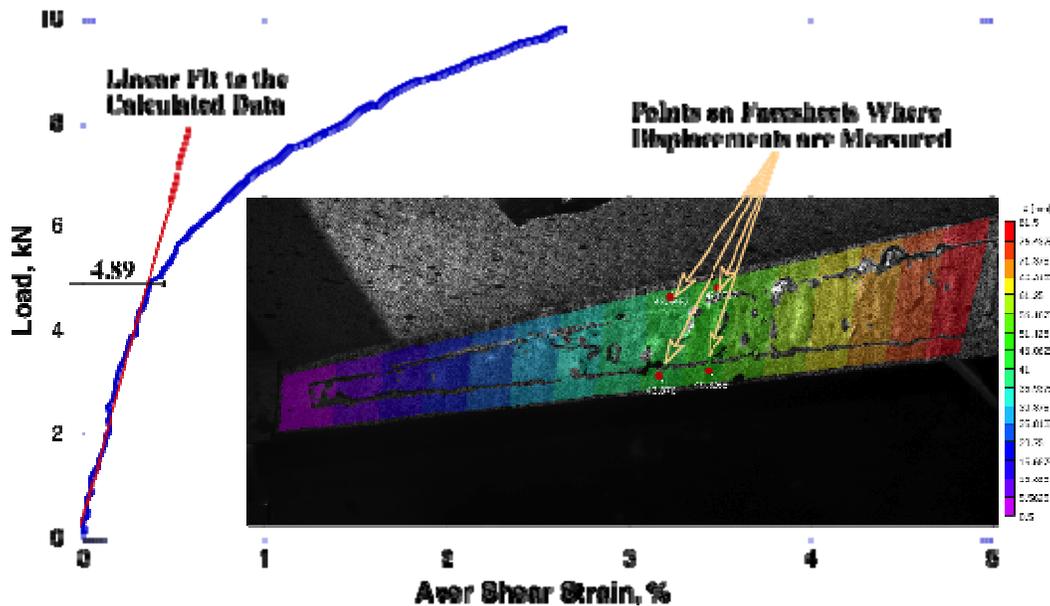
Figure 15. Average core shear strain as a function of load

For this indirect calculation the shear strain,  $\gamma$ , was related to the rate of change of deformations using Equation 1. Displacements were tracked at four reference points located on the facesheets of sample 5 and are shown in the inset of Figure 15. This calculation produced an average shear strain through the thickness of the core. A plot of the average through-the-thickness shear strain versus load is presented in Figure 15.

Through non-linear in its entirety the load/shear-strain response of Figure 15 appears to become progressively more non-linear at higher load. In particular, the response appears to deviate from a linear fit of the initial portion of the data at approximately 4.89 kN. The decrease in the core shear stiffness is most likely associated with the initiation of shear yielding and/or cell shear buckling (wrinkling of the cell walls).

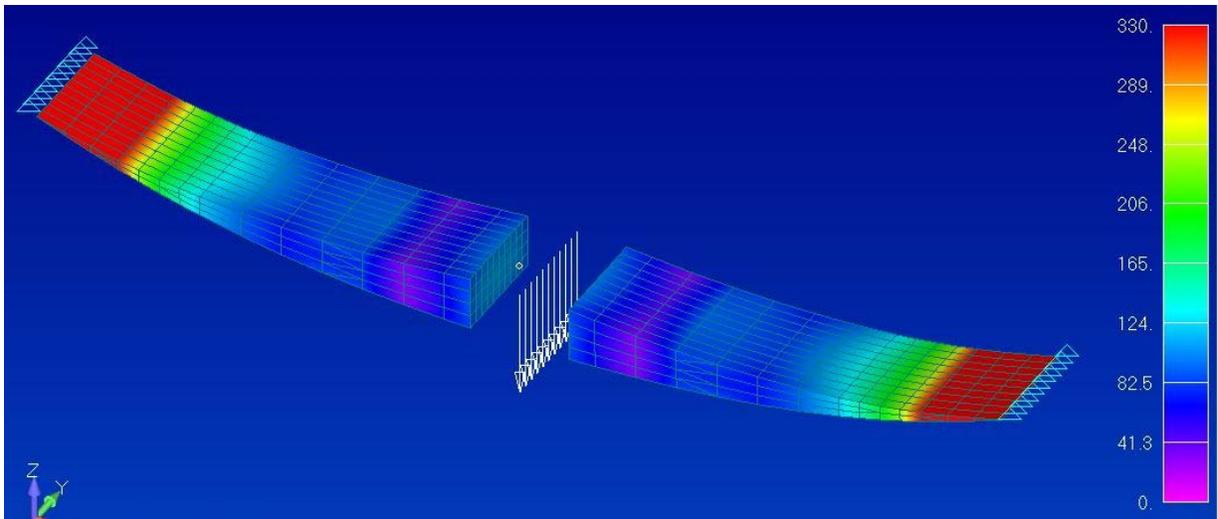
Figure 16. Shear stress distribution in the core at an applied load of 6.23 kN. Elements in red (at the knife-edge) are at the core allowable value

As shown in the FEA core shear strain distribution in Figure 16, peak shear stress occurred at the core knife-edge. At 6.23 kN of applied load, nearly one quarter of the core ramp had reached the shear stress allowable of 2.28 MPa (330 psi).

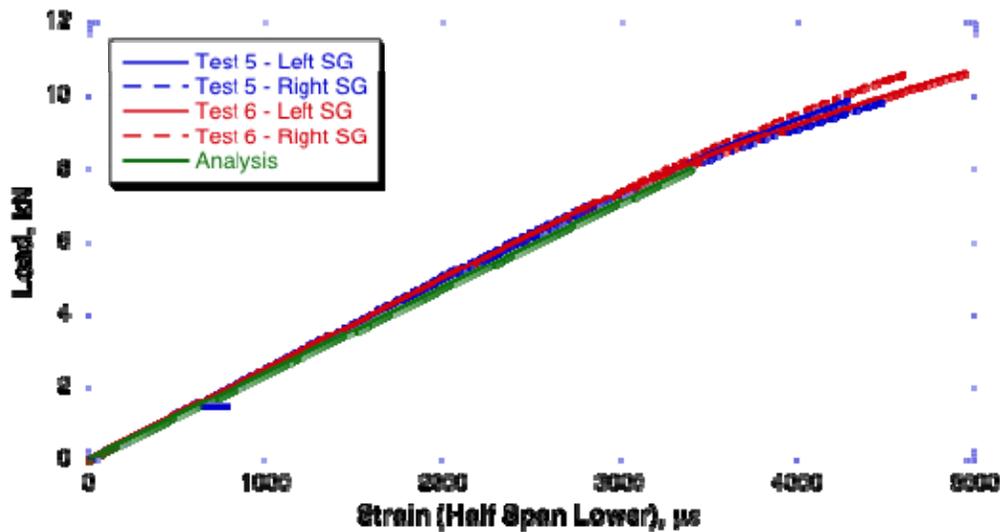
Figure 17. Test versus analysis at strain gage positions 1 and 2

Test/analysis correlations of tensile mid-span axial strains (at positions 1 and 2) for sample 5 and 6 are shown in Figure 17. Compared to the corresponding FEA strain, Figure 17 shows a good correlation between measured and predicted strains at the mid-span. Moreover, the responses of Figure 17 show that the facesheet strain responses remain linear beyond the load of approximately 4.89 kN where a deviation from linearity was observed in load/shear strain response of the core. A similar result was also true for the facesheets in compression (strain gage positions 3 and 4).

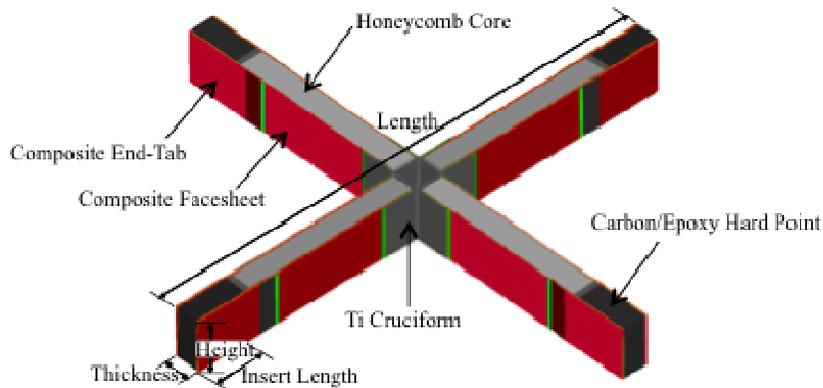
Figure 18. Diagram of a cruciform specimen showing critical dimensions

A total of five cruciform samples were fabricated individually and tested. The test specimen geometry is shown in Figure 18. Each leg of the cruciform consists of a sandwich panel, representative of the corresponding backbone beam. Each piece was paste bonded into the clevis of the titanium cruciform. The free end of each leg was reinforced to accommodate grip pressure for load application. At the reinforced ends, the aluminum core was replaced with a solid graphite/epoxy composite block and the facesheets were reinforced with extra plies, tapering in thickness as they extended beyond the length of the composite block. The specimen length dimension was 489.2 mm, the height (or width of each sandwich leg) was 50.8 mm, the thickness of each sandwich leg (excluding the ends) was 26.2 mm and the end-tab insert was 50.8 mm long.

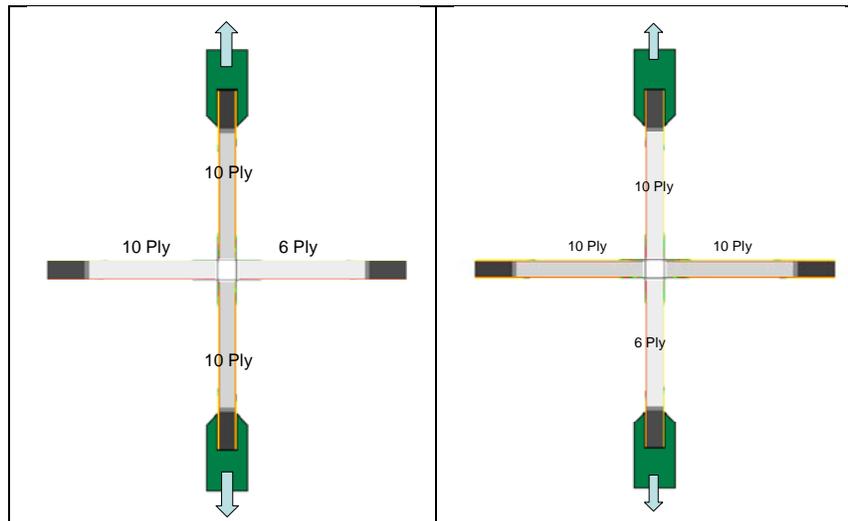
Figure 19. Schematic of the two loading configurations

To represent the backbone construction correctly, three of the sandwich panels (branches) contained 10-ply facesheets and the fourth contained 6-ply facesheets. Consequently, tests were conducted along two orientations as shown in the schematic of Figure 19.

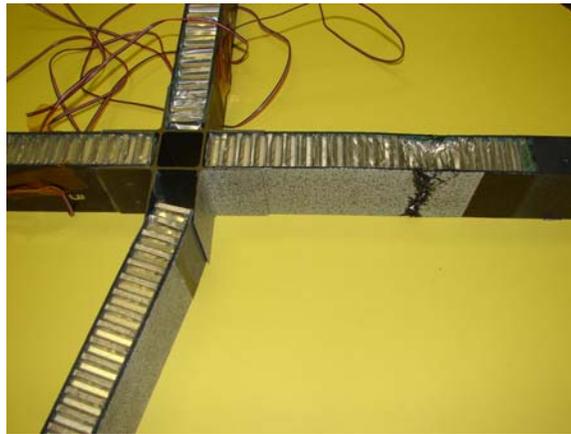
Figure 20. Facesheet failure in the horizontal leg of sample 2 when pulled along the 6-10 orientation, caused bond failure in transverse direction due to spring back

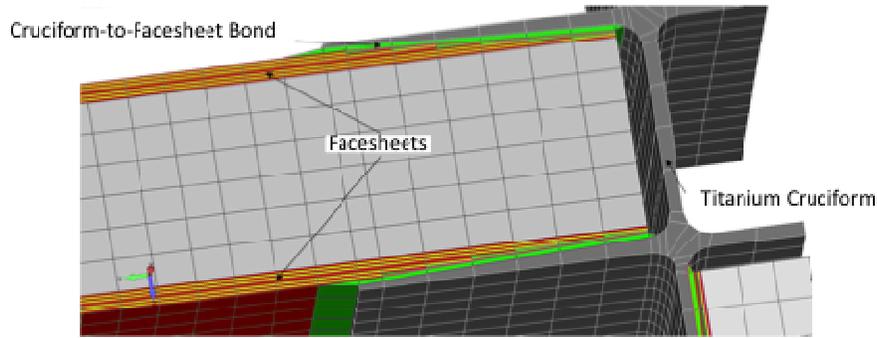
Figure 21. Close-up of facesheet to cruciform bond (paste bond is shown in green)

The build up for the clamped end of the panels was multiple plies of carbon fiber fabric co-cured with the facesheets. In the model, this was modeled ply-by-ply just like the facesheets. The paste bond between the cruciform and the face sheets was modeled using one element through the thickness. As shown in Figure 21, the model included the paste-bond taper and the taper at the end of each titanium cruciform leg.

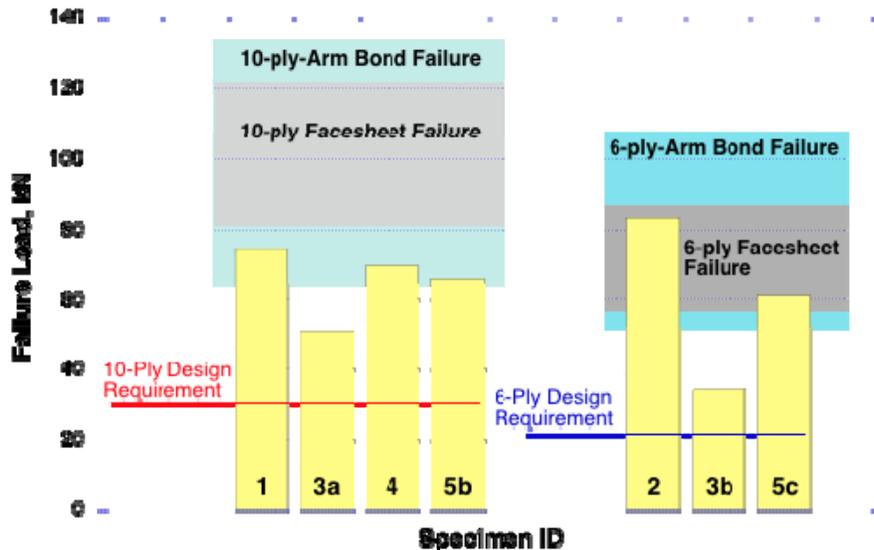
Figure 22. Predicted and measured strengths

A comparison of predicted versus measured failure loads are summarized for both the 6- and 10-ply legs in Figure 22. In addition to the load range for each possible mode of failure, Figure 22 also shows the design strength requirement for each of the leg types.

For both the 6- and 10-ply arms, the predictions for the bond and facesheet mode of failure overlap. Consequently, in every loading case there are two competing failure modes. For specimen 2, where the pull was in the 6-10 direction, facesheet failure in the 6-ply arm occurred within the predicted range. The bond integrity for specimen 2 also exceeded the minimum bond failure predictions for both the 6- and 10-ply legs. All other tensile specimens failed in the bondline and at lower load. For these samples, the failure loads were near or below the predicted minimum bond strengths. The only pristine sample that failed below the minimum prediction was sample 3a. Test case 3a was lower than the minimum bond-failure prediction but still 67 % higher than the design allowable. The large variation in bond strength, which could account for this anomaly, is not unusual with paste bonds, Reference [5]. Factors that can contribute to bond strength scatter include surface preparation and adhesive thickness, which can vary from specimen to specimen and from side to side.

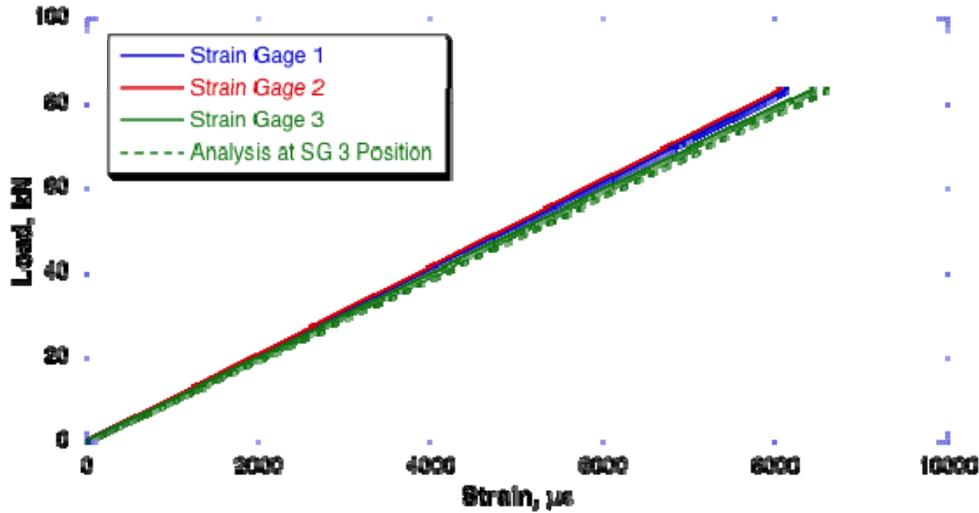
Figure 23. Sample 2 loaded in tension along the 6-10 direction

A Typical example of the measured versus predicted strains is shown in Figure 23 for sample 2. The plot shows the individual load/strain responses for each of the three gages on the particular leg that was loaded and a prediction for the center gage.
