Analysis of 100-lb_f (445-N) LO₂-LCH₄ Reaction Control Engine Impulse Bit Performance

NASA/TM—2012-217613

National Aeronautics and
Space Administration

June 2012

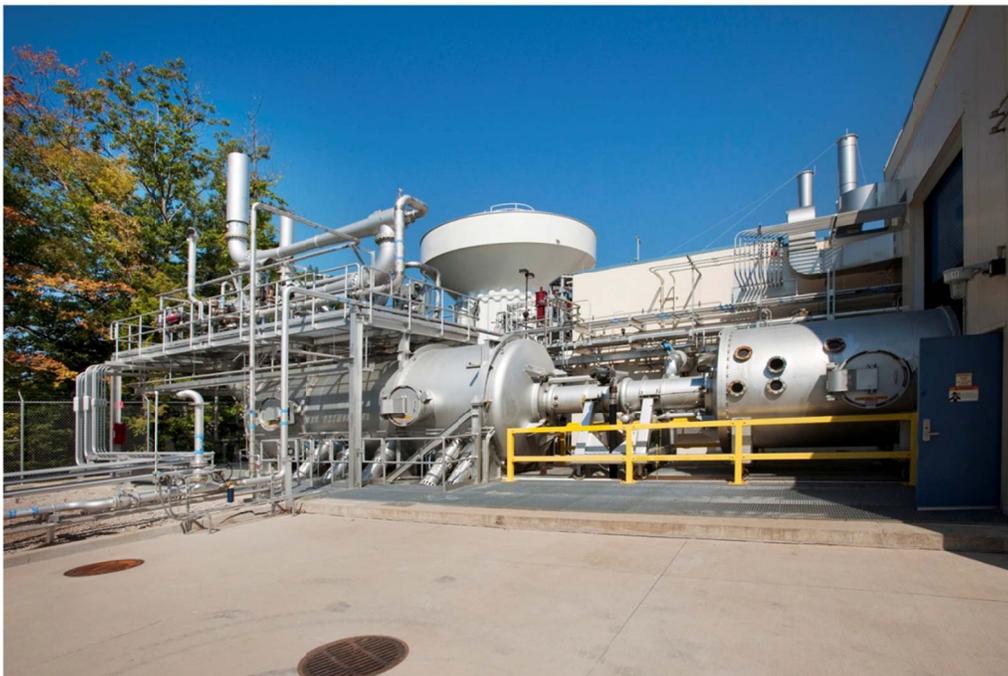
Figure 1: ACS facility test capsule, spray cart, and ejector platform.

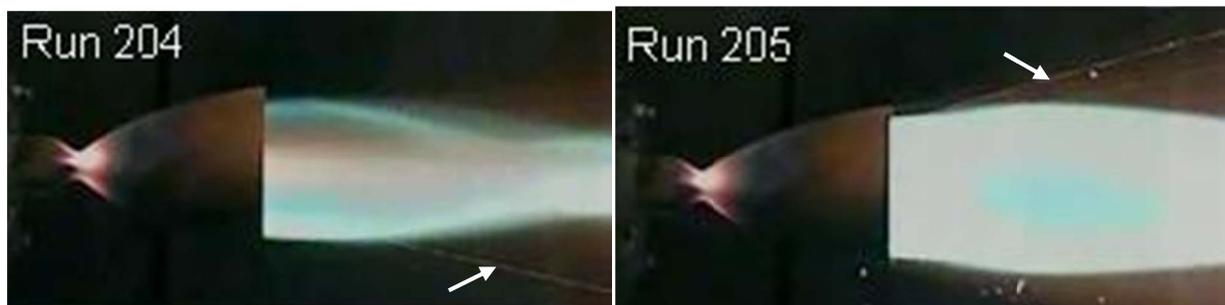
Figure 32: Sparks appearing in the plume during two tests with the SN-3 chamber are likely related to the coating damage.

The first chamber, SN-3, was damaged during the first pulse test day that used propellants at nominal temperature conditions. This test day consisted of 95 pulses at a 50-percent duty cycle totaling 38 s of burn time. (Prior to pulse testing the nozzle had undergone 131 s of specific impulse testing.) Since the chamber inspection can only be done at the end of the day, it is difficult to pinpoint which test caused the damage. However, sparks were observed in the final two tests, at the end of the 20-pulse trains (Figure 32).
