Composite Pressure Vessel Ground Processing Hazards and Risk Management at KSC

**Joseph Hamilton 2012
KSC S&MA Directorate/SMASS/MEI**

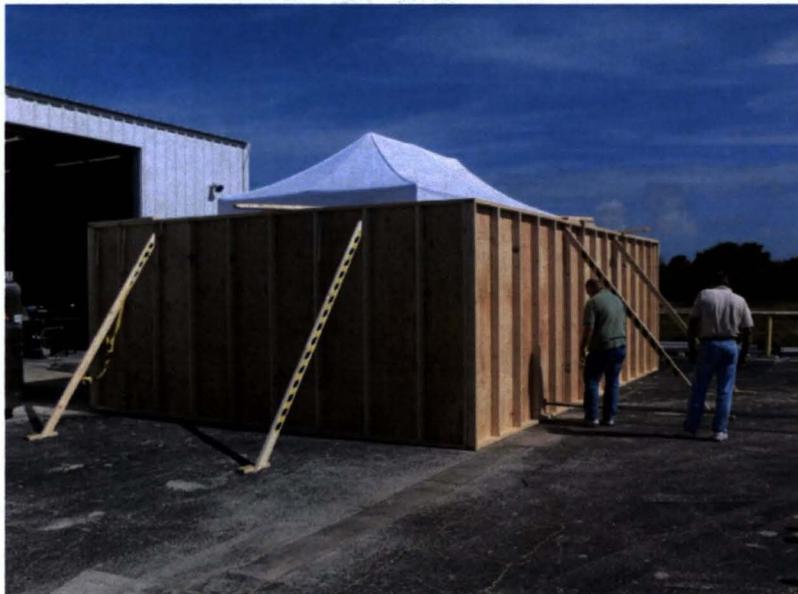
Test Unit Plywood Protective Barrier Under Construction

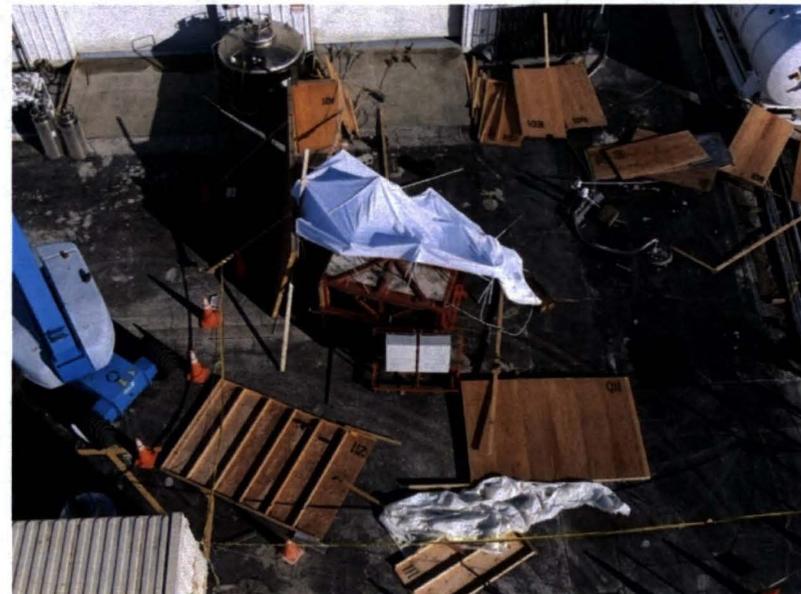
Area surrounding test unit following tank rupture. Test team location was behind roll-up door at top of image.

- The pretest analysis was in error regarding the total energy available during a failure; it only considered the pneumatic energy of the 10% by volume ullage space.
- There was no blast/fragmentation or QD siting analysis of barrier capabilities, plywood, or door.
- The Test Team accepted the manufacturer's CPV structural analysis without sufficient review.
- The manufacturer of the tank maintained it would fail by a Leak Before Burst scenario without supporting evidence, as did the test team in its Test Readiness Review.

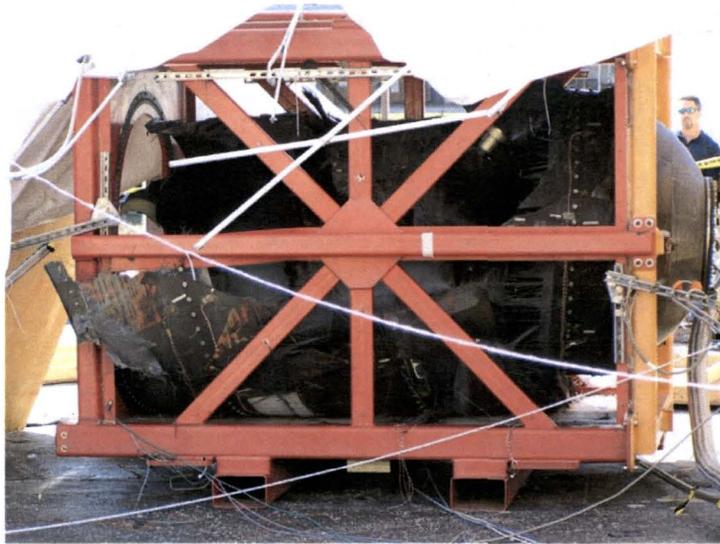
Post-Rupture

- On December 23, 2008 a composite pressure vessel (no liner) burst during pressure testing while filled with LN₂ (~900 gal.) and pressurized with GN₂. The test team expected a **leak-before-burst** failure and failed to take into account additional energy potential including **BLEVE** (Boiling Liquid Expanding Vapor Explosion).
- The test team thought they were protected by plywood barriers and a roll-up door. However a high velocity jet of LN₂ impacted and opened the door, directly contacting 4 team members and filling the room with N₂. Several team members received mild cryo burns, one member received a cracked rib, 2nd degree cryo burns and other injuries. The test team was fortunate, they could have suffered much worse consequences.

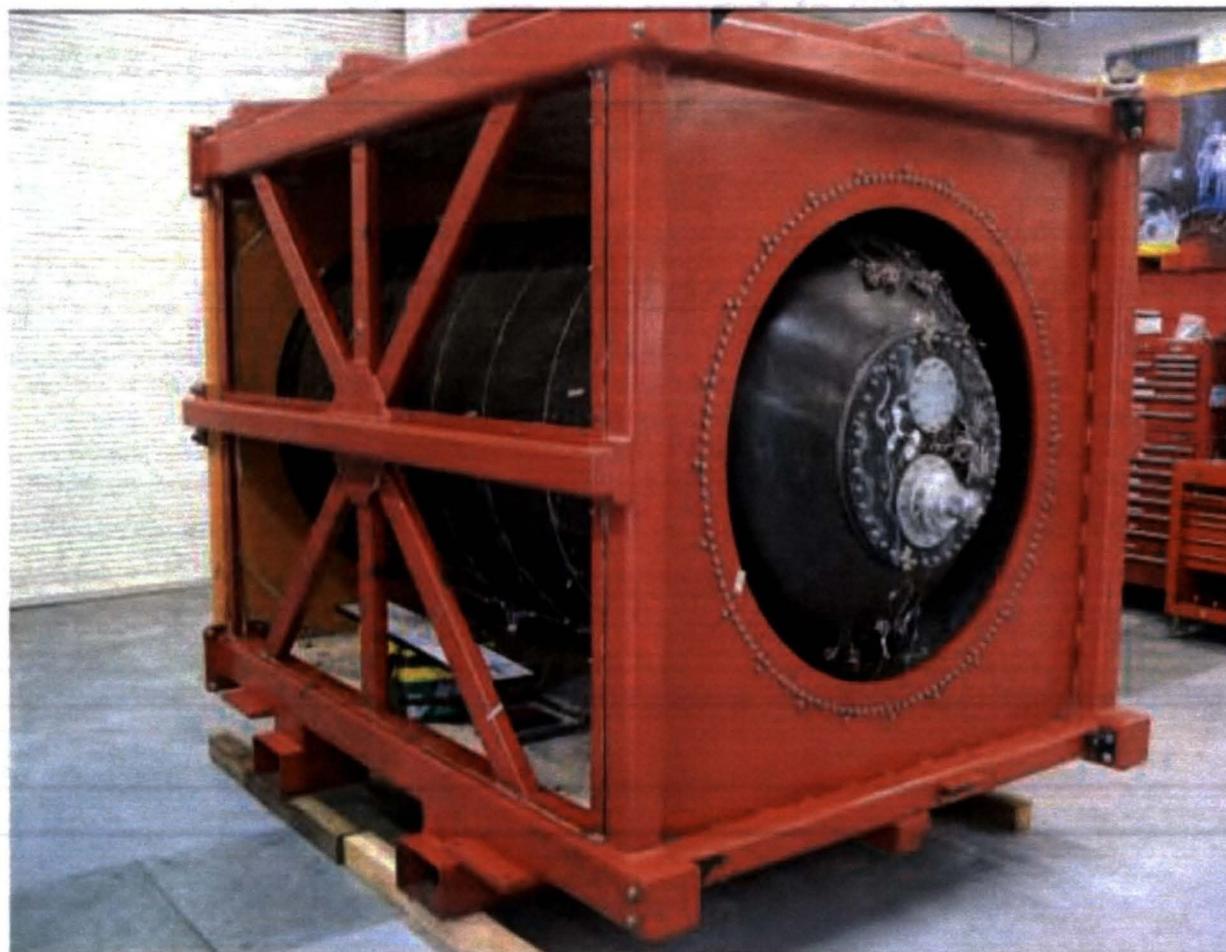
Figure 2-2. Composite Tank in Support Structure

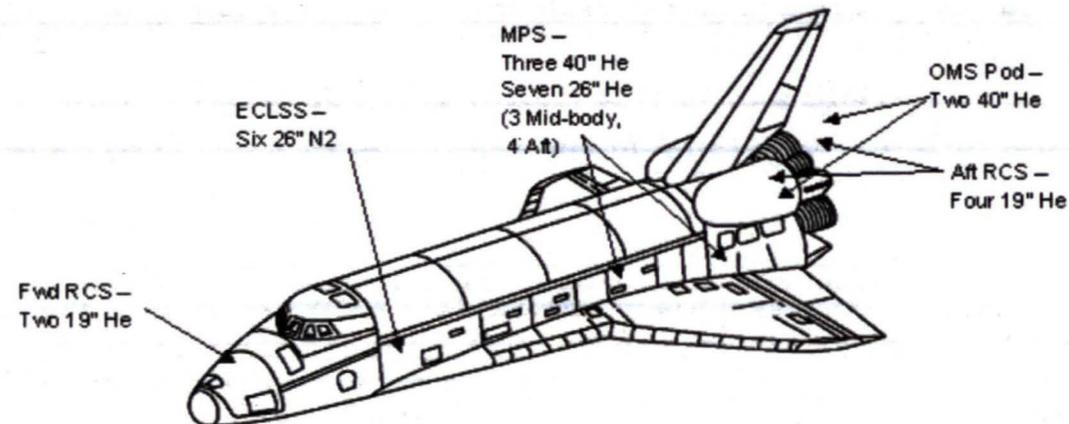
Orbiter COPV risk from 10/18/2007 PRCB

- OMS tank s/n 020 in RP03 is the driver for OV-103 reliability numbers
- OMS tank s/n 018 in LP03 is the driver for OV-105 reliability numbers
- MPS tank s/n 021 in OV-105 is a large contributor to reliability numbers

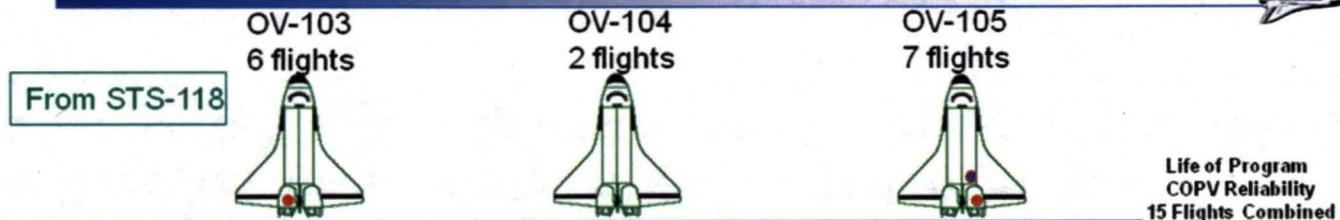
Life of Program Reliability Estimate Two Day Launch Scrub - PRCB 10/18/2007

Per Flight Reliability Numbers Point	OV-103		OV-104		OV-105		Life of Program COPV Reliability 15 Flights Combined
	OMS Full	OMS Reduced	OMS Full	OMS Reduced	OMS Full	OMS Reduced	
Mean	.999 53	.999 84	.999 989	.999 995	.999 78	.999 918	.998 0 1:489
95% CL	.998 3	.999 42	.999 958	.999 978	.999 20	.999 69	.992 5 1:134

Cumulative Reliability (per vehicle) From # of Flights	OV-103		OV-104		OV-105		Life of Program, 15 flight Failure Likelihood
	1 Flight	5 Flight	1 Flight	1 Flight	1 Flight	6 Flight	
Point	0.999 09	1:1,099	0.999 991	1:111,111	0.999 51	1:2,041	
Mean	0.998 7	1:769	0.999 984	1:62,500	0.999 27	1:1,370	
95% CL	0.995 3	1:213	0.999 936	1:15,625	0.997 3	1:370

Note that reliability for each individual flight is virtually the same for all the individual flights through the end of the Program

Note: OV-104 numbers based on replaced MPS Tanks.

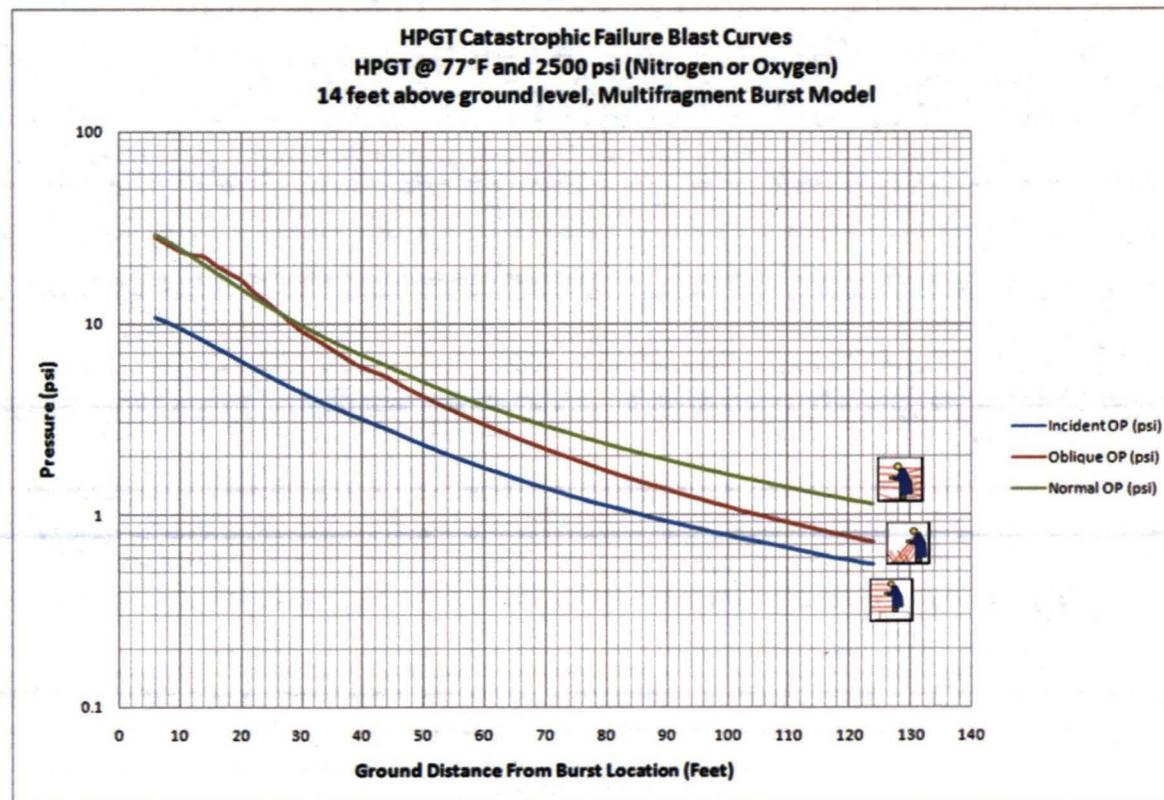
- **KSC assessed the COPV stress rupture consequence based on the Chris Keddy WSTF ISS COPV blast/fragmentation analysis report (Examination of Catastrophic Failure of COPVs During Ground Operations: KSC SSPF Flight ULF-3 2009)**
 - **Primary COPV rupture effects as well as some secondary effects were considered**
- **Below is a ISS COPV blast overpressure result using the PV HAZARD software**

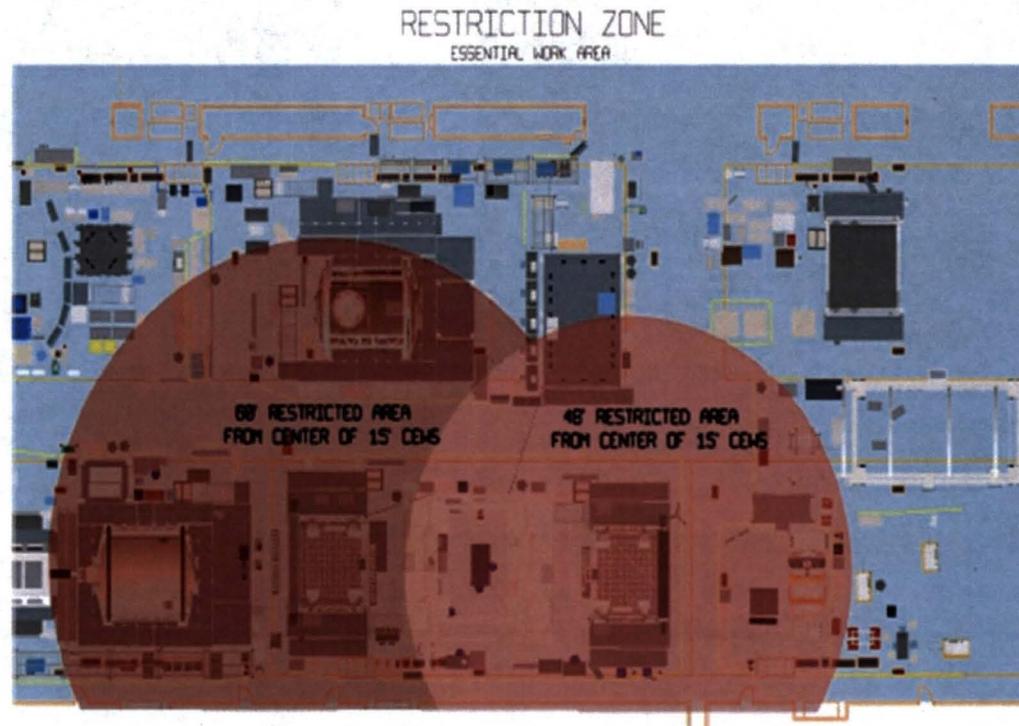
- All Space Station Processing Facility (SSPF) residents are notified of the presence of pressurized COPVs and the associated hazards.
- Personnel access restrictions around pressurized COPVs in the SSPF were based on the WSTF ISS COPV blast fragmentation analysis report overpressure curves at 3psi.
- Personnel access restricted zones in the SSPF for pressurized HPGT and NTA are shown below

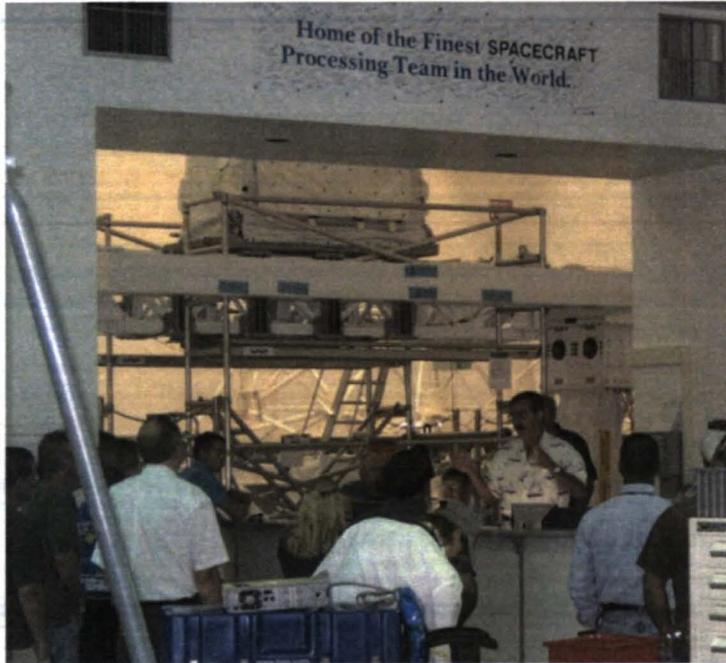
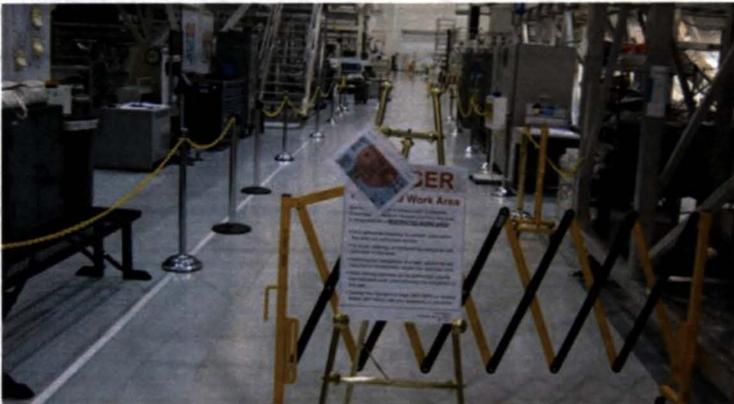
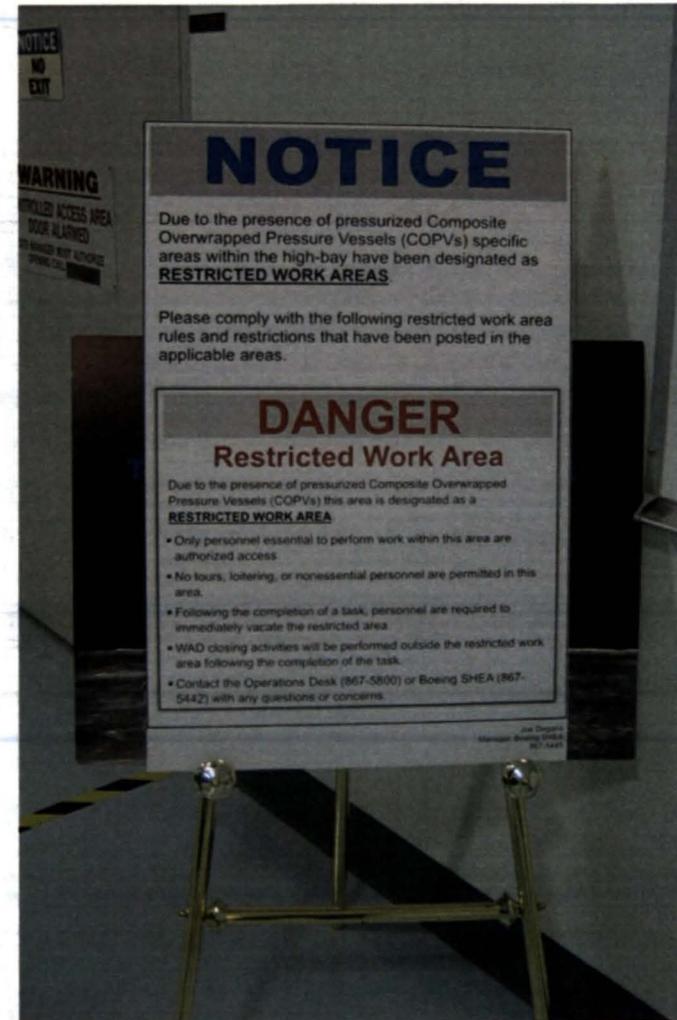
- COPV restricted areas in SSPF processing area with warning signage
