NASA Engineering
Safety Center

**External Tank (ET)
Thermal Protection
System (TPS)
Non-Destructive Evaluation (NDE)
Super Problem Resolution Team
(SPRT)
Activities**

**Presented at the
Quantitative NDE Conference
Portland, Oregon
August 2, 2006**

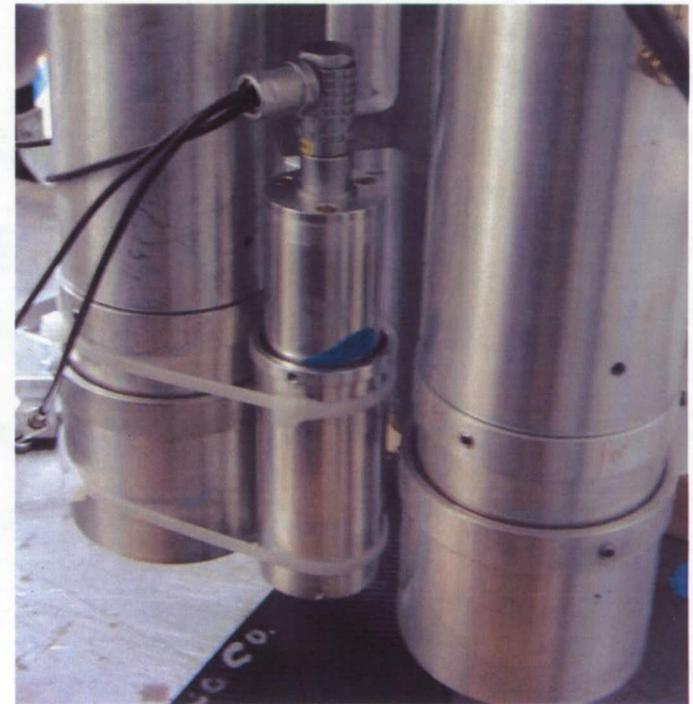
NaI versus YSO detectors
