So Close Yet So Far: The Jammed Airlock Hatch of STS-80

Overview

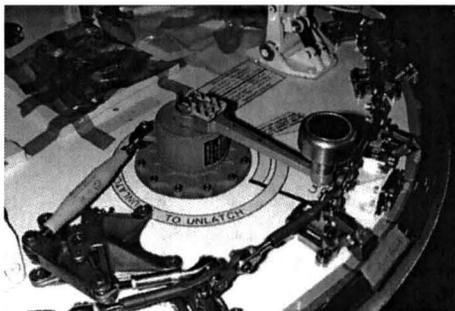
Figure 2: View of outer airlock handle and actuator assembly. NASA Image

Following the successful deployment of the ORFEUS-SPAS II and WSF satellites, preparations began for the two EVAs. After almost two hours of preparation, Tamara Jernigan attempted to open the outer hatch of the airlock only to discover the hatch was jammed.

“It smacked solidly into some obstacle at the 30-degree mark. After several grunting attempts to force the handle around, I could see... We were nowhere near turning the handle the one full circle required to retract the metal rollers that held the hatch against its seals. There was nothing obvious in the way, yet the handle felt like it was jamming against a hard metal stop [2].”
