NASA/TM-2013-218021/Volume II
NESC-RP-12-00824

Independent Assessment of Instrumentation for ISS On-Orbit NDE

Appendices

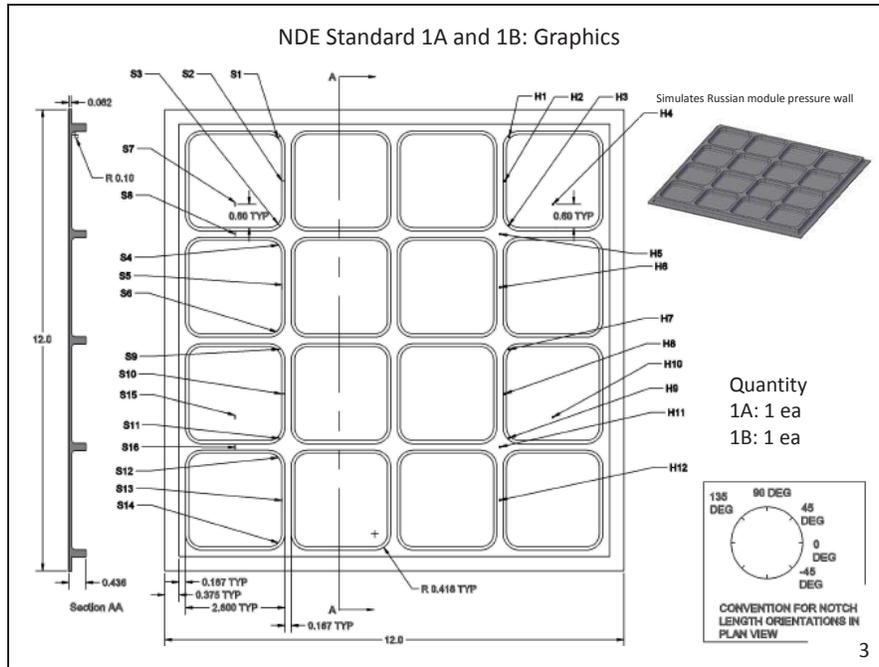
NDE Standard 1: Notes

Part
Name: **NDE Standard 1A**
Part Description: Flat plate with drilled holes and EDM slots

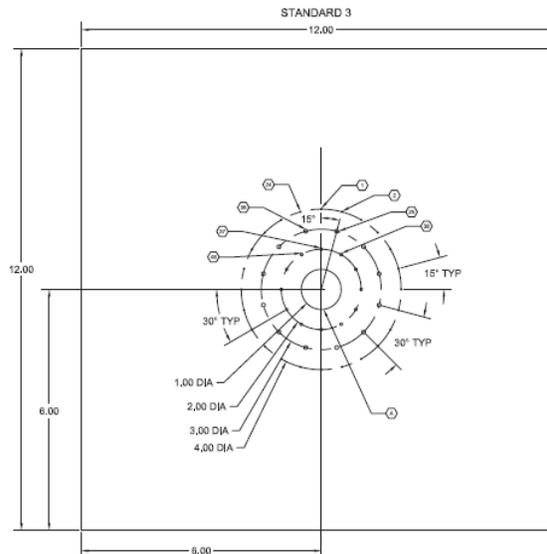
NDE Standard 3

Simulates US module
pressure wall.
For NDE flaw detectability
study under patch or don
repair

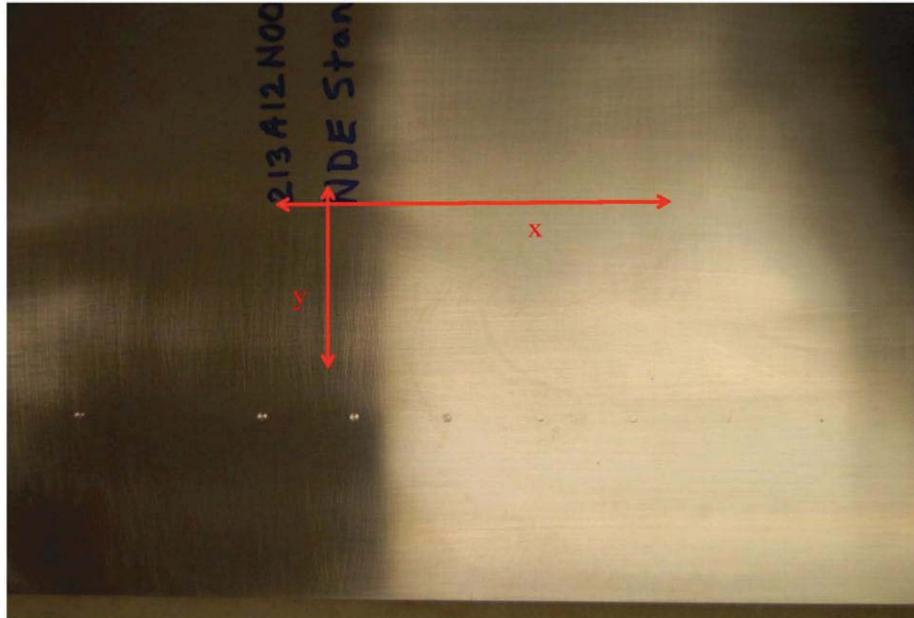
Plate 551 NDE Standard 4

551-clean-hole
(gain was set too high)

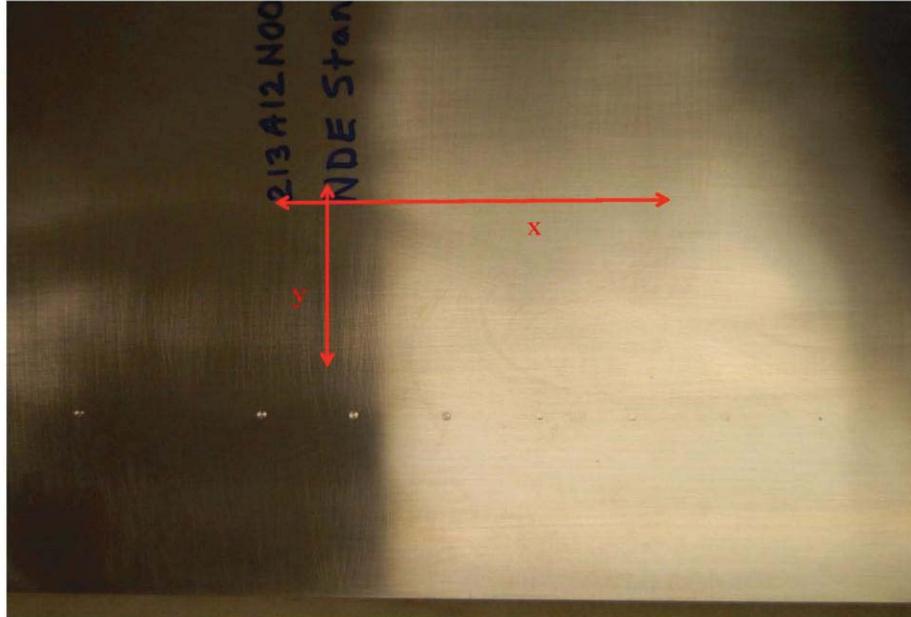
Plate 551 NDE Standard 4

551-clean-hole
(gain was set too high)

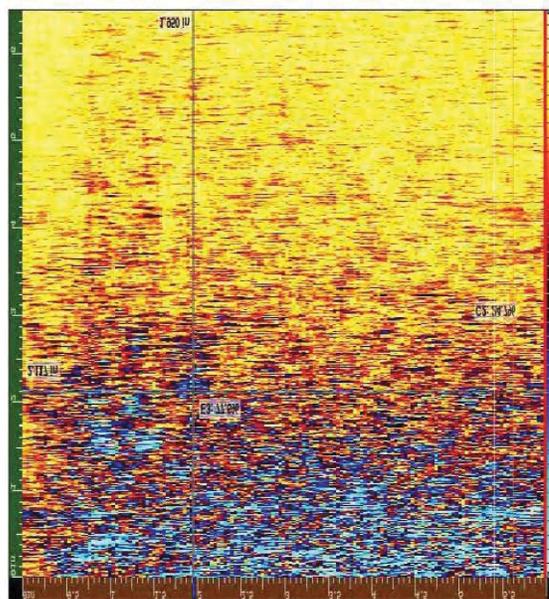
Not able to detect large
cracks from 4" away.

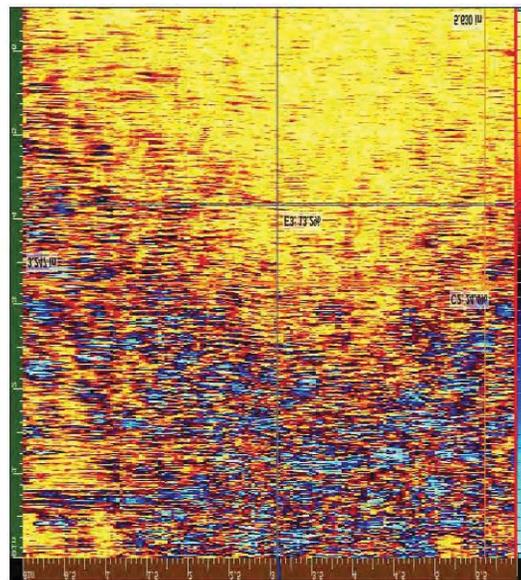
Not able to detect large
cracks from 4" away.

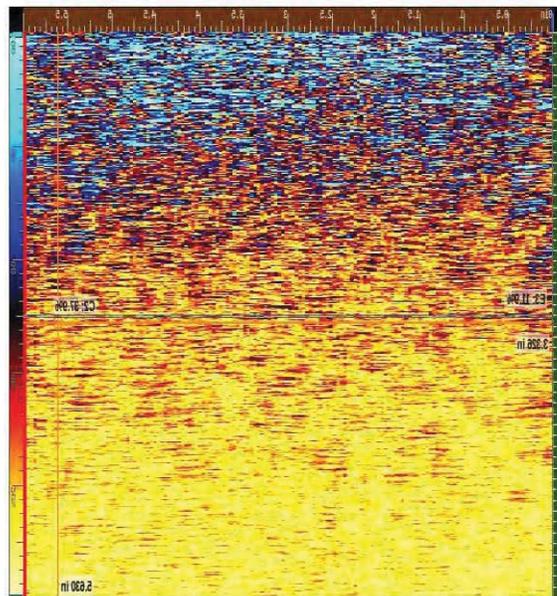
Not able to detect large
cracks from 4" away.

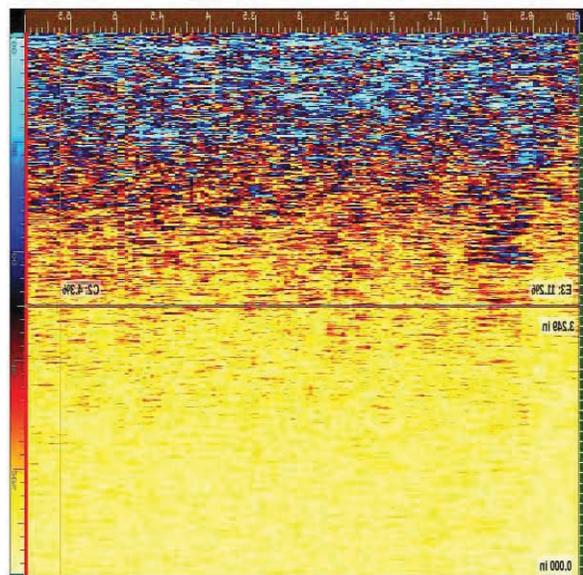
Not able to detect large cracks from 4" away.

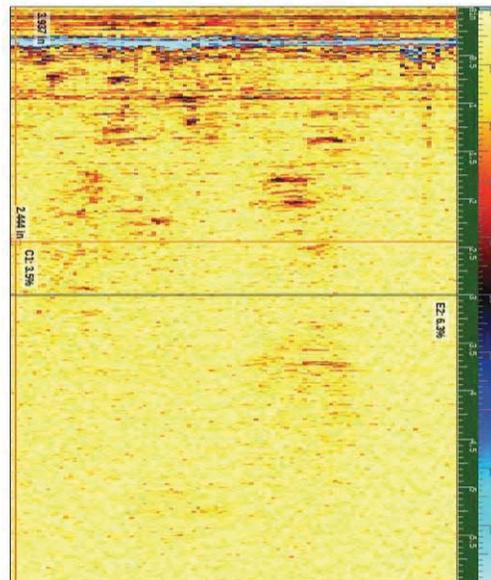
Small hole

Multiple dents

Single element transducer
mapped out the damage
faintly.

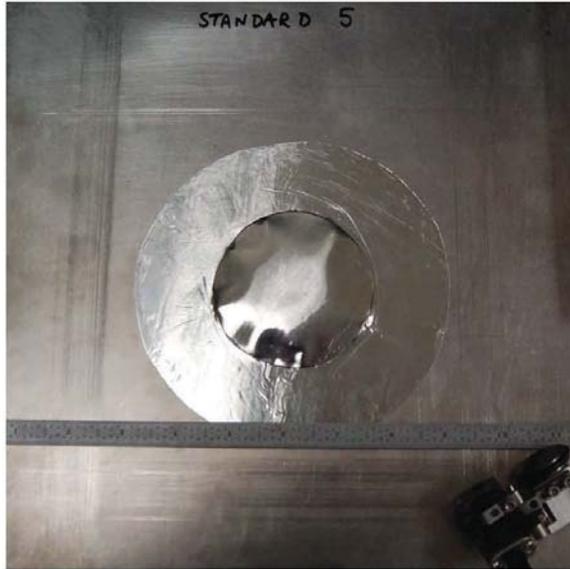
NDE Standard 5

This system will still have trouble with the tape patch at the repair's center
Engineering evaluation is that it would measure through the tape with some degradation See Std 4.

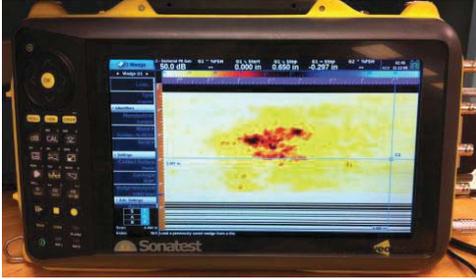
NDE Criteria	Crewmember Observations
Sonatest Veo

<ul style="list-style-type: none"> • Nice imagery, like pictorial image of damage; easy to understand. • Adapt probe for use on-orbit. • Seems easier to use but still has a troublesome encoder. • Spring on encoder okay. • Power cable sticks out from the back—will interfere with setting the device on its back. • Easy to handle. • Good file and menu system, GUI easy. • Like lots of features, such as Ethernet capability, USB, and VGA out. • Preferred model (x2).
UniWest ECS-3

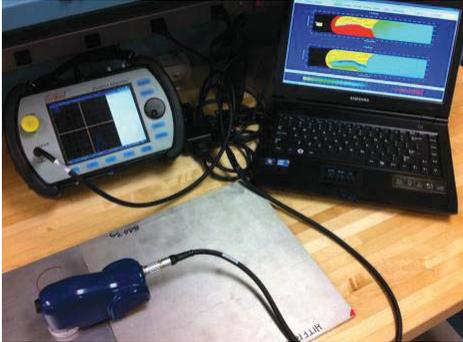
<ul style="list-style-type: none"> • Laptop would allow more direct remote control from ground (black box). • Avoid using a laptop. • Current probe design too big and cumbersome (x3). • Cable out the back of probe will limit access on ISS. • Great imagery, “neat.” • Would prefer two-dimensional imagery. • Too bulky, not really space/ISS ready (x2).
