Property Evaluation and Damage Evolution of Environmental Barrier Coatings and Environmental Barrier Coated SiC/SiC Ceramic Matrix Composite Sub-Elements

Dongming Zhu, Michael Halbig, Martha Jaskowiak, Janet Hurst, Ram Bhatt and Dennis Fox
NASA Glenn Research Center, Cleveland OH

**38th Annual Conference on Composites, Materials and Structures
Cocoa Beach, Florida
January 27-30, 2014**

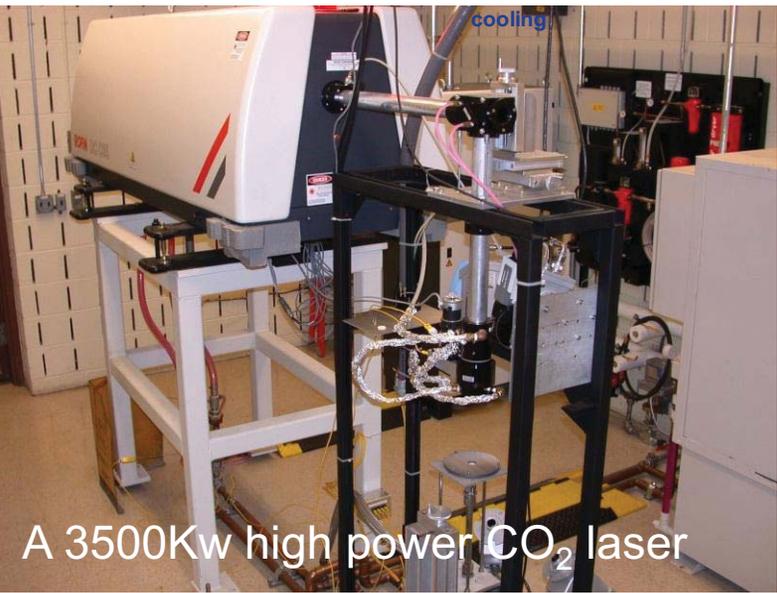
Laser Heat Flux Rigs for Advanced EBC-CMC Developments

- Turbine level heat flux, environment and load testing capabilities
- Quantitative one dimensional (one-D) steady-state thermal conductivity measurements and durability testing
- Two dimensional (2D) coating and component material degradation real time monitoring under development

$$k_{ceramic}(t) = q_{thru} \cdot l_{ceramic} / \Delta T_{ceramic}(t)$$

$$q_{thru} = q_{delivered} - q_{reflected} - q_{radiated} \quad \text{and} \quad \Delta T_{ceramic}(t) = T_{ceramic-surface} - T_{metal-back} - \int_0^{l_{bond}} \frac{q_{thru} \cdot dl}{k_{bond}(T)} - \int_0^{l_{substrate}} \frac{q_{thru} \cdot dl}{k_{substrate}(T)}$$

A 3500Kw high power CO₂ laser

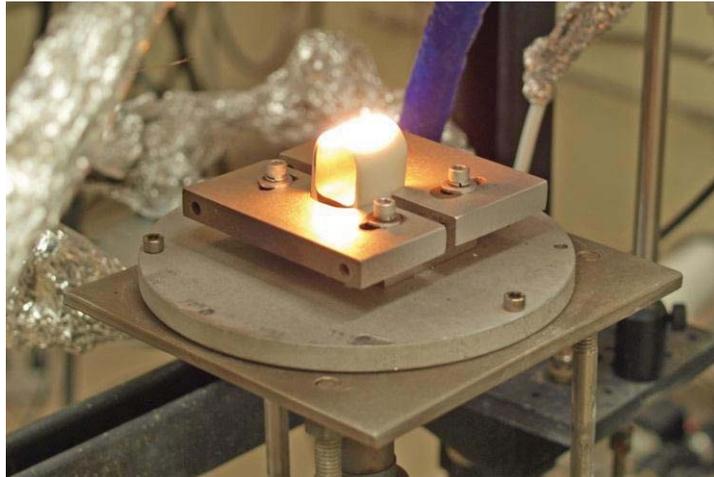
- In-situ, real time 2D or 3D thermal conductivity monitoring being implemented

- 1" and 2" specimens in testing
- Heated area 1.25" diameter

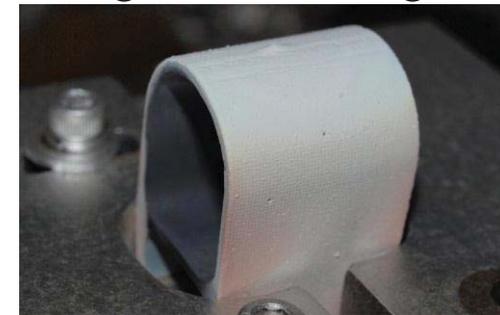
Turbine Environmental Barrier Coating System Long-Term Durability Testing on a Prepreg SiC/SiC Subelement

- The LE element tested at $T_{\text{EBC surface}} \sim 2700^{\circ}\text{F}$ (1482°C), $T_{\text{EBC-CMC interface}} = 2400\text{-}2460^{\circ}\text{C}$ ($1300\text{-}1348^{\circ}\text{C}$)
- Completed 550, 1 hr cycles
- Coating damage evolution was monitored using during the entire testing
- The coating had only very minor degradation after the long term testing

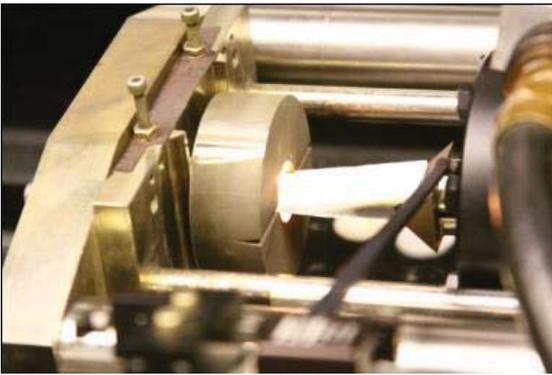
- Testing approaches developed for EBC-CMC trailing edge thermomechanical testing
- High heat flux capability to simulate required high thermal gradients and more complex temperature distributions in a turbine engine
- Mechanical loading to simulate the high pressure turbine airfoil pressure (ballooning) effects
- EBC-CMC durability being evaluated, planned incorporation of stream jet environments

EBC coated Trailing Edge (TE)
“wedge” testing in high heat flux and
mechanical fatigue loading

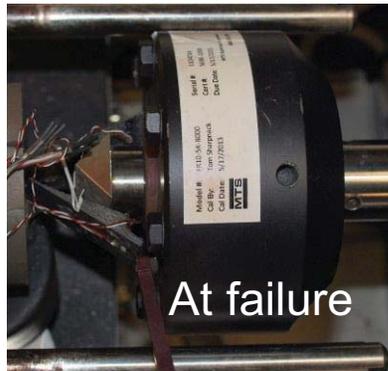
- Maximum failure strain observed from the gauge at Thin Wall inner location, at ~0.5%
- Failure load at 538 lbf (approximately corresponding to 20 ksi stress at the thin wall inner location)
- The coated element failure load 700 lbf after the progressive fatigue cycles
- Lower than the previous failure load of 800 lbf for an as-received element specimen
