NASA/TM-2014-218171  
NESC-RP-11-00697

# Orion Multi-Purpose Crew Vehicle (MPCV) Capsule Parachute Assembly System (CPAS) Wake Deficit Wind Tunnel Testing

February 2014

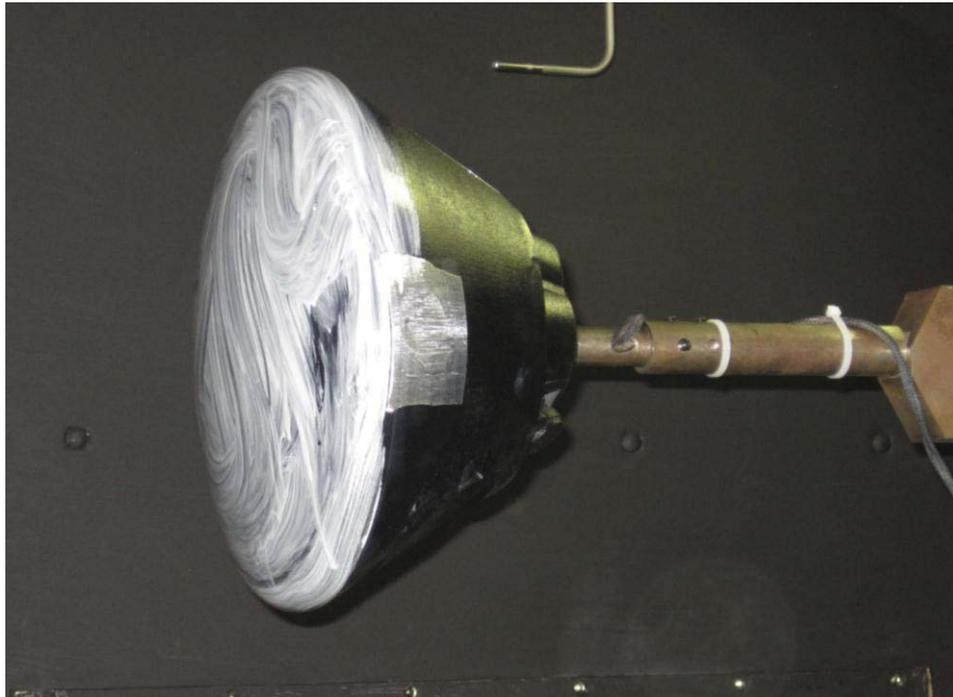
The first test was performed in the ARC FML Test Cell 2 32x48-inch subsonic wind tunnel. The model used in the study is shown in Figure 6.1-1, mounted on a sting and balance. The SLS material is white and fairly rough when manufactured so the model was filled and painted to give a smooth heatshield. The black color provided good contrast with the white oil (Figure 6.1-1) used for flow visualization with IR imagery.

**Figure 6.1-1. MPCV CM Model Mounted in 32x48-inch FML Subsonic Wind Tunnel**

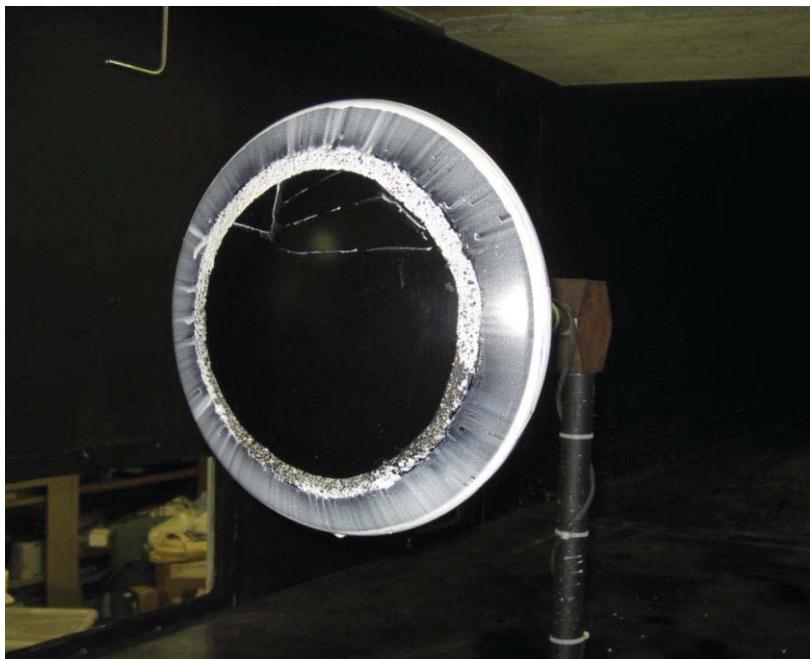
**Figure 6.1-3. Oil Flow Visualization on the Heatshield Corresponding to the IR Image in Figure 6.1-2**  
Note: Streaky oil may be coincident with the streaks in IR image; separation is indicated by the white band around the shoulder.

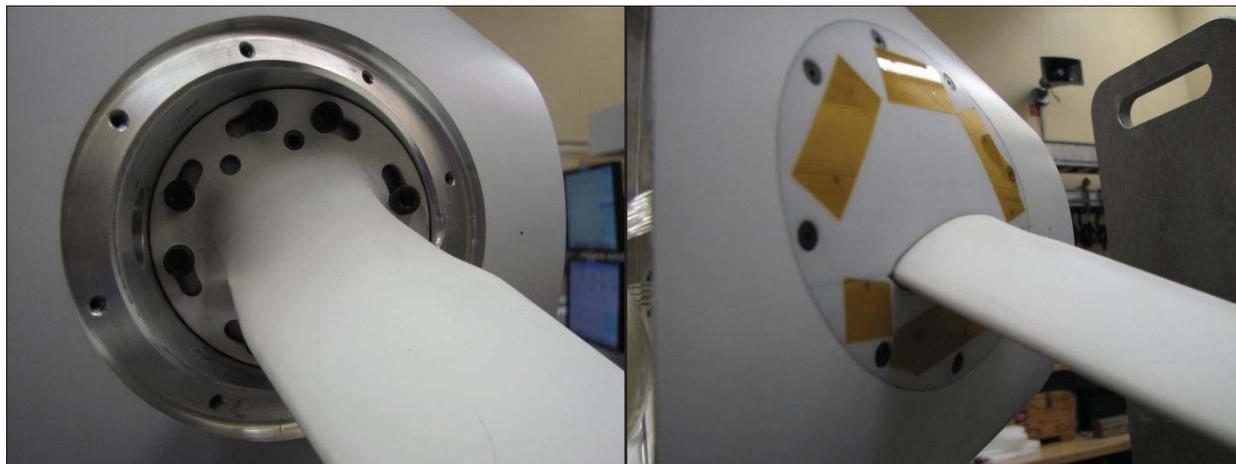
CM pivot is shown on the model in Figure 7.2-3. The AoA was set by matching specific pin and bolt holes on the strut flange and the CM model.

*Figure 7.2-3. Interior Pivot and Pivot Cover Plates on the CM Model*

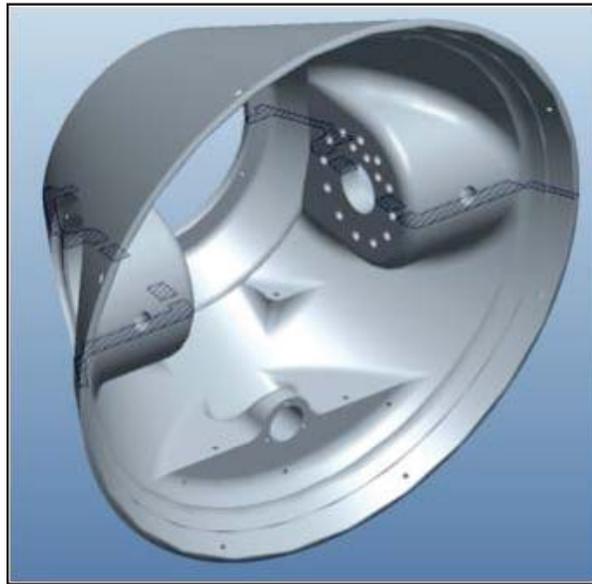
The CM back shell was fabricated using normal machining techniques from a billet of 7075 aluminum. Figure 7.3-3 shows the details of the inside of the part. The two pivot points and the associated bolt/pin holes are evident in this view as is the mount at the bottom for the AoA sensor. Steel inserts were used for the pivot bearing surface. The strut pocket holes were for quick disconnects that attached the pressure tap tubing from the strut cover plates. A circular flat plate closes the hole of the truncated CM apex.

*Figure 7.3-3. Back Shell Design showing Inner Details*

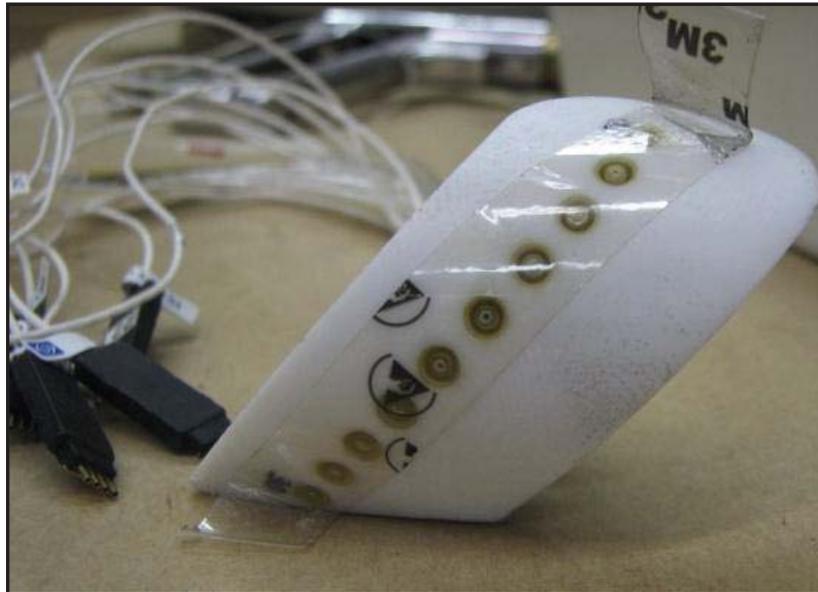
*Figure 7.3-4. Unsteady Transducer Insert*

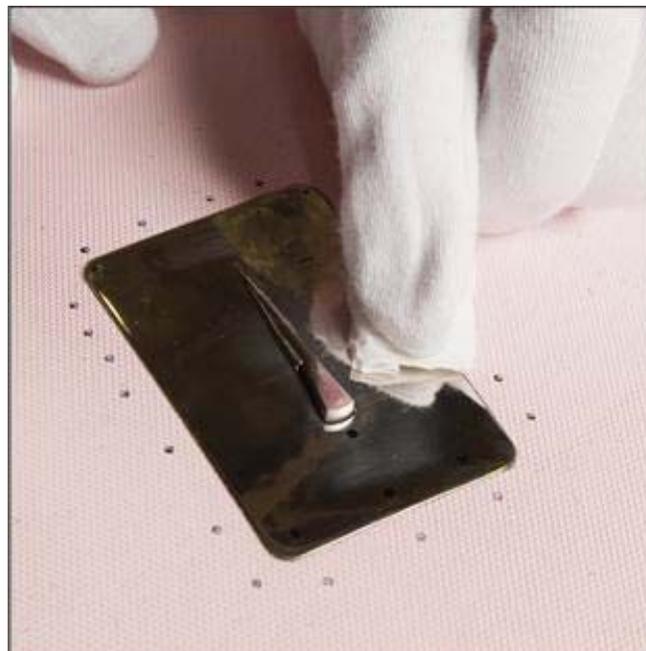
An image of the insert installed in the rough heatshield is shown in Figure 7.4-8. The black fiducial marks around the insert were measured precisely on the model using a portable FaroArm™ coordinate measuring machine. These marks were used to calibrate the OFI images. OFI skin-friction measurements depend on accurate determination of the spacing of fringes generated by a sheared layer of oil.

*Figure 7.4-8. Boundary Layer Insert Mounted in Rough Heatshield*

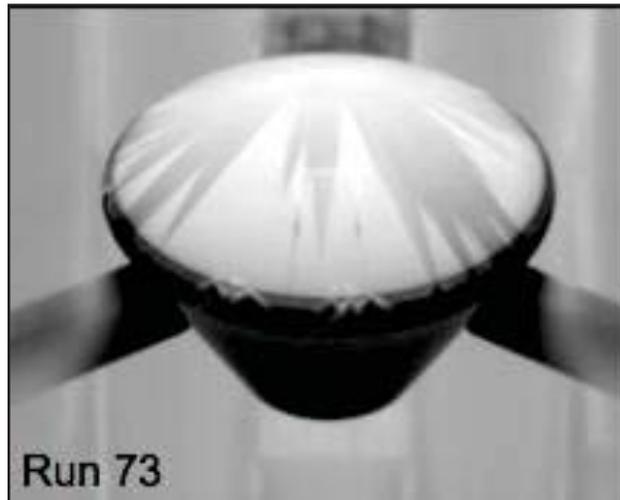
The smooth heatshield at low Reynolds number showed a complicated pattern of transition that was nearly always traceable to a surface defect. Figure 8.1-6 shows a top-view IR image of the smooth heatshield at Mach 0.7. Laminar flow is present where the temperature is lower (i.e., darker) with turbulent flow in the warmer (i.e., lighter) areas. Figure 8.1-7 shows the same test point taken with the side-view camera. Both images show that where the boundary layer remains laminar to the shoulder, the flow separates immediately downstream of the suction peak with little pressure recovery.

*Figure 8.1-6. Top-view IR Image of Smooth Heatshield;  $M = 0.7$ , AoA of 30 degrees, and Reynolds Number  $10 \times 10^6$*

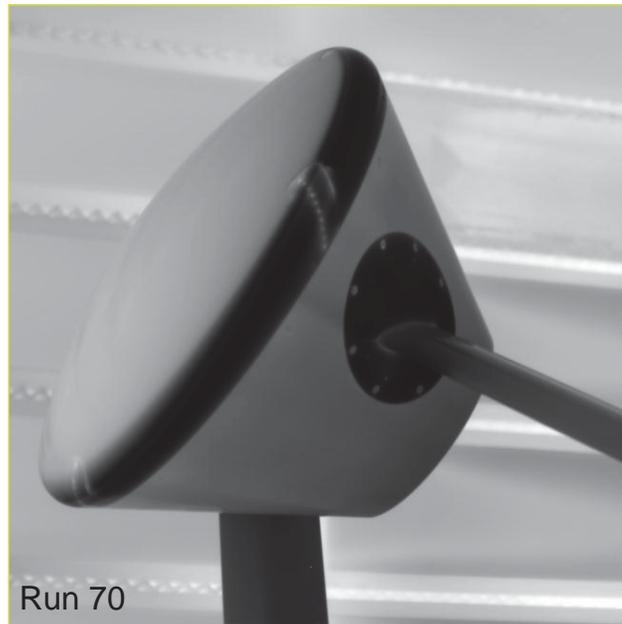
At low Reynolds numbers the boundary layer behavior was significantly different. The flow remained laminar for all test conditions to the suction peak around the heatshield shoulder. Figure 8.1-9 shows an IR image of a low Reynolds number case at Mach 1.02. The flow accelerates to the shock location, where it separates. This is typical of the flow behavior at higher Mach numbers, particularly for the smooth heatshield.

*Figure 8.1-9. IR Image of Smooth Heatshield Mach 1.02, AoA of 30 degrees, and Reynolds Number  $1.33 \times 10^6$*
