The Komplast Experiment: Space Environmental Effects after 12 Years in LEO (and Counting)

J. L. Golden, Ph.D.
Boeing Technical Fellow
SAMPE TECH 2014 - Seattle, WA
03 June 2014

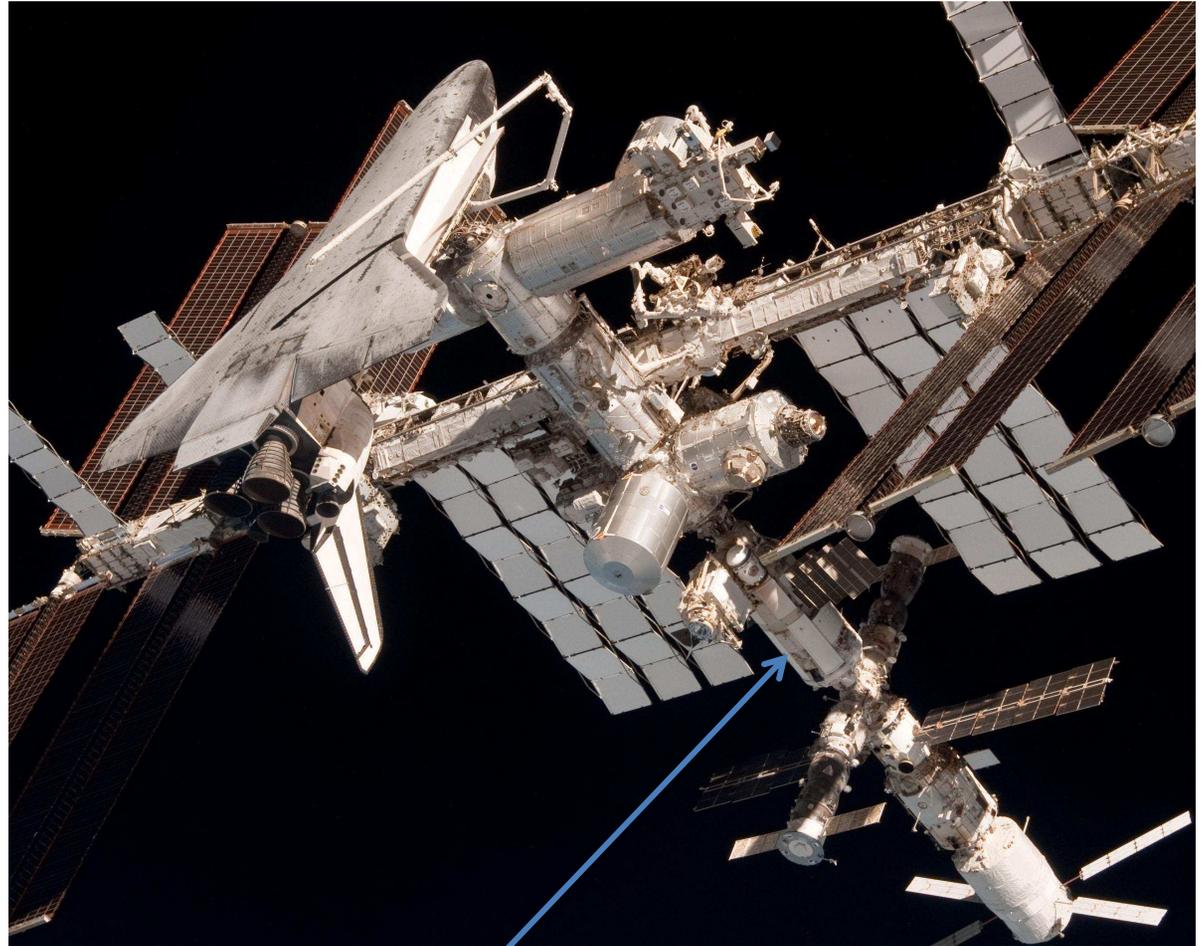
FGB – “Zarya”

- **The FGB module, like most of the ISS Vehicle was originally designed for a 15 year operating life.**
 - **Launched in late 1998.**
- **ISS Service Life Extension efforts seek to determine if the ISS Vehicle can be reasonably maintained in operation through 2028.**
- **Komplast panels were selected to obtain materials specimens which would best support the service life extension objectives.**
 - **Assessing risk of continued operation beyond original design life.**

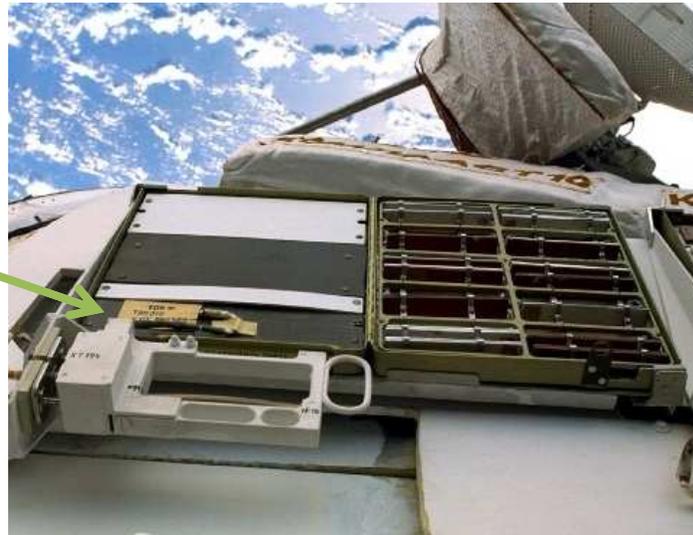
Komplast Panel #10, on-orbit

Temperature
Sensor

- **Temperature telemetry measured ranges of +85°C to –80°C for Panel #2, and +107°C to –80°C for Panel #10, with 20±10°C average for both panels.**
- **Solar ultra-violet (UV) radiation on each panel was determined from the temperature telemetry (cumulative solar illumination time).**

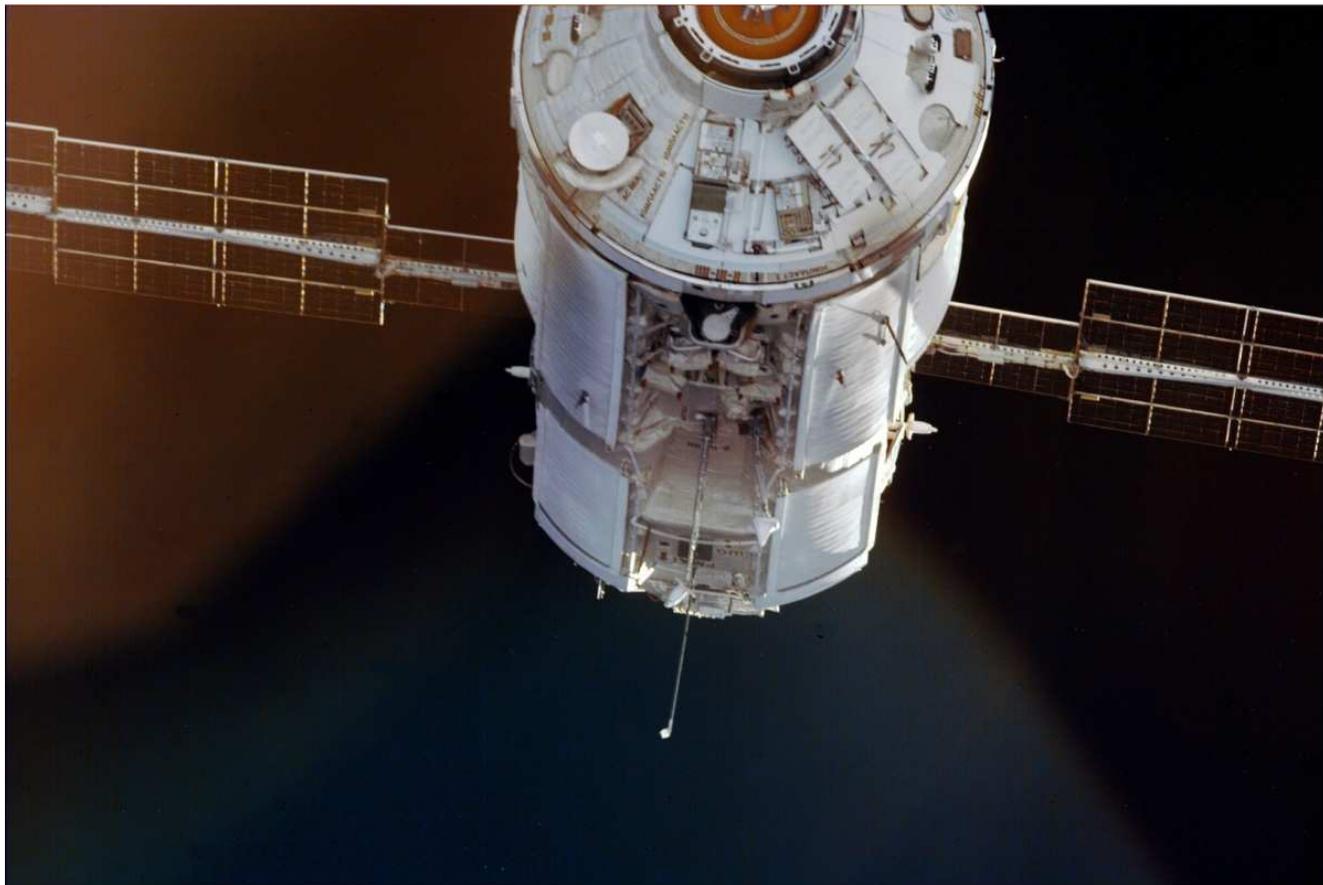
S88E5044 1998:12:06 22:53:55

Komplast panels were integrated onto the FGB module (the first ISS flight element) and open (except Panel #3 and #10) at launch. Panel #10 was opened during EVA3 on ISS Flight 2A (covered ~3 weeks).

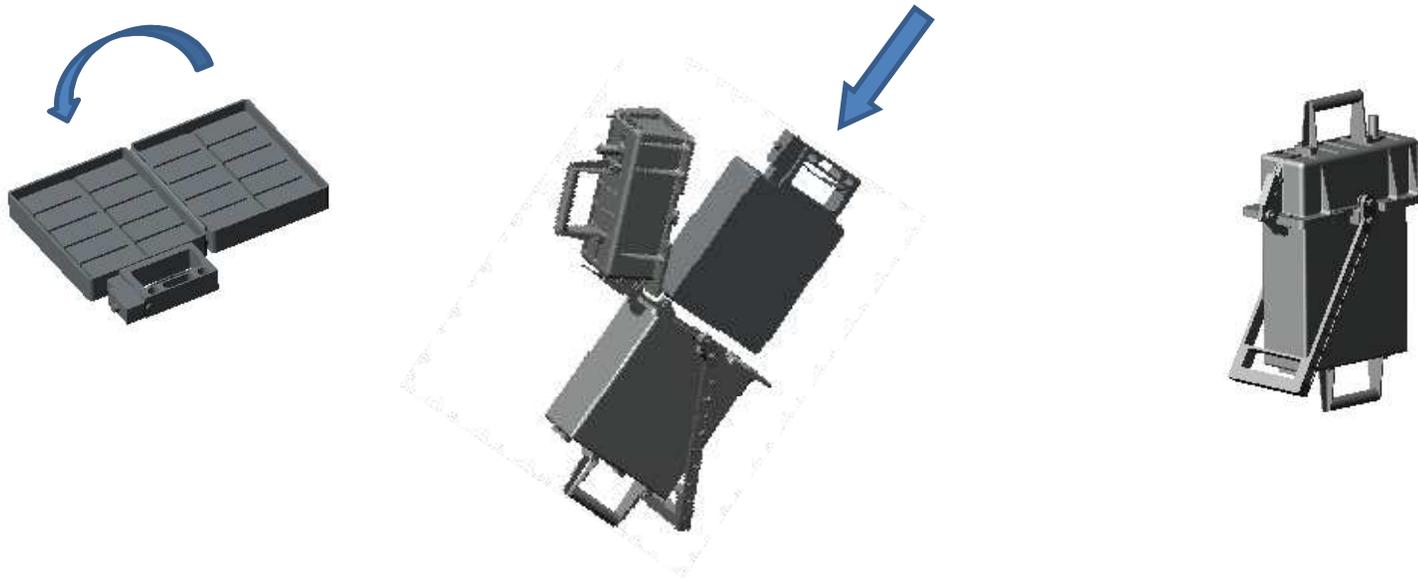
- The deployed Komplast Panel is closed during EVA retrieval to protect the exposed samples (like a suitcase).
- Two closed panels fit into a Komplast transportation canister.
- The closed canister includes a sealing interface to inhibit the ingress of atmosphere.

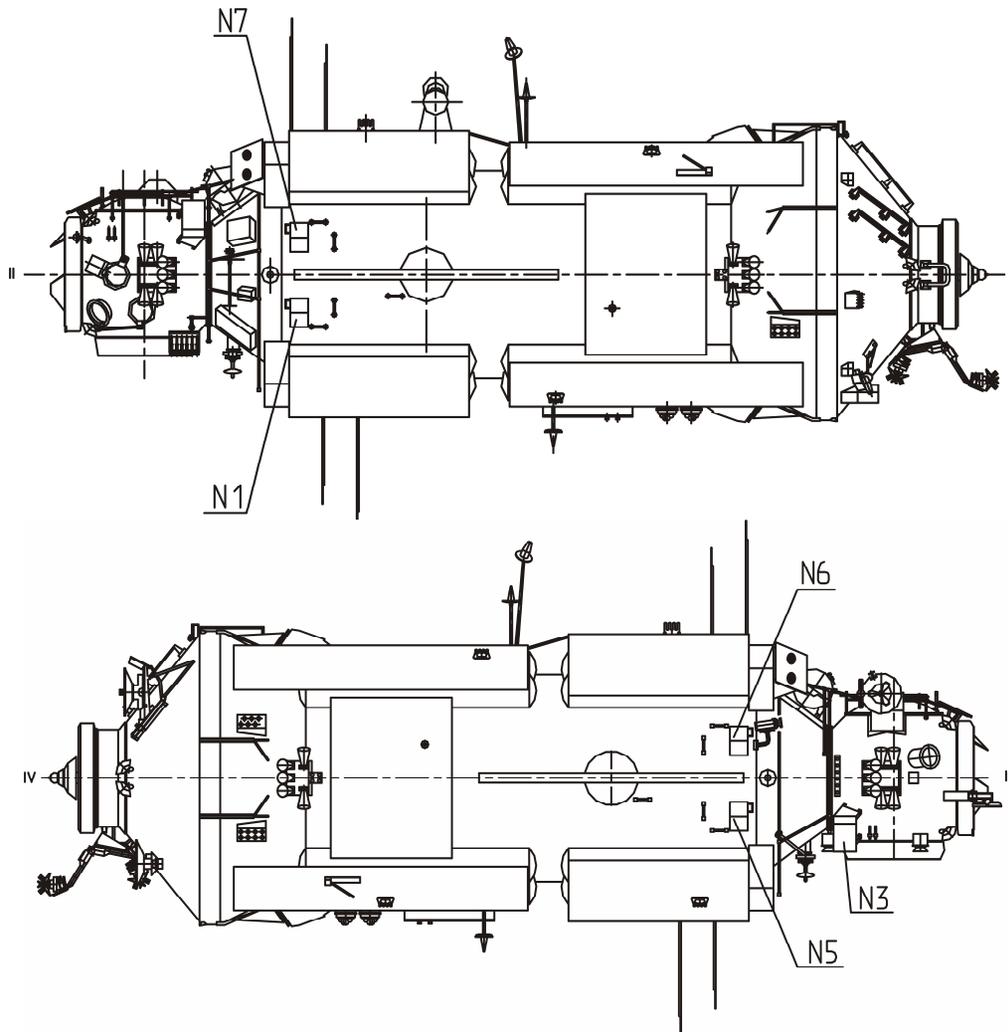
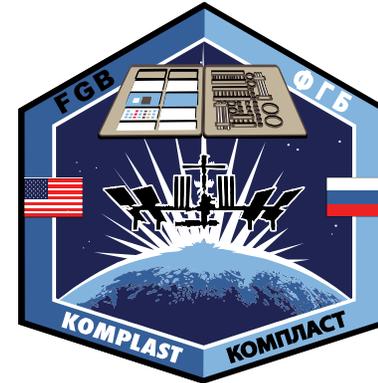
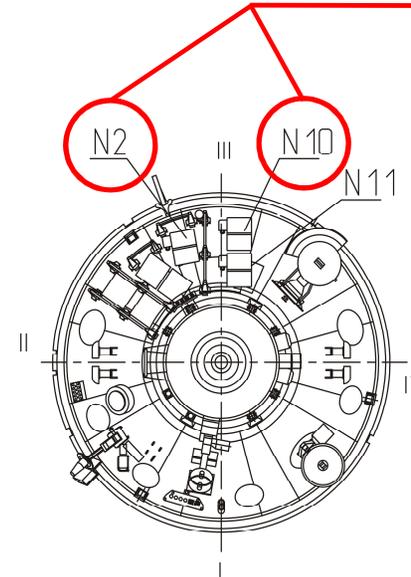
Removed panels

There were eight Komplast panels on the FGB

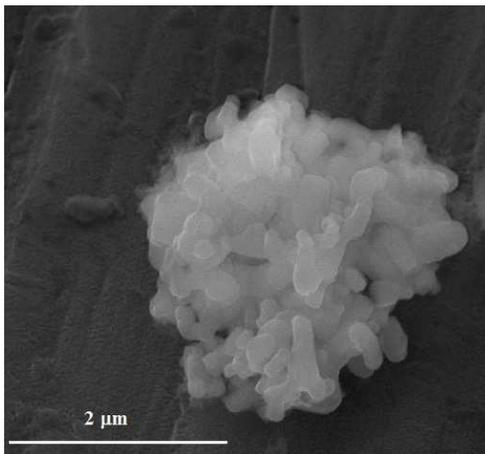
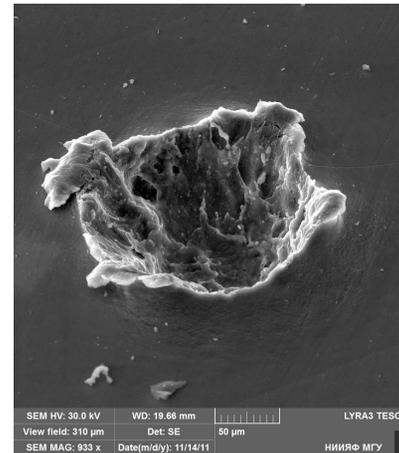
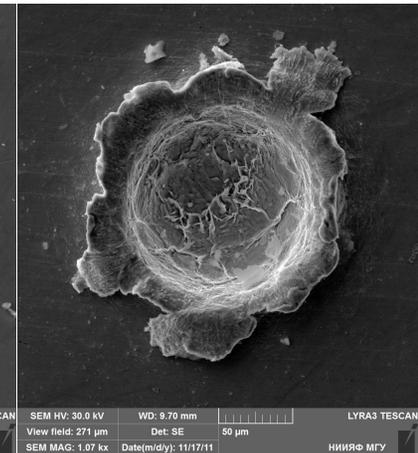
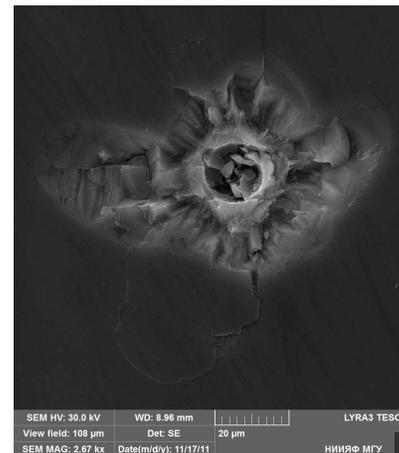
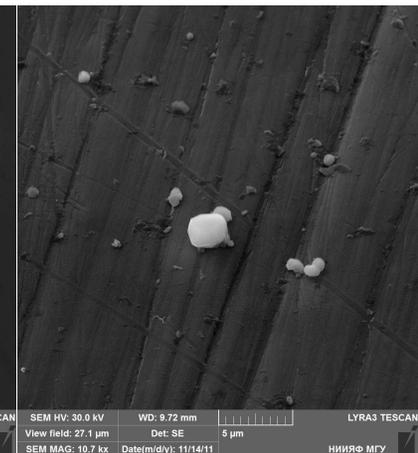
1. Micrometeorites classification into natural and artificial (chemical and physical characterization).
2. Determined the character of interaction between micrometeorite particles and different types of materials.

Particle imbedded in Ti

Al

Cu

Si

Ti

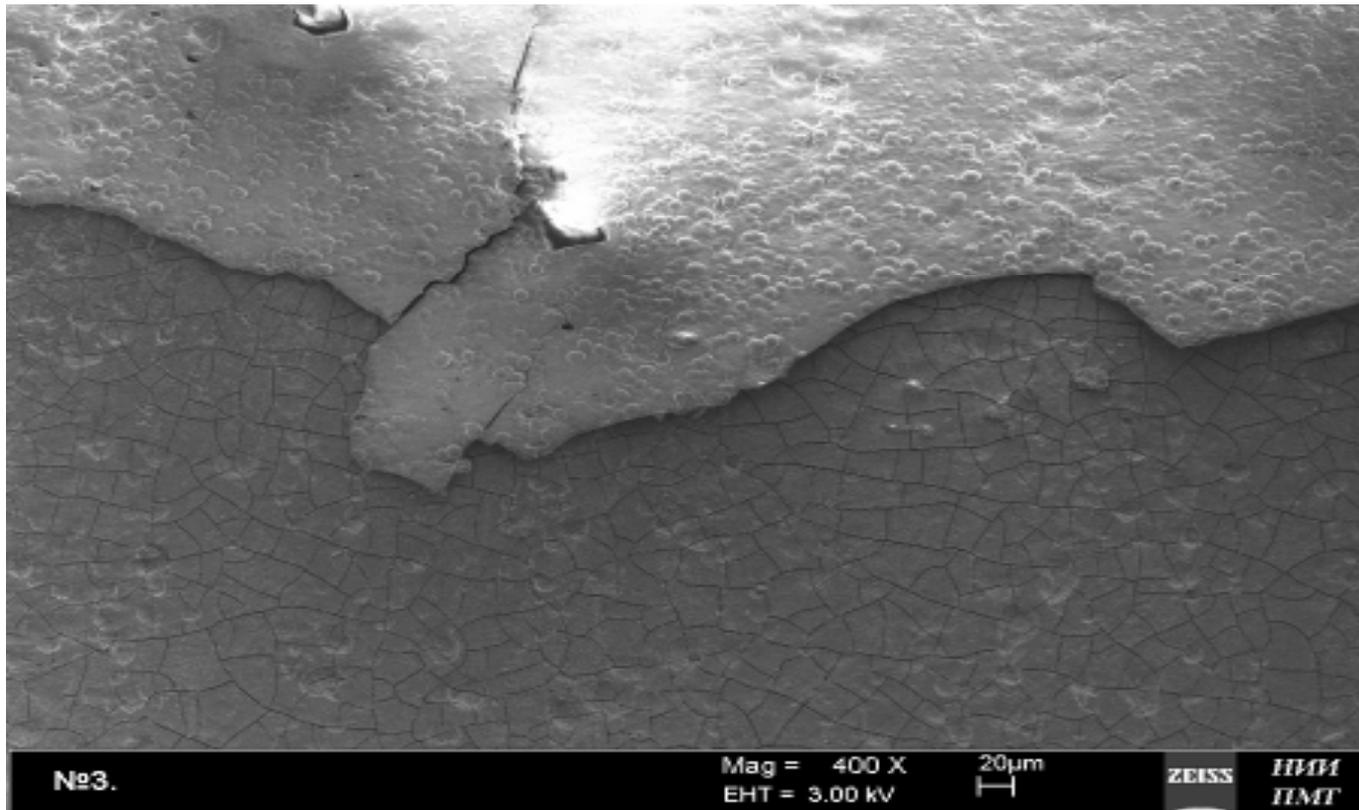
- Surface contamination was assessed.
 - Most heavily localized around the rubber samples, primarily consisting of silicon oxide (oxidized silicone plasticizers).

Contamination film (top) on the Komplast Panel surface.

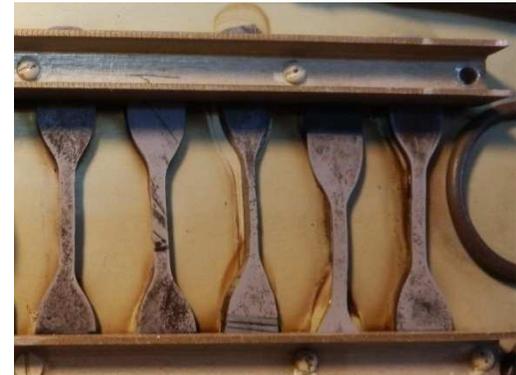
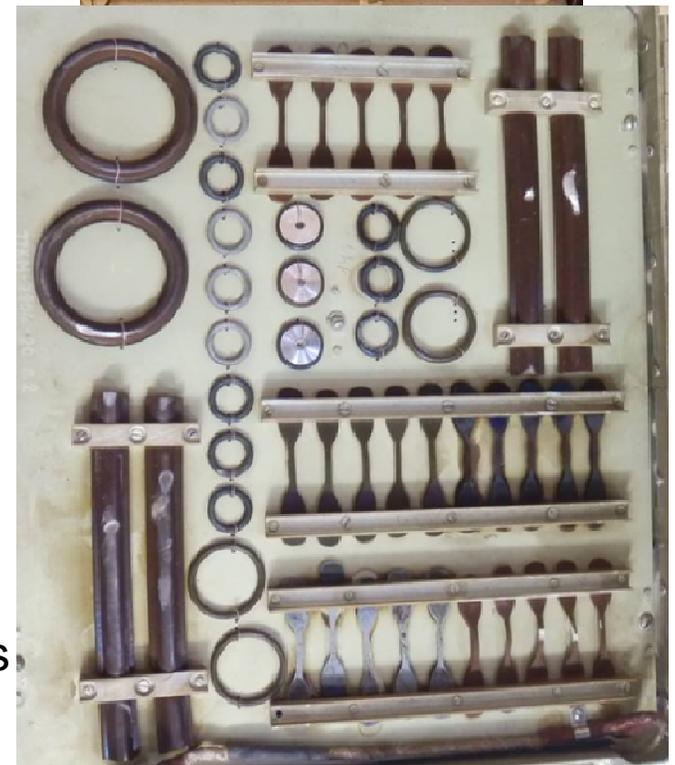
- Seal Materials on Panel No. 2 consist of the following:
 - ИРП-1118, methyl styrene rubber-based
 - ИРП-1175, nitrile rubber-based
 - ИРП-1399с, vinyl silicone rubber-based
 - 51-1447, methyl styrene rubber-based
 - 51-1567, fluorosilicone rubber-based
 - 51-2066, fluorosilicone rubber-based
- Detailed visual inspections of all samples (macro and micro examination)
- Material properties testing after space exposure (hardness, sealability, leakage, frictional coefficient, elongation, residual strain, etc.)
- Additional atomic oxygen (AO) and radiation on select samples were performed to demonstrate 30 year life with thermal aging residual strain effects

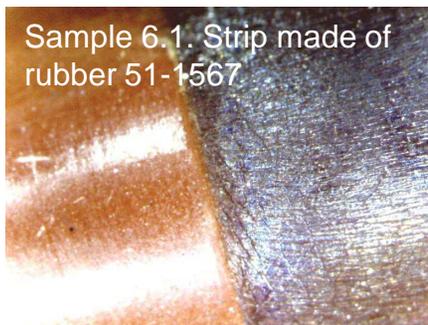
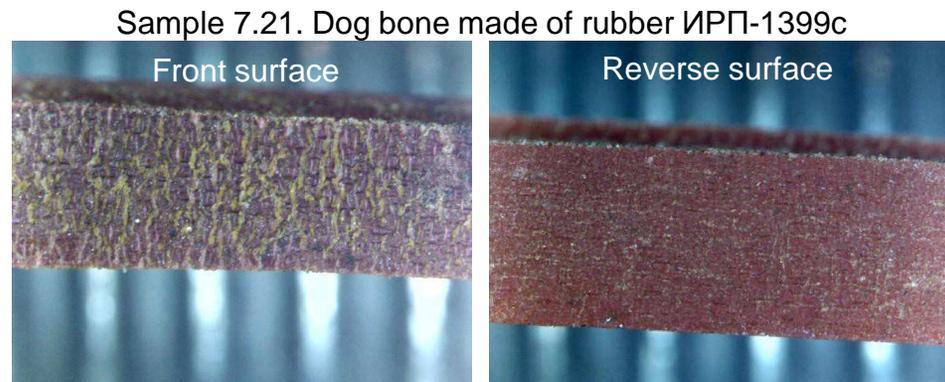
- Exposed specimens all demonstrated preservation of their volumetric strain and relaxation characteristics.
- All rubber types exhibited disintegration and partial separation of the exposed front surface layer during up to 50-per cent extension, but without bulk volume damage.
- This long-term exposure to UV and AO and consequent surface modification resulted in a seal performance mechanism change from a diffusion leak path to a contact leak path.
- Areas protected/screened from long-term UV and AO (but still exposed to ionizing radiation and thermal vacuum cycling) still maintained their as- designed sealing properties.

Expansion 50%

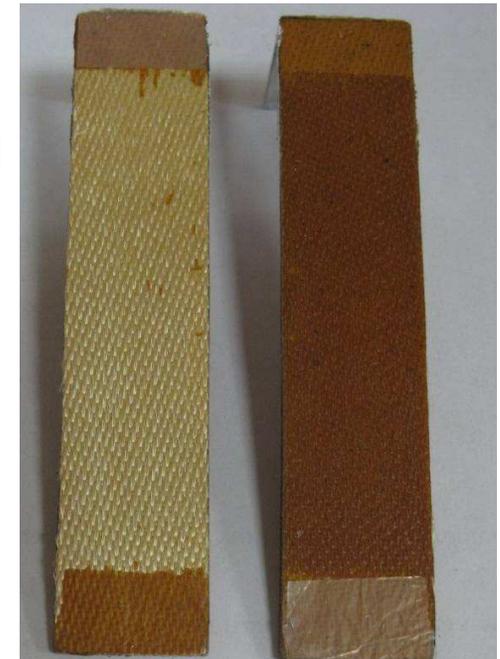
- The failure mode of all adhesive-bond joints analyzed occurred adhesively, i.e. along the adherent boundary, while the polymer base of all adhesive coats (cured epoxy polymer) is space factors-resistant. Essentially, in adhesive-bond joints the adhesive is well protected by the adherents from the direct effects of space environment factors.

Specimen No. 24,
КАКТ+ ВК-9 + КАКТ constituents

- The adhesive specimens research carried out made it clear that all types of adhesive-bonded joints remained serviceable as components of FGB module construction for 30 years from the date of beginning their service under space conditions.
- Samples were of Aluminum (Д-16) or fiberglass laminates (КАКТ-В) substrates with epoxy adhesives К-300, ЭПК-1 or ВК-9
- Some specimens were post irradiated and thermal aged to provide predictions for 30 year life
- Extensive visual and material property data obtained

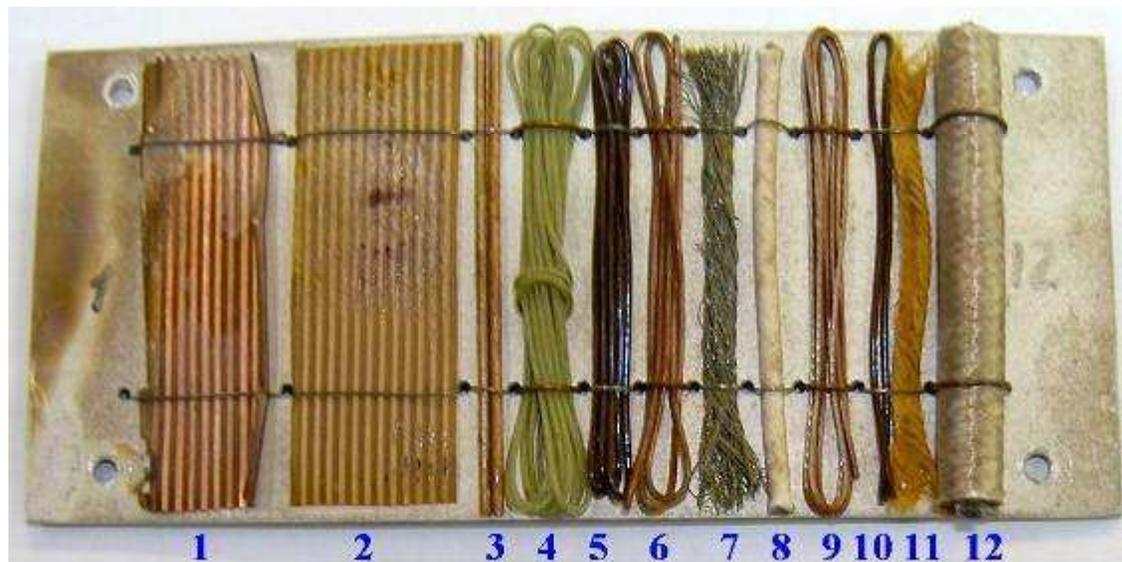
- **Cabling materials on Panel No. 2 were evaluated, including wire bend testing post-exposure.**
 - **Durability results varied by material, but results were typically good, especially when compared to the much more benign environment to which these materials are exposed on the FGB vehicle itself.**

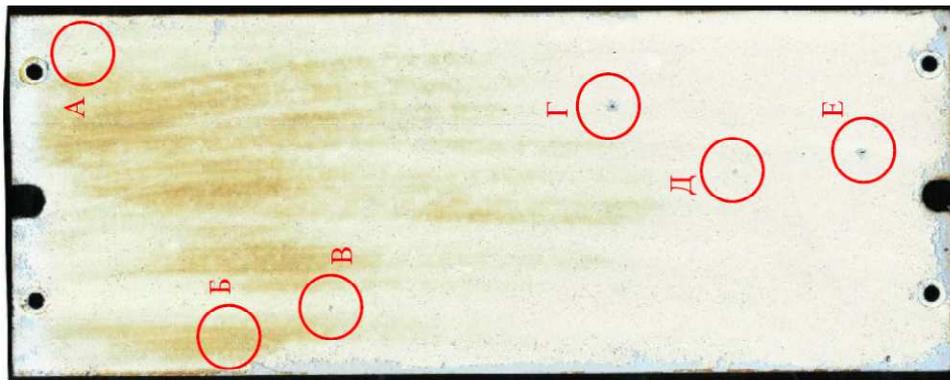
Carbon composite KMY-4лс with white thermal control coating TP-CO-2, showing several MMOD impacts.

- Composite polymer KMY-4лс was evaluated, some of which was bonded to aluminum alloy sheets of AMг6 using epoxy adhesive BK-9, and some as samples coated with white thermal control coating TP-CO-2.
- Some small MMOD damage was observed and evaluated using detailed visual inspection (including microstructural using Scanning Electron Microscopy) and chemical analysis.
- Three point bending tests indicated no critical changes from exposure.
- A protective outer layer in the composite lay-up completely prevented significant microstructural changes in the composite.

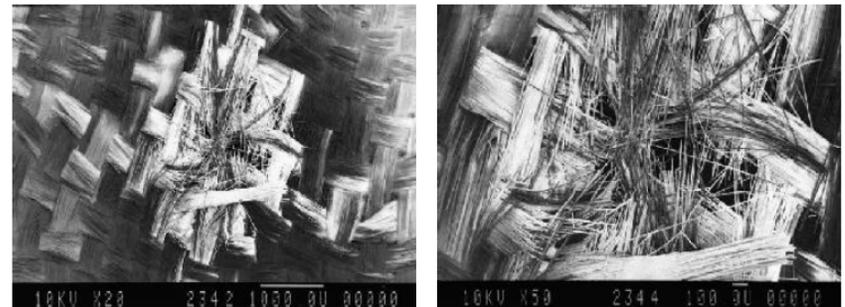
Carbon composite KMY-4лс without thermal control coating, showing MMOD impact close-up.
