U.S. Army Research, Development and Engineering Command

**Microscopic and
Spectroscopic
Characterization of Gear
Tooth Damage from a Loss-
of-Lubrication Event**

Dr. Stephen Berkebile, U.S. Army Research Laboratory
Dr. Robert F. Handschuh, NASA Glenn Research Center
MAJ Edwin A. Churchill II, U.S. Army Research Laboratory
20 May 2014

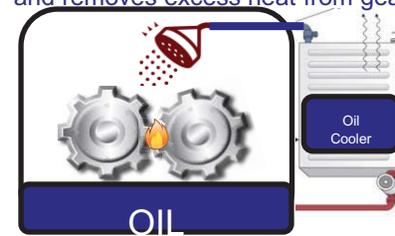
OIL-OUT OPERATION

Gear contacts generate more heat + no flowing lubricant to remove heat = thermal runaway
