Validation Ice Crystal Icing Engine Test in the Propulsion Systems Laboratory at NASA Glenn Research Center

Michael J. Oliver¹

NASA Glenn Research Center, Cleveland, OH, 44135

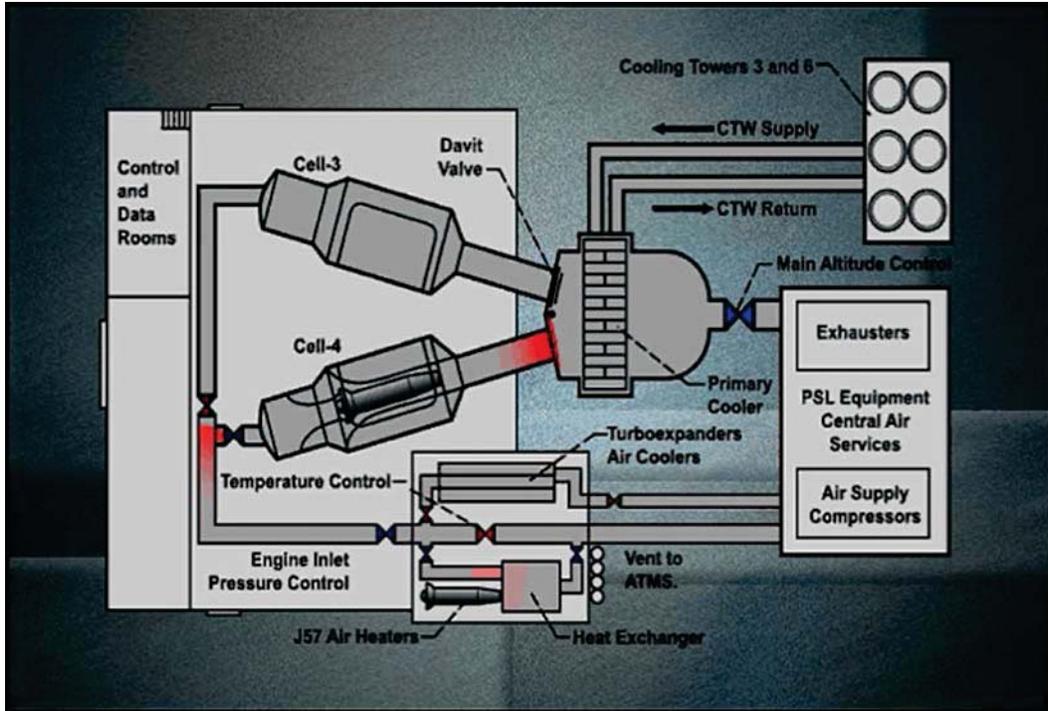
Figure 2. Schematic of the PSL.

PSL includes three turbo expander units each capable of supplying 110 lbm/sec for a maximum supply of 330 lbm/sec of cold combustion air for engine testing. The PSL-3 combustion air can be as cold as -50F and PSL-4 can be supplied at -90F for optimized running conditions. The inlet air can also be heated with a pair of J57 engines that run their exhaust through two shell and tube heat exchangers to supply up to 280 lbm/sec of 1200°F air. Inlet air and exhaust pressures are set by facility valves that can be run in a manual mode or in an automatic mode with the distributed control system.

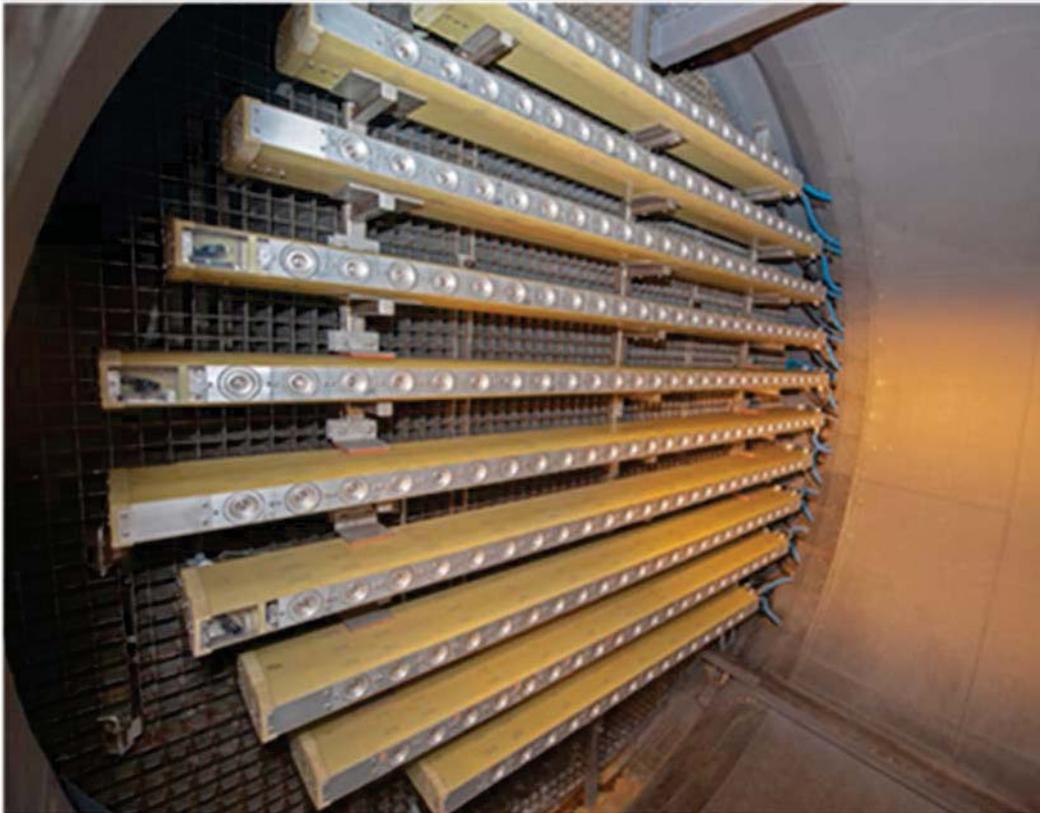
Figure 3. Water injection spray bars installed into the PSL cell three.

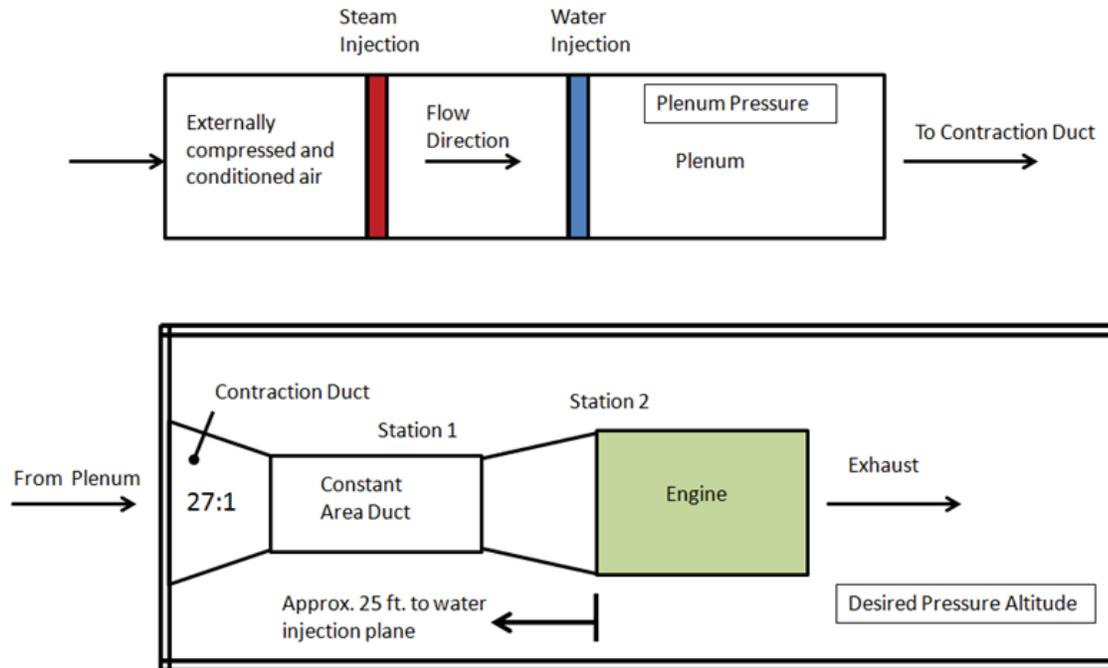
Figure 4. Schematic of the PSL-3 Engine Icing Test Configuration

system configured for direct connect engine testing. The objective of the retrofit was to produce conventional (super cooled liquid water droplet), fully glaciated (ice crystal) or mixed phase cloud testing conditions to gain capability to conduct engine icing and other aviation safety research and development. The icing configuration does have some limitations compared to the non-icing configuration. Predominantly the restrictions are related to the capacity to cool the air mass flow rate. [Table 1](#) displays a high level PSL capabilities comparison between non-icing and icing configurations. One note is that [Table 1](#) depicts the originally targeted design criteria for the icing modification. The icing system's operational envelope could be expanded to include higher altitudes and lower temperatures if needed for future research missions.

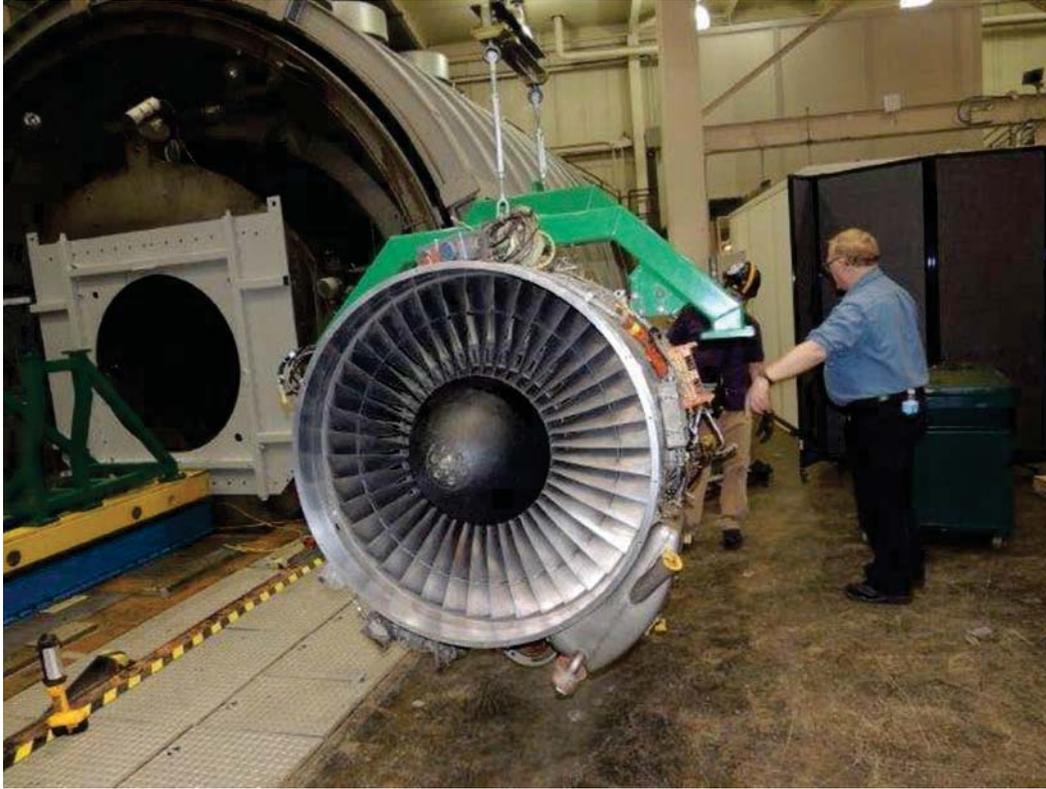
Figure 5. The ALF502-R5 (S/N LF01) engine being installed into PSL-3

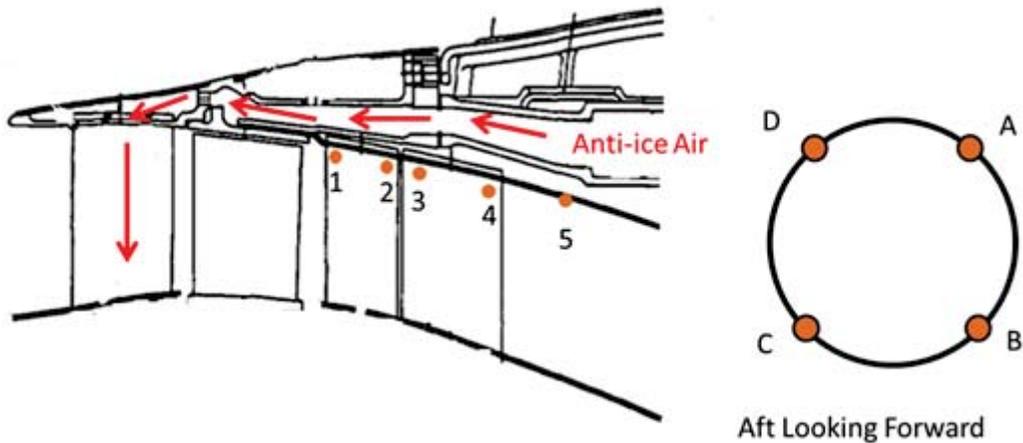
Figure 6. Schematic showing instrumented engine planes (1-5) with circumferential location (A-D) of thermocouples installed at each plane in LF01 for the 1997 flight test campaign. This instrumentation remains installed in LF01 for the PSL testing.

[Figure 6](#) shows a sanitized flow path/schematic of the unmodified low pressure compression system for ALF502-R5 engine. In LF01 there were five instrumented planes of interest, Plane 1(P1), Plane 2(P2), Plane 3(P3), Plane 4(P4) and Plane 5(P5). Each plane is instrumented with four thermocouples installed at clockwise positions A, B, C and D aft looking forward. The thermocouples were embedded into the metal at flow path locations of interest for the flight test campaign. This same instrumentation remained installed in LF01 for the February 2013 PSL-3 validation testing. [Figure 6](#) also shows the path of splitter lip and inlet guide vane (IGV) anti-ice air flow from the HPC exit. P1 and P4 thermocouples are installed on the pressure side of the airfoils and P2 and P3 are installed on the suction side.

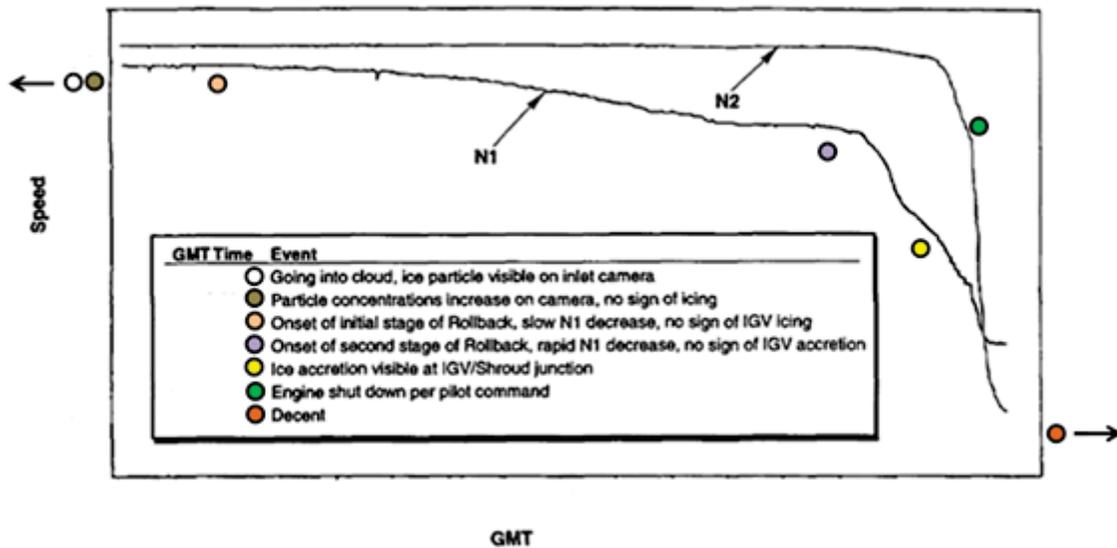
Figure 7. N1 and N2 plots for the ALF502-R5 LF01 engine showing an uncommanded reduction in thrust event recorded during a 1997 flight test.

A flight test campaign was conducted in 1997 to investigate a series of ice crystal icing related events that resulted in uncommanded loss of thrust for several revenue service flights powered by the unmodified ALF502-R5 engine. Two key test flights from this test campaign were used as validation test points for the PSL testing; Flight Test Flight 850 (FT FLT850) and Flight Test Flight 855 (FT FLT855). For clarity, an FT will precede all references to 1997 flight test points. If there is no FT preceding the test point name that exists for both the flight test and the PSL test it refers to a test point conducted in PSL simulating the FT test point conditions of the same name. FT FLT850 is the flight test that coincidentally documented both engine and environmental parameters during an uncommanded in-flight reduction of thrust event. FT FLT855 was operating in a similar environmental condition compared to FT FLT850 but the engine did not roll back. During FT FLT855 the aircraft was operating in a warmer ambient temperature at a lower altitude. Figure 7, shows a sanitized version of the roll back event that was recorded during FT FLT850. It is clear that both fan speed (N1) and High Pressure Compressor or Core Speed (N2) decrease as the flight test point ensues prior to the commanded shutdown of the engine by the pilot. In contrast, there is no decrease in either speed for FLT855 (not shown). These two FT test points were conducted within an envelope defined by several revenue service events leading up to the flight campaign. The FT test points and the revenue service events were used to define the test envelope for the validation testing in PSL.

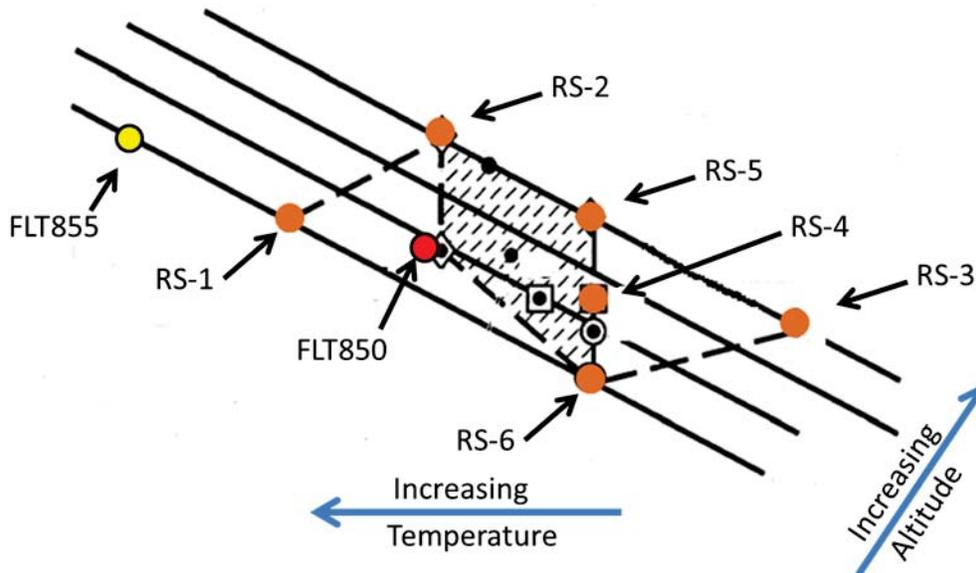
Figure 8. Envelope of uncommanded reduction in thrust flight test and field events.

The FT FLT850 test point is represented by the red dot in Figure 8. To date this is the first and only flight test that both the environmental operating conditions and engine operating parameters were being measured and recorded on a partially instrumented engine and aircraft when an uncommanded reduction in thrust event occurred related to ice crystal ingestion. The engine operating parameters, aircraft flight altitude and instrumented plane thermocouple measurements, Figure 6, were all known with good confidence for FT FLT850. However, due to subsequent analysis by atmospheric scientists who collected the original FT FLT850 environmental/cloud data, an uncertainty existed as to the correct cloud parameters of MVD and TWC experienced during FT FLT850.

Referencing Figure 8, in the range of RB events based on ice buildup and RB time for given cloud on conditions, FT FLT850 and points near it seem to be near the center of a highly probable RB operating condition for this test article. As the temperature and altitude move away from this region the ice buildup time for a given condition appears to increase. Near to the boundaries of the test event envelope it is required to manipulate the TWC or PLA during testing in order to influence the onset of ice buildup leading to RB or CRB. RB/CRB is able to be turned off and on (RS-1, Figures 15, 16 and RS-3 Figures 18, 19 for example) by small incremental changes in either TWC or PLA. The TWC effect is more obvious to explain since more or less surface cooling capacity of impinging cloud particles increases or reduces respectively the potential for ice buildup and the subsequent RB/CRB event. Changing the PLA is less obvious of an effect since it changes fuel flow most directly but the impact via the control system, a hydro mechanical unit (HMU) for this test article, is more difficult to assess.

The FT FLT855 test point is represented by the yellow dot in Figure 8. It is the single documented NRB event from the 1997 flight test campaign within the PSL-3 cloud calibration envelope. It is interesting because it falls outside of but close to the grouping of the FT FLT850 and the documented RS RB events. Figure 14 shows the RB indicating parameters chart for test point PSL-3, FLT855-1. Note that there are no decreases in LOAD, Ps, N1 or N2 for this test point. The target TWC for this test point is identical to that of FLT850-2, Figure 13a. This PSL-3 test point was called as a no roll back test point after a certain time frame elapsed while observing minimal if any changes in the roll back indicators. Note that both the X and Y axis scales of Figure 14 are identical to those of Figures 12 and 13a. The only targeted difference beyond the Figure 8 location is that the FLT850-1 test point, Figure 12, has twice the TWC of the other two test points, FLT850-2 and FLT855-1. The average cloud on thermocouple measurements for the NRB point in Figure 14 are significantly higher than both the RB test points of Figure 12 and 13a for all instrumented planes. In Figure 14, it is shown that immediately upon cloud off all the average thermocouple measurements from P1 to P5 returned to pre-cloud on conditions. The engine required zero recovery time for this test point. The roll back indicators chart of PSL-3, FLT855-1, Figure 14, is typical for test points that are CNRB test points. This is indicative that little to no firmly accreted ice buildup occurred at these instrumented planes of the engine. For NRB test points, Figures 14, 15 and 18 unsteady thermocouple behavior was observed. This may indicate loosely accumulating and shedding ice buildup for NRB test points vs. firmly accreted ice buildup for RB/CRB test points.

The test points labeled as RS-xx in Figure 8 are revenue service field events that were tested in PSL during the test period. They represent field events that span the altitude, temperature and engine operation calibration envelope of the PSL-3 cloud generating system for this inaugural ice crystal icing test. Since none of these events had similar data measured as that of FT FLT850, NASA and Honeywell Engines worked to develop a test methodology based on the ALF502-R5 cycle deck to determine engine operation at the specified ambient temperature, pressure altitude, cloud variation (centered on the FLT850 cloud parameters) and documented knowledge of the RS events. In general during testing, all RS test points started with the identical MVD and TWC as FLT850-2. Cloud TWC was increased incrementally as necessary to produce a CRB event for a given RS test point. Cloud MVD adjustment was not performed for any RS test point to produce the CRB event. The RS test points near the colder/higher as well as warmer/lower boundaries of the temperature, altitude envelope shown in Figure 8 required incremental TWC adjustments to produce a CRB. The CRB events that occurred near FT FLT850 conditions were characteristically similar to FLT850-2 with similar ice buildup rates, CRB and recovery times and cloud parameters. The roll back indicators for selected RS test points are shown in Figures 15 to 19. Figures 15/16 and 18/19 show how incremental adjustment of TWC caused the CRB event to occur. For RS-1b (Figure 16), 3b (Figure 19) the cloud TWC was targeted to be 1.3 times and 2 times respectively compared with RS-1a (Figure 15), 3a (Figure 18) to produce the CRB event.

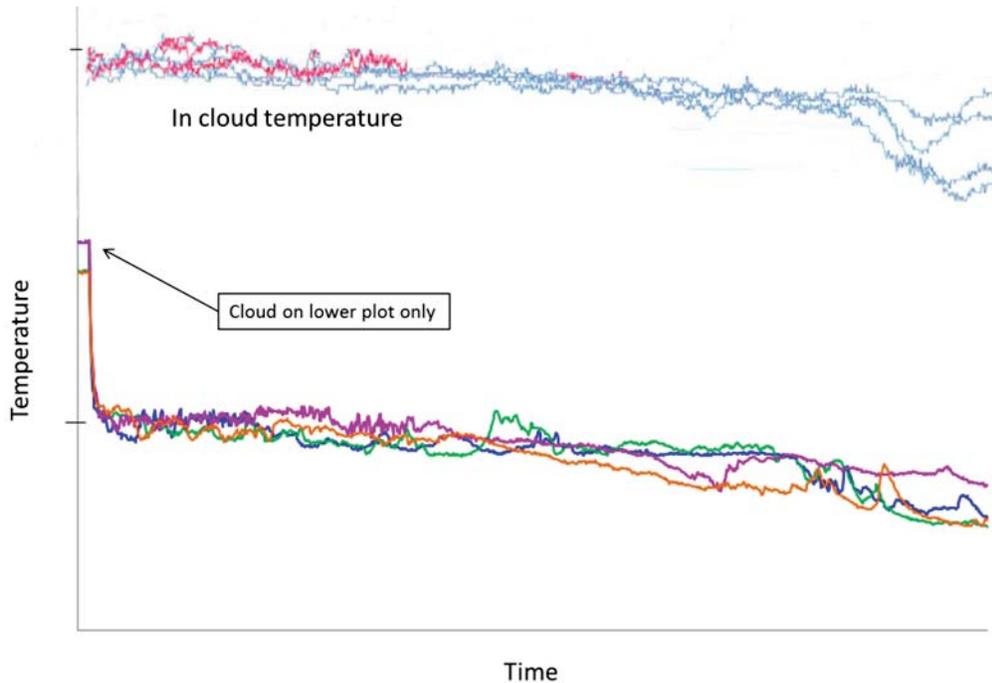
Figure 9. Plane 4 LF01 thermocouple plots recorded during the FLT850 1997 flight test (top) and PSL testing (bottom) at the same conditions.

Implementing these test conditions in PSL-3 led to a full roll back test point closely duplicating FT FLT850 in both sensor response and time to roll back. [Figure 9](#) shows a comparison between the thermocouple readings at P4, from FT FLT850 and P4 measurements from a PSL-3, FLT850 full roll back test point. The charts are sanitized, have the same axis scales and a single tick mark on the temperature scale represents the same temperature for both. Note how the thermocouple traces for the PSL chart (lower) drop immediately when cloud on operation commences.

Based on documented information and flight test data these thermocouple traces drop to a certain value initially at the cloud on condition and subsequently drop to a lower value as the test point ensues if a roll back event is going to occur. In general for all roll back test points conducted in PSL within the primary test envelope the thermocouple traces dropped to a similar certain initial value and then lowered to a similar second value prior to the roll back event occurring. For test points where no roll back occurred the initial drop in the thermocouple traces was to a higher temperature than that for the RB test points and the no roll back test points did not demonstrate the trend of a secondary thermocouple drop.

The initial temperature drop is likely the surface embedded thermocouples measuring either the temperature of surface water or cooling due to evaporation (i.e. a wet-bulb temperature effect as water evaporates from the surface to bring the air passing immediately over it to saturation¹⁴). Since air outside of the engine is quite cold and likely saturated with a given humidity ratio, as the air enters the engine and heats up the humidity ratio remains similar for the warmer air which increases the potential to evaporate or sublimate water/ice on the surface. The thermodynamic wet-bulb temperature of dry air would be significantly lower than the ambient static temperature which explains the rapid decrease in cloud on thermocouple measurements along the LPC flow path. The second temperature drop is interpreted as the result of the ice forming on the surface and cooling as ice sublimates into the air flowing over it. Due to the lack of internal cameras to identify and characterize ice buildup, this interpretation of the thermocouple response as equating to ice buildup is used for all subsequent roll back test points.

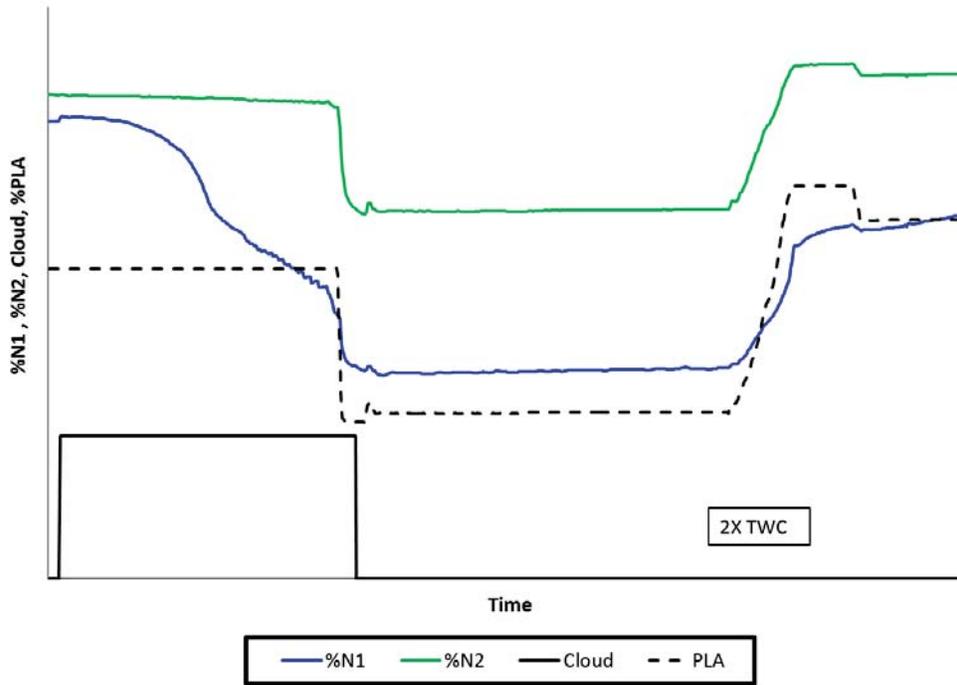
Figure 10. Fan Speed (%N1) and Core Speed (%N2) Chart showing uncommanded roll back for the first ever FLT850 test point in PSL-3.

Once the full roll backs shown in [Figures 10 and 11](#) occurred, the engine needed to undergo a recovery process. The first step in the recovery process is to exit the cloud on condition. Two methods were tried. In [Figure 10](#) it is seen that the PLA was reduced prior to the cloud turning off. In [Figure 11](#) the cloud is turned off simultaneously with the PLA being reduced. This was an effort to develop a procedure to exit the cloud on condition in as safe a manner as possible to the engine.

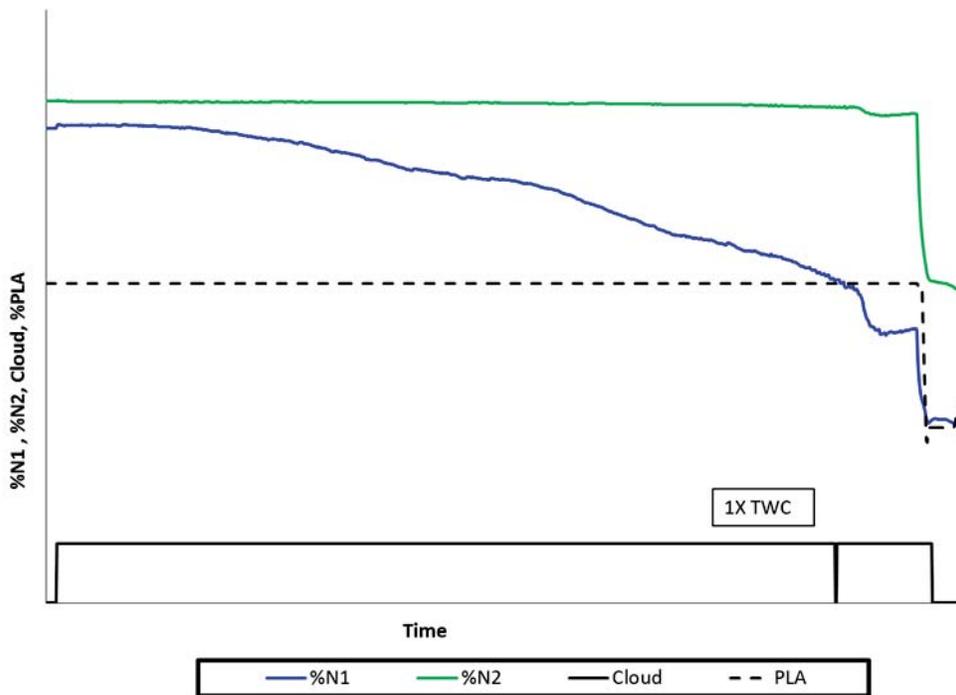
Figure 11. Fan Speed (%N1) and Core Speed (%N2) Chart showing uncommanded roll back for the second ever FLT850 test point in PSL-3.

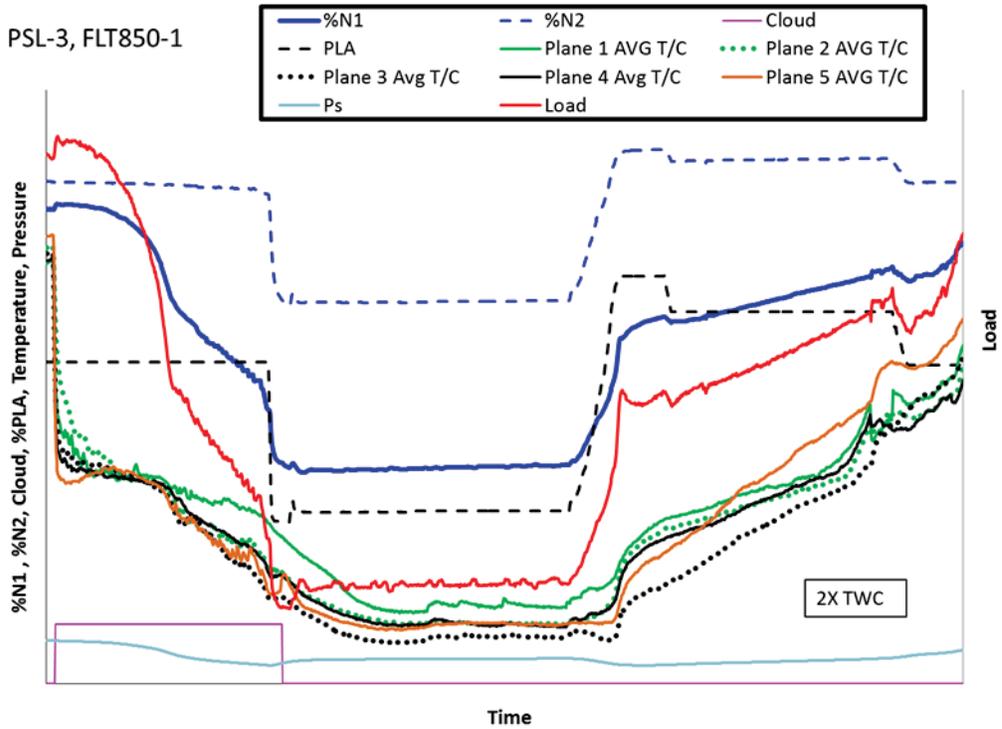
Figure 12. Roll back indicators chart for first PSL-3 FLT850-1 full roll back test point

A “called roll back (CRB)” procedure was developed to minimize the risk of critical damage to the engine due to ice buildup and subsequent shedding. In order to develop this procedure, plots of several parameters measured during two separate full RB test points were analyzed: FLT850-1 and FLT850-2. Figures 12 and 13a show the RB indicating parameters plotted and analyzed for these test points. Note that the X and Y-axis scales are identical for both figures and TWC for the Figure 12 test point is 2 times that of the Figure 13a test point.

The plot trace labeled LOAD in the roll back indicator charts throughout the paper is an average of two load cell measurements made on the engine thrust stand. In Figures 12 and 13a LOAD is shown to increase at cloud on conditions and then begin decreasing as the RB test point ensues. This LOAD decrease occurs prior to the %N1 decrease in both figures. Note that the measured HPC inlet static pressure (Ps) also begins to drop before the %N1 decrease. This suggests that significant ice buildup has occurred and that RB is imminent. The LOAD increase at cloud on is due to an increased momentum change occurring as the engine ingests cloud particles entrained in the air flow.

The thermocouple plots in Figures 12 and 13a show delayed recovery or return to pre-cloud on values at cloud off. This is evidence that ice buildup occurred and remains on and/or around the flow path embedded thermocouples. The thermocouple traces return to pre-cloud on values after an engine recovery period in which this ice sheds. Note that in Figure 13a the full recovery is cut off to make the axis scale identical to Figure 12. In general the longer the time required for RB/CRB to occur, the longer the time required for engine (thermocouple) recovery to occur. Though the recovery time varied for different test points, this cloud off engine recovery period is typical for all RB and CRB test points conducted in PSL-3.

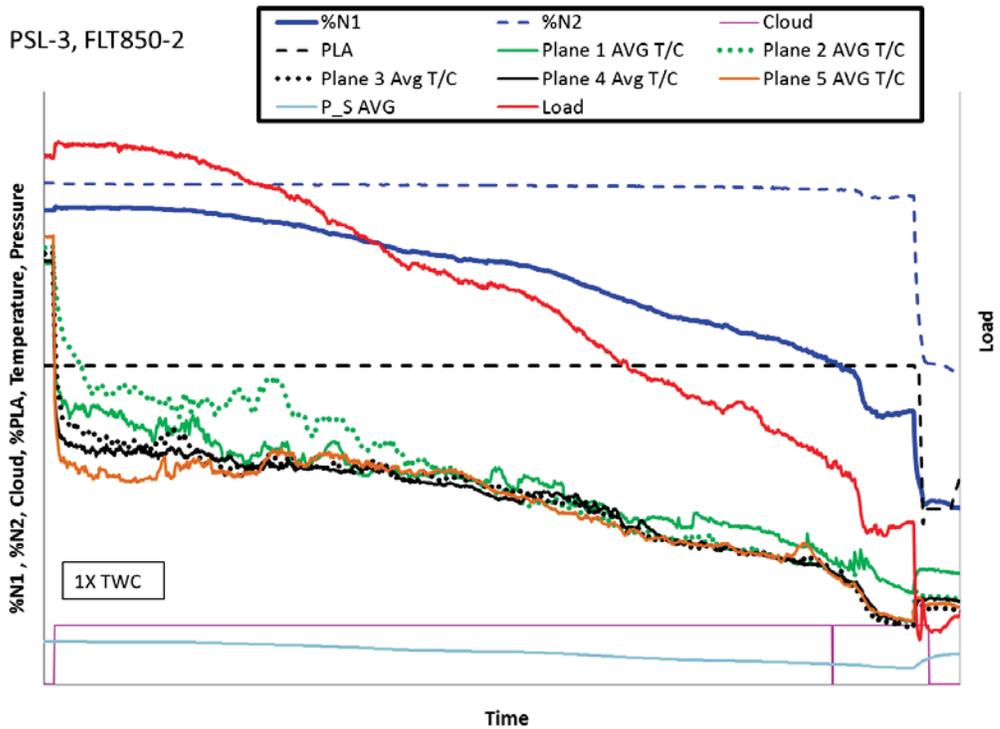
Figure 13a. Roll back indicators chart for FLT850-2 full roll back test point

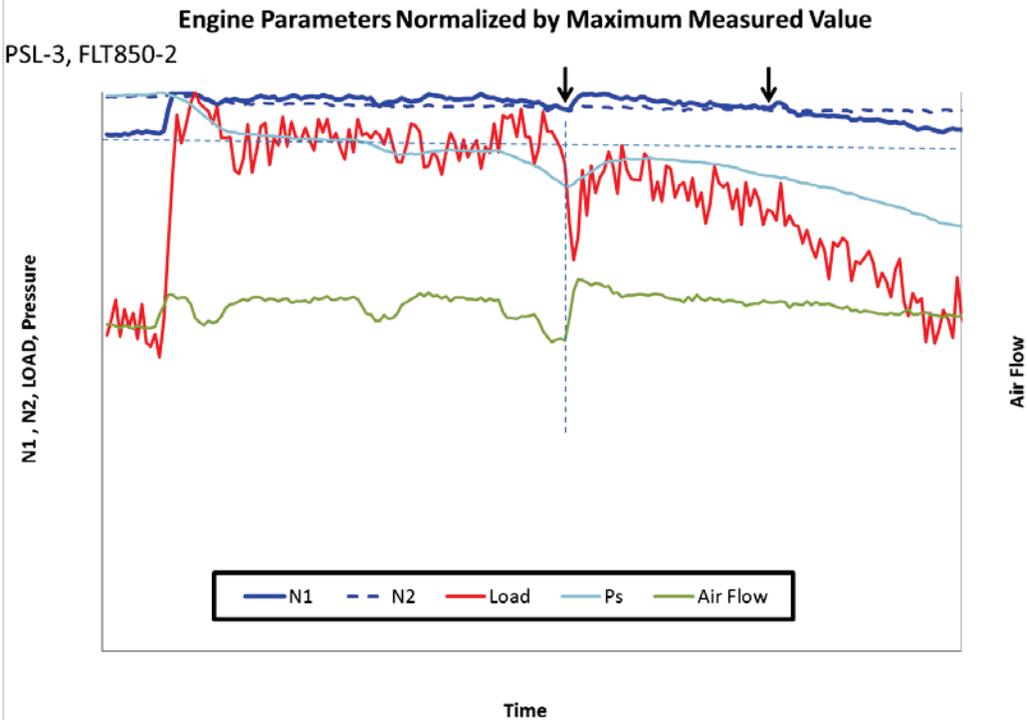
Figure 13b. Roll back indicators chart Zoomed View for FLT850-2 full roll back test point

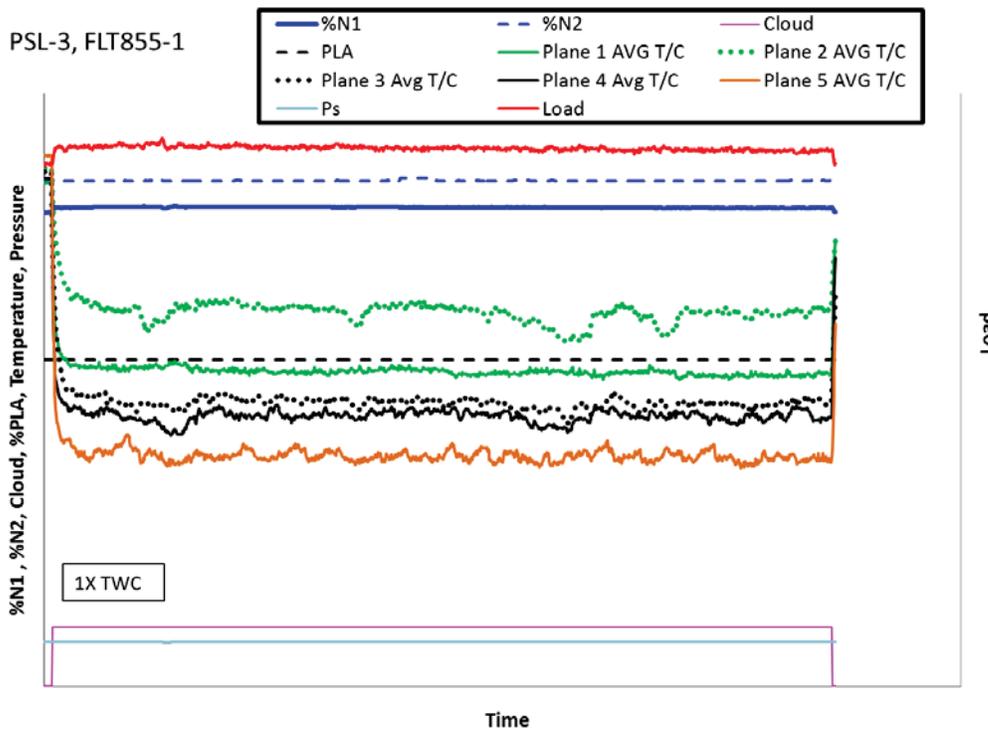
Figure 14. Roll back indicators chart for PSL-3 FLT855-1 no roll back test point

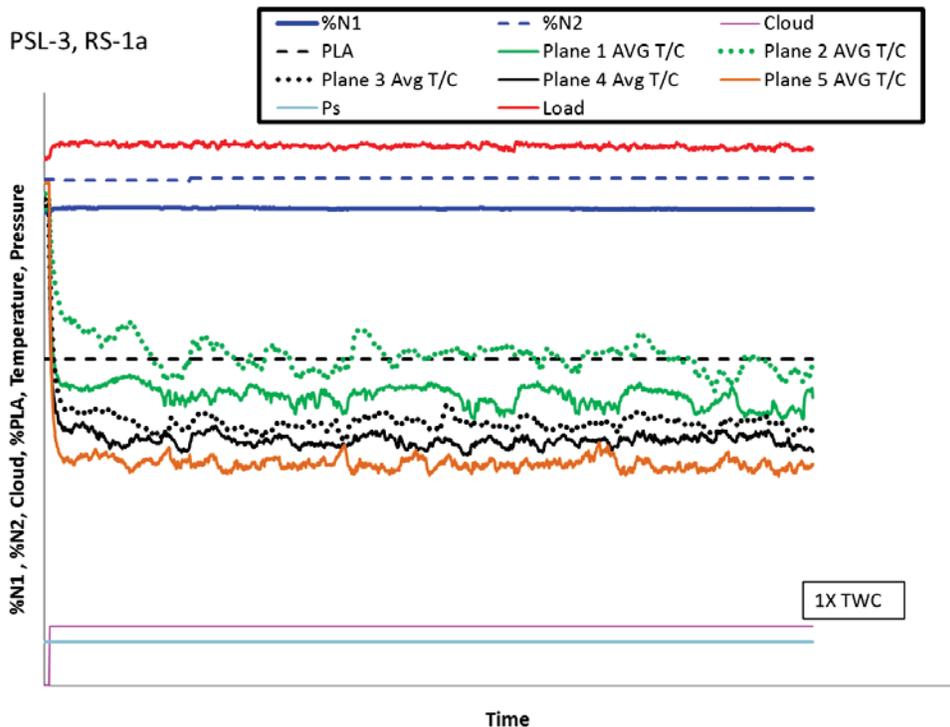
Figure 15. Roll back indicators chart for test point RS-1a, relative to Figure 16.

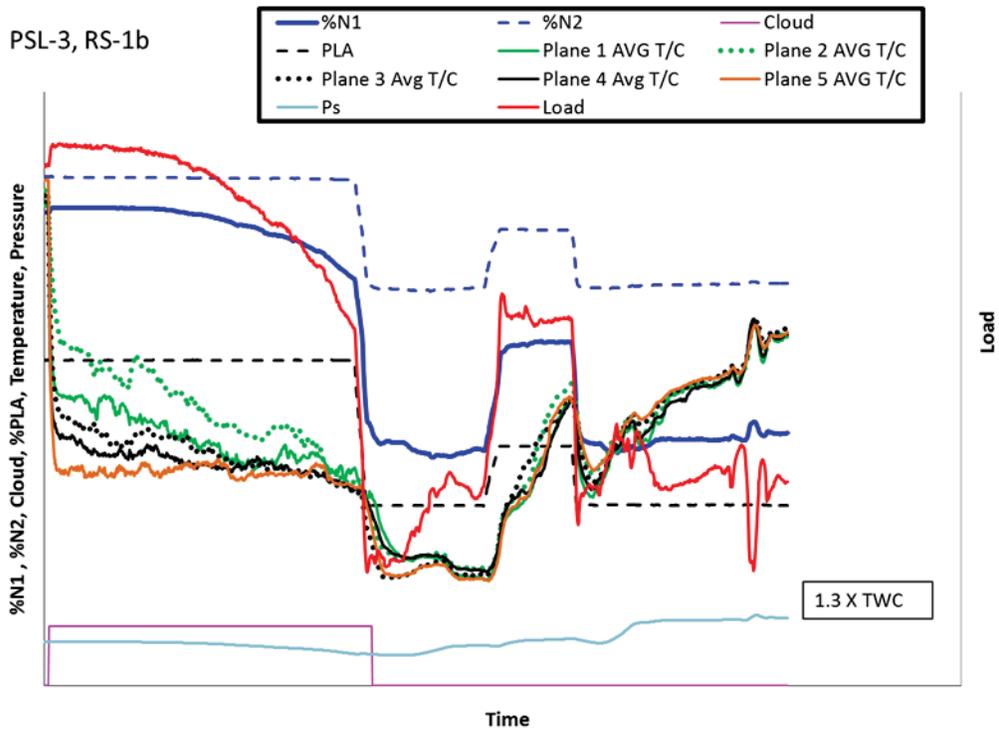
Figure 16. Roll back indicators chart for test point RS-1b relative to Figure 15.

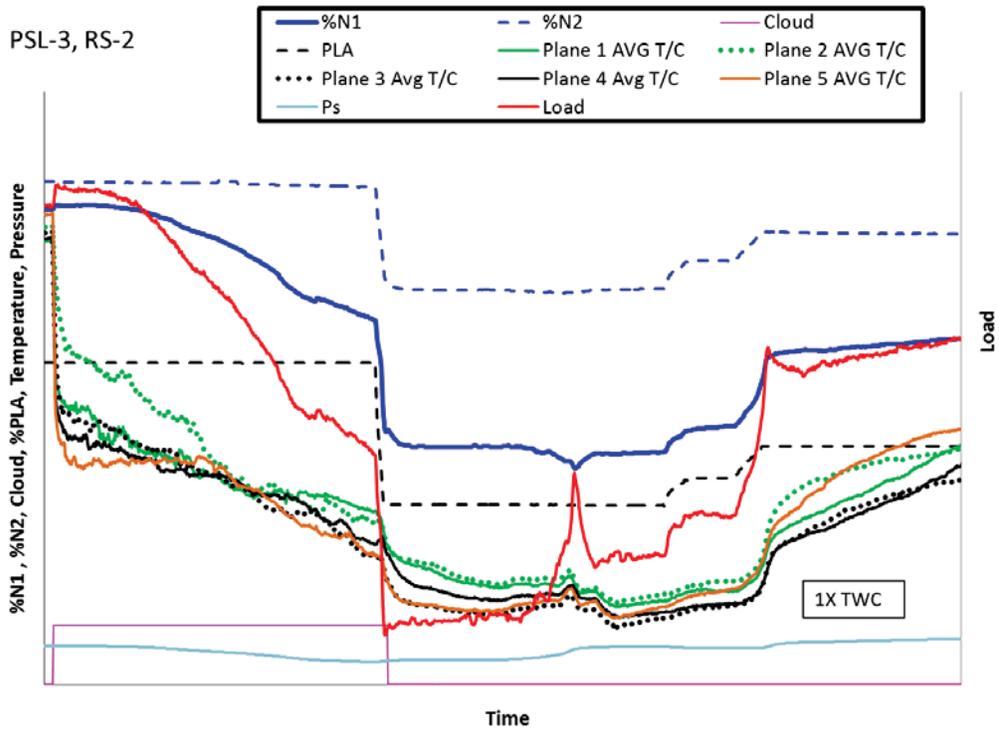
Figure 17. Roll back indicators chart for test point RS-2

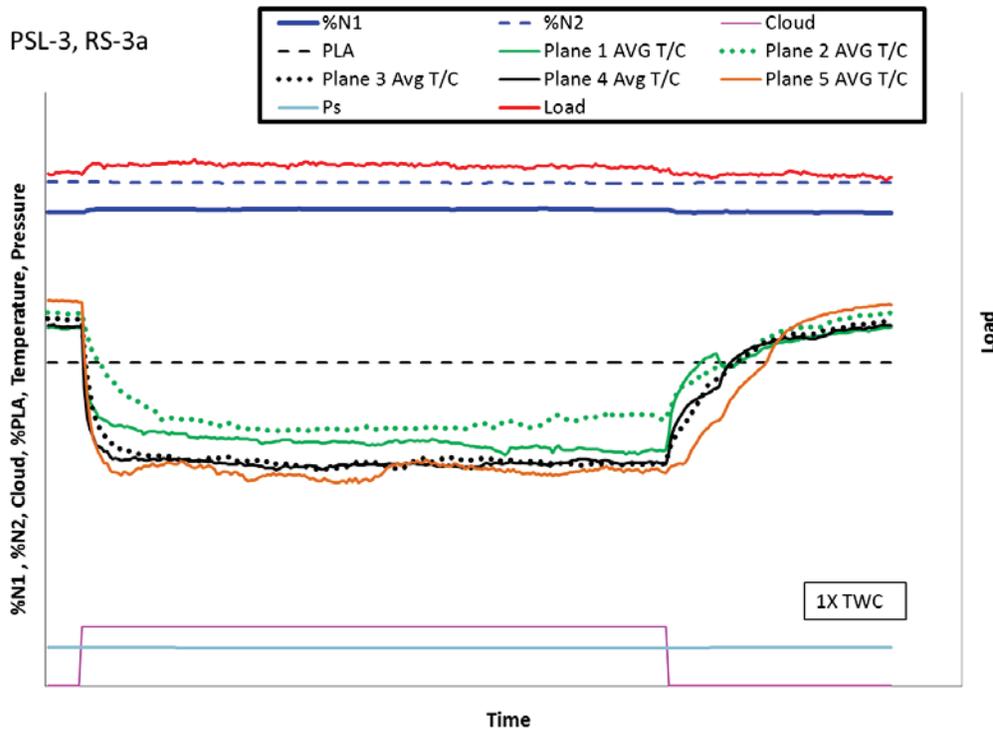
Figure 18. Roll back indicators chart for test point RS-3a, relative to Figure 19.

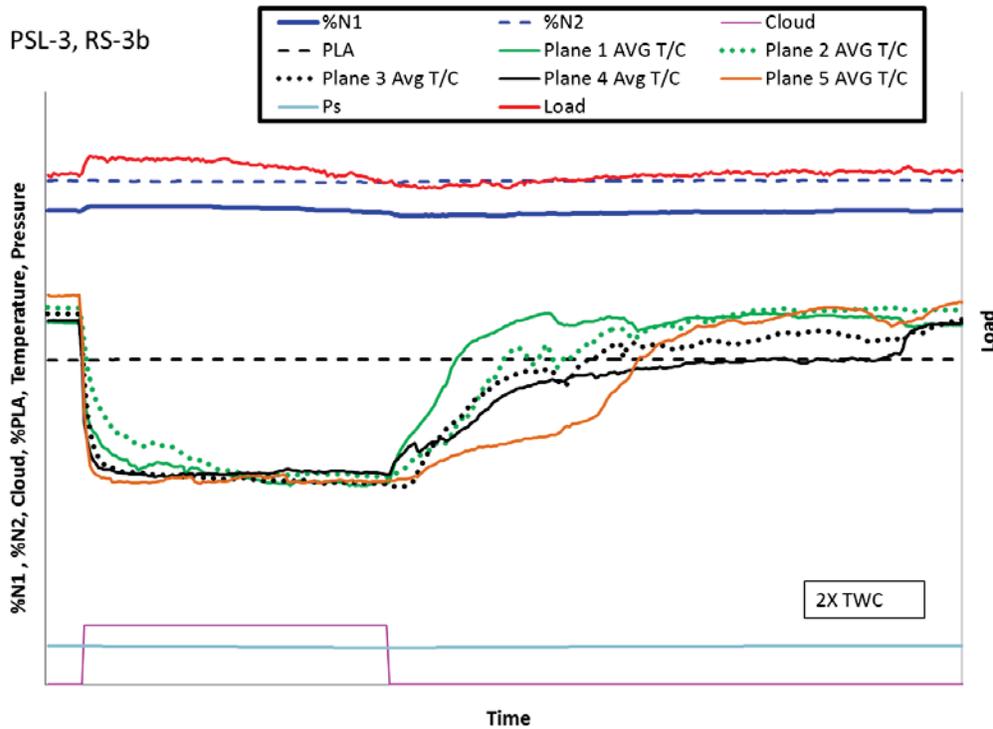
Figure 19. Roll back indicators chart for test point RS-3b, relative to Figure 18.

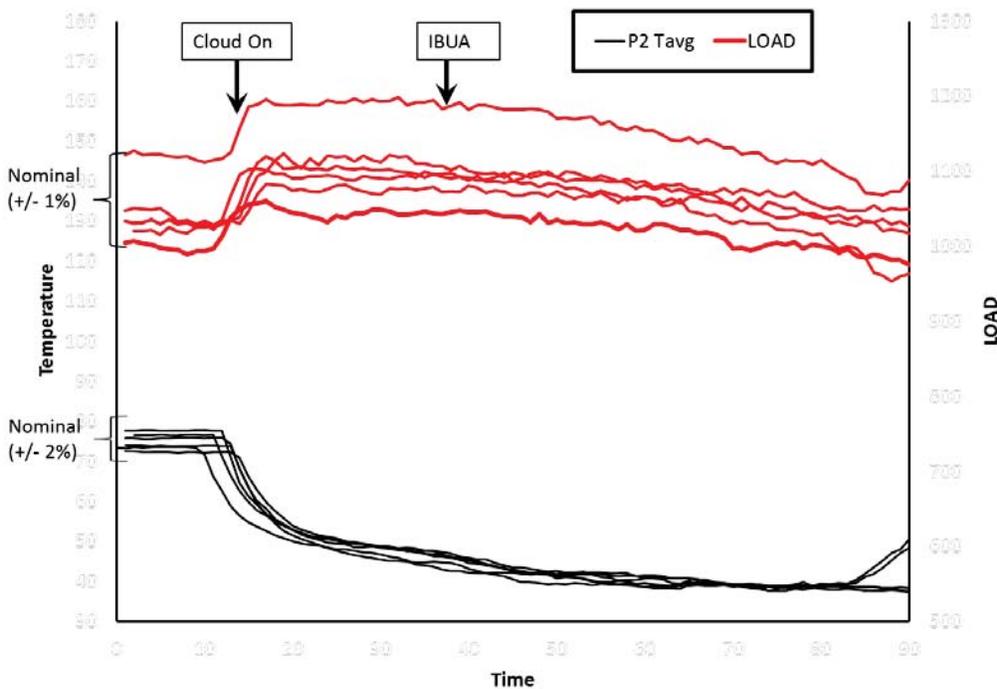
Figure 20. PSL-3, FLT850 test points conducted throughout the month long test

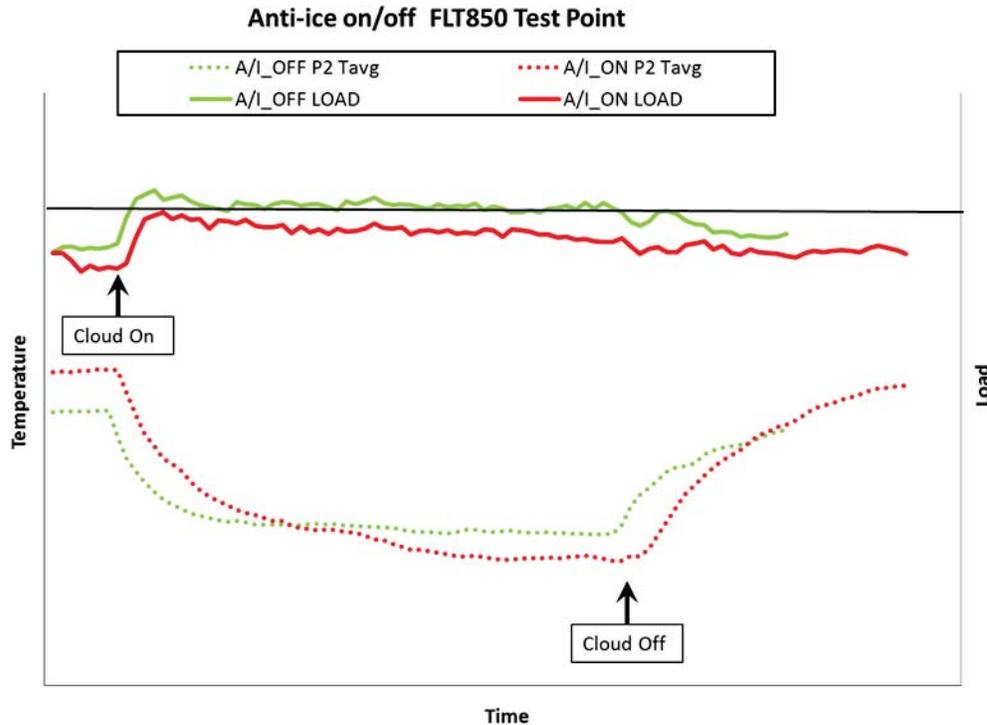
Figure 21. PSL-3, FLT850 test points conducted with the engine anti-icing system turned on and off

The result for a test point with FT FLT850 conditions conducted with and without the engine anti-ice system turned on is shown in [Figure 21](#). The engine anti-ice system works by allowing hot air from the high pressure compressor exit region to flow into the annular area cavity that surrounds the low pressure compressor outer flow path and down through the inlet guide vane. The individual P1 to P5 thermocouples are mounted in or on vanes that are bonded directly to the outer flow path of the LPC, [Figure 7](#). From [Figure 21](#) the cloud off P2 Tavg trace for the anti-ice on test point is shown to be higher than the anti-ice off trace. This is likely due to either anti-ice air heating the outer shroud from the back side, leaking into the flow path near the outer wall, air heating up as it passes over the heated IGV or some combination of the three. Note that the anti-ice off trace falls immediately and levels off

to a relatively steady value at cloud on condition and that there is no secondary temperature drop indicating ice buildup. The LOAD trace for the anti-ice off test point remains steady at the cloud on value. The P2 Tavg trace for the anti-ice on test point drops immediately to the same value as the anti-ice off test point at cloud on condition but undergoes a secondary temperature drop as the anti-ice on LOAD trace begins to drop. This is indicative of critical ice buildup and imminent RB.

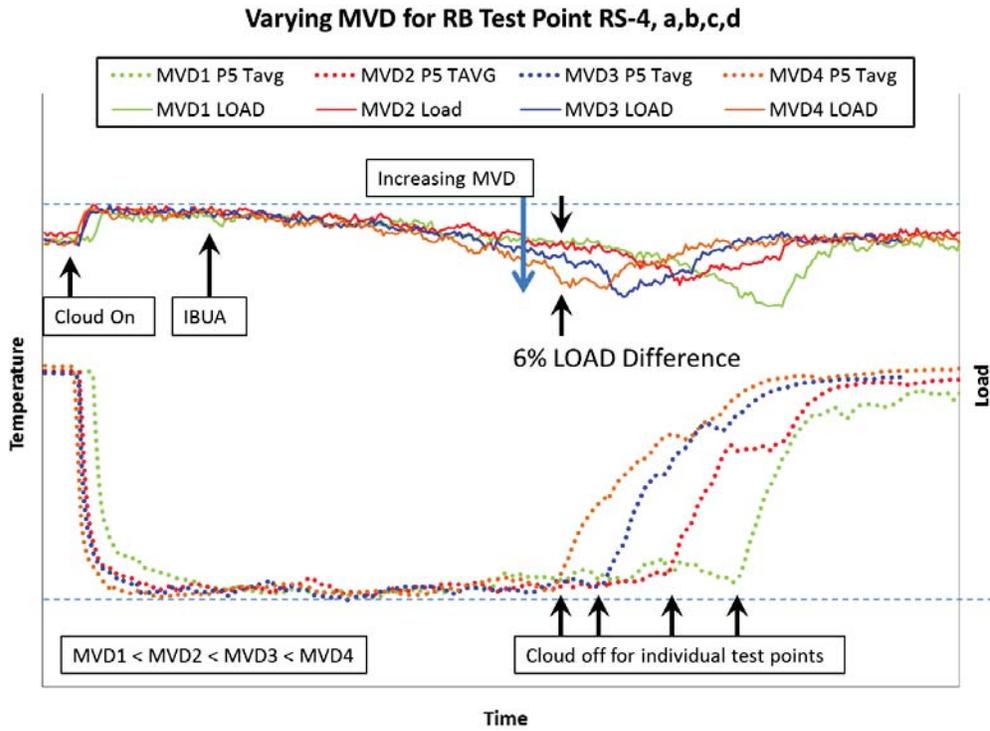
Figure 22. RS-4 RB test points conducted implementing a cloud MVD sweep.

MVD sweeps were conducted for both a RB RS test point and a NRB FLT855 test point. Note that each MVD was investigated as a separate test point. The objective was to investigate the influence of cloud particle size on one RB and one NRB condition. The RB indicator charts showing the results of an MVD sweep for the RS RB and NRB (FLT855) test points are shown in [Figure 22](#) and [23](#) respectively. For the RS RB test point in [Figure 22](#) the particle size does not appear to affect the on-set of IBUA. All loads appear to begin decreasing at a similar time after cloud on condition. Note that the rate of LOAD decrease is greater for the larger MVD cloud test point and is least for the smallest MVD cloud. For the NRB series of test points the only difference is a significantly warmer P5 Tavg trace. This is likely due to the larger MVD cloud not being fully glaciated. It appears that while cloud particle size does not influence the onset of ice buildup it does influence the rate of ice buildup if it is occurring for a given test point.

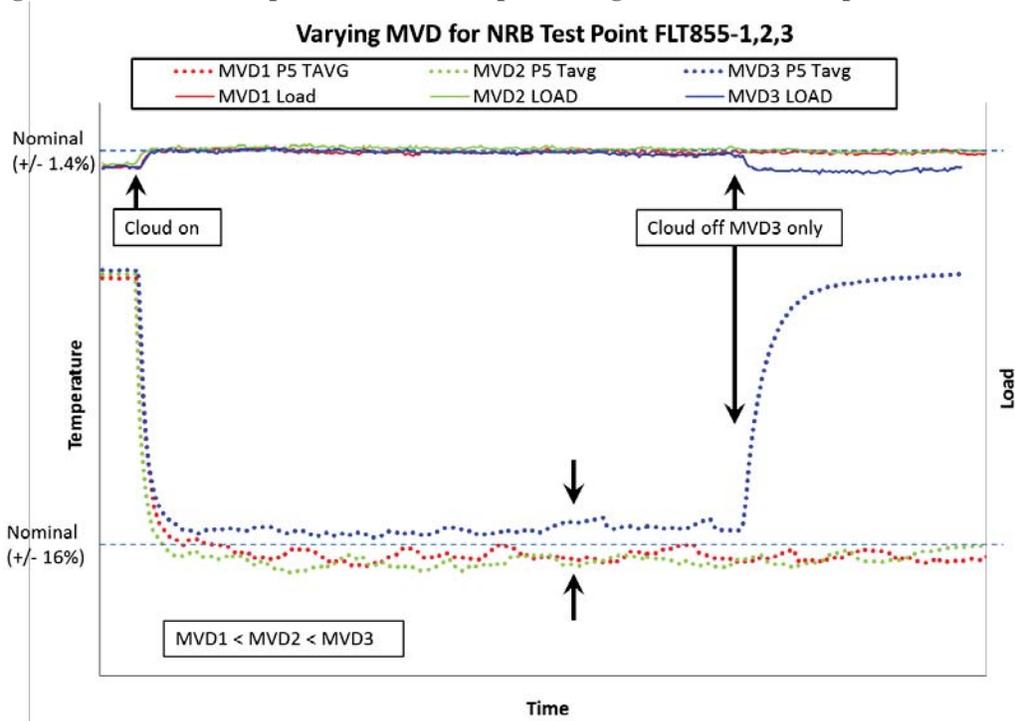
Figure 23. FLT855 NRB test points conducted implementing a cloud MVD sweep.

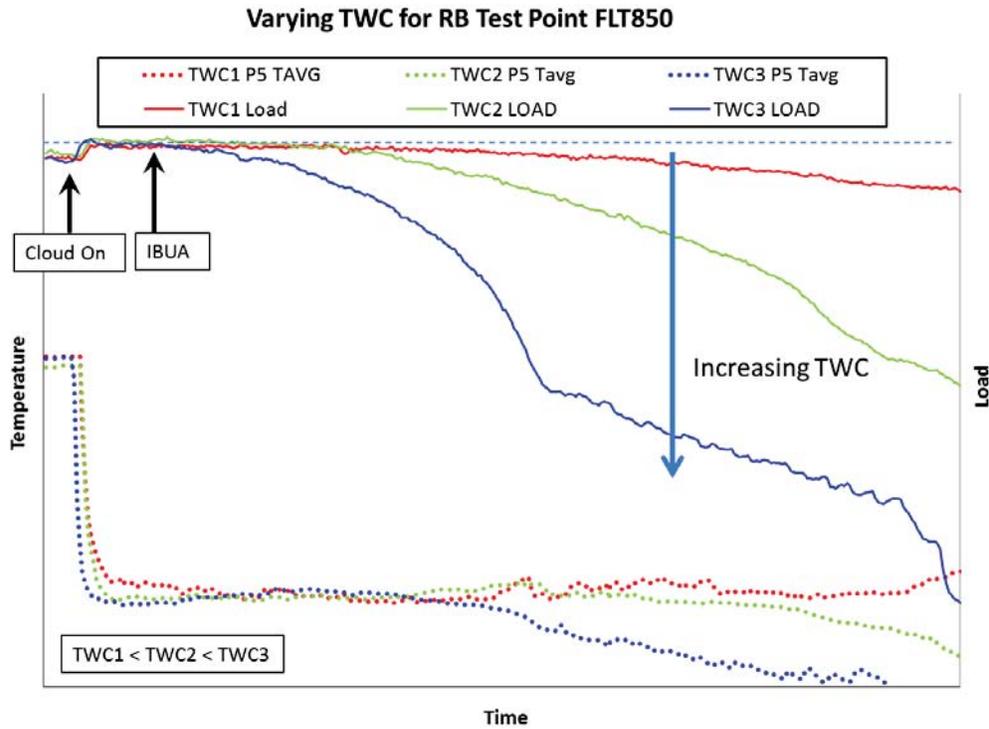
Figure 24. FLT850 RB test points conducted implementing a cloud TWC sweep.

TWC sweeps were conducted for the FLT850 test point. The objective was to investigate the influence of cloud TWC on RB condition. The RB indicators chart showing the results of the TWC sweep is shown in [Figure 24](#). It is clear that the largest TWC cloud produces the highest rate of LOAD decrease for this test point. Note that the largest TWC also produces the most rapid initial and secondary temperature drop at cloud on conditions. TWC has a major influence on both the rate of ice buildup and cooling of the flow path.
