Validation Ice Crystal Icing Engine Test in the Propulsion Systems Laboratory at NASA Glenn Research Center

Michael J. Oliver¹

NASA Glenn Research Center, Cleveland, OH, 44135

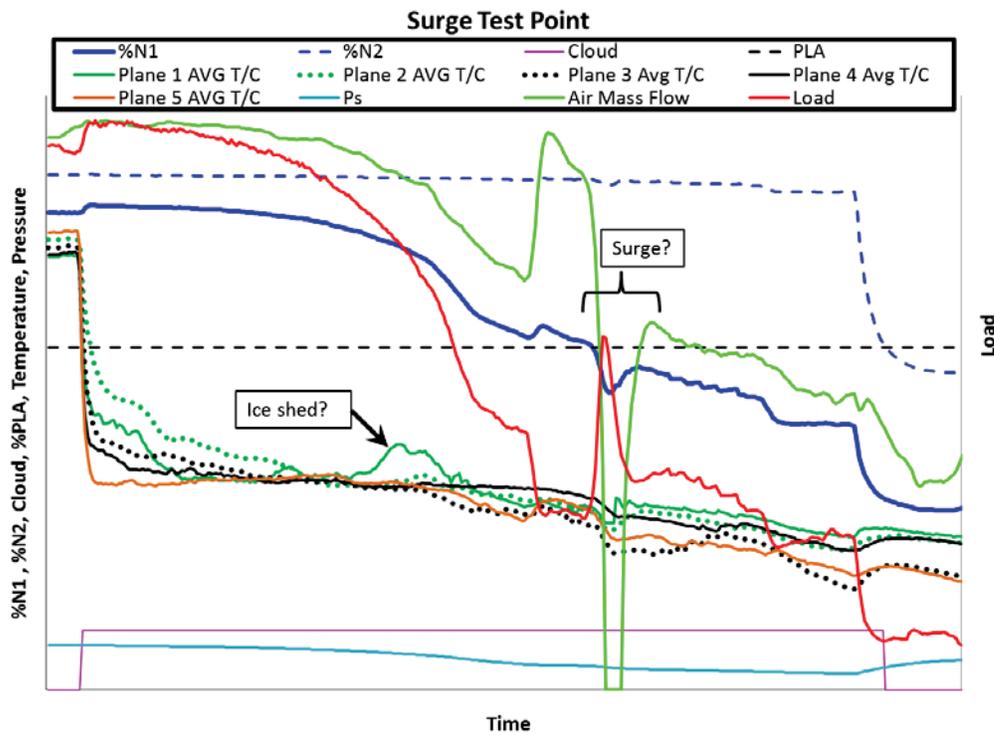
Figure 25. FLT850-3 full roll back test point RB indicators chart. The thermocouple traces shown are averages for each plane of interest.

In [Figure 25](#), the air mass flow trace shows a distinctive movement suggesting a sudden disturbance in the air flow. This is interpreted as an engine surge for this test. The facility airflow parameter is calculated using an averaged series of static pressure transducers in the PSL-3 plenum. These are not dynamic pressure sensors and the nature of how the pressure sensors function resulted in the “drawn out” representation of the surge as compared to a spike and return that would be expected as the engine surges and recovers. Note that the label for non-uniform ice shed in [Figure 25](#) suggests an ice shed occurred in P1 prior to the surge behavior. [Figure 26](#) shows the non-uniform behavior of the individual thermocouples in P1. This suggests that a non-uniform circumferential ice shed occurred and entered the HPC and resulted in the stall/surge.

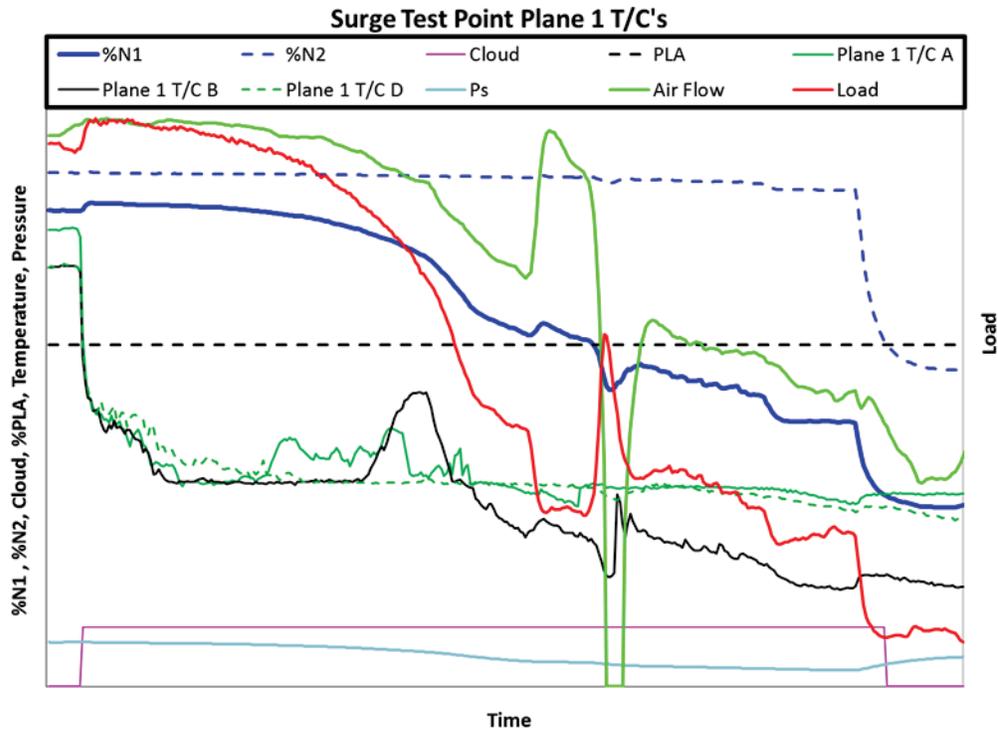
Figure 26. FLT850-3 full roll back test point RB indicators chart. The thermocouple traces shown are the individual traces for the instrumented plane 1-- labeled as “Non-uniform ice shed?” in Figure 25.

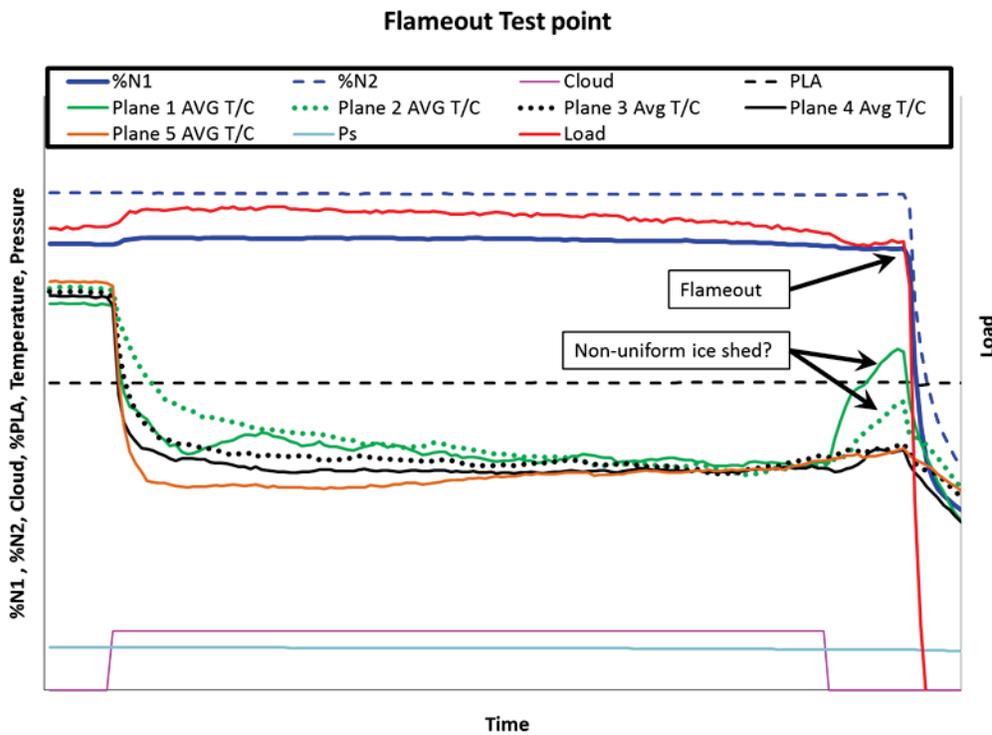
Figure 27. DOE-1 test point centered on FLT850—flameout. The thermocouple traces shown are average for each plane of interest.

The flameout test point was part of a design of experiment (DOE) series of test points to investigate sensitivities of the RB and ice build up to various parameters. In this particular case the CRB was made, the cloud was turned off and the ice shed occurred resulting in the flameout. [Figures 27, 28](#) show the RB indicators chart for the flameout test point with average plane and individual thermocouple traces respectively. [Figures 29, 30](#) show the RB indicators chart for the repeated flameout test point with average plane and individual thermocouples respectively. The repeated flameout test point failed to produce another flameout. Inspection of the two RB indicator charts plotting the P1 and P2 measured thermocouples [Figures 28 and 30](#), reveals a non-uniform ice shed at cloud off condition for the flameout point and a more uniform ice shed for the repeated flameout test point.

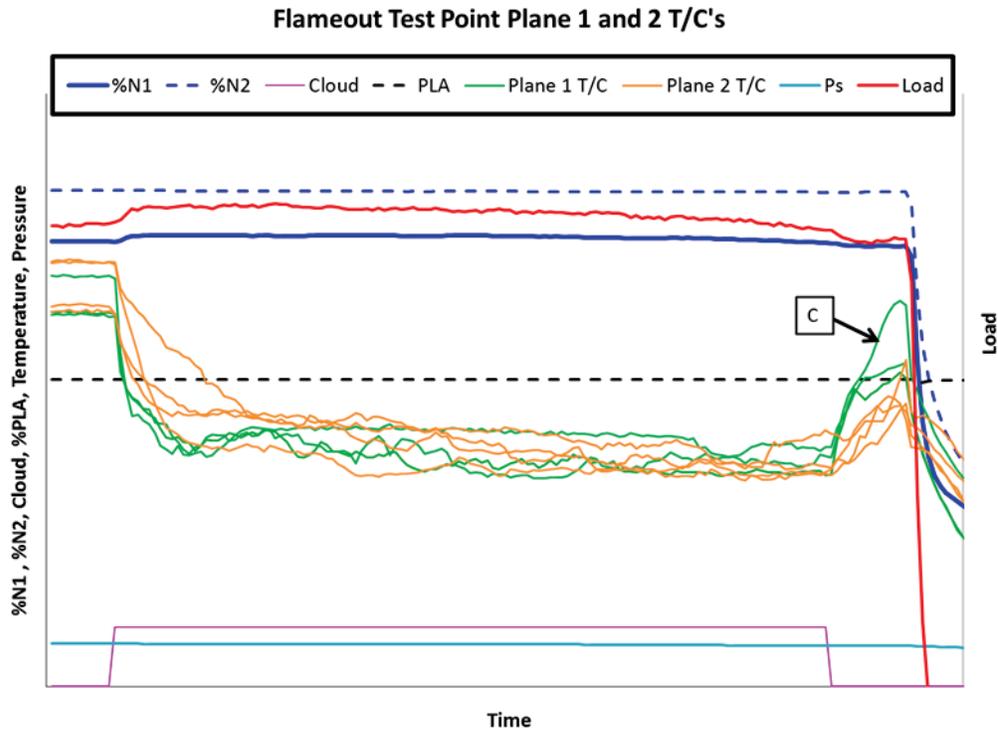
Figure 28. DOE-1 test point centered on FLT-850—flameout. The thermocouple traces shown are the individual traces for the instrumented planes 1 and 2 labeled as “Non-uniform ice shed?” in Figure 27.

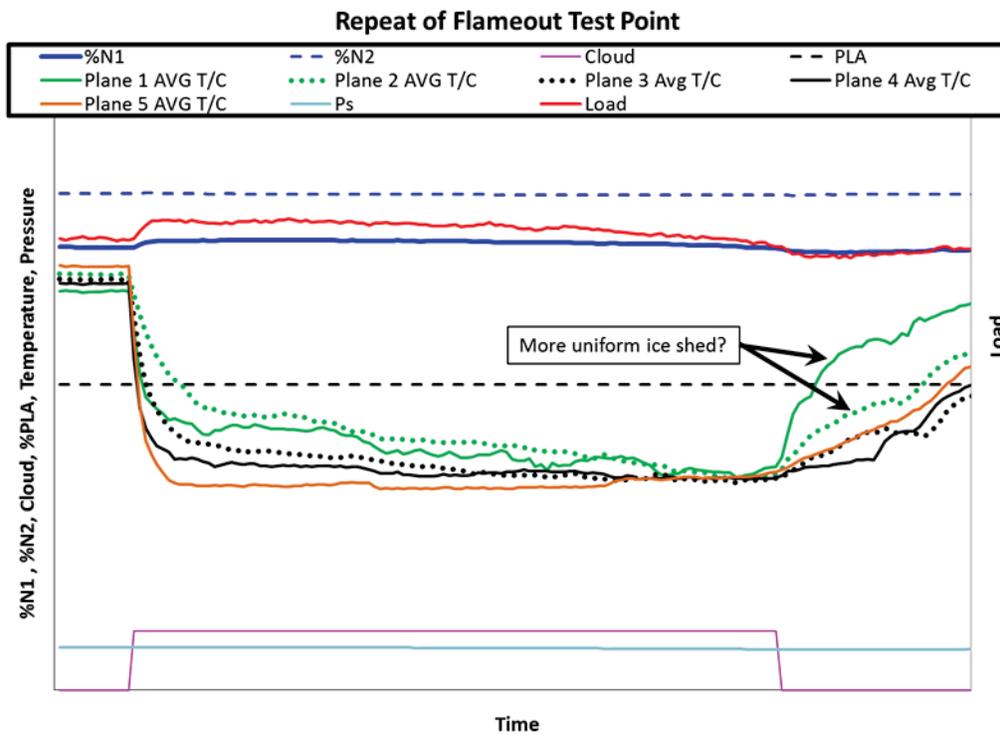
Figure 29. Repeat of DOE-1 test point centered on FLT850—no flameout. Thermocouple traces shown are average of each plane of interest.

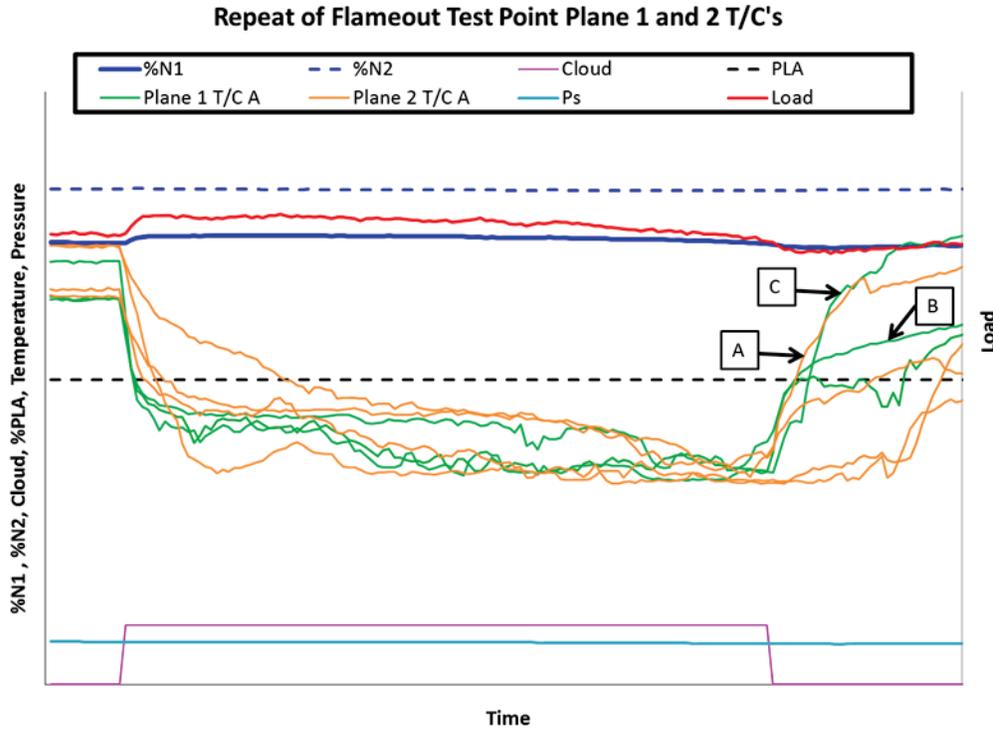
Figure 30. Repeat of DOE-1 test point centered on FLT850—no flameout. The thermocouple traces shown are the individual traces for the instrumented planes 1 and 2 labeled as “More uniform ice shed?” in Figure 29.

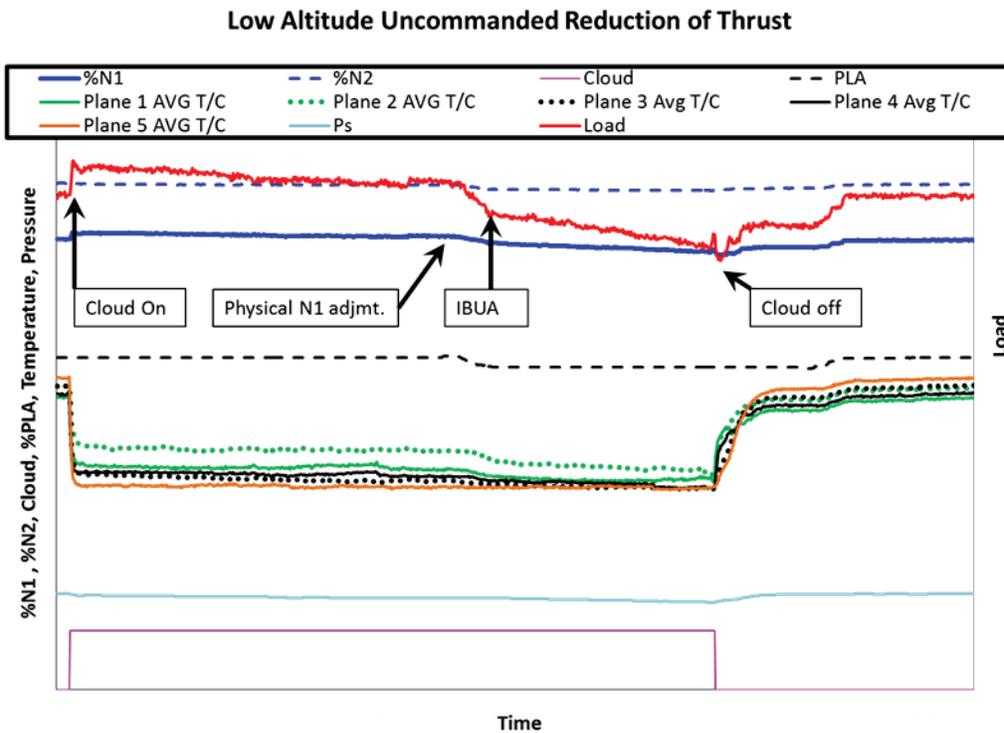
Figure 31. A PSL-3 low altitude test point Roll Back Indicator Chart showing an Uncommanded Reduction of Thrust.

The low altitude test point, [Figure 31](#), shows that ice buildup similar to that at high altitude RB/CRB test points occurs. Note, the low altitude test points were not intended to be feasible operational flight conditions. They were conducted in an effort to investigate the feasibility of developing ice crystal icing scaling laws in a facility such as PSL-3 where non-realistic flight and operating parameters are easily tested to develop the physics or investigate the feasibility thereof for engine icing scaling. The ultimate goal is to develop scaling laws that are feasible and transferable to engine and air frame manufacturers to perform ice crystal icing testing at large scale, sea level turbofan engine test facilities. Without cameras in the flow path to specifically characterize and determine similarity or lack thereof of low altitude ice buildup compared to high altitude ice buildup there is no way to confirm or deny that low altitude ice buildup is the same or similar as high altitude ice buildup. Data was generated at incrementally lower altitudes and this data will be studied in detail. Future testing should include flow path cameras to characterize the ice between low and high altitude as well as the location of the buildup.

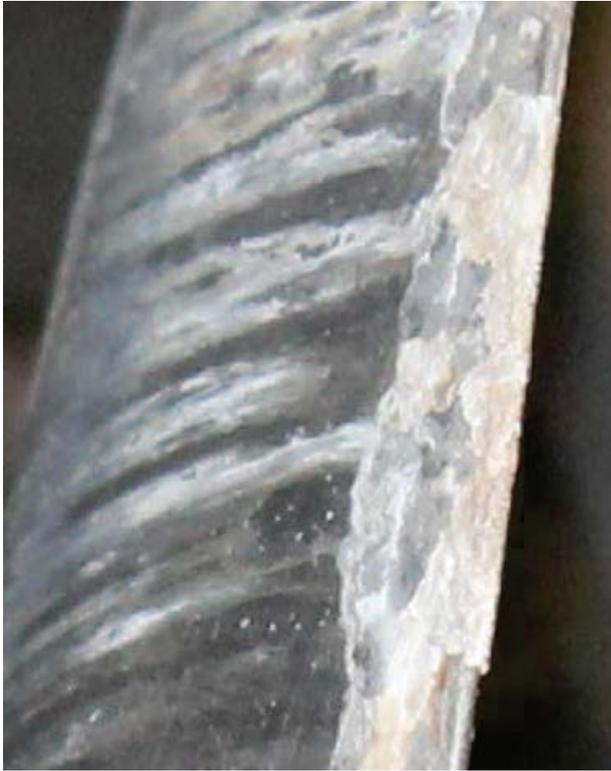
Figure 32. Mineral deposits on LF01 engine core flow path hardware.

1. There was chronic engine degradation (in the form of turbine exit temperature rise) throughout the test believed due to mineral deposits, [Figure 32](#), from the use of filtered (not demineralized) city water for the ice crystal cloud. This was done to use small particulate in the city water as nucleation sites for ice crystal formation. This degradation would recover somewhat on low altitude high TWC cloud test points.

Filtered city water used in the cloud generation nozzle system to provide ice crystal nucleation sites resulted in mineralization forming on flow path hardware that led to a chronic degradation of engine performance during the month long test.

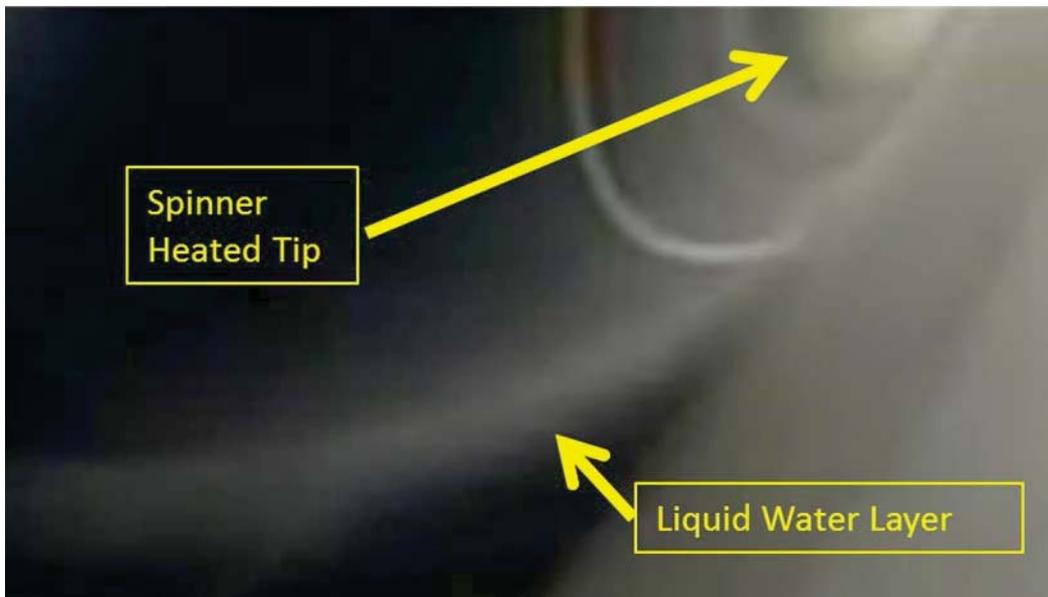
Figure 33. ALF502-R5 spinner during cloud on conditions.

2. The heated spinner was a source of liquid water for all cloud on conditions, [Figure 33](#). During anti-ice off test points this liquid water formed ice accretion on the lower third of the IGW, [Figure 34](#).

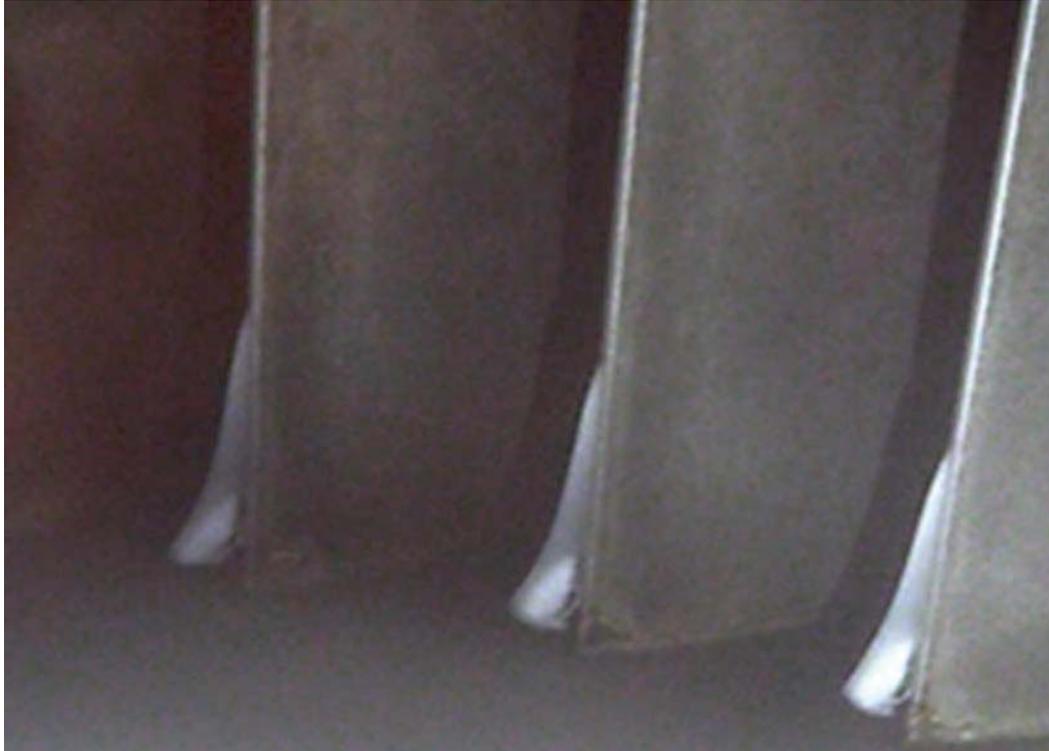
Figure 34. Ice accretion forming on bottom leading edge of LPC IGV during anti-ice off cloud on conditions.

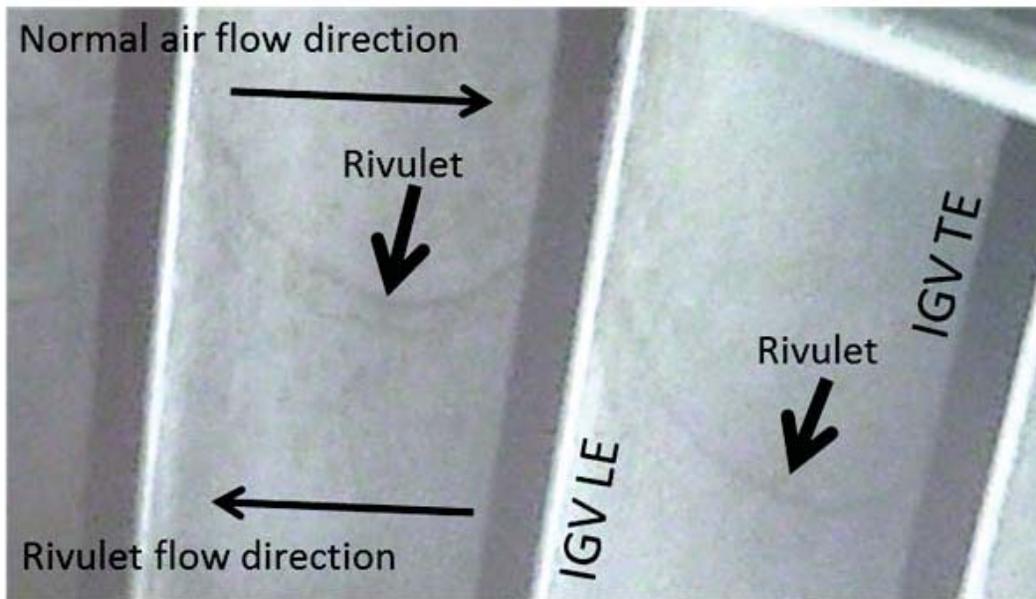
Figure 35. Reverse flow rivulet running from LPC IGV trailing edge to leading edge during a RB test point.

3. Reverse flow of liquid water was observed on the LPC IGW for RB test points, [Figure 35](#).
4. Flow path hardware was damaged during a full roll back test point. This is suspected to be a result of an ice shed impacting the rotating hardware during cloud off engine recovery, [Figure 36](#).

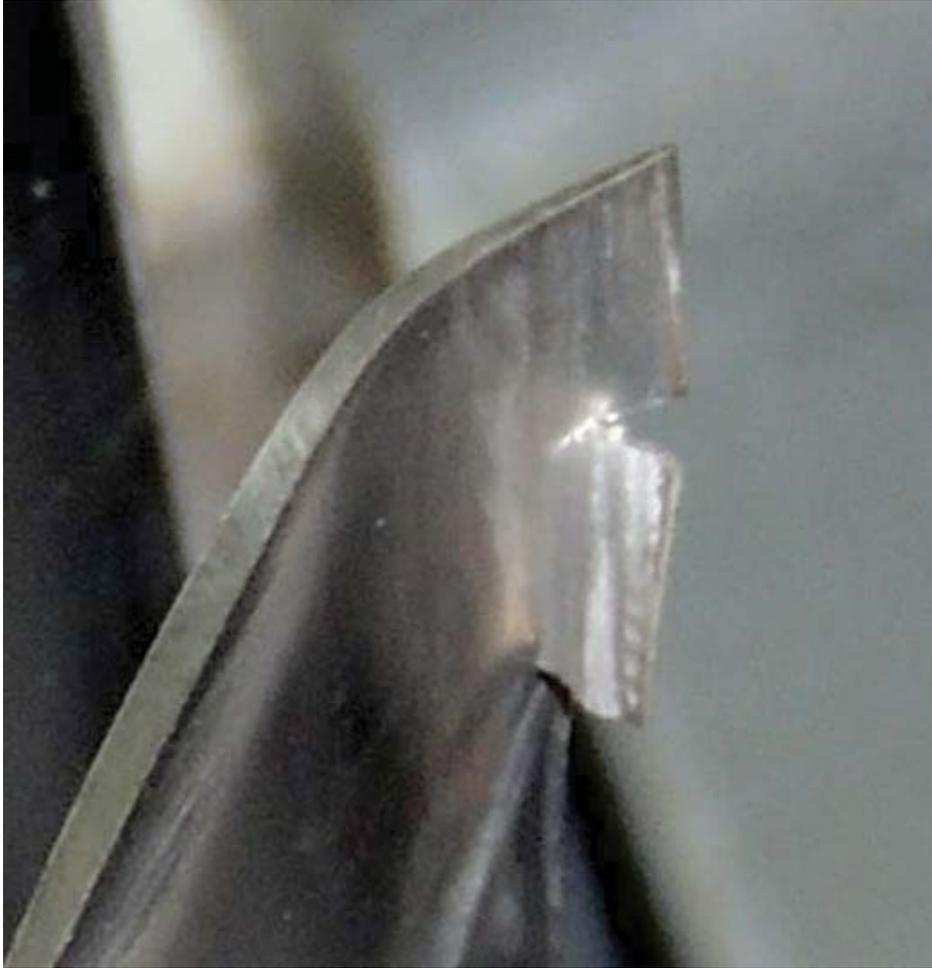
Figure 36. HPC Rotor 1 mechanical damage.

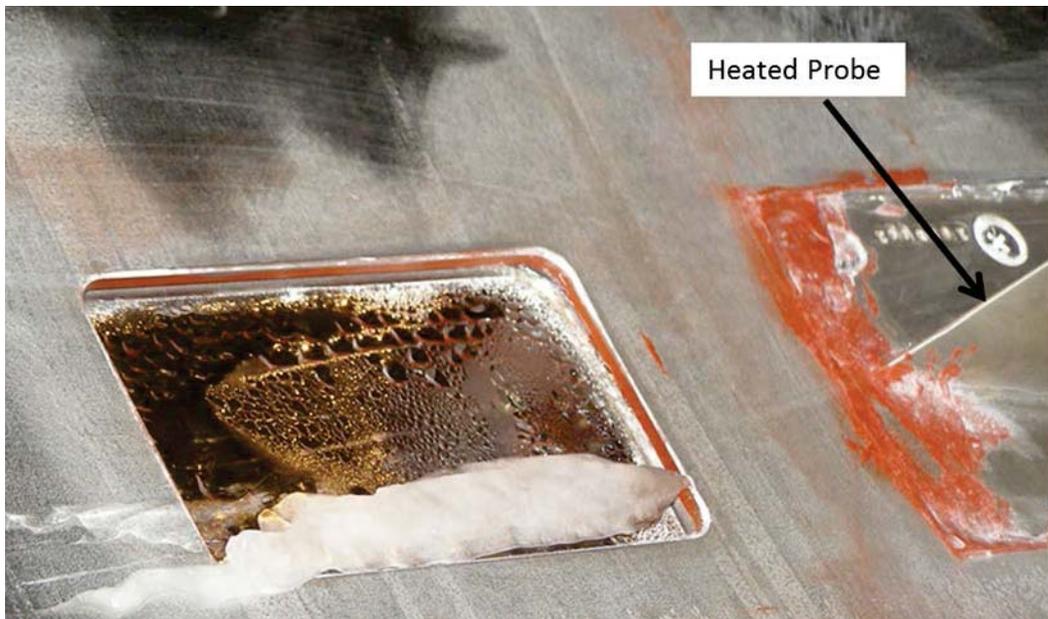
Figure 37. Ice mass accreting to side wall downstream of heated pitot probe.

7. The PSL-3 tunnel walls were all grounded to successfully prevent the static cling of ice crystals.
8. During integrated systems testing heated pitot tube probes were used during ice crystal cloud on operation. A rivulet of water ran back and froze to the tunnel side wall approximately 6 to 8 inches downstream of the heated probe, [Figure 37](#).
