# NASA CPAS Drogue Textile Riser Feasibility Study

Elsa J. Hennings\* and Michael L. Petersen†  
Naval Air Warfare Center Weapons Division, China Lake, CA, 93555

Steel cable was chosen for the lower end of the drogue and main parachute risers on NASA's Orion Multi Purpose Crew Vehicle Parachute Assembly System (CPAS) to protect the risers from extreme temperatures and abrasion should they contact the crew module during deployment, as was done for Apollo. Due to the weight and deployment complexity inherent in steel, there was significant interest in the possibility of substituting textile for steel for the drogue and main parachute risers. However, textile risers could be damaged when subjected to high temperature and abrasion. Investigations were consequently performed by a subset of the authors to determine whether sacrificial, non-load-bearing textile riser covers could be developed to mitigate the thermal and abrasion concerns. Multiple material combinations were tested, resulting in a cover design capable of protecting the riser against severe riser/crew module contact interactions. A feasibility study was then conducted to evaluate the performance of the textile drogue rise

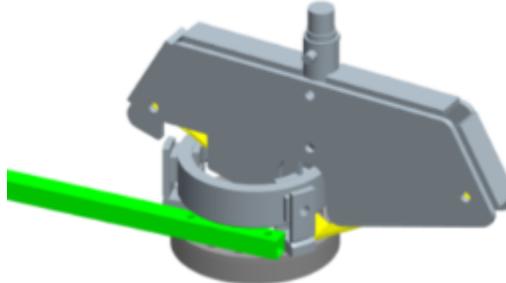
Figure 2. CAD model of edge radius fixture with turntable attachments.

Figure 3. CAD model of edge radius fixture installed on turn-table with attached rotating bar and riser fixture.

The available abrasion distance was constrained by the edge radius fixture attachments shown on Figure 2 and was measured to have an arc length of approximately nine inches. Subtracting the riser width of about two inches resulted in a total traversable arc length of about six inches, which was approximately half of the desired total length, requiring two passes to achieve the desired total abrasion length.

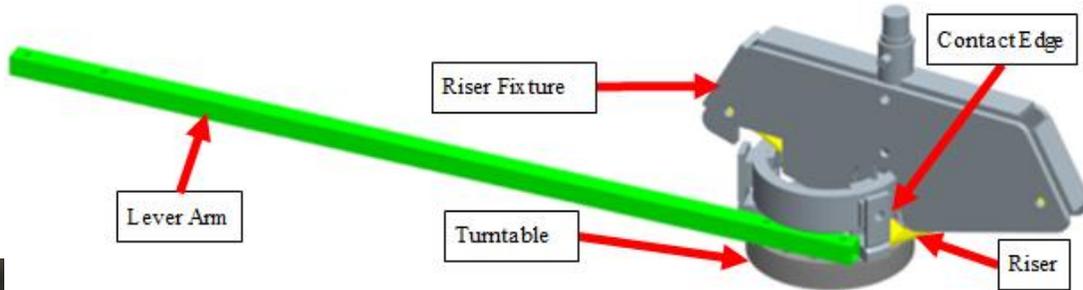
**Figure 4. CAD model of fixture.**

All abrasion tests were performed using the same Instron 8800 used in [1], which has a maximum load rating of 56,200 lbs. Additionally, the test series was designed to re-use several existing test fixture components used during previous testing to save fabrication time. A computer aided design (CAD) model image of the test fixture is shown on Figure 4.

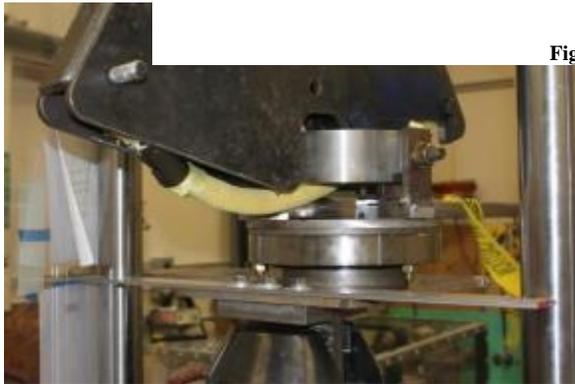
**Photo 3. Test fixture with protected riser and contact edge.**

Photos of the actual test setup are shown on Photo 3, Photo 4, and Photo 5.

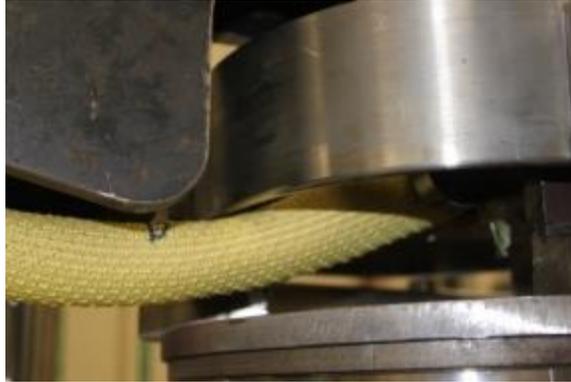
Photo 4. Protected riser and contact edge (close-up view).

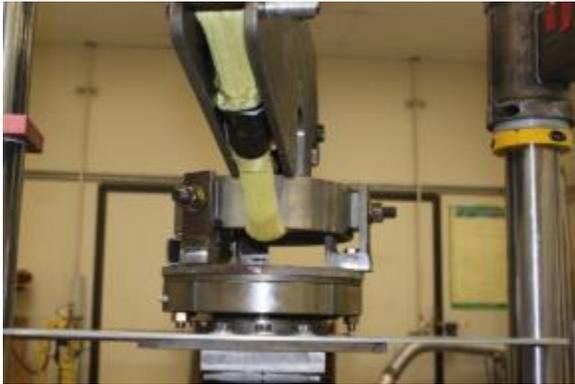
Photo 5. Protected riser under load.

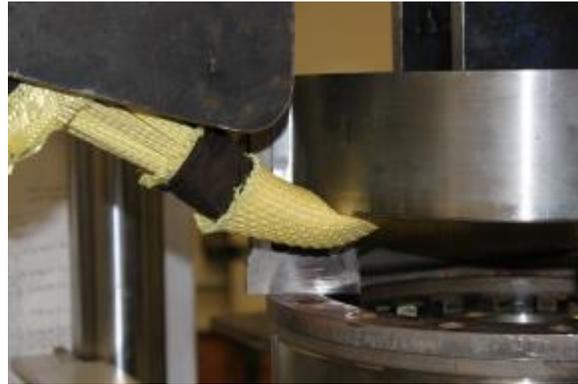
Photo 6. Protected riser under load (close-up view).

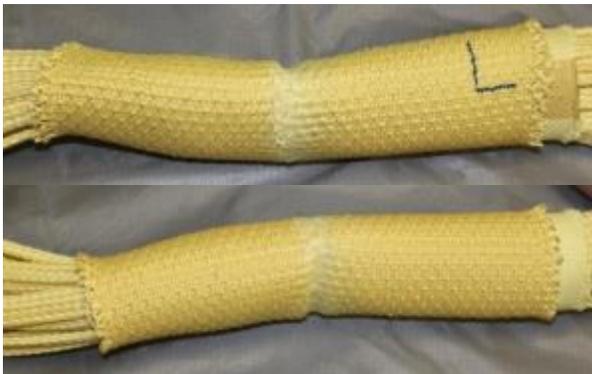
Photo 8. Post-test exterior, “L”.

Based on these test results, cover design “L” demonstrated the most effective abrasion protection and was selected for knockdown factor evaluation. Design “N” was an over-test of “L” and was also selected for comparison. Observable effects of abrasion on designs “L” and “N” are shown on Photo 8 through Photo 13.

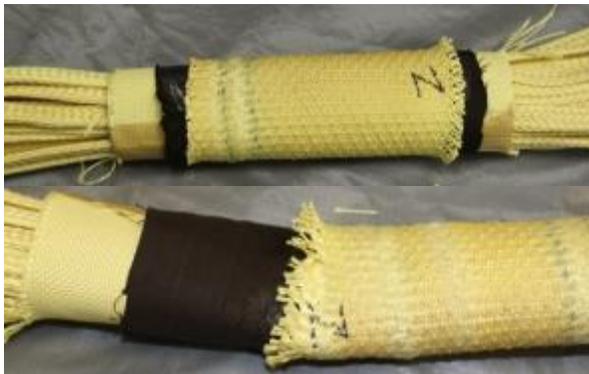
Photo 9. Post-test exterior, “N”.

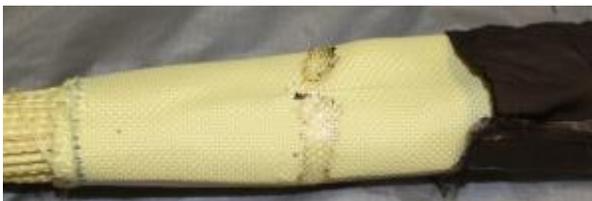
Photo 10. Post-test inner Kevlar sleeve, “L”.

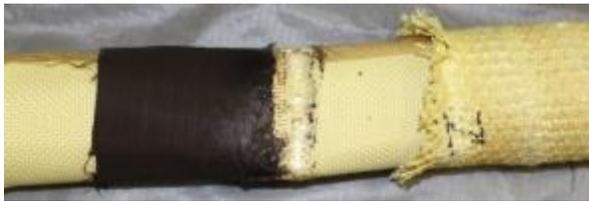
Photo 11. Post-test inner Kevlar sleeve, “N”.

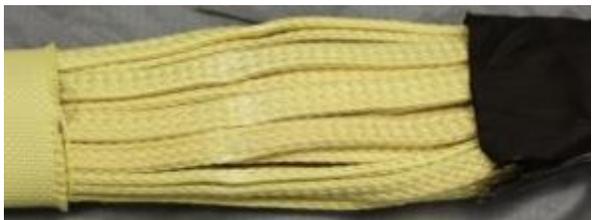
Photo 12. Post-test lines, “L”.

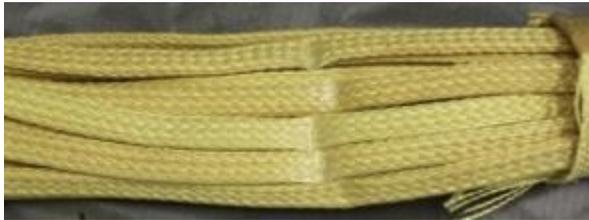
Photo 13. Post-test lines, “N”.

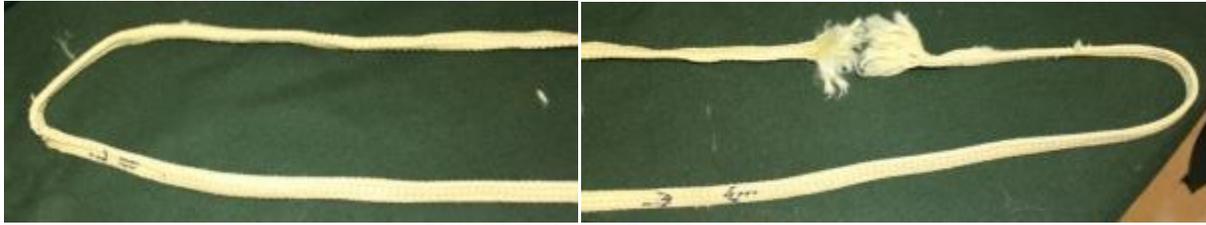
Photo 14. Typical tensile testing results.

Each individual loop of the L and N riser samples was then tensioned to failure using an Instron 5884 with 1.375-inch diameter polished bushings on the 0.5-inch diameter pins in order to match the flight pin diameter. Each loop was marked prior to testing to identify the abrasion point (see the arrows on Photo 14). The failure modes for all the samples included bushing break (BB), end of insertion break (IB), and damage break (DB). Typical results of a failure at the end of the inserted line (IB) are shown on Photo 14. Maximum tensile strength data and failure mode for each sample are shown in Table 4. Nine unabraded control samples were tested for comparison.

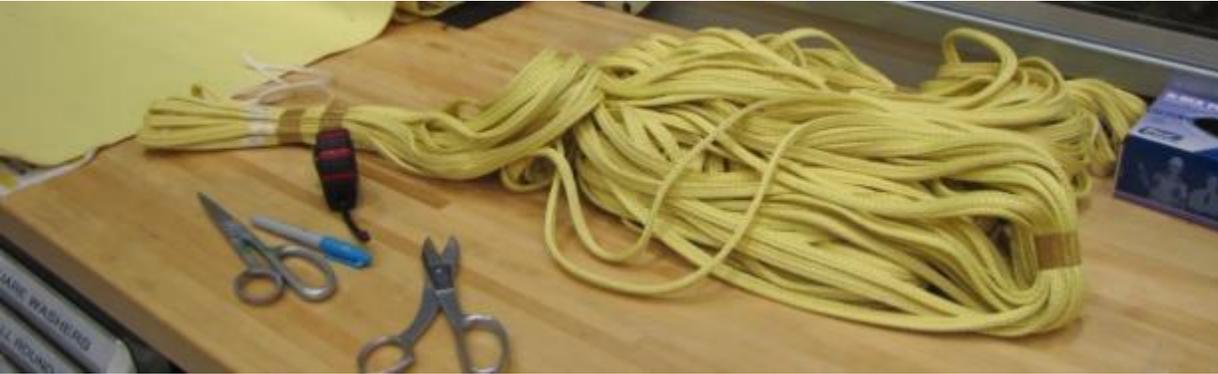
Photo 15. CPAS drogue riser sample.

A total of ten riser samples were fabricated for evaluation testing at JSC. Each riser was 17 ft long and composed of 12 continuous loops of 5000-lb Kevlar® rope. Each loop was numbered and labeled to aid assembly. One riser was set aside as a control. An example riser is shown on Photo 15.

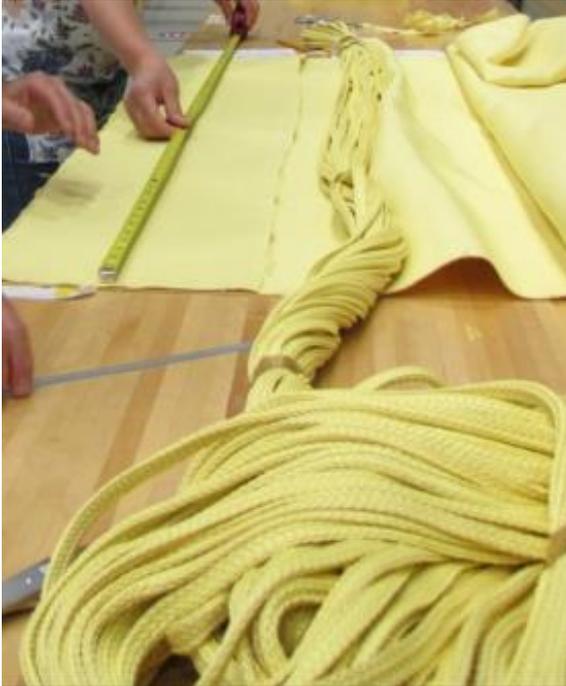
**Photo 16.** Riser sample about to be wrapped in Kevlar cloth.

Each riser sample was laid out on the assembly table atop the inner Kevlar sleeve cloth, as shown on Photo 16. The 10-oz plain-weave Kevlar cloth of the inner Kevlar sleeve was measured and cut to a width sufficient to wrap twice about the riser sample, thus forming two protective layers, as shown on Photo 17. The inner sleeve was sized to be evenly snug along its length. The inner Kevlar sleeve was then secured with Teflon tape, as shown on Photo 18. The Teflon cloth of the middle sleeve was cut to be slightly shorter than the inner Kevlar sleeve, wrapped about the inner Kevlar sleeve to form a single lubricating layer, and secured with Teflon tape, as shown by Photo 19. The Teflon sleeve was also sized to be evenly snug along its length. The sleeved riser sample was then inserted into the outer Kevlar sleeve, as shown on Photo 20. The inner Kevlar sleeve was taped to the riser and the Teflon sleeve taped to the inner sleeve on each end, with the outer sleeve left untaped to allow it to roll. The final assembly of the protected riser sample is shown on Photo 21 and its flexibility is demonstrated on Photo 22.

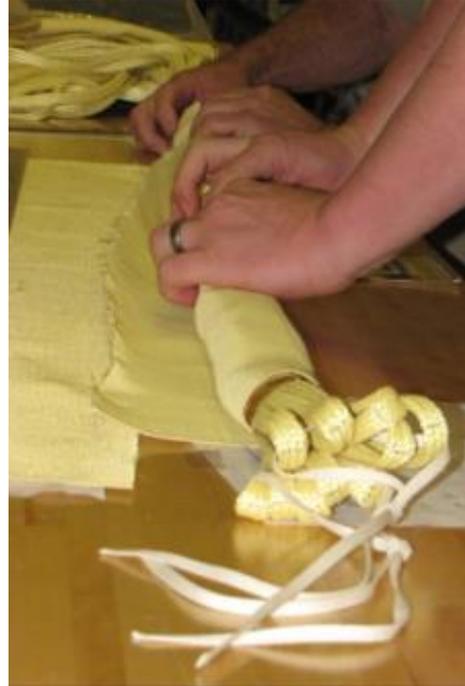
**Photo 17.** Riser sample being wrapped in Kevlar.

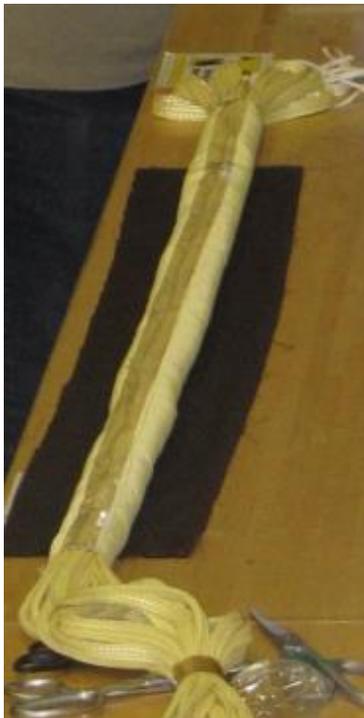
**Photo 18.** Kevlar cloth inner sleeve secured with Teflon tape.

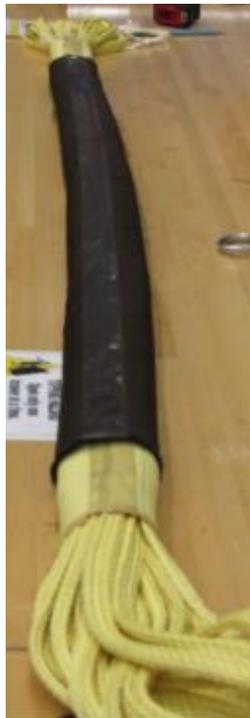
**Photo 19.** Teflon middle sleeve secured with Teflon tape.

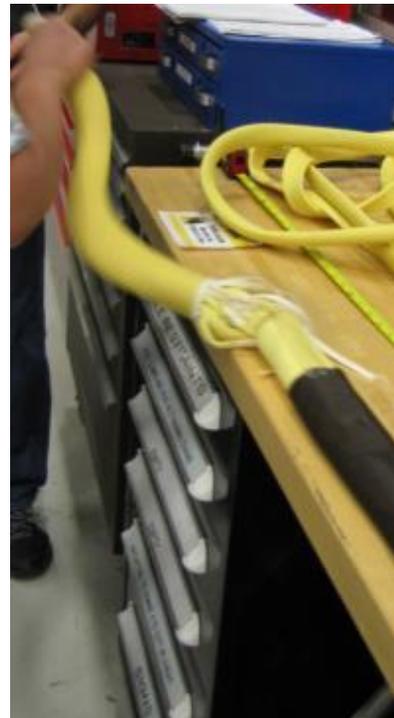
**Photo 20.** Riser sample being inserted into tubular Kevlar outer sleeve.

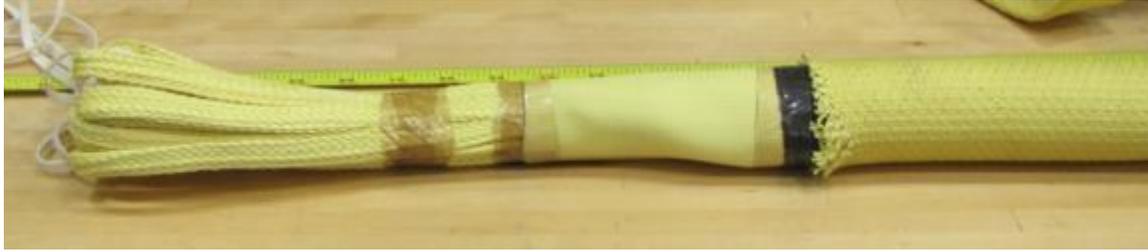
**Photo 21. Riser sample with protective textile cover.**

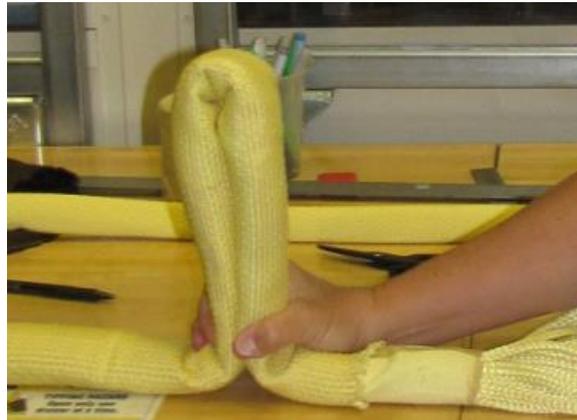
**Photo 22. Flexibility demonstration of protected CPAS drogue textile riser.**

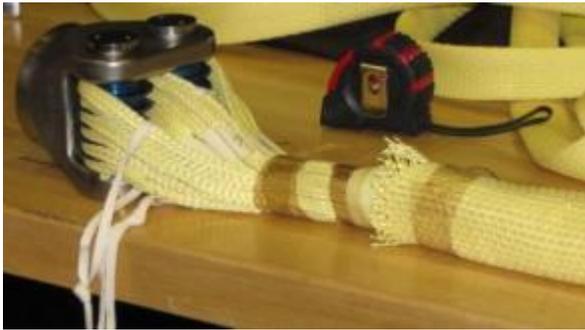
**Photo 23. Riser sample with hardware interface “knuckle” attached (abrasion fixture end).**

Two hardware interface “knuckles” were used to connect the riser sample to the test fixture. The knuckle used to simulate attachment to the capsule is shown on Photo 23, whereas the knuckle used to simulate the parachute load is shown on Photo 24. The riser sample was first attached to the capsule knuckle and installed in the abrasion fixture, as shown on Photo 25. The far end of the riser was then fed through the edge radius tube, as shown on Photo 26 and Photo 28. The riser cover was marked to provide visual indication of rotation. Finally, the far end of the riser sample was routed through safety ties, as shown on Photo 27 and attached to the parachute knuckle, load cell, and hydraulic ram assembly, as shown on Photo 29.

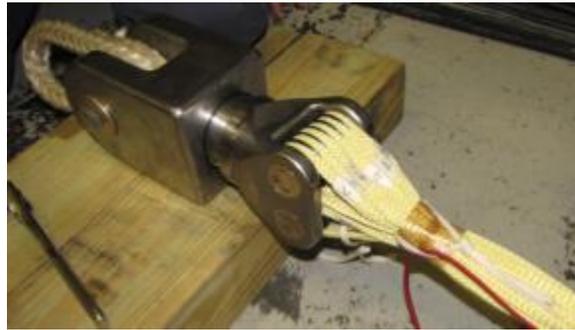
**Photo 24. Riser sample with hardware interface “knuckle” attached (tensioned end).**

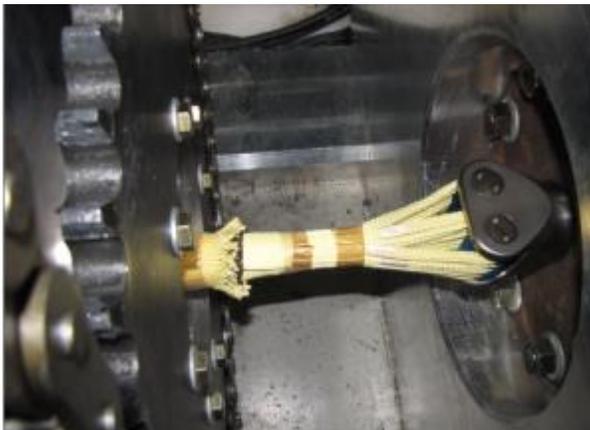
**Photo 25. Riser sample attached to abrasion fixture.**

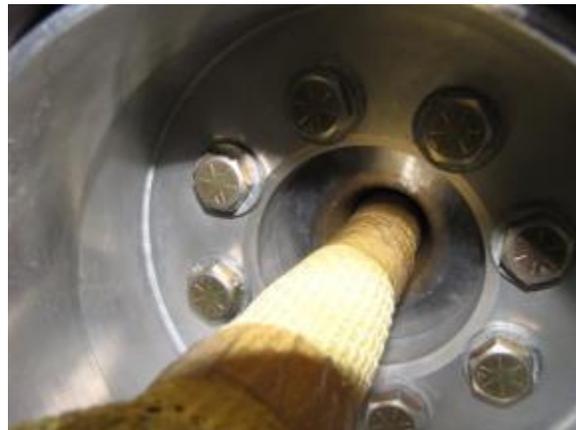
**Photo 26. Riser sample passing through edge radius tube.**

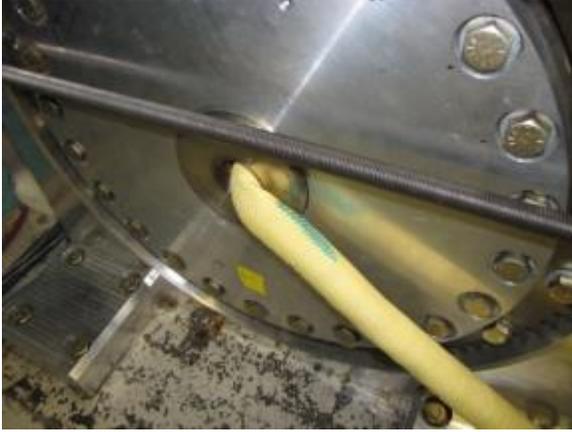
**Photo 28. Riser sample in contact with 5/8" edge radius (Fair Lead analogue) and marked to provide visual indication of rotation.**

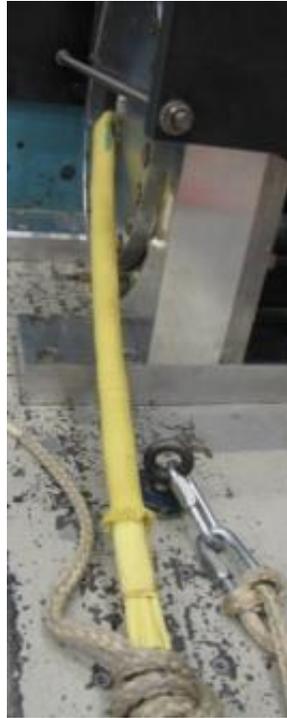
**Photo 27. Riser sample at 90° bend angle (Fair Lead analogue).**

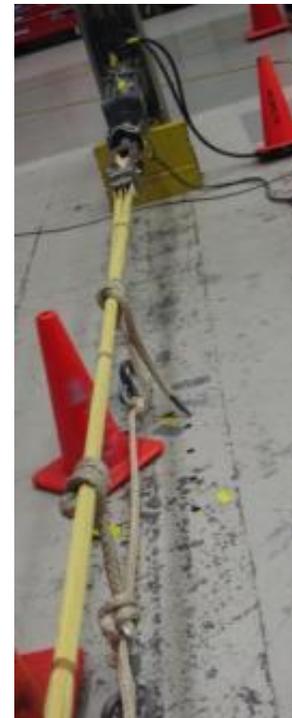
**Photo 29. Hydraulic ram and load cell attachment.**

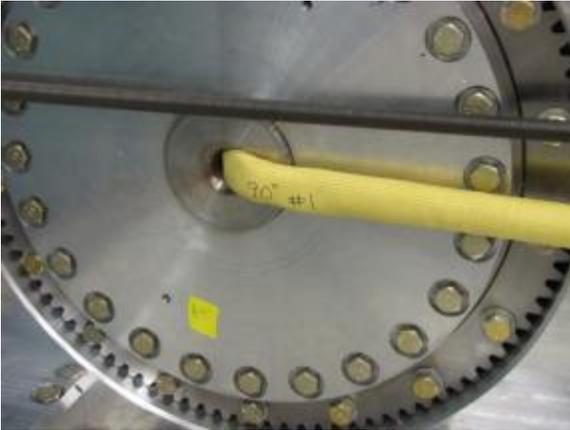
Photo 30. Test 1 before testing.

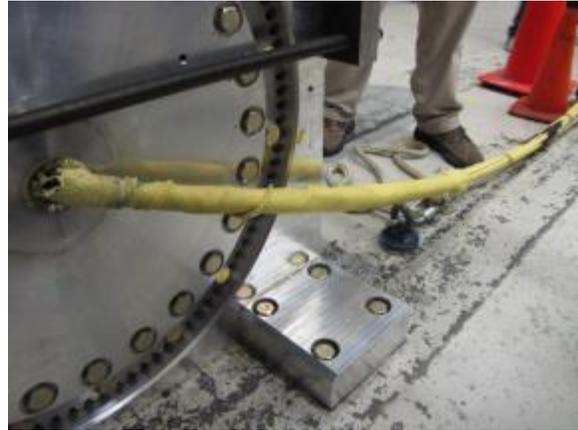
Photo 31. Test 1 post-test.

As previously mentioned, Test 1 failed to achieve the desired peak load of 42,000 lbs. The load instead peaked at 37,000 lbs. The command inputs and system response was used to determine an overall system response time of 3.17 seconds, allowing subsequent tests to achieve the desired load. As the peak load was not achieved, damage due to abrasive contact was consequently reduced and was not used to evaluate the knockdown factor due to abrasion.

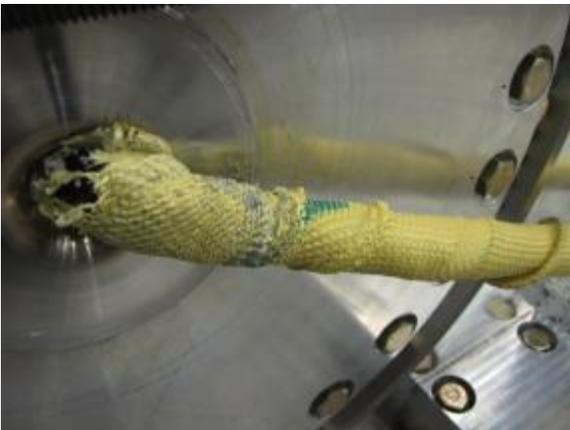
Photo 32. Test 1 post-test (close-up).

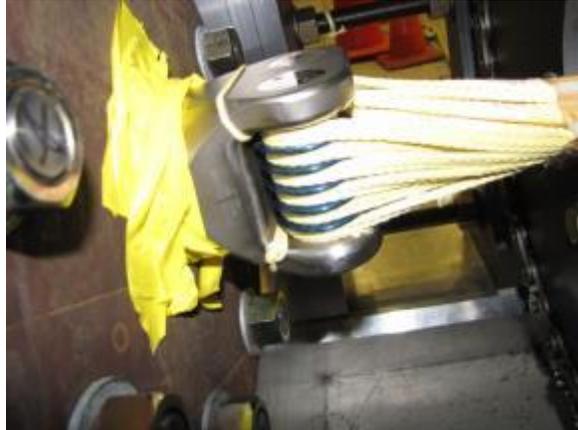
Photo 33. Test 1 post-test (knuckle).

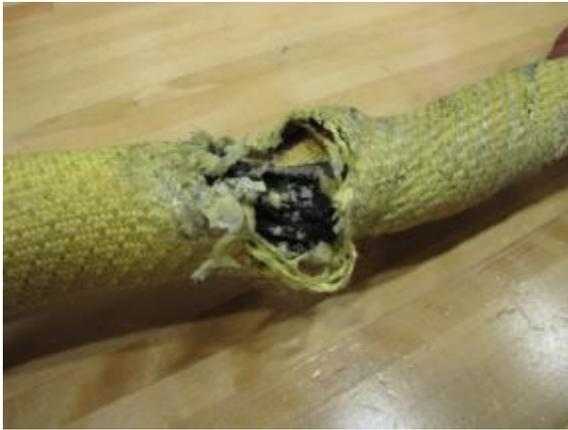
**Photo 34. Test 1 effects (outer Kevlar sleeve).**

The outer Kevlar sleeve and middle Teflon sleeves were torn, as shown on Photo 34 and Photo 35, respectively. The inner Kevlar sleeve, however, exhibited only a shiny spot and no visible damage, as shown on Photo 36. The lines were similarly devoid of visible damage, as shown on Photo 37.

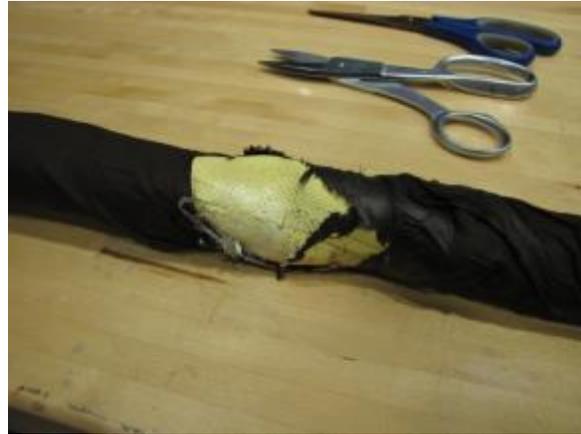
**Photo 35. Test 1 effects (Teflon sleeve).**

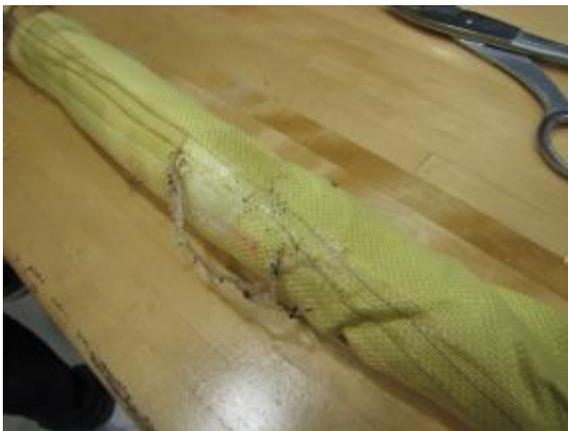
**Photo 36. Test 1 effects (inner Kevlar sleeve).**

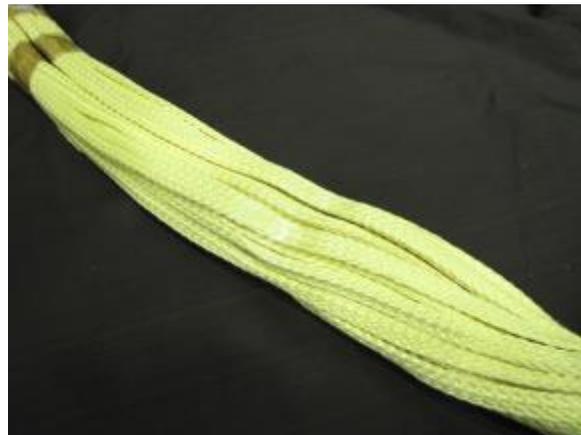
**Photo 37. Test 1 effects (lines).**

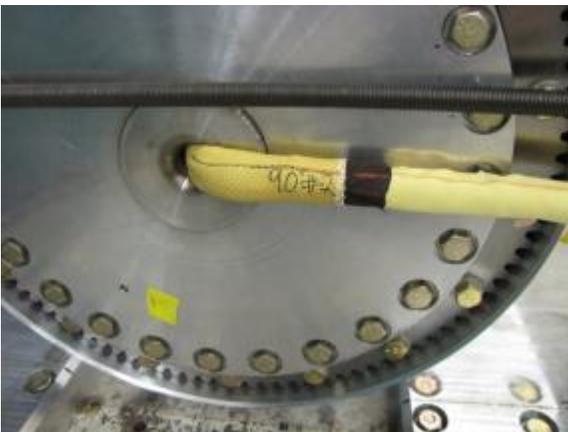
**Photo 38. Test 2 before testing.**

Test 2 was prepared with a short (24”) outer cover to preserve the limited amount of cover material. It was also the first to employ the modified command profile. The test achieved a peak load of 42,700 lbs, meeting the 42,000 lb requirement.

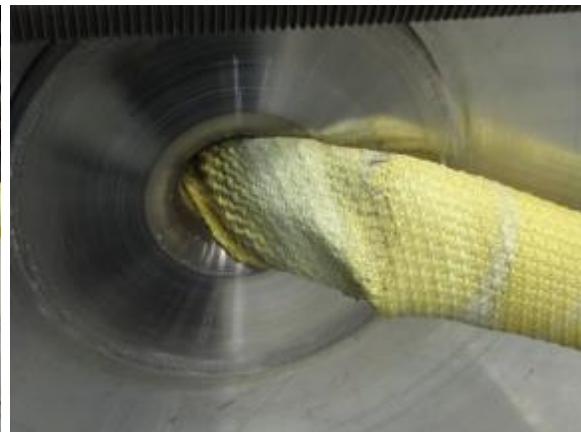
**Photo 39. Test 2 post-test (close-up A).**

The effect of abrasion on the riser cover was different from Test 1. The outer cover rotated during abrasive contact loading, but did not tear the outer Kevlar sleeve, as shown on Photo 38, Photo 39, Photo 40, Photo 41, and Photo 42. The middle Teflon sleeve was torn, as shown on Photo 43. The inner Kevlar sleeve and lines were compressed and shiny, but had no visible damage, as shown on Photo 44 and Photo 45.

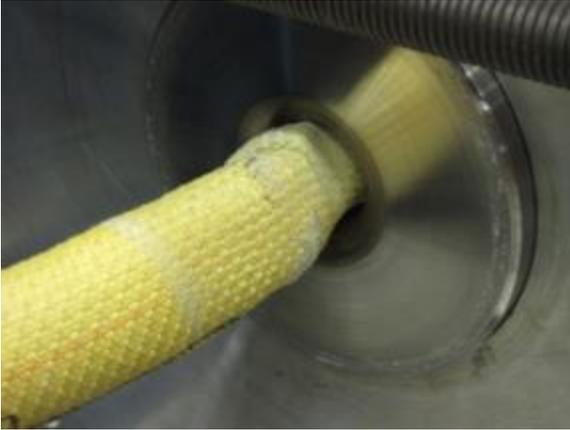
Photo 40. Test 2 post-test (close-up B).

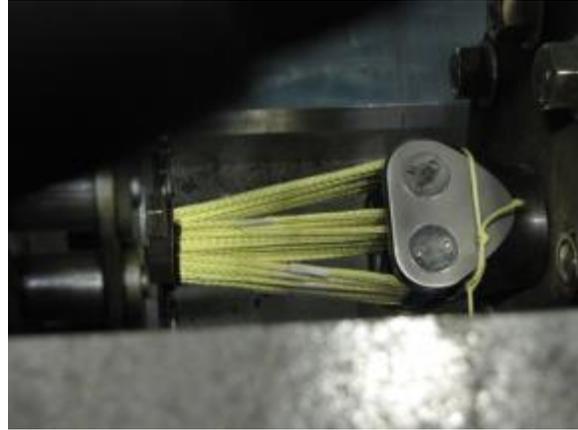
Photo 41. Test 2 post-test (knuckle).

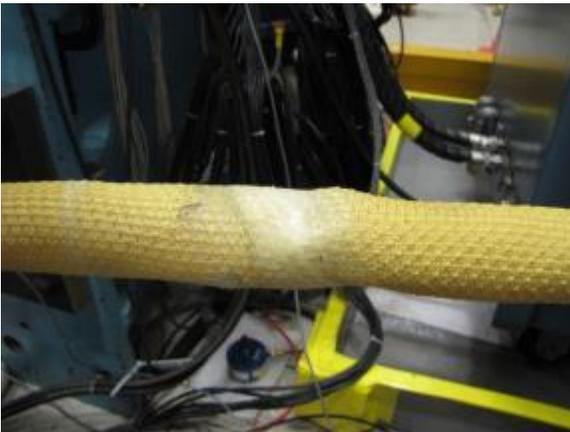
Photo 42. Test 2 effects (outer Kevlar sleeve).

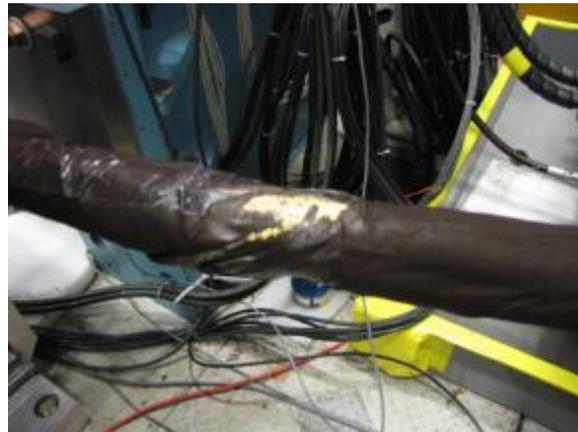
Photo 43. Test 2 effects (Teflon sleeve).

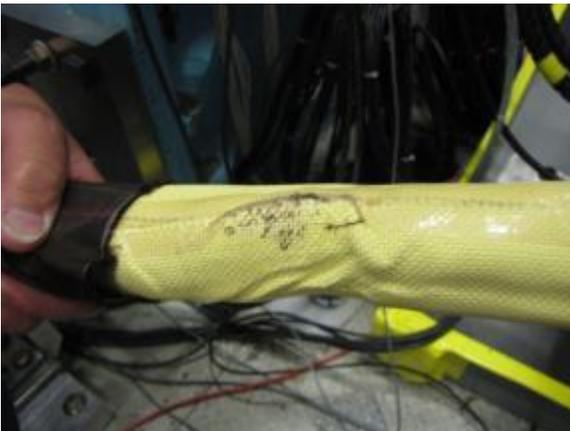
Photo 44. Test 2 effects (inner Kevlar sleeve).

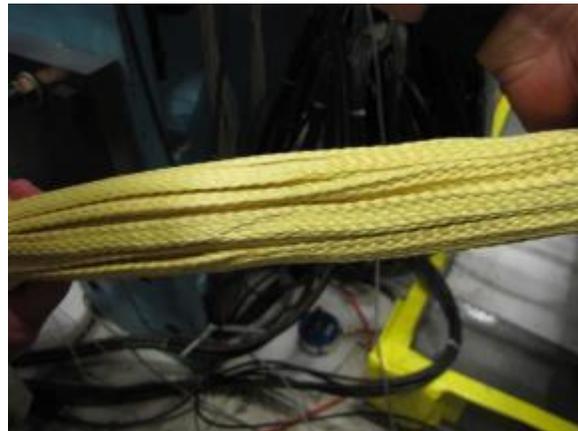
Photo 45. Test 2 effects (lines).

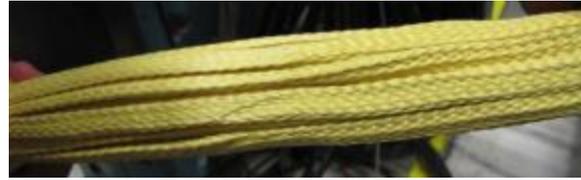
Photo 46. Test 4 effects (lines).

Test 4 was conducted in the same manner as Test 3, with similar results. The peak load was observed to be 42,800 lbs. The outer Kevlar sleeve did not rotate and had minor holes. The Teflon middle sleeve was torn, as usual. The inner Kevlar sleeve showed Teflon residue, but no damage. Line 7 was folded where the inner cover seam mashed it (Photo 46).

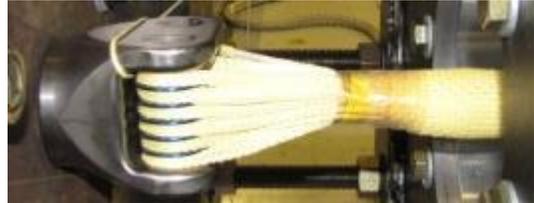
Photo 47. Test 5 taped outer sleeves.

Test 5 was conducted in the same manner as Test 3, with the outer Kevlar sleeve taped directly to the riser (Photo 47) to help limit rotation.

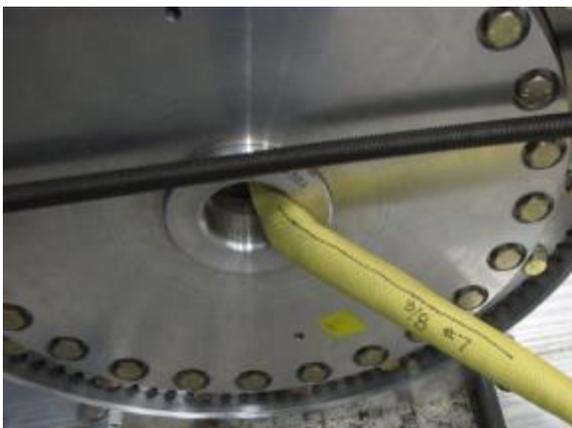
Photo 48. Test 7 (LAS R&R) setup (bend angle).

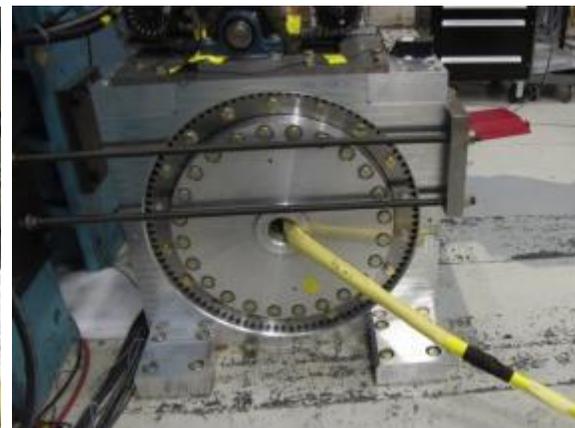
Photo 49. Test 7 setup (taped sleeves).

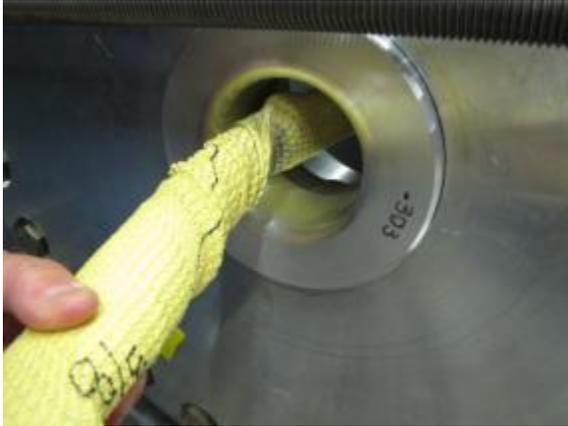
Photo 50. Test 7 results (outer sleeve).

The Kevlar outer sleeve rotated about a quarter turn and then slid. It appeared to receive some aluminum residue from the contact radius (Photo 50). The Teflon middle sleeve was torn about half the way around the sleeve (Photo 51). The Kevlar inner sleeve displayed some Teflon transfer, but had no visible damage (Photo 52). The lines likewise had slightly shiny areas, but no visible damage (Photo 53).

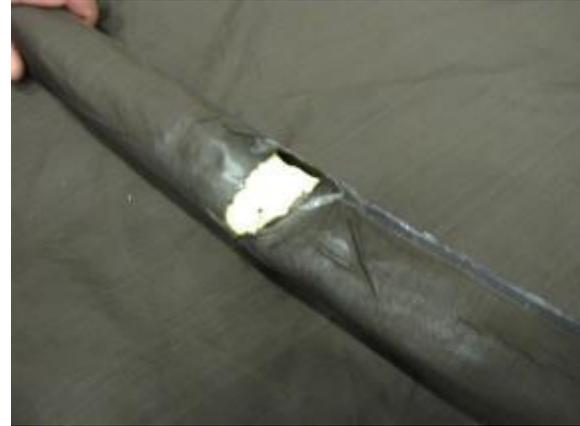
Photo 51. Test 7 results (middle sleeve).

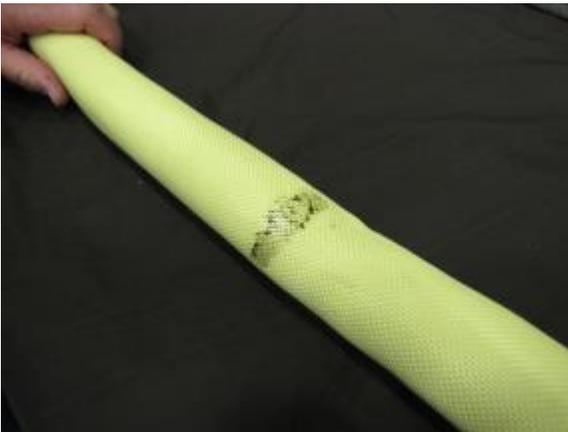
Photo 52. Test 7 results (inner sleeve).

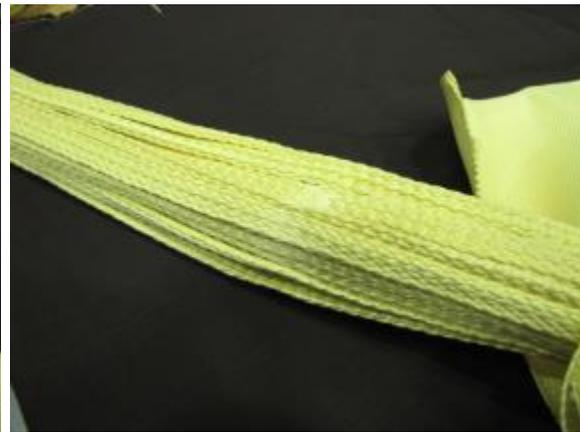
Photo 53. Test 7 results (lines).

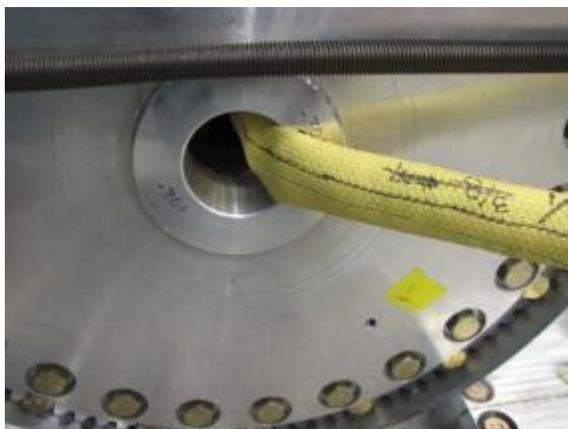
Photo 54. Test 8 setup (LAS R&R 1/8").

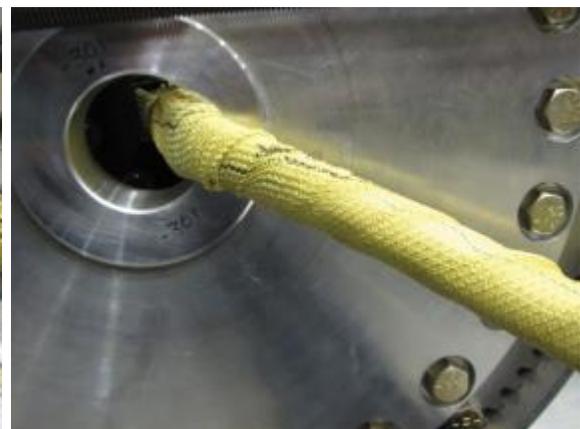
Photo 55. Test 8 results (twist).

The Kevlar outer sleeve twisted at least one complete rotation (Photo 55) and retained some Aluminum residue from the contact radius, but was otherwise undamaged (Photo 56). The middle sleeve was torn (Photo 57) and transferred Teflon residue to the inner sleeve (Photo 58); the inner sleeve was buffed but undamaged. The lines were also slightly shiny and undamaged (Photo 59).

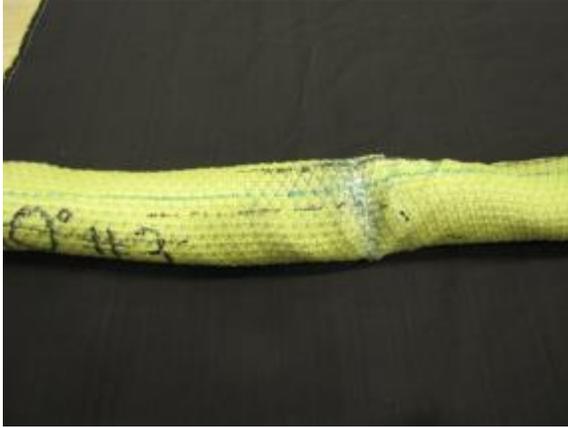
Photo 56. Test 8 results (outer sleeve).

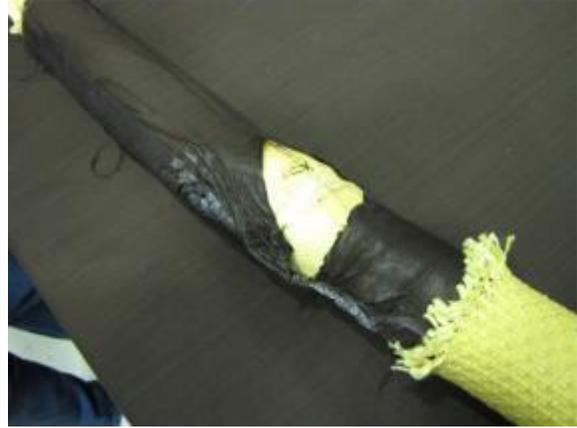
Photo 57. Test 8 results (middle sleeve).

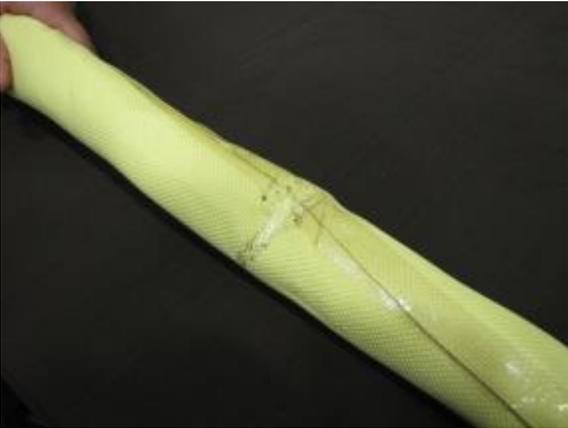
Photo 58. Test 8 results (inner sleeve).

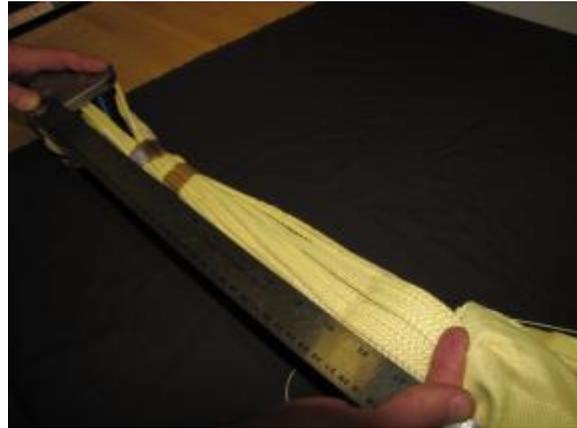
Photo 59. Test 8 results (lines).

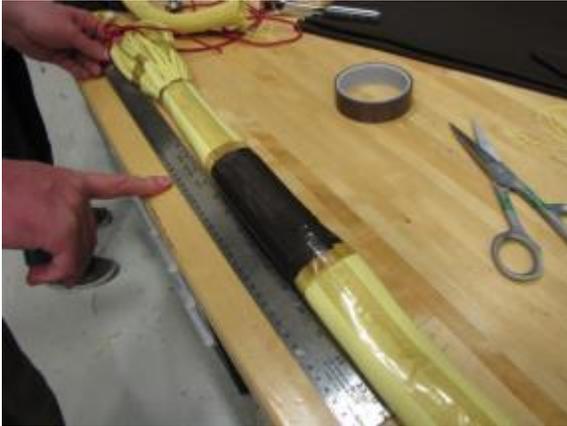
Photo 60. Test 11 setup (Short Teflon middle sleeve).

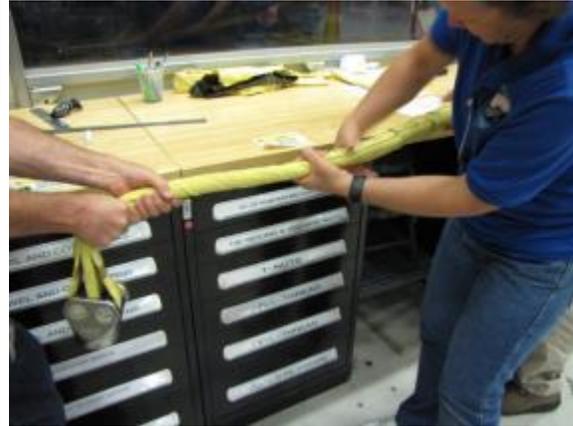
Photo 61. Test 11 setup (pre-twist).

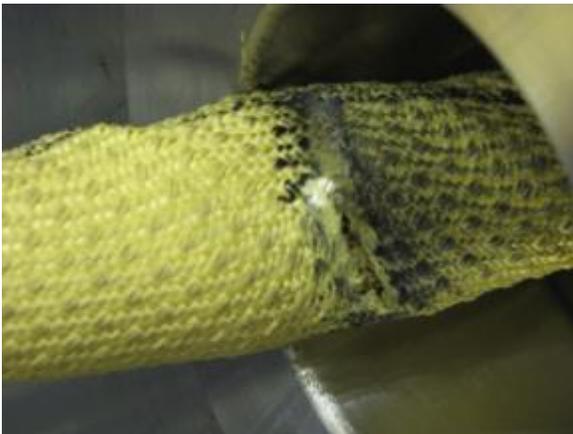
Photo 62. Test 11 results (outer sleeve).

The Kevlar outer sleeve only rotated about 3/8-inch and experienced a 3/4" cut. The Teflon middle sleeve was cut halfway through. The Kevlar inner sleeve had Teflon residue and no damage. The lines were slightly shiny.

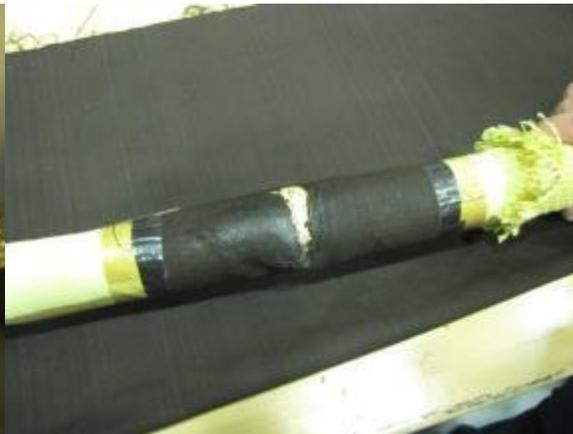
Photo 63. Test 11 results (middle sleeve).

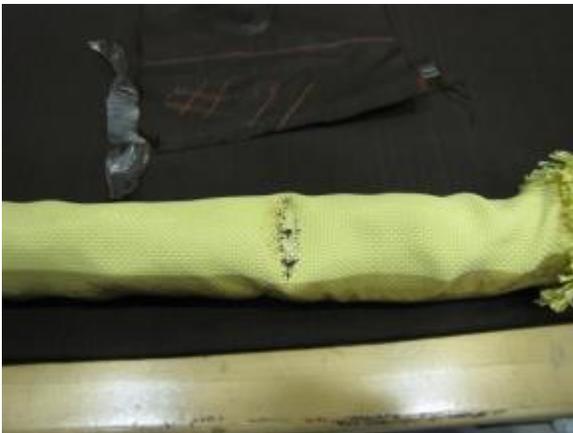
Photo 64. Test 11 results (inner sleeve).

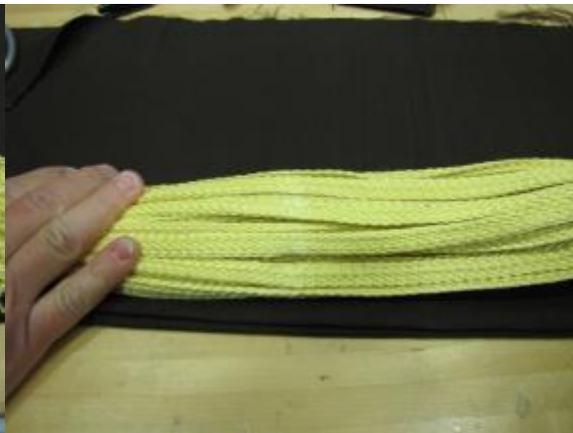
Photo 65. Test 11 results (lines).

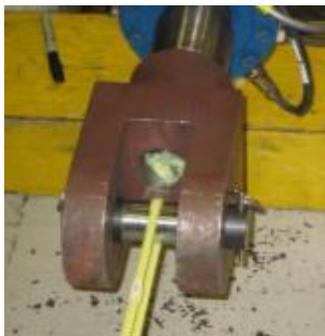
Photo 66. Tensile test fixture (1-3/8" pin).

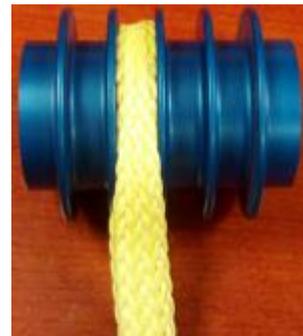
Photo 67. Drogue Knuckle Spool.

so than the 3/8-inch and 1/8-inch radius samples), while the control samples had no preload. Additionally, during abrasive testing the samples were attached to drogue knuckle spools (Photo 67), which constrain the width of the cord and increase its thickness. The control samples were never attached to knuckle spools and were only pulled to failure using 1-3/8-inch diameter pins.
