## *Coring the Wide-Field Planetary Camera 2 Radiator for Impactor Trace Residue Assessment*

*Phillip Anz-Meador and J.-C. Liou*

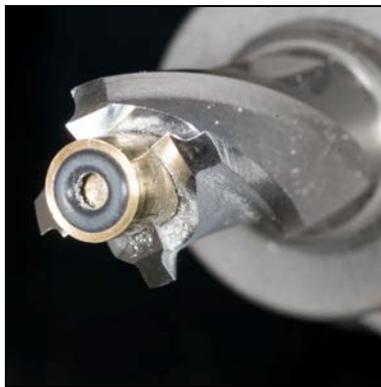
*Figure 1.– The coring device developed at JSC. Cores taken have a diameter (measured at the core's painted surface) of approximately 7 mm, corresponding to the inner diameter of the annular cutter.*

A unique sampling tool was developed to perform clean room coring of the WFPC2 impact features. The annular cutter is shown in figure 1. In this case, a standard 5/8-in.-diameter cutting tool was modified with a concentric, spring-loaded, phosphor-bronze cylinder. The cylinder is tipped with a standard O-ring to protect the feature being cored. As the core drill is brought into contact with the radiator's surface, friction between the surface and the O-ring brings the cylinder to rest within the rotating annular cutter. As the cutter is advanced into the surface, the cylinder retracts, allowing the radiator's aluminum substrate to be cut while protecting the feature of interest.

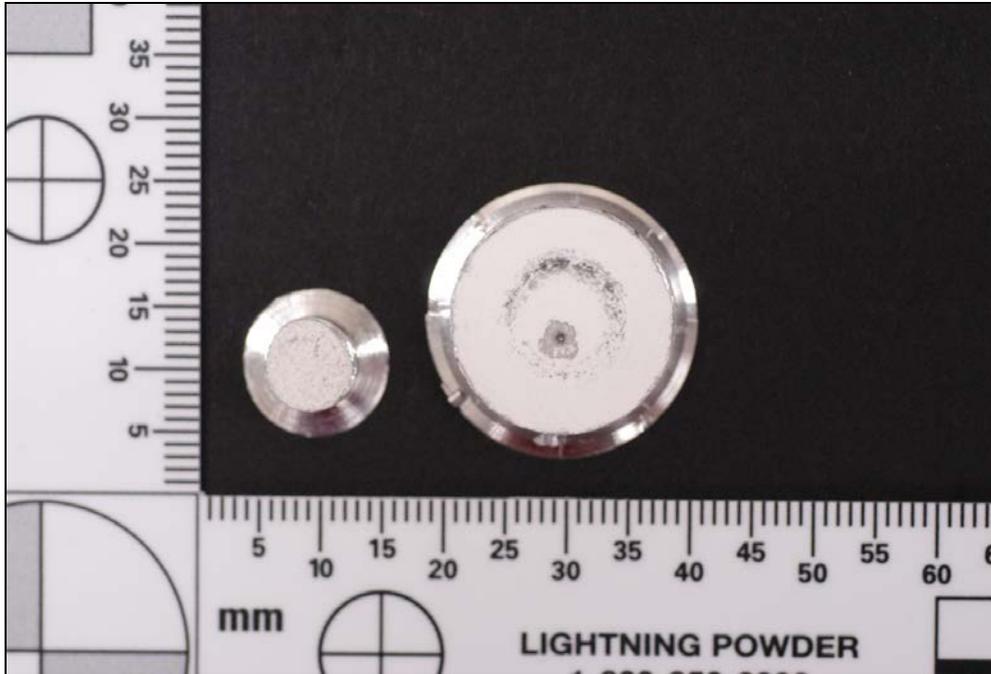
*Figure 2.– Small (taken with the cutter portrayed in figure 1) and large cores collected using a larger, 1-1/16-in. diameter cutting tool. The small core is a “blank” taken as a standard reference for the YB-71 paint coating and Al substrate. Clearly visible on the surface of the large core is an impact crater displaying paint spallation. Also visible is an abrasion left by the large cutter’s O-ring – this was later remedied by decreasing the cutter’s spring constant.*

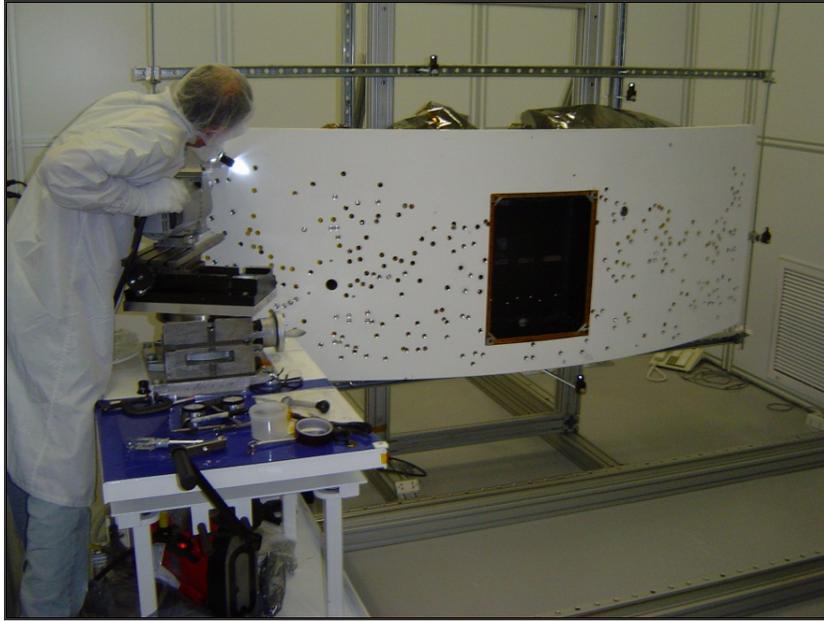
*Figure 3.— Preparation for coring a feature.*

Figures 3 and 4 illustrate the process by which cores are collected. The process begins with the identification of a feature to be cored. In figure 3, Orbital Debris Program Office team member Joe Caruana is aligning the core drill table roughly with a feature to be collected. The table allows 4 degrees of freedom in aligning the high-torque drill motor assembly with the feature. After a rough alignment, the assembly is rotated to enter the radiator’s surface normally, and fine positioning is achieved with a laser alignment system.

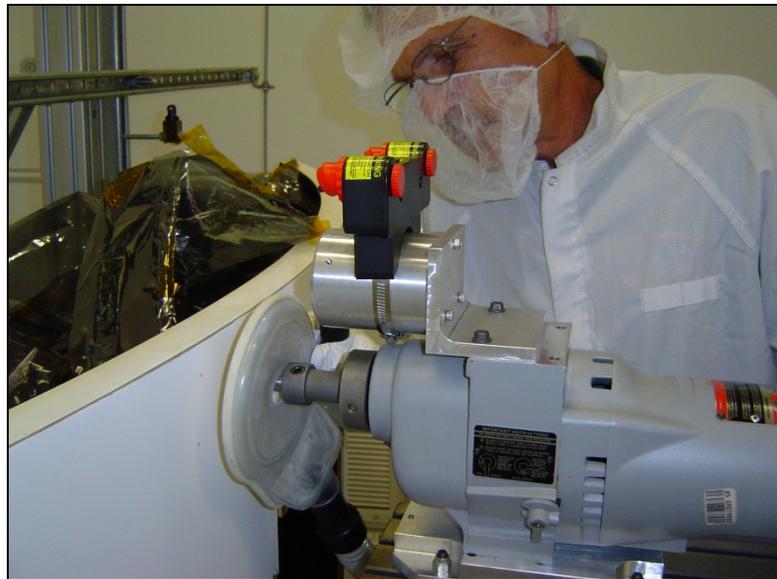
*Figure 4.— The system cores an impact feature.*

In figure 4, the cutter is engaging the surface. As the feature is protected, so is the clean room environment – a vacuum shroud is visible around the cutter; dust generated by cutting is collected by a HEPA-filtered vacuum, while larger strands are collected by the shroud assembly itself.

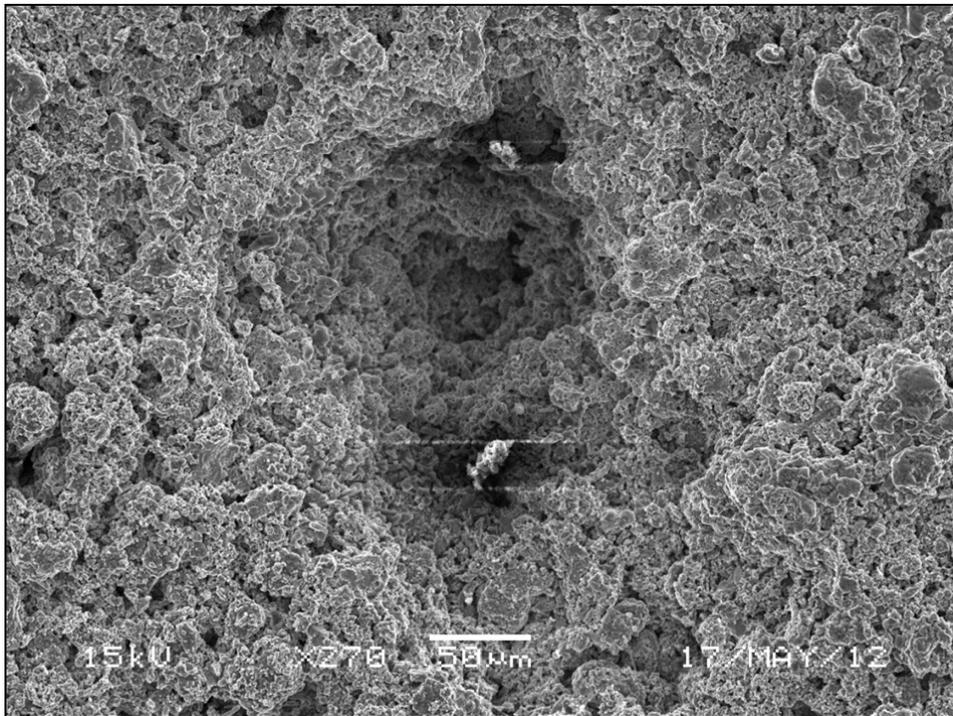
*Figure 5.— Core sample 29, typical of the so-called “paint craters.”*

Figure 5 depicts a small, so-called “paint crater,” a conical impact feature resident entirely in the paint coating. Figures 6a and 6b depict a larger impact feature. The ARES and NHM IBC teams are concentrating their analytical efforts on characterizing the elemental constituents of the residue melts in both types of features.

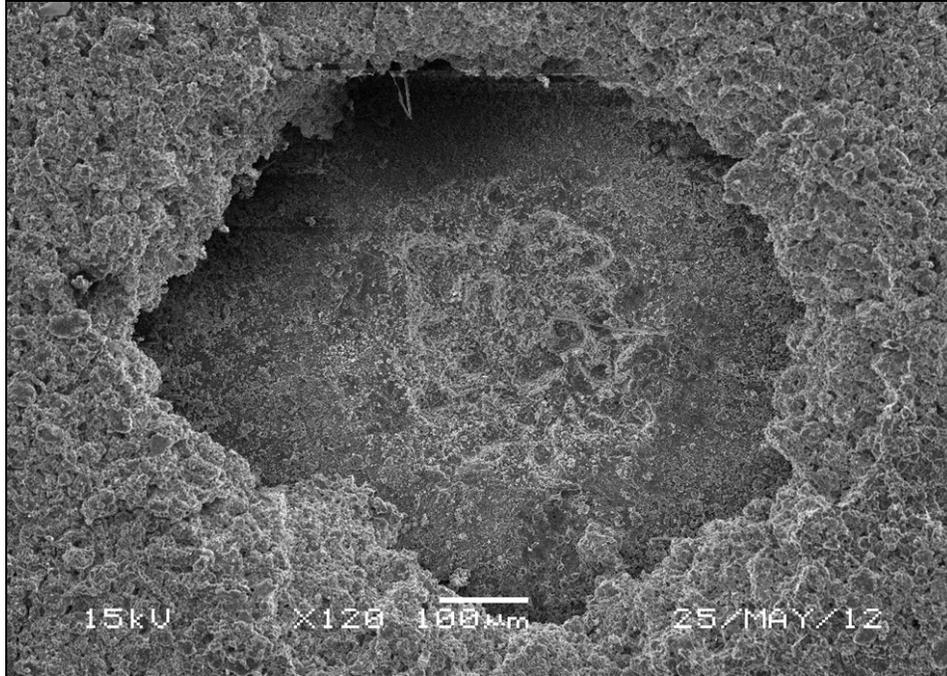
Figure 6a.— Core sample 29, typical of the larger impact features. Note the area of spalled paint and the relatively shallow impact feature on the revealed Al-6061 substrate surface.

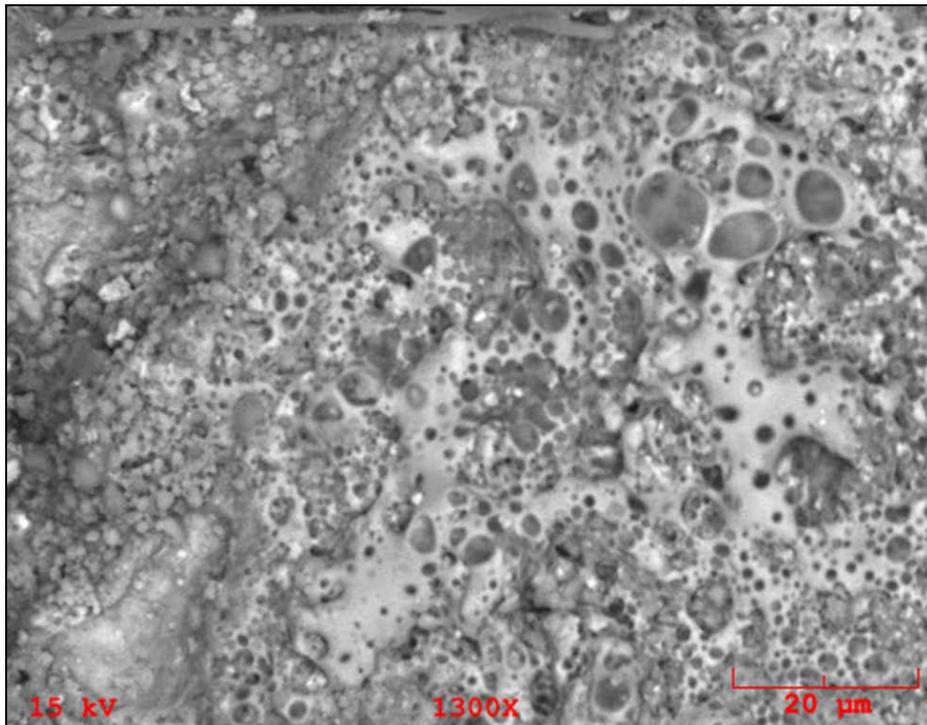
Figure 6b.— Projectile and target residue melt on the floor of the sample 29's impact feature. Note the frothy appearance and large number of vesicles in the melt.
