DEVELOPMENT OF TEST PROTOCOLS FOR INTERNATIONAL SPACE STATION PARTICULATE FILTERS

R. Vijayakumar (Aerfil),
Robert D. Green (NASA GRC),
Juan H. Agui (NASA GRC)

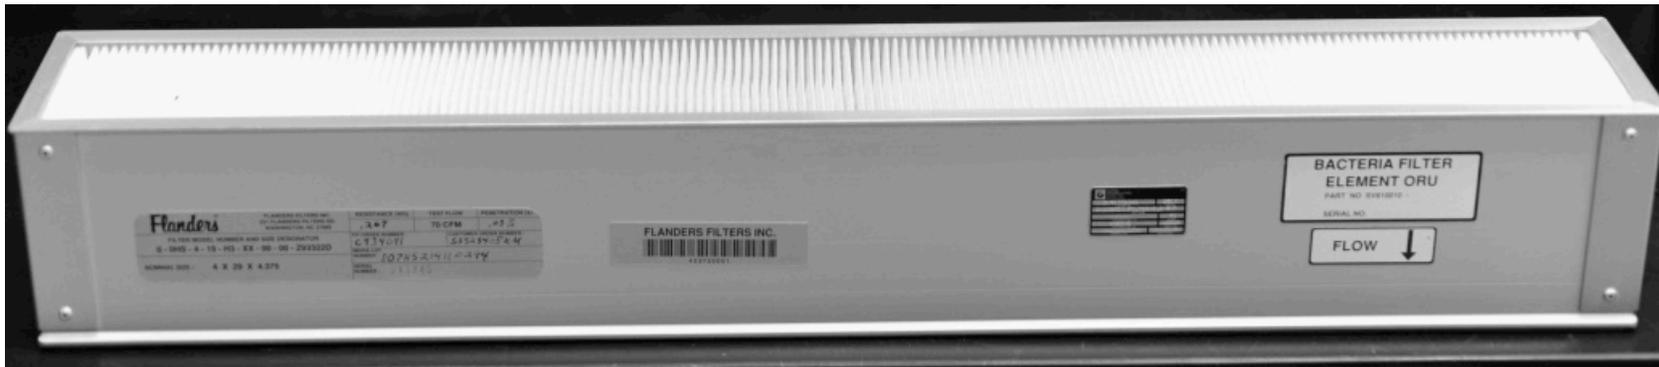
ISS FILTER ELEMENT

S INC. ERS RD. 27889	RESISTANCE (WG)	TEST FLOW	PENETRATION (X)
	.269	70 CFM	.03%
R 22D	FFI ORDER NUMBER : C934091		CUSTOMER ORDER NUMBER : SS523405KM
	MEDIA LOT NUMBER : D07H5214110294		
	SERIAL NUMBER : 283245

FILTER DETAILS

Al frame mini pleat HEPA filter

29" x 4" x 4.375".

20-mesh (0.84-mm clear opening) face screen,

(Nomex™) at inlet;

aluminum at outlet.

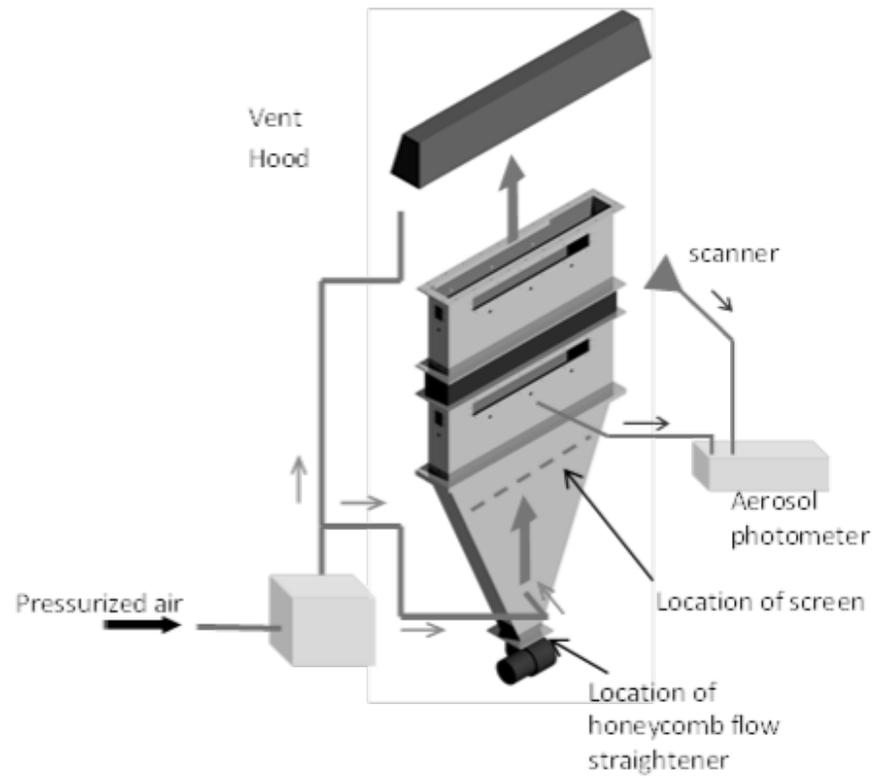
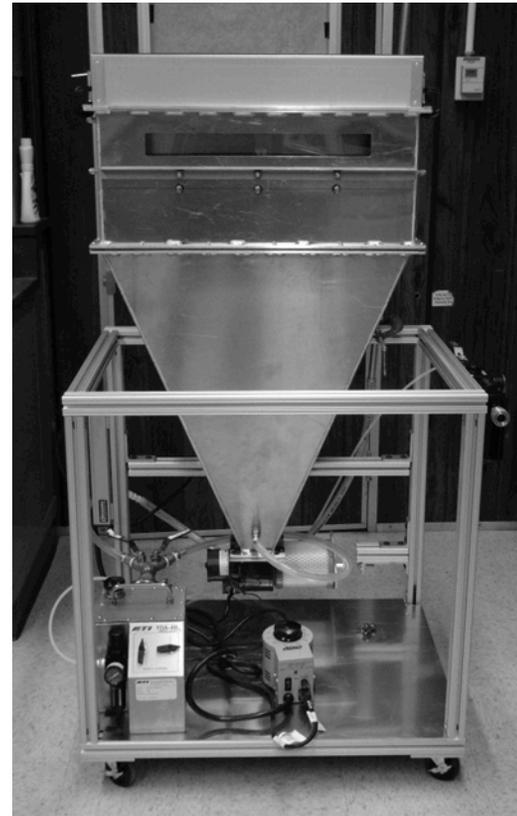
NASA GRC FILTER TEST SYSTEM

TEST SET UP

Leak testing

RP 034 recommended design

Test system met best practice for air and aerosol uniformity

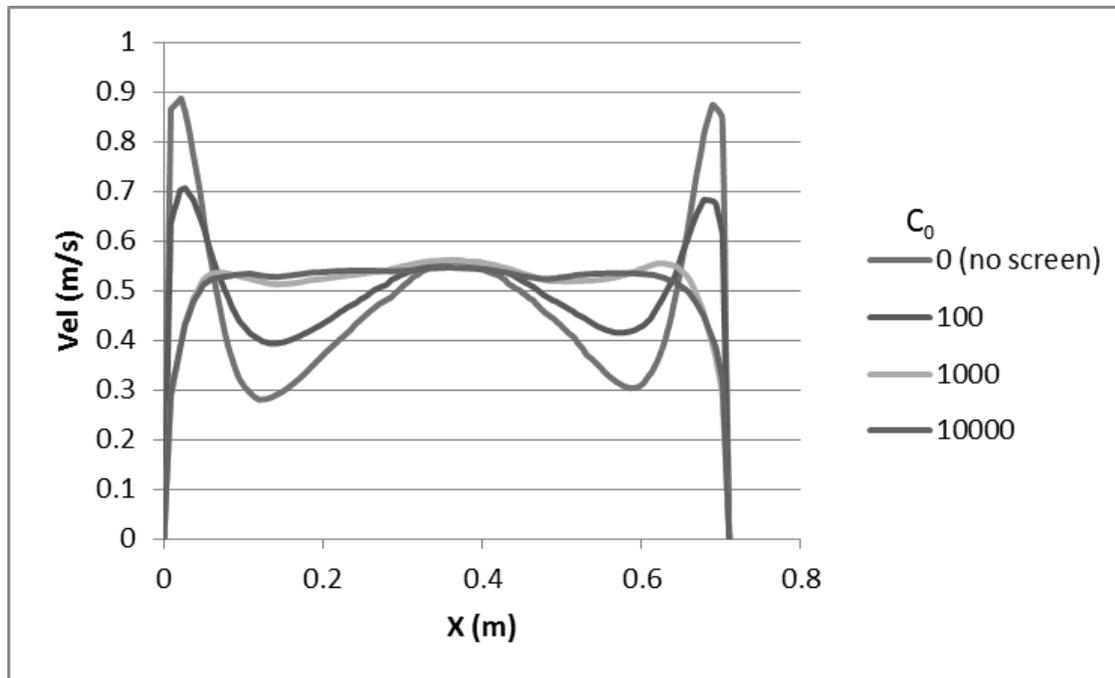
FLOW MODELING

Good uniformity with screen

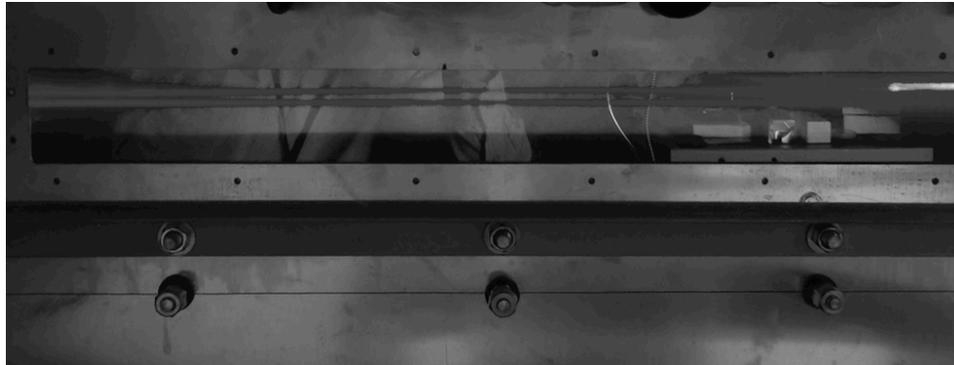
FLOW AND AEROSOL DISTRIBUTION MEASUREMENTS

Light sheet visual aerosol uniformity

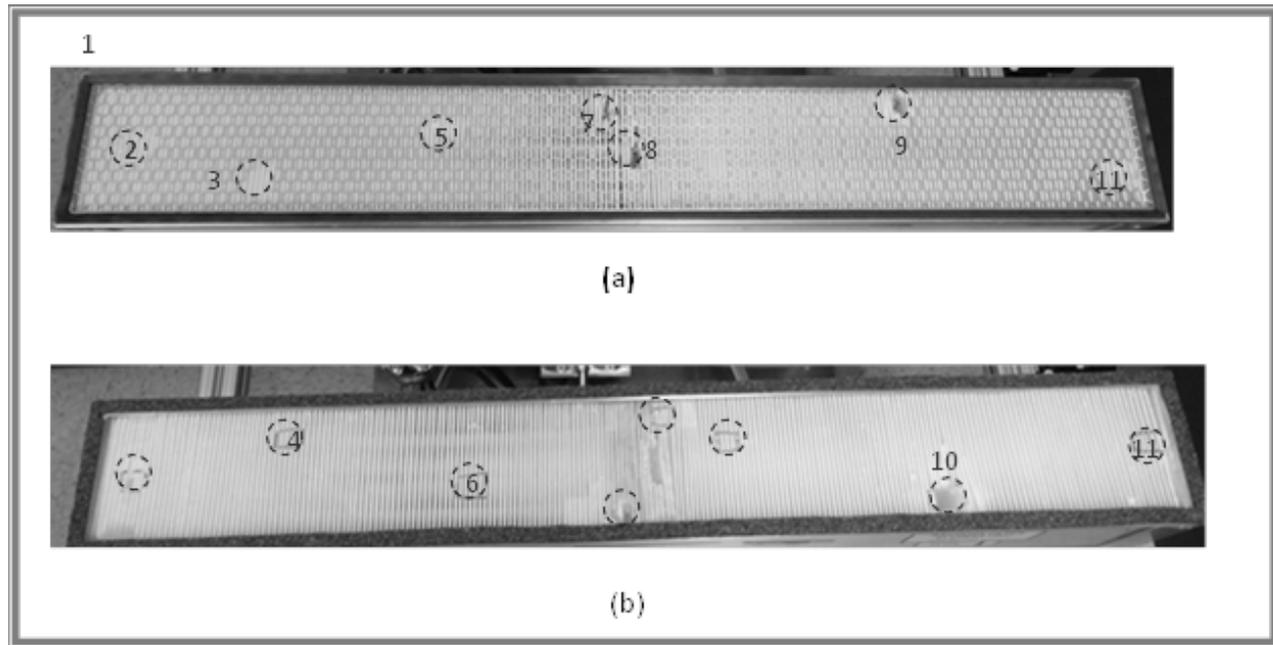
LEAK TESTING PRELIMINARY RESULTS (CONT.)

Filter #1:

Nominal penetration 0.2-5% with spikes in the readings as noted below.

Several readings did not correlate with known damage.

Filter #2: Scans showed values typically <0.001 with incidental readings in the 0.01 range.

Test point	Location (in cm from LHS)	Measured penetration (%)
1	0 (left edge)	18-20%
2	5	0.0018-0.0021
3	10	0.0008
4	16.8	55.0, 52.4
5	20.3	0.64-0.66
6	28	6.80-7.00
7	34.3	19.0-23.9
8	36.5	47.9-48.5
9	45.7	0.0000
10	58.4	0.0000
11	73.7 (right edge)	0.54, 0.82, 0.93

Preliminary results indicate ability to detect leak
