**NASA Prototype All Composite Tank Cryogenic pressure tests to Failure with
Structural Health Monitoring**

September 2015

Rudolph J. Werlink MS PE

NASA Fluids and Technology Branch NE-M5c

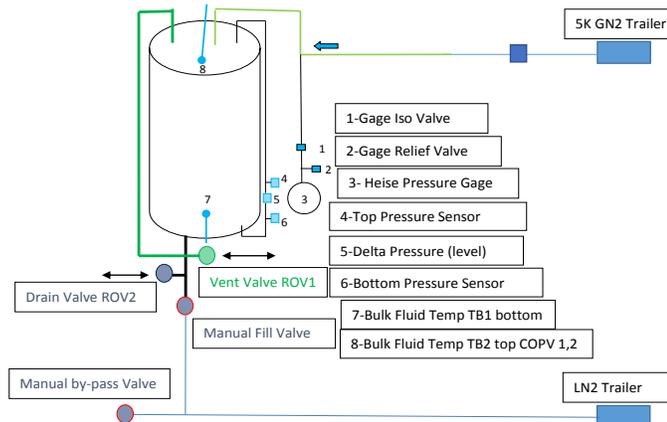
Figure 2 Test Tank Setup Main Components

Test Description: Test Tank setup mechanical components are shown below (Figure 2)

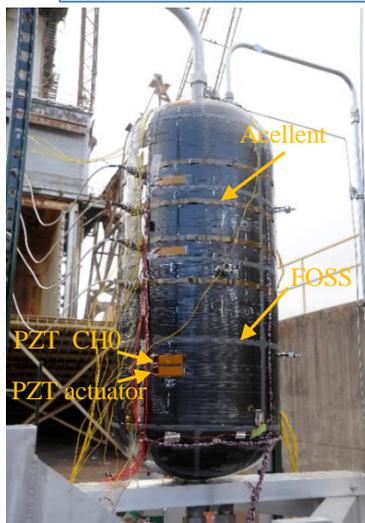
Figure 4 Scorpius Composite Tank 2/19/15

Figures 4-6 above show the test tanks and installed sensor layout on the Primary side for the PZT actuator and sensors. The AFRC FOSS was only installed on the Scorpius Tank and COPV 1 due to the schedule delay from the Hydrostat damaged outer mid hoop fibers which were repaired with a hoop overwrap (Table 1). The cause of the fiber breakage under only 1850 psig was due to over sanding on the surface prep for sensors

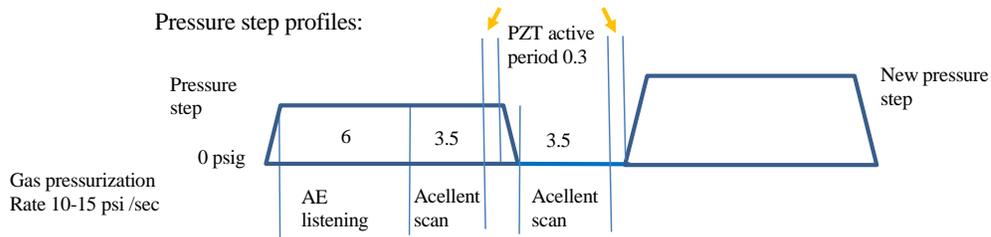
Figure 7 Pressure Step Profiles

installation. Shown below (Figure 7) is the details of the pressure profiles and health monitoring data gathering.

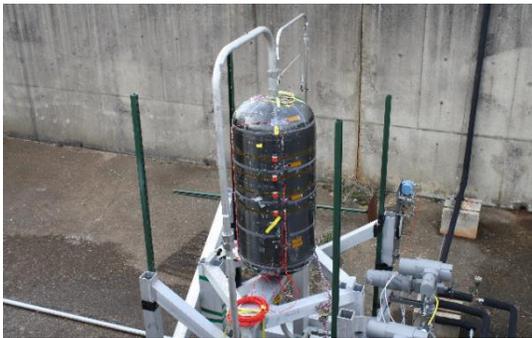
Figure 8 Scorpius Tank in test site just prior to LN2 fill

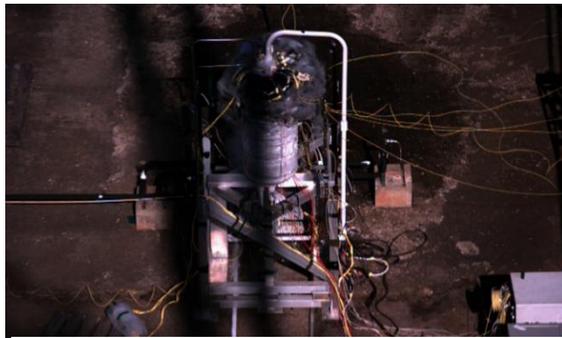
Figure 9 Beginning of burst, 1230 psig top of Scorpius tank

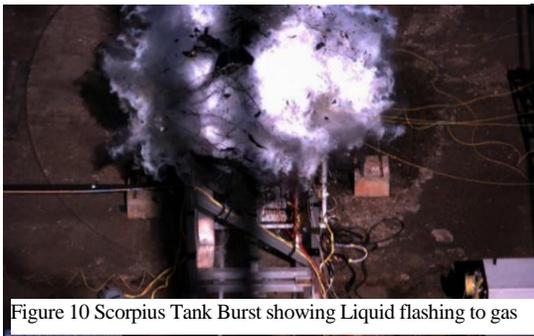
Figure 10 Scorpius Tank Burst showing Liquid flashing to gas

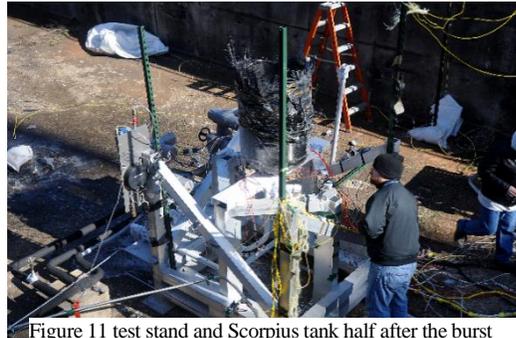
Figure 11 test stand and Scorpius tank half after the burst

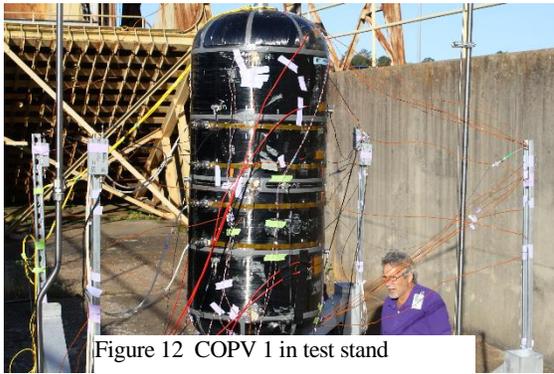
Figure 12 COPV 1 in test stand

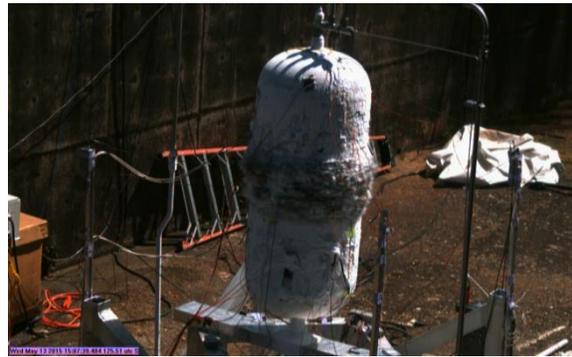
Figure 11 COPV 1 at burst mid- hoop 3150 psig

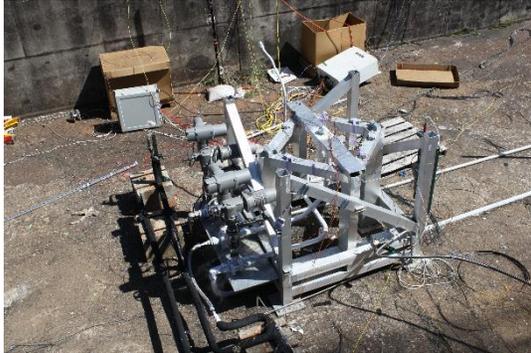
Figure 14 test setup after COPV1 burst May 13 2015

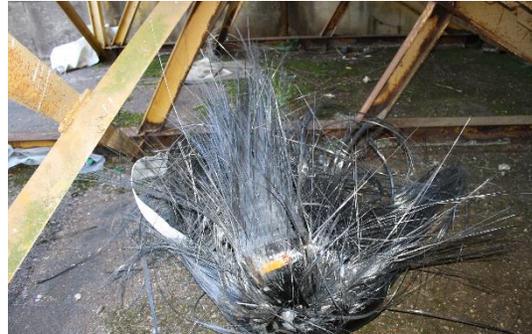
Figure 15 COPV 1 main fragment in trench under tower after burst

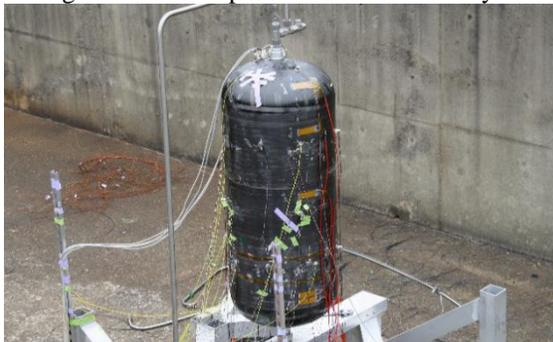
Figure 16 COPV 2 (center section was repaired) in test stand

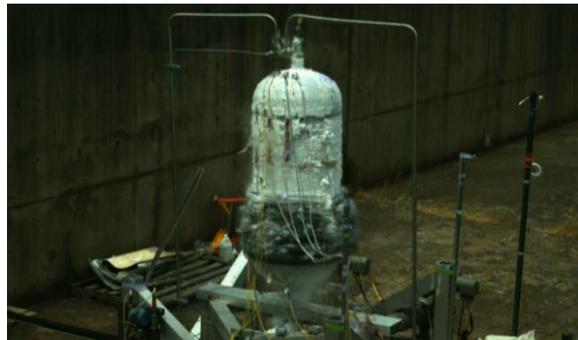
Figure 17 COPV 2 at burst lower- hoop 3370 psig

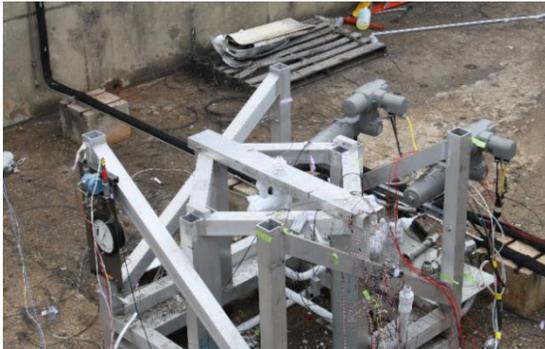
Figure 18 test setup after COPV2 burst May 15 2015

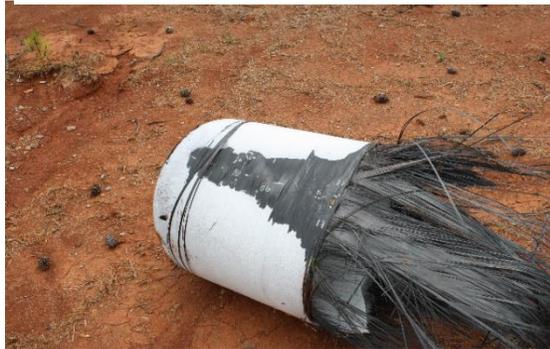
Figure 19 after burst Main fragment -upper part of COPV 2 landed approx. 300 ft. from setup

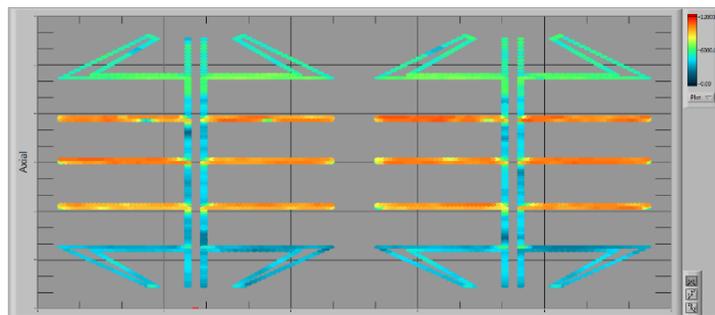
Figure 20 COPV 1 FOSS-2D micro strain surface plot during 2,600 psig of internal pressure (the tank is full of LN2 with gaseous nitrogen

the FOSS.. The high spatial resolution enables engineers to develop dense strain contours which may enable the development of real time Factor of Safety assessments, and measurements could potentially be used as a pre-burst strain indicator to avoid catastrophic failure. The figure shows the continuous grating fiber optic sensors that were installed in a serpentine pattern on the pressure vessels to characterize strain gradients along the axial length of the COPV as well as along the hoop orientation of the COPV. The outer most layer of composite wrap was aligned in the hoop direction. Sensors orientated in the hoop direction were able to directly monitor the tensile

strength of the composite tow due to their parallel alignment. Though the hoop strains were generally of larger magnitude than the longitudinal direction for all-metal vessels (due to vessel geometry), equal sensing area was dedicated to longitudinal direction. Sensors running in the longitudinal direction could potentially evaluate whether composite wrap in the hoop direction separates. The widening of the tow spacing can be used as a precursor to rupture since the results of widening tow may cause there to be a region of unsupported metallic liner.

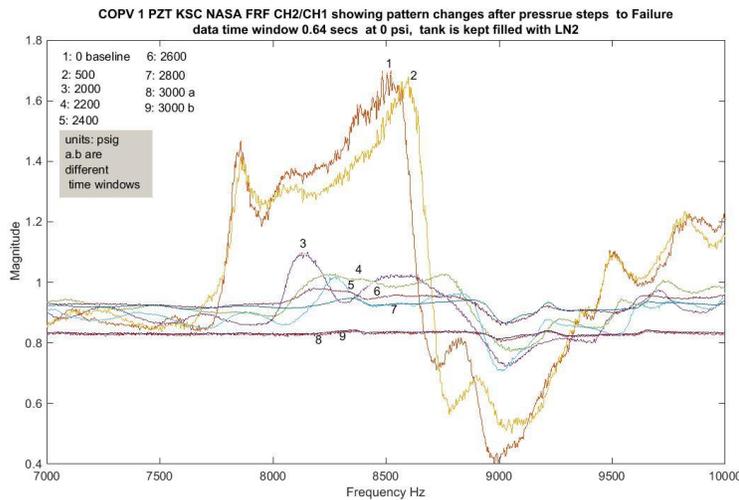
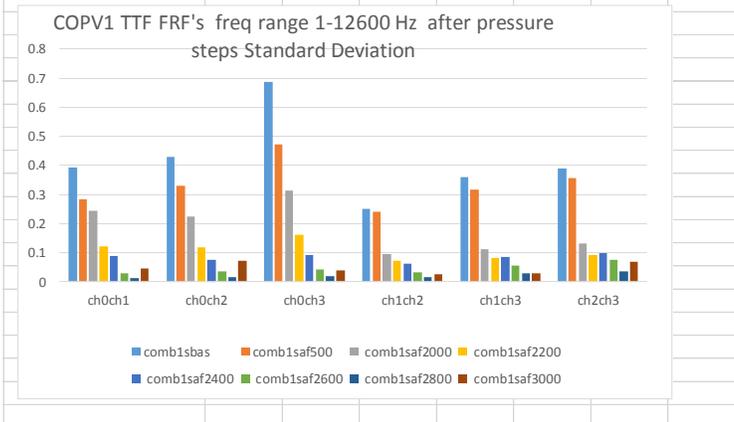
COPV1 TTF May 13 2015	Standard Deviation for FRF's over 1-25600 HZ					
	Frequency response functions (FRF)					
	ch0ch1	ch0ch2	ch0ch3	ch1ch2	ch1ch3	ch2ch3
After pressrue steps (psig)						
comb1sbas	0.394298	0.42845	0.687158	0.250916	0.358735	0.389905
comb1saf500	0.284316	0.33105	0.472983	0.241558	0.316847	0.356271
comb1saf2000	0.243102	0.224546	0.312303	0.095529	0.113137	0.131837
comb1saf2200	0.121989	0.119856	0.162475	0.073394	0.08188	0.091484
comb1saf2400	0.090212	0.075685	0.091766	0.061226	0.08389	0.097179
comb1saf2600	0.029519	0.03493	0.042775	0.033095	0.056563	0.075431
comb1saf2800	0.012414	0.017066	0.018147	0.016326	0.030223	0.03417
comb1saf3000	0.045644	0.071535	0.039625	0.0272	0.028907	0.068029

Figure 21 FRF plots showing the effects of increasing Pressure steps on the modal signatures and Standard deviations plot directly above for COPV 1.

Discussion: the system uses a PZT actuator to supply a consistent random input while recording PZT sensor responses on the tanks. Because pressure affects stiffness, the data is compared at near 0 psig following a new pressure step, (Figures 21 and 22). The Graphs show the relative frequencies transferred between two sensors with differences due to the tanks stiffness changes which affect the frequencies and magnitudes of the responses. The basic equation is:

was tested on an extremely cold day (<20 Deg. F) and the PZT front end data system containing a battery and disk drive temporary froze, therefore there was no vibration data during burst pressurizations for the Scorpius tank. The COPV 1 and 2 data however clearly show the effects of the tank damage most noticeably with decreasing modal peak amplitudes. Just prior to failure there is usually an increase in peaks at lower frequencies. The tables show that standard deviation clearly predicts the failure in these tests. With reference to the before condition (baseline) any changes which are significant can be detected and a software program developed to automatically flag the damage. Sensor Installation methods are still being developed for this extreme application (temperature under -310 Deg. F and very high strain levels well over 1.5%) These conditions often exceed the capabilities of the adhesives used to attach the sensors.^{iv} This an area of development to provide a robust technique, also quicker installation methods will need to be developed for example, applying sensors as the last step in manufacturing an integrated health monitored tank. Scaling up from medium size tanks (100-750 gallons) to very large tanks such as to be developed for the SLS is a problem for health monitoring systems. The current Acellent system sensor spacing was 5-6 inches with a maximum of 360 sensors, thus limiting coverage for large tanks. The FOSS from NASA AFRC has promise in covering large tank surface areas with several thousand sensors. For a practical In-Sutu system, the FOS methods require lower cost and temperature sensitivity of the electronics. AE data sets are large because the sensors must be ‘listening’ at all times to detect events and require expertise in interruption. Software algorithms need to be developed for faster analysis without intervention. The KSC PZT system shows the ability to measure changes in the tank stiffness as compared to a baseline signature. This system is a practical and relatively inexpensive system that can be developed for detection of serious structural changes, while not determining locations and type of flaw. The PZT needs refinements such as amplifier optimization, and will benefit from FE modeling^v to predict theoretical frequencies and automate mode shapes to aid in developing go/no go software.

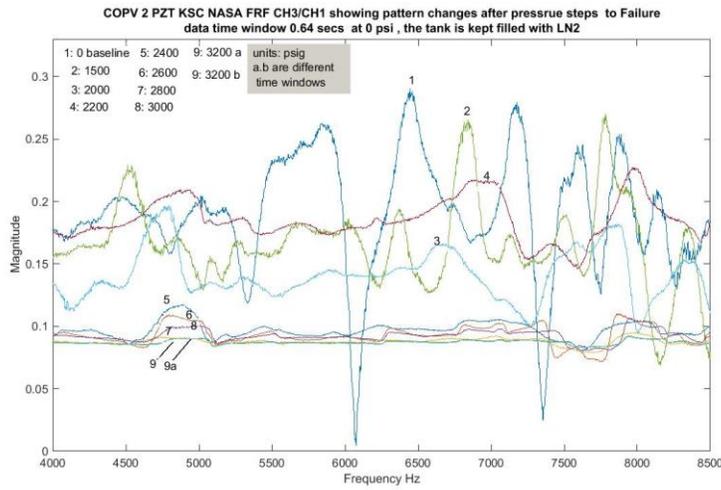
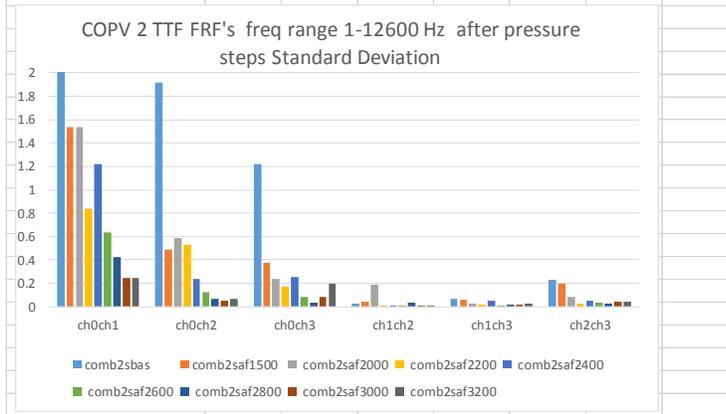
COPV2 TTF May 15 2015	Standard Deviation for FRF's over 1-25600 HZ					
	Frequency response functions (FRF)					
	ch0ch1	ch0ch2	ch0ch3	ch1ch2	ch1ch3	ch2ch3
After pressrue steps (psig)						
comb2sbas	5.677951	1.913549	1.221844	0.030099	0.068592	0.228772
comb2saf1500	1.533109	0.486287	0.379201	0.044064	0.056631	0.199532
comb2saf2000	1.532659	0.589517	0.237518	0.19084	0.02368	0.081262
comb2saf2200	0.835633	0.530409	0.176204	0.01325	0.020397	0.029509
comb2saf2400	1.222877	0.239062	0.253959	0.01072	0.052267	0.051806
comb2saf2600	0.637375	0.121404	0.08356	0.012428	0.011085	0.033942
comb2saf2800	0.423887	0.066238	0.035373	0.036389	0.018472	0.028852
comb2saf3000	0.249069	0.053262	0.082082	0.008373	0.015479	0.043305
comb2saf3200	0.247044	0.065158	0.19568	0.010679	0.025334	0.041459

Figure 22 FRF plots showing the effects of increasing Pressure steps on the modal signatures and Standard deviations plot directly above for COPV 2.
