# Forward Skirt Structural Testing on the Space Launch System (SLS) Program

**Joe Lohrer**

January 2016

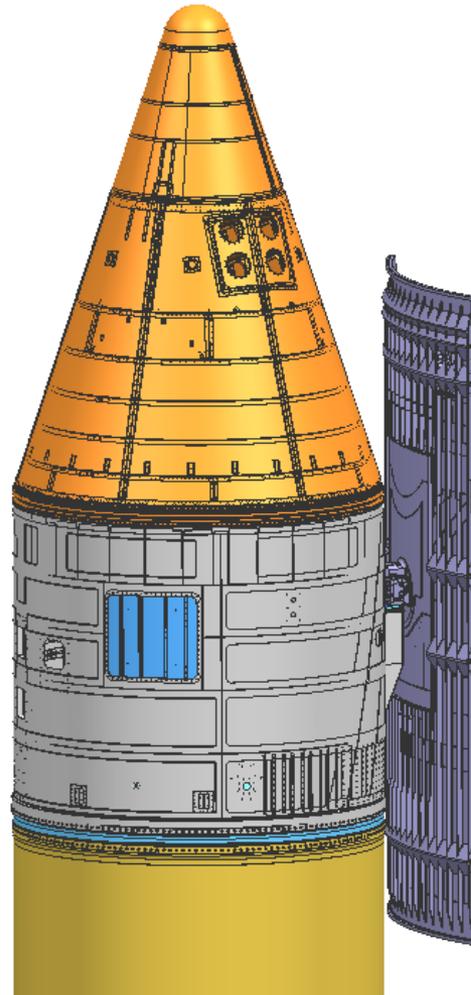
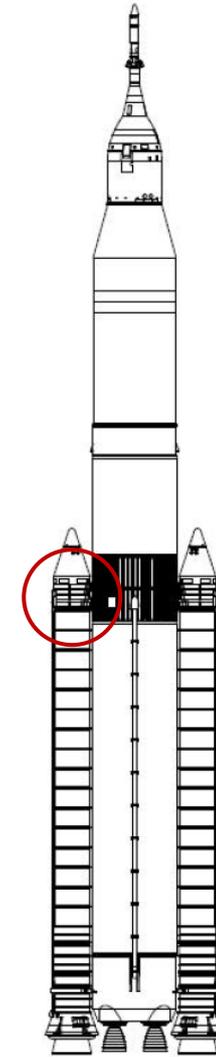
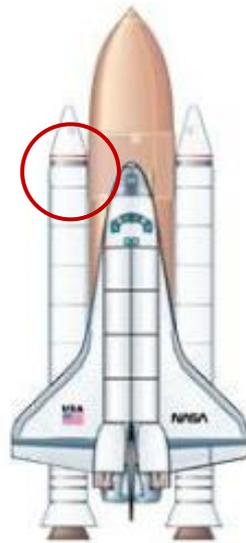
Forward Skirt

SLS Vehicle

Shuttle

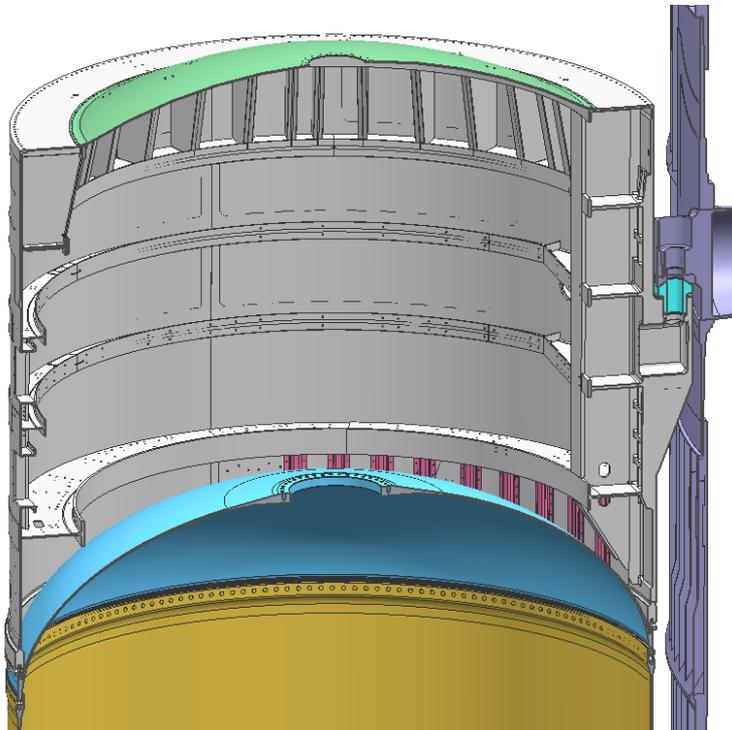
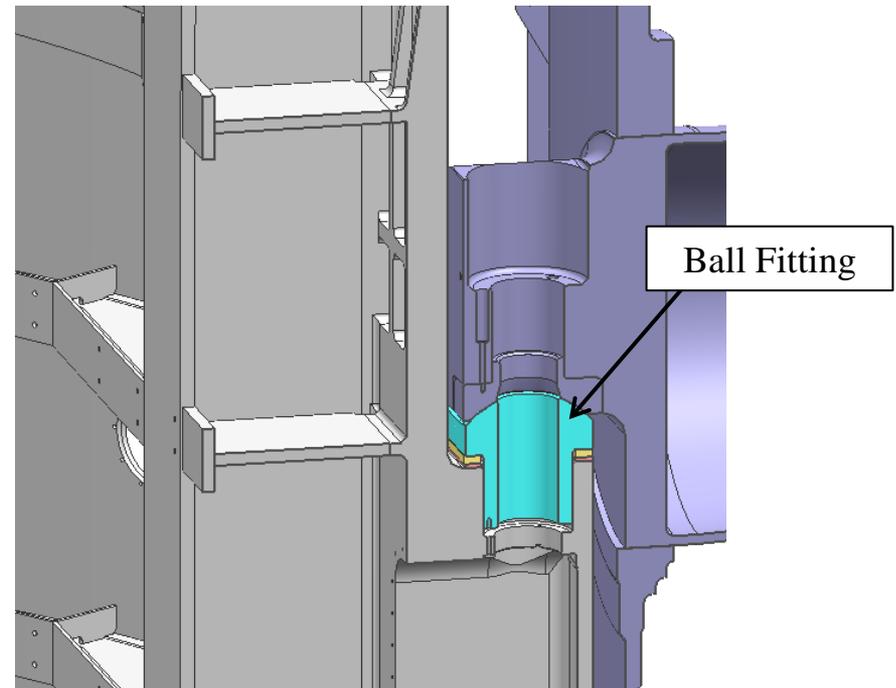
- Forward skirt transfers thrust from the solid rocket booster to the core vehicle during flight. A spherical interface allows only translation loads to be carried and not moments.
- The highest axial loads are compressive and reacted through the ball fitting instead of the separation bolt (not shown). Because of this the separation bolt was not included in the testing.

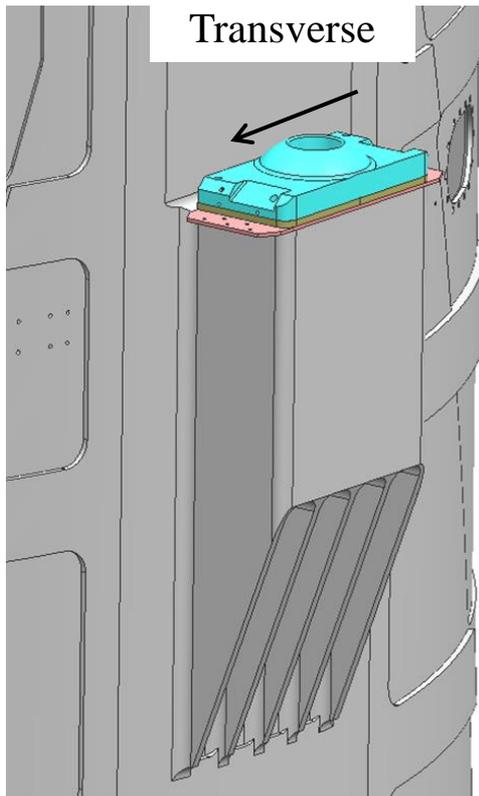
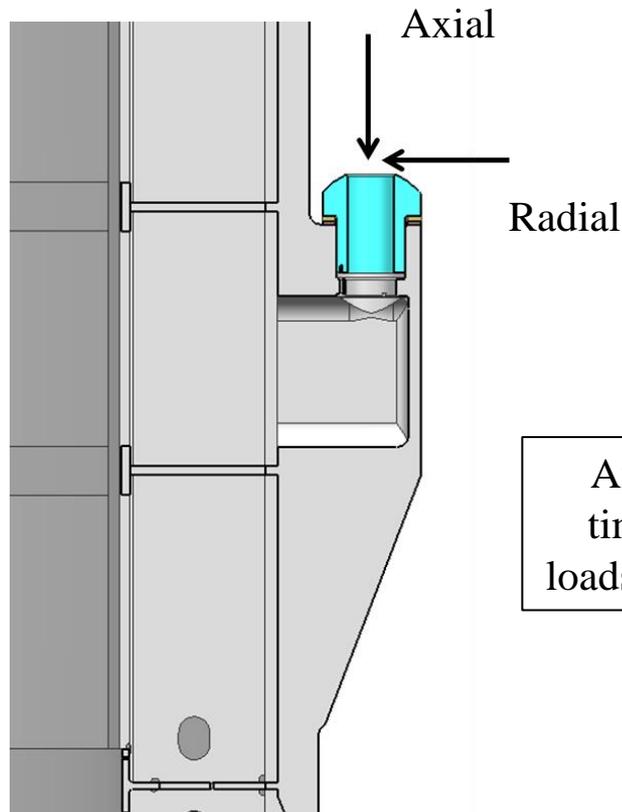
- Axial loads during ascent increased 35% over shuttle.
- Radial loads during liftoff increased 68% (inward) and 200% (outward) over shuttle.
- Transverse loads were similar to shuttle.

Axial loads are 10 to 20 times greater than radial loads depending on the event

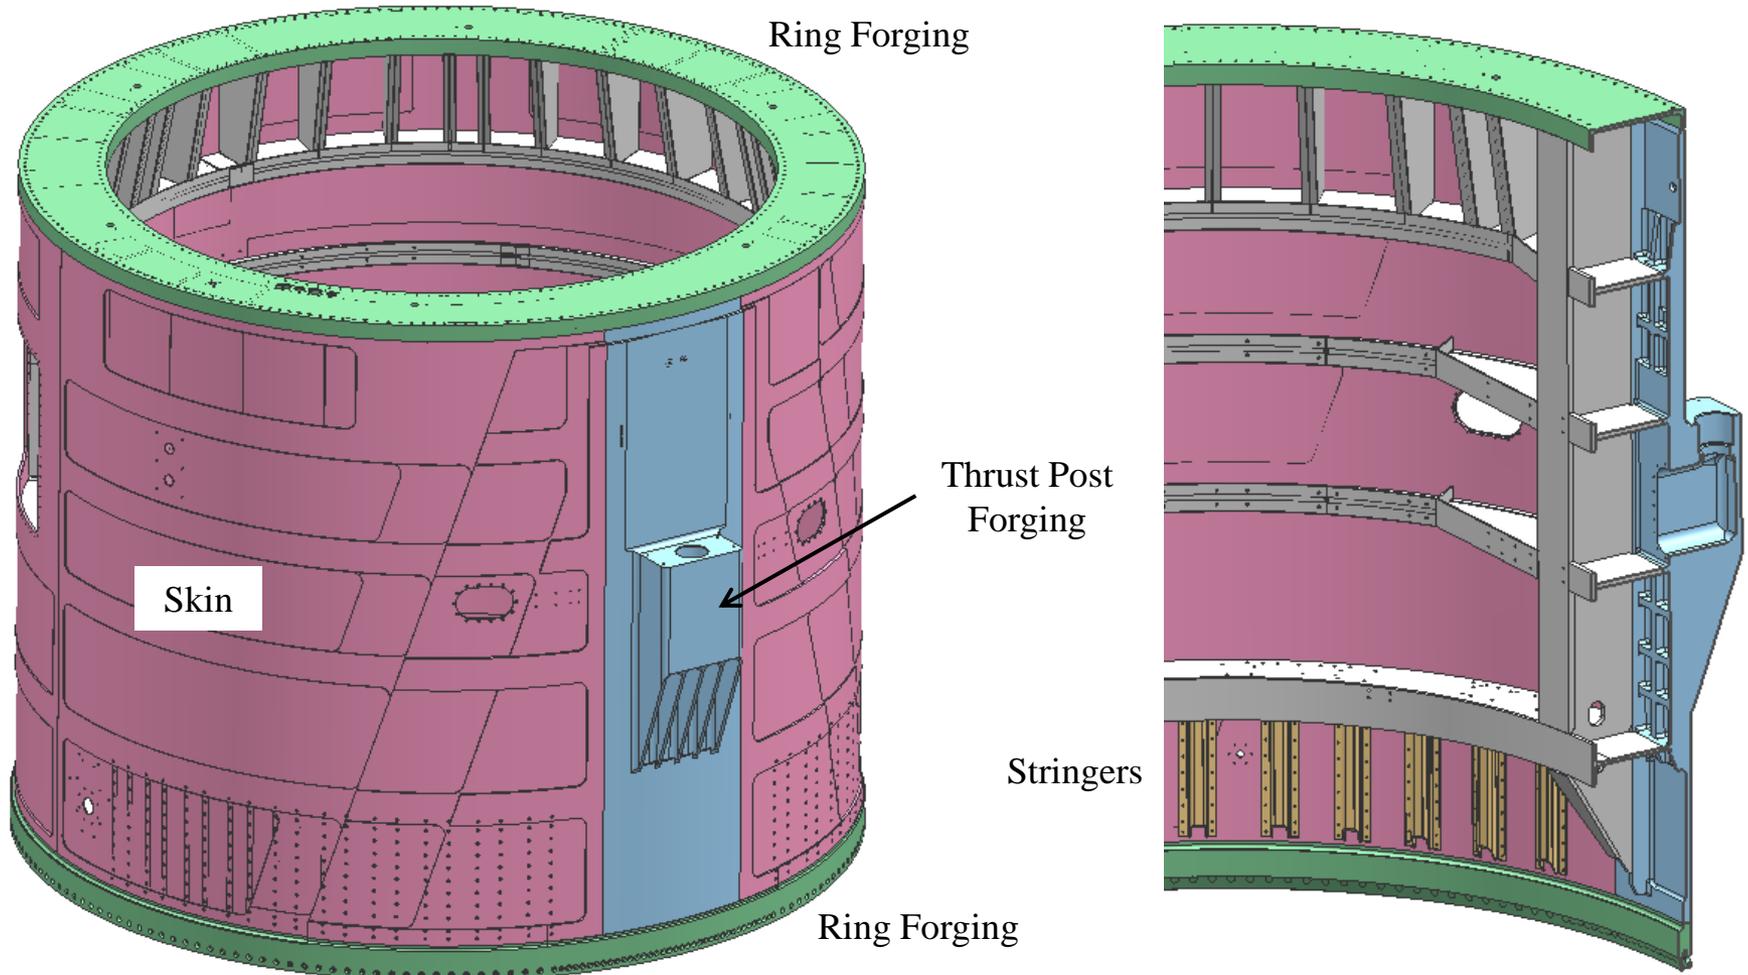
- Aluminum 2219 weldment. Lowest properties occur in the thrust post.

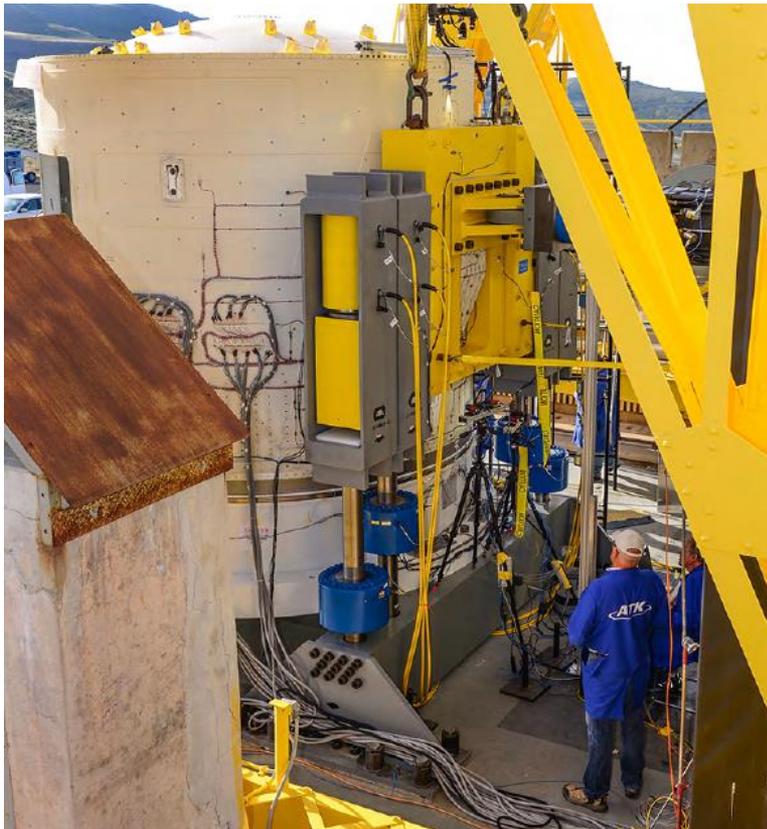
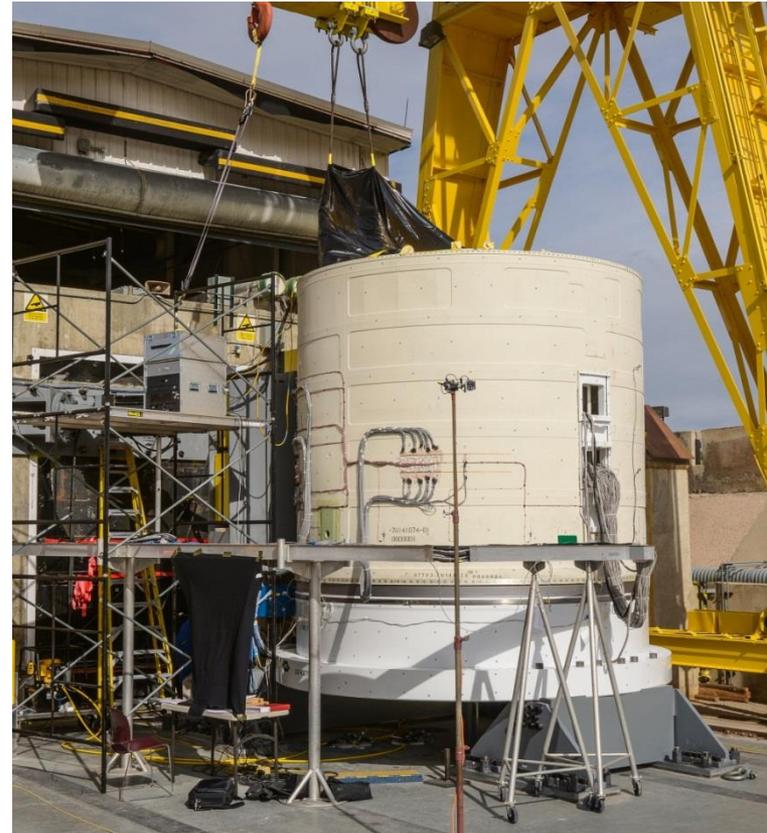
- Testing was performed at Orbital ATK facilities in Promontory, Utah.
  - FSTA-1 was focused on ascent load cases
  - FSTA-2 was focused on liftoff load cases
  - Both tests applied ascent loads until failure occurred

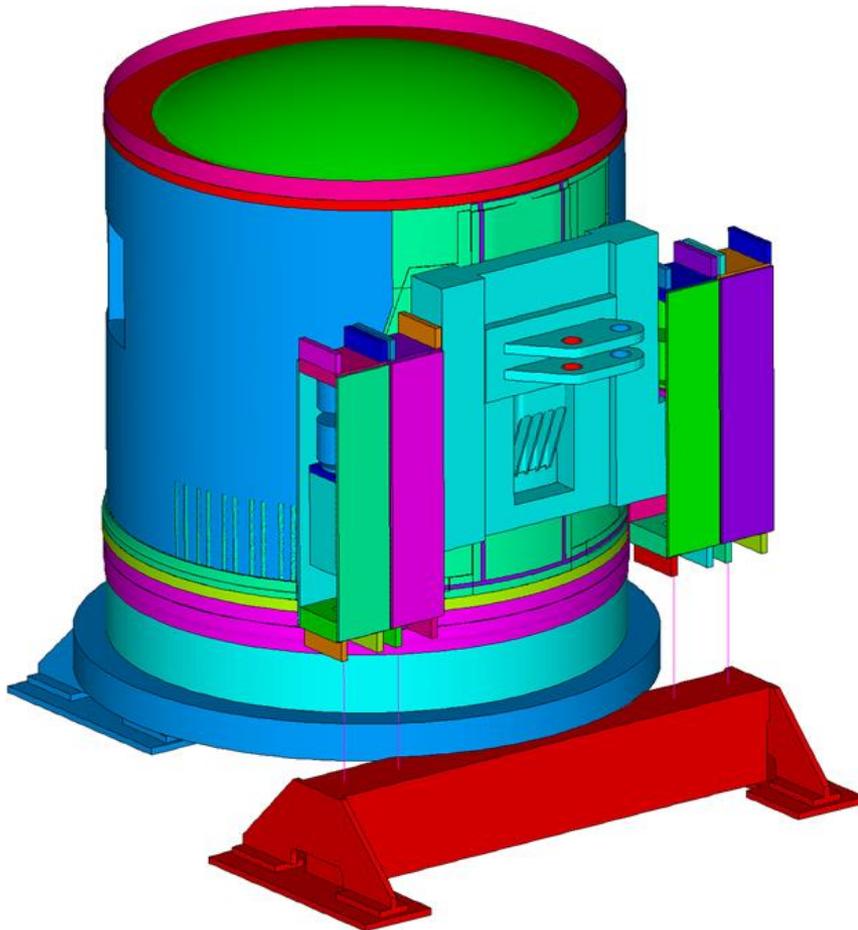
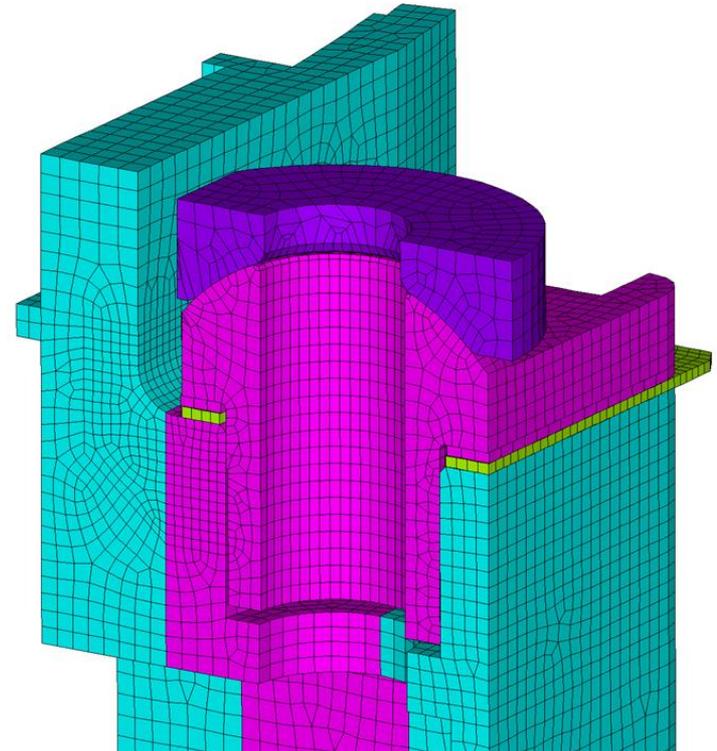
- Both the forward skirt and tooling was modeled. This allows the analysis to simulate the loading as close as possible to the actual test configuration.

Mesh density in thrust post region

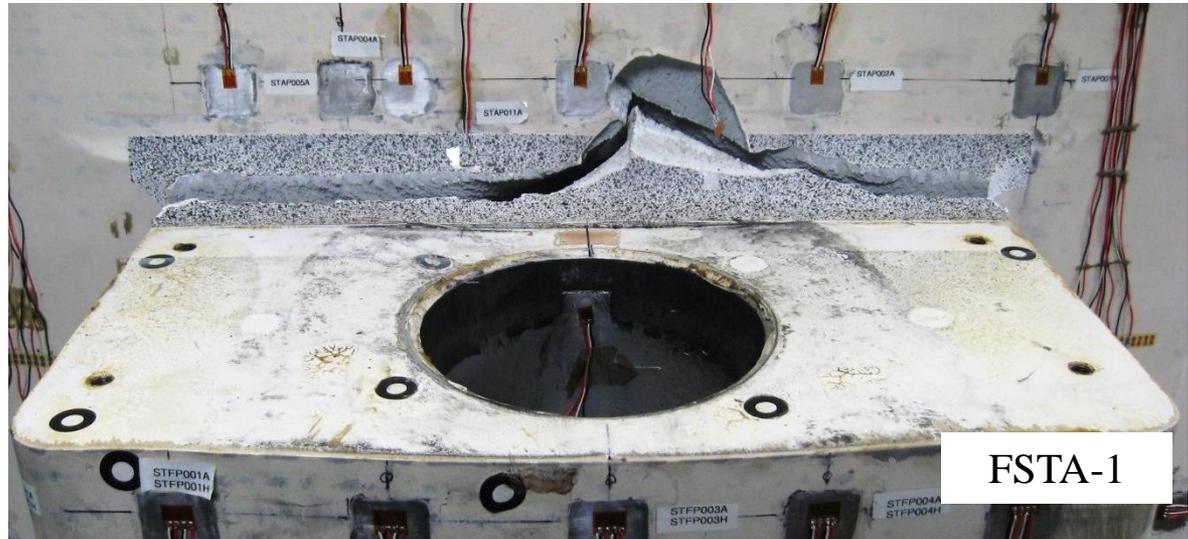
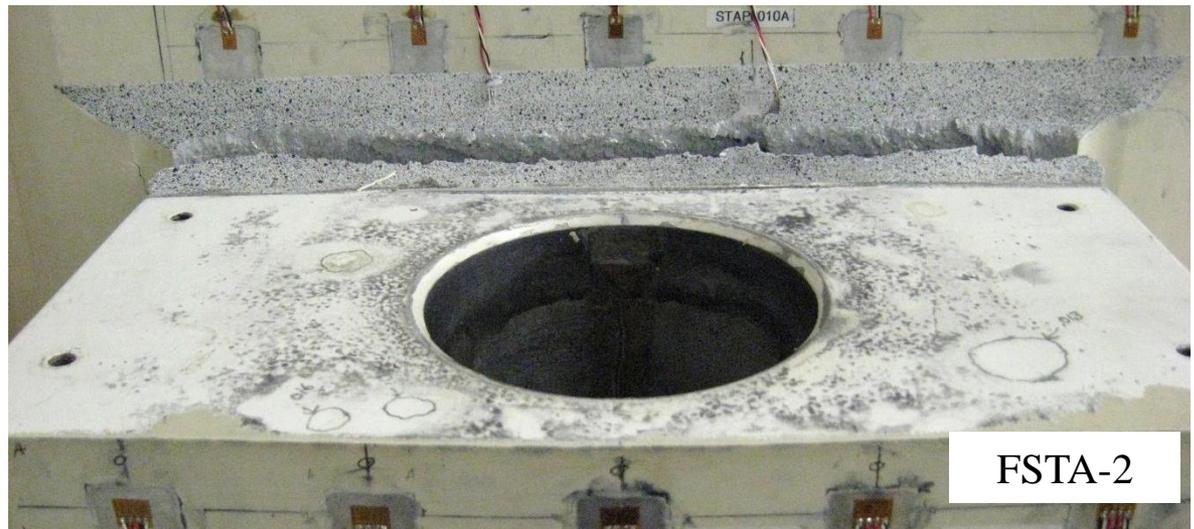
- Failure occurred in the thrust post radius.
  - Both tests failed above 1.4 limit load
  - Testing alone was not sufficient to show forward skirts were acceptable
- Still needed to understand the failure and correlate to analysis to determine a margin of safety.

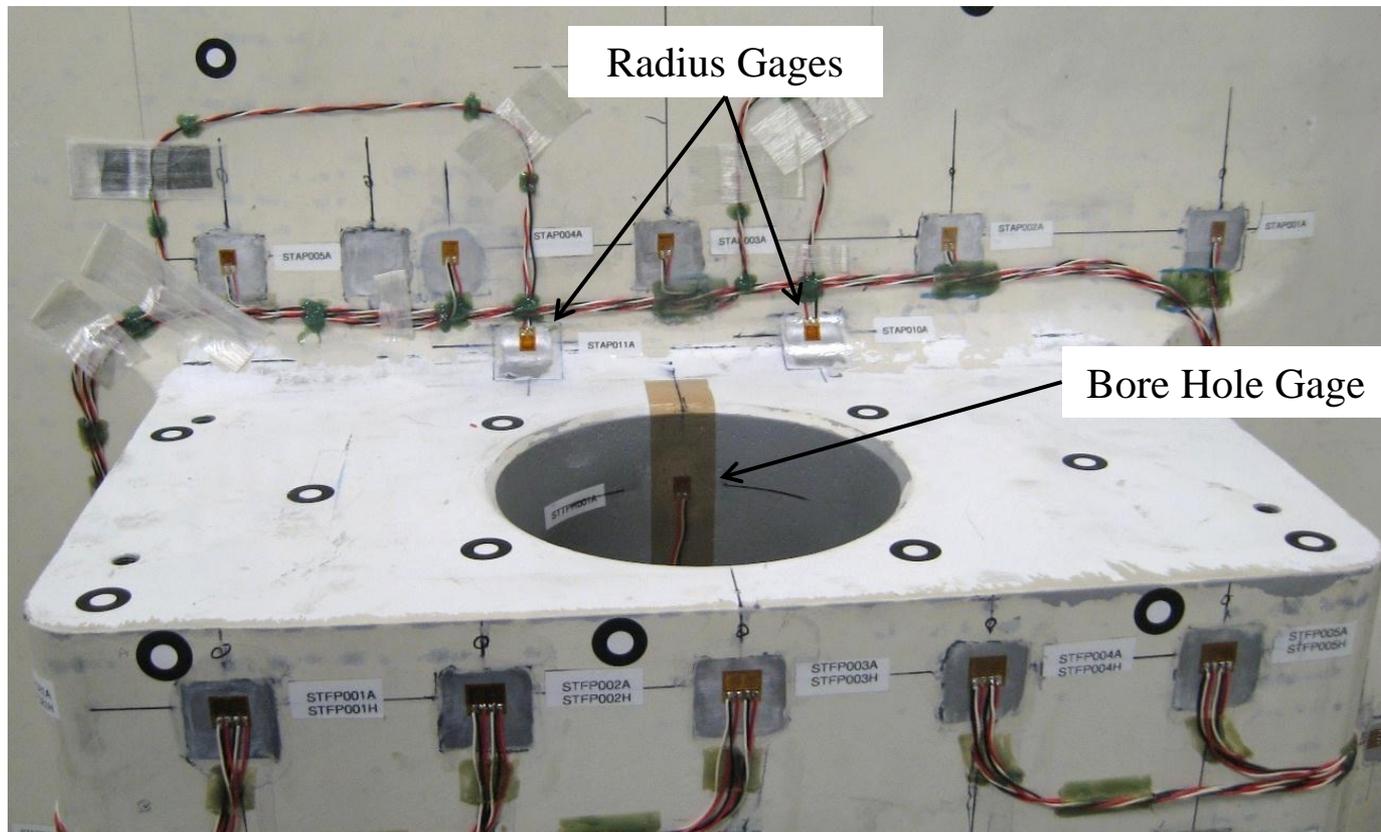
- FSTA-1 and FSTA-2 were instrumented with over 200 strain gages to ensure all possible failure modes could be captured. However, it turned out that three gages provided the most useful strain data.

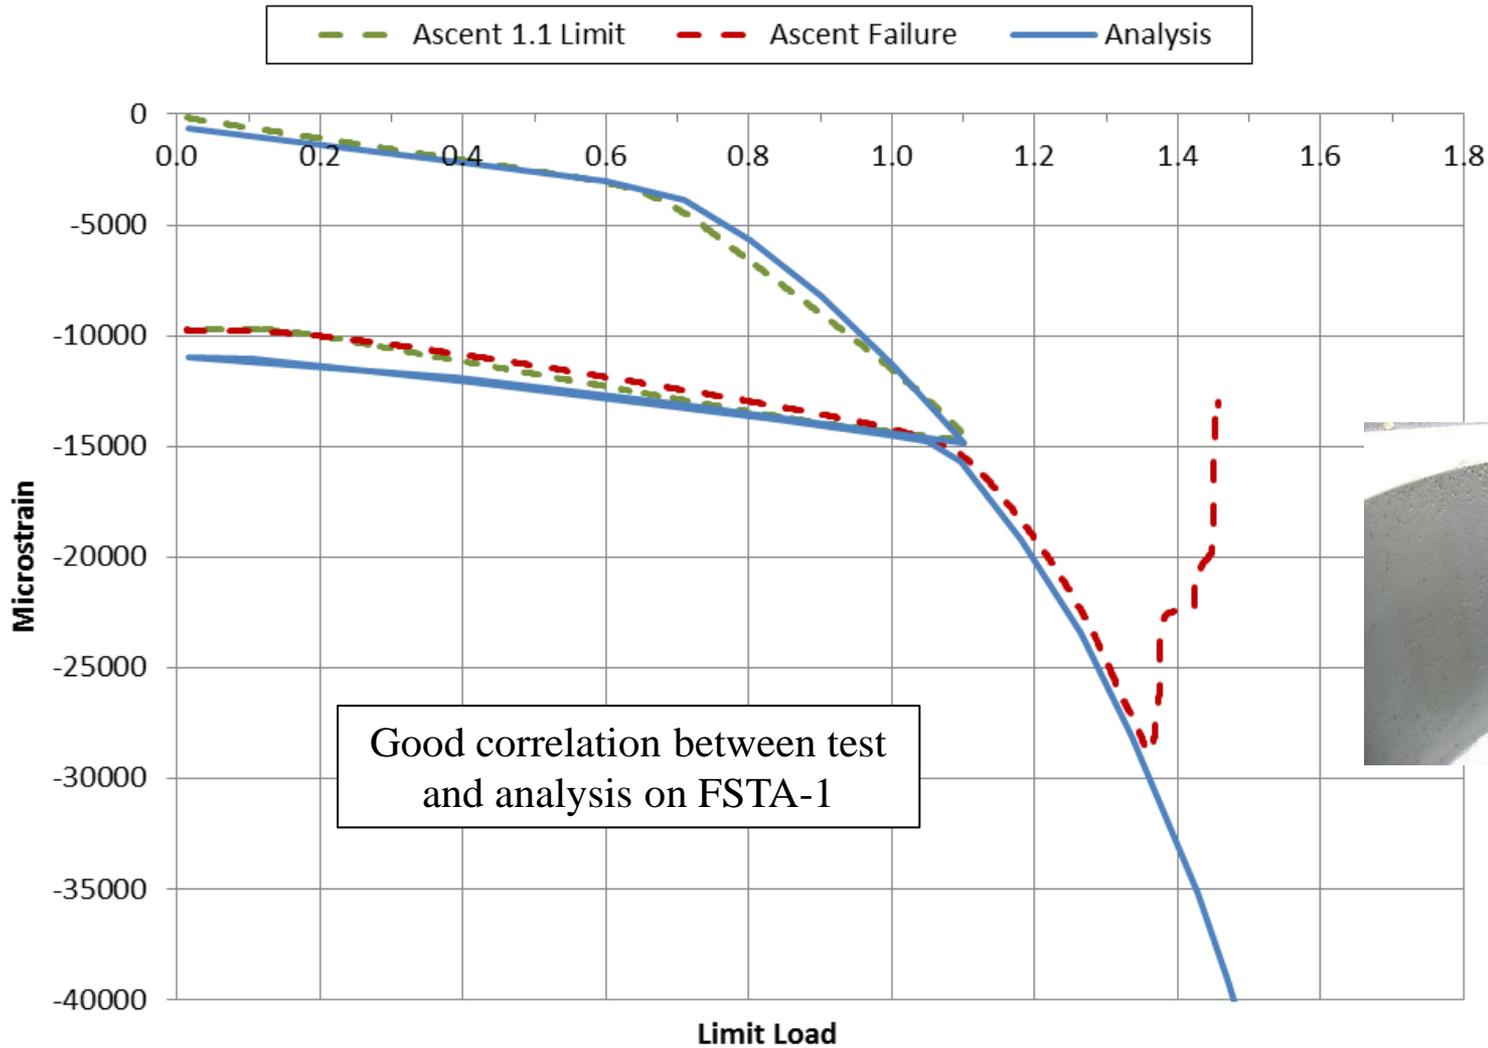
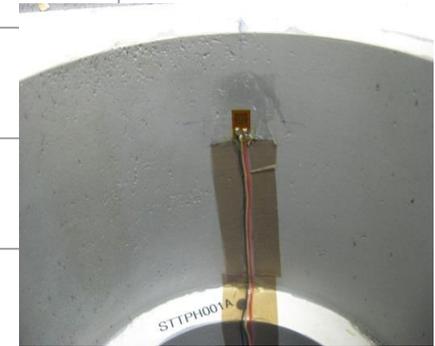
Good correlation between test and analysis on FSTA-1

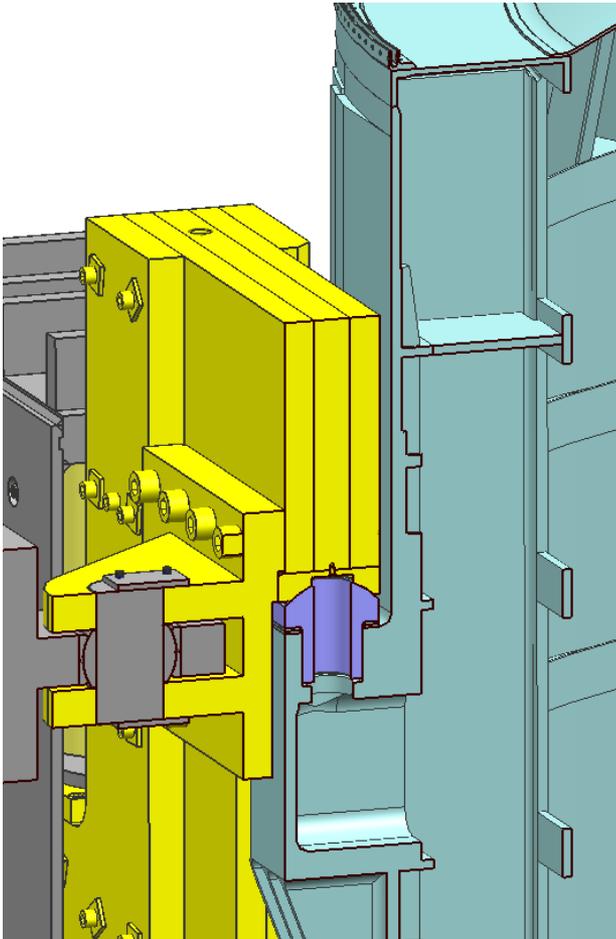
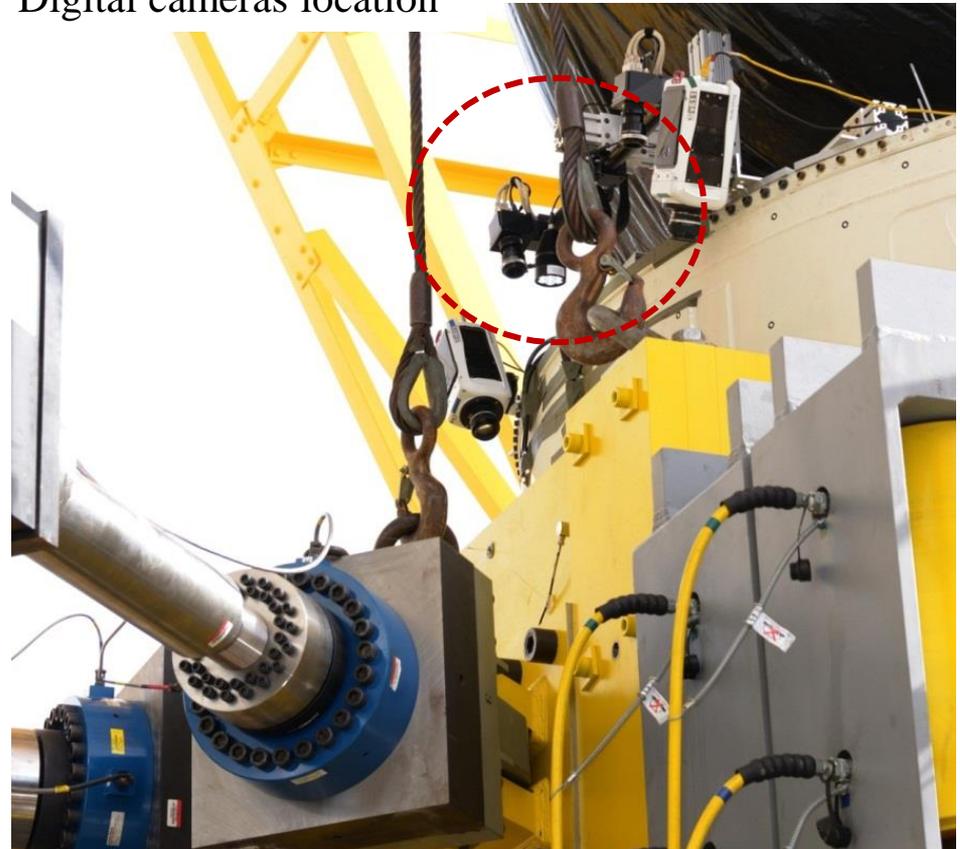
- Strain at the post radius was determined by processing digital images with the ARAMIS system.

Digital cameras location

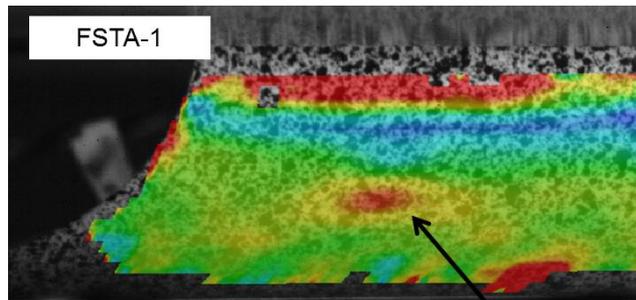
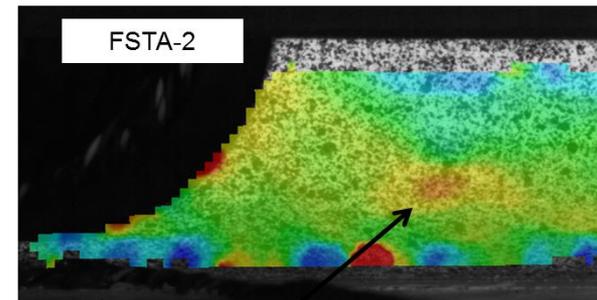
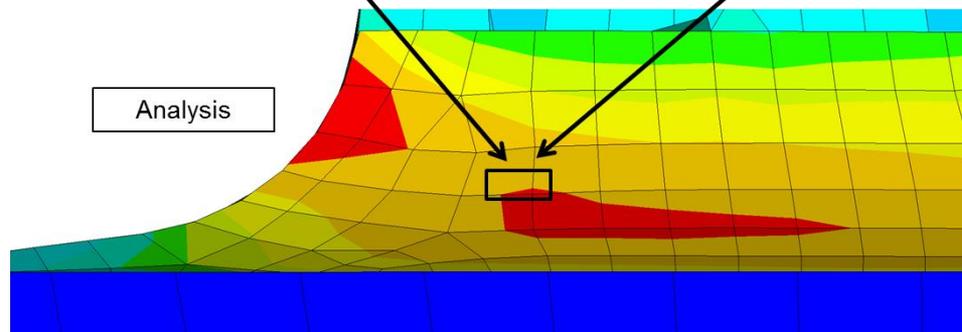
- ARAMIS was able to accurately capture the thrust post strain. Correlation to analysis was excellent.

Strains just prior  
to failure

Hot spots match  
failure initiation  
sites

Analysis

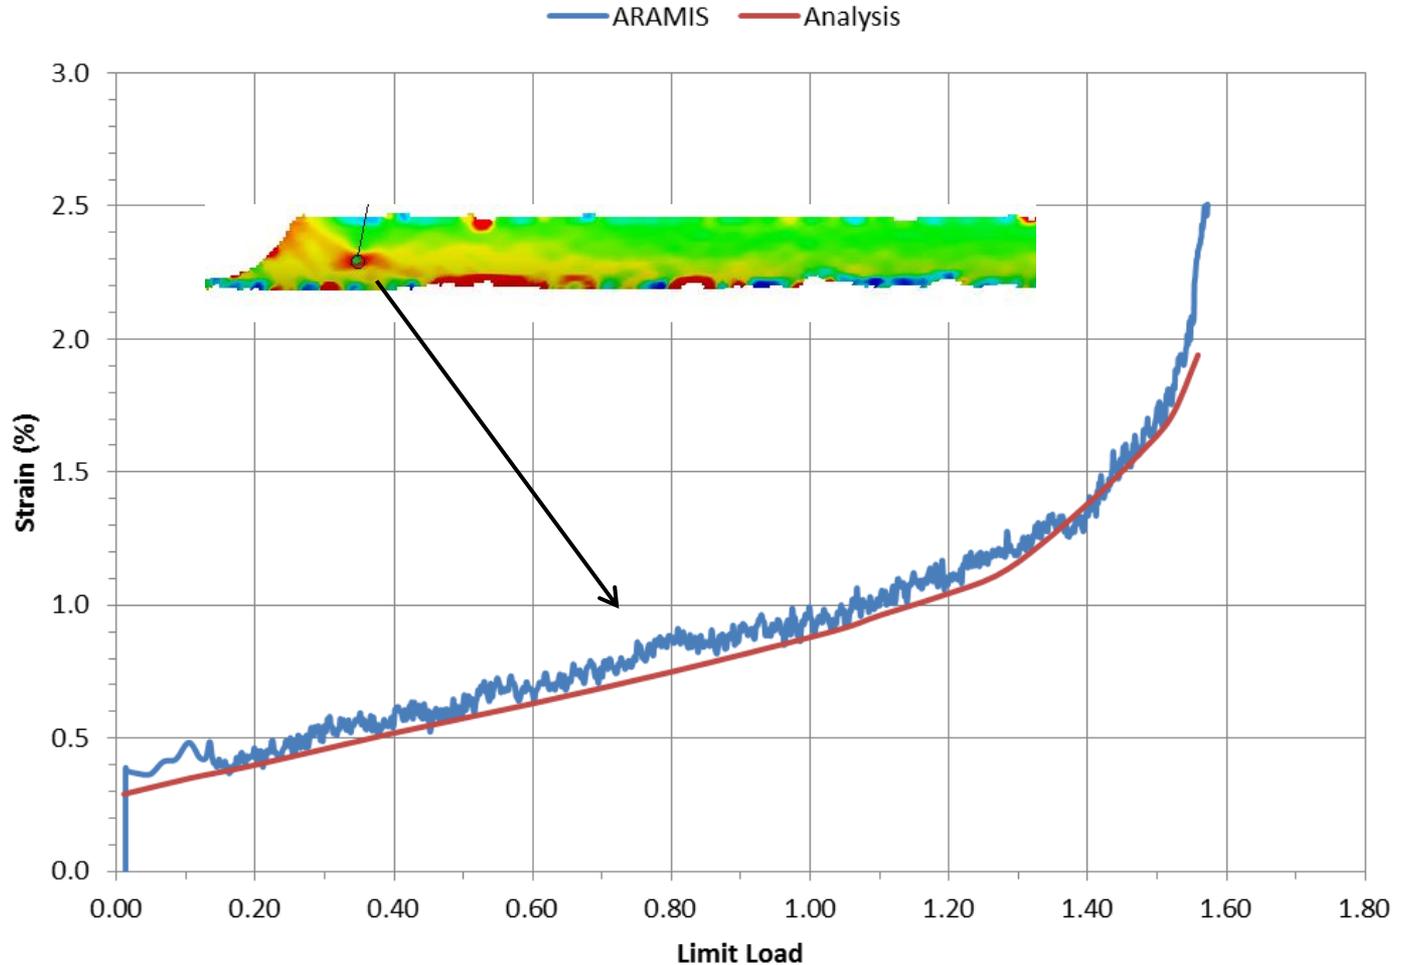
- ARAMIS allowed strain at hot spot to be plotted versus load. Correlation to analysis was excellent.

FSTA-2 strain versus analysis

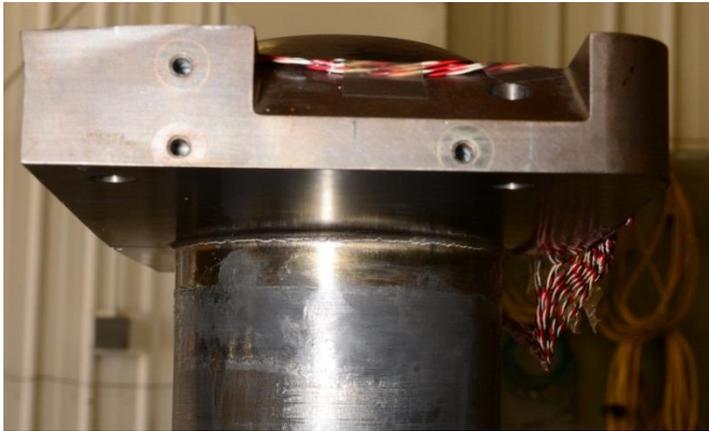
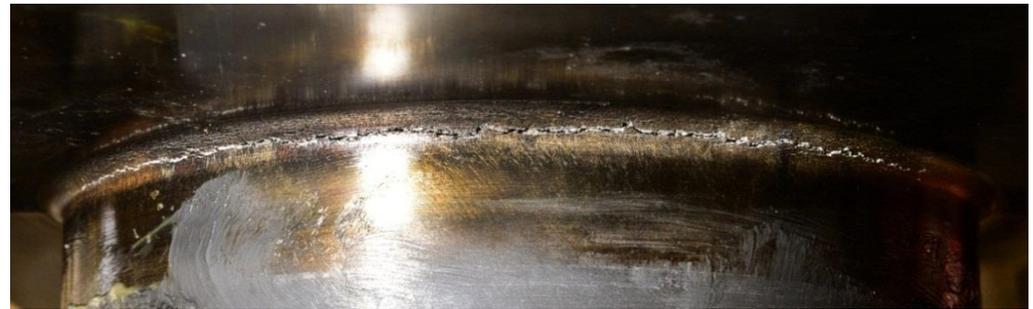
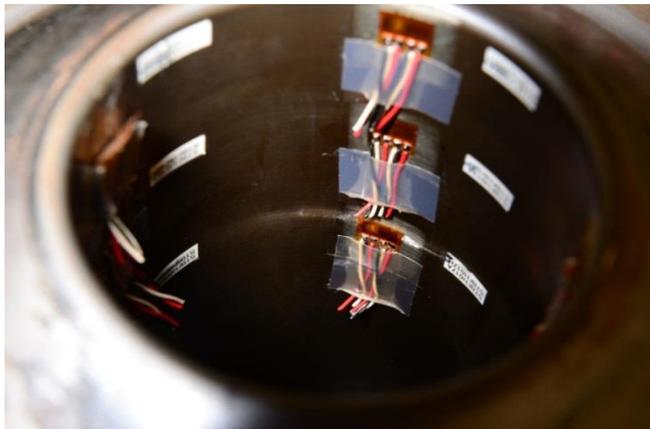
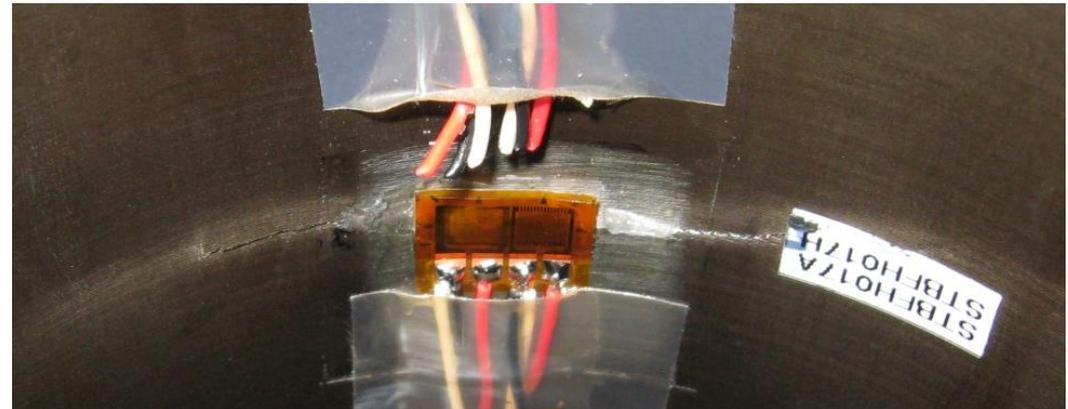
- Acoustic emission (AE) sensors were used to monitor for damage formation during testing (e.g. crack formation and growth). AE was important because after disassembly of FSTA-1 a crack was observed in the ball fitting radius.

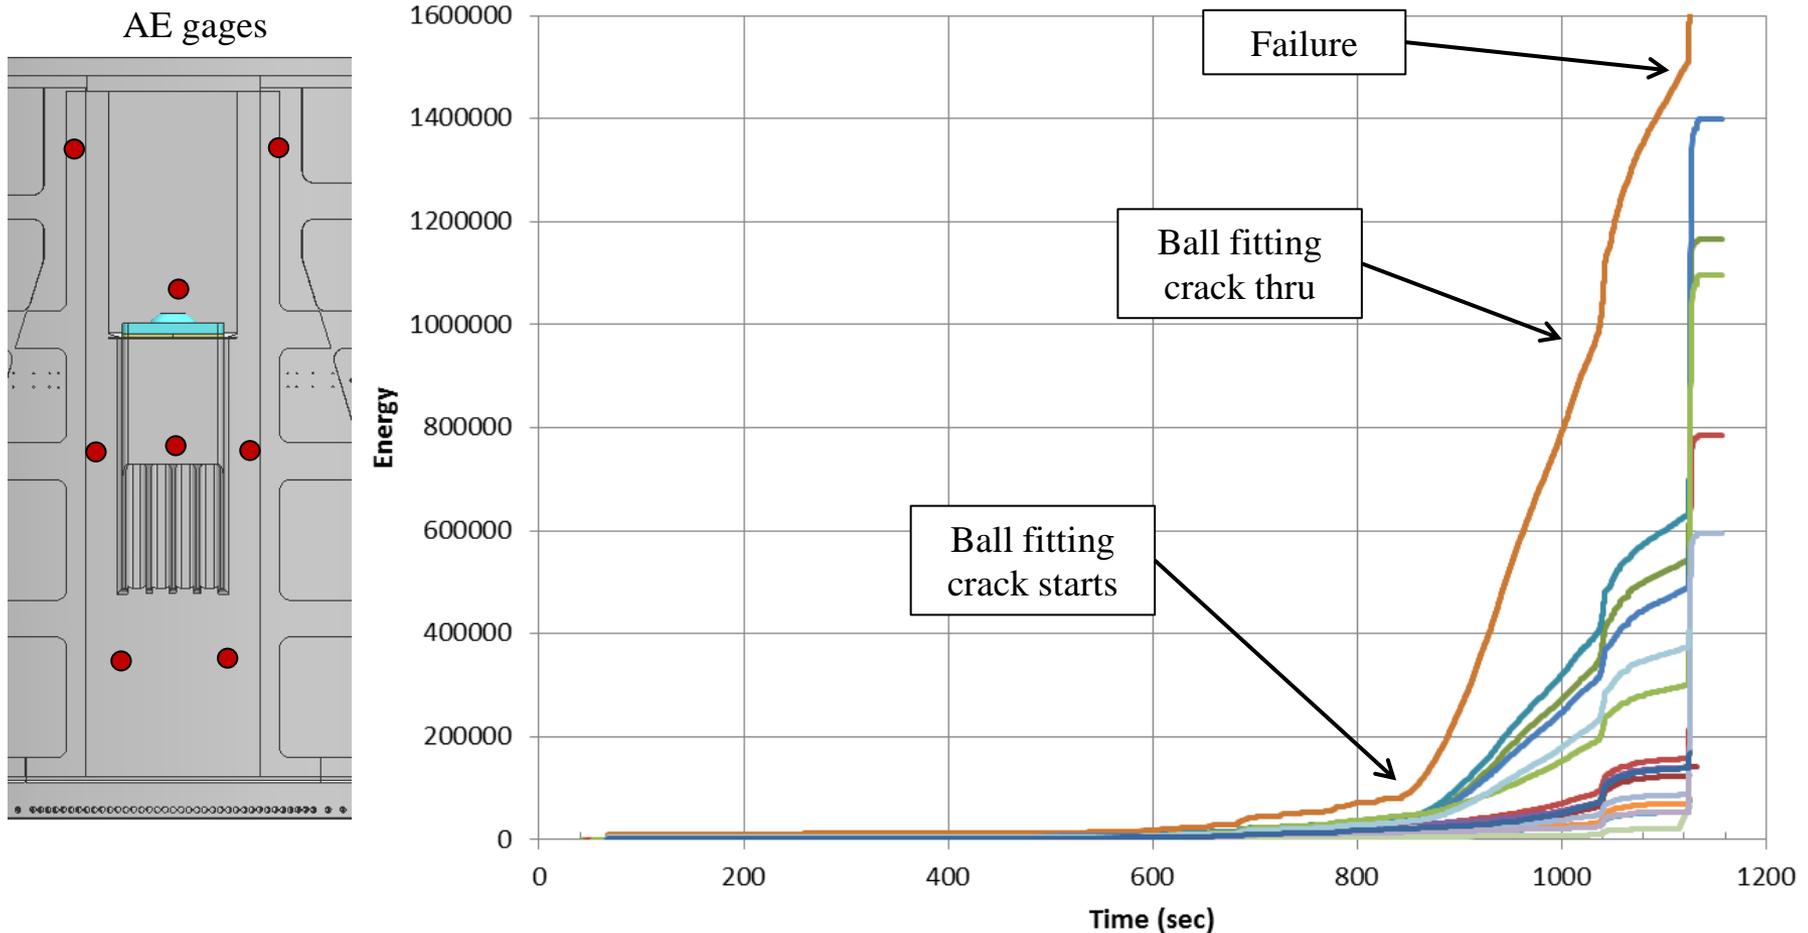
- AE data was used to reconstruct when the crack occurred. This was essential in determining the ball fitting margin of safety.
