Analysis and Testing of a Composite Fuselage Shield for Open Rotor Engine Blade-Out Protection

¹ NASA Glenn Research Center, Cleveland, Ohio

² FAA William J. Hughes Technical Center, Atlantic City, NJ

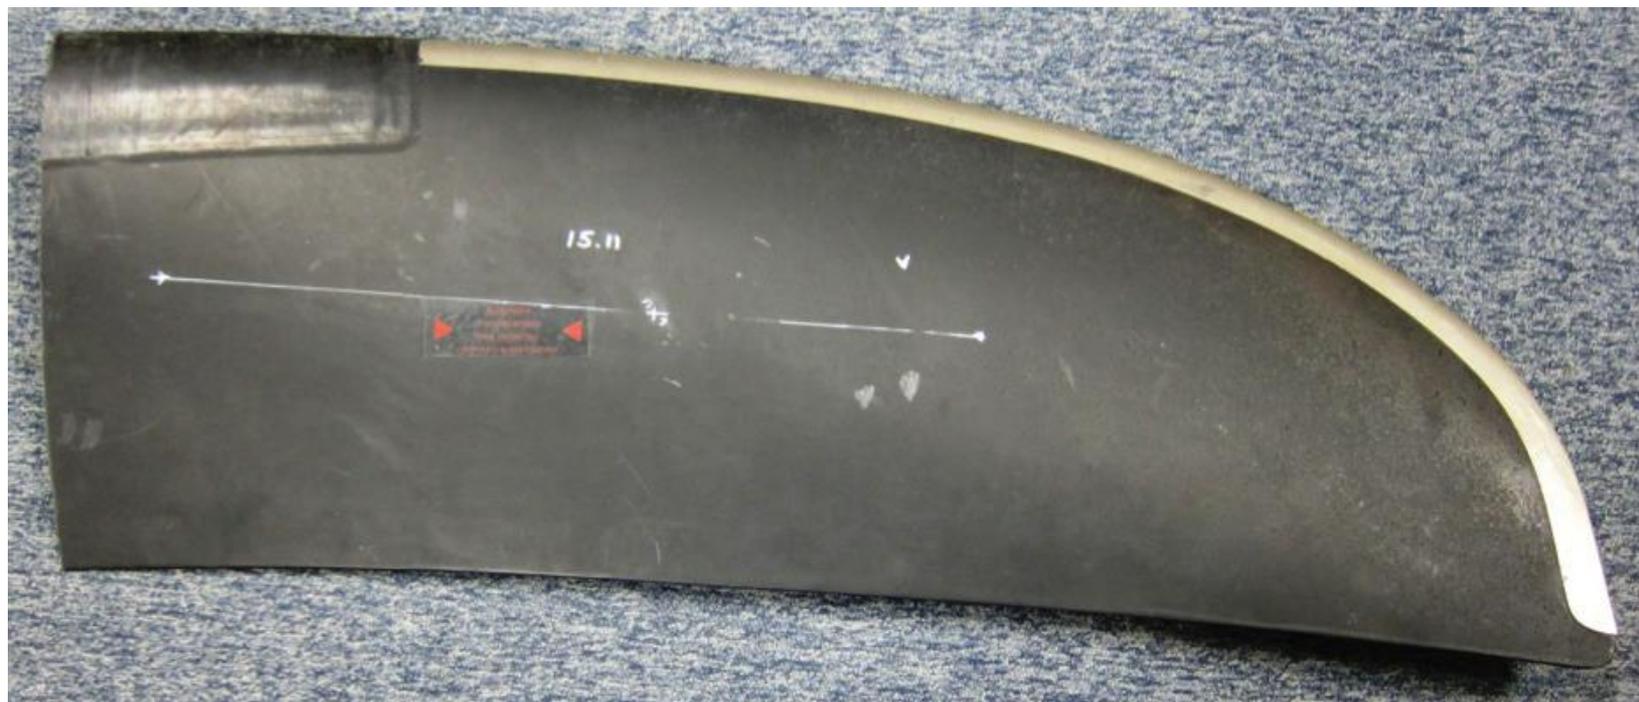
Blade

Overall length: 41.25"
Weight: 15.11 lb

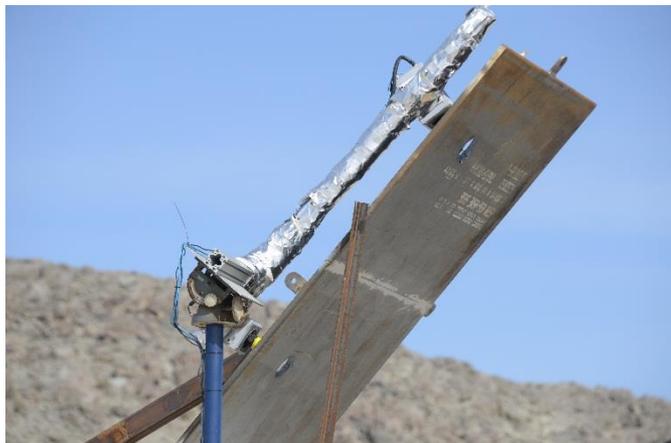
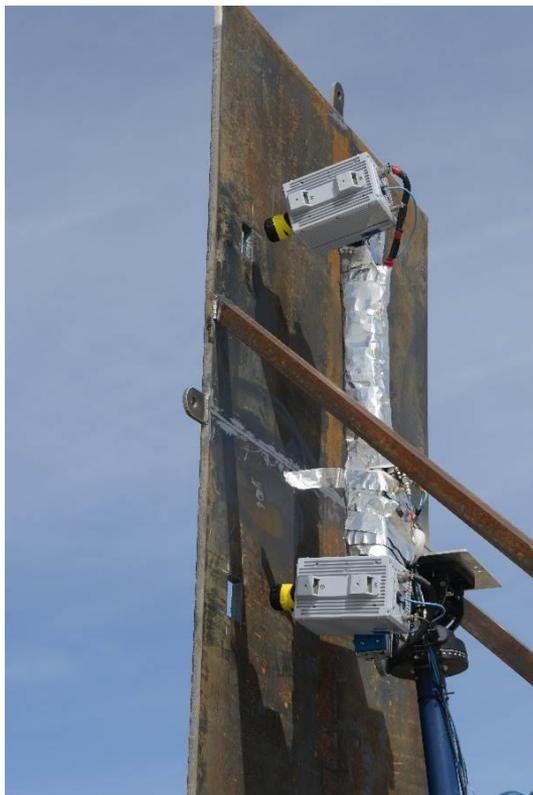
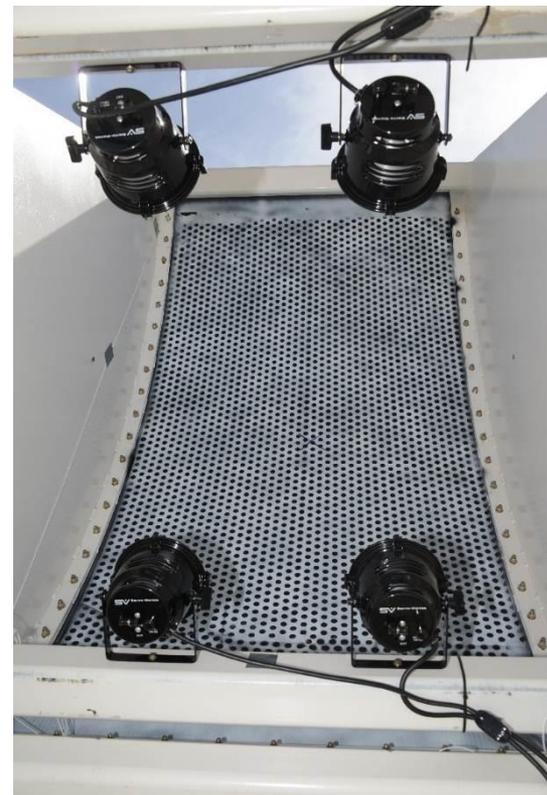
Instrumentation

- High speed cameras for qualitative assessment
- Three pairs of cameras for photogrammetric measurements
- Six accelerometers on each test frame
- Assorted instrumentation for monitoring engine conditions
