K0000287565-RPT
Revision Status: Baseline
Effective Date: 09/15/2015

INFICON Transpector MPH Mass Spectrometer Random Vibration Test Report

Regolith and Environment Science & Oxygen and Lunar Volatile Extraction (RESOLVE)
INFICON Transpector MPH Mass Spectrometer Random Vibration Test Report

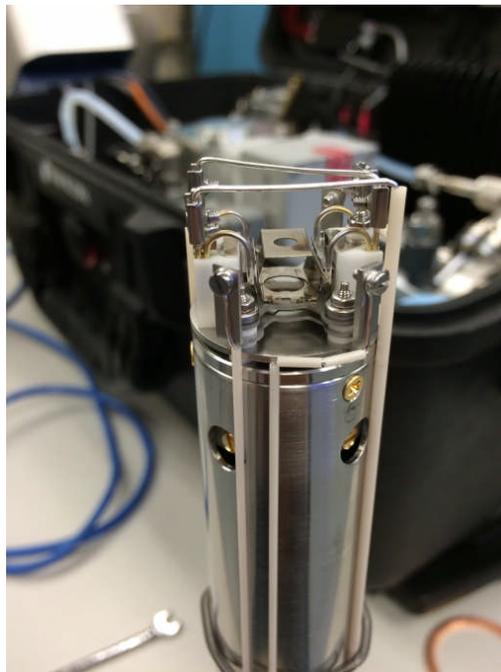
Figure 1. Crossbeam Ion Source.

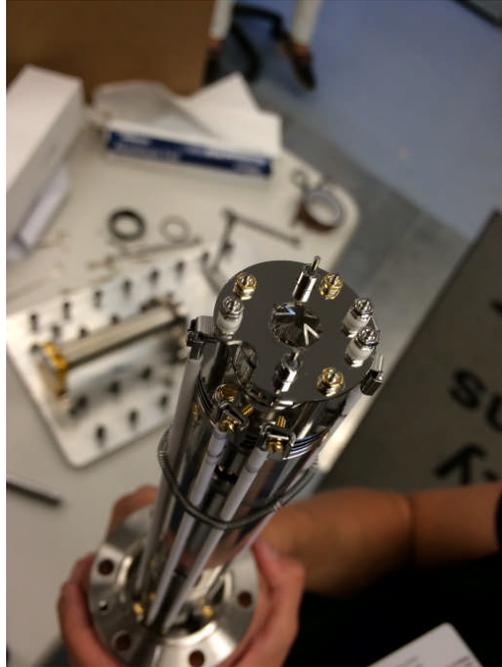
Figure 2. Open Ion Source.

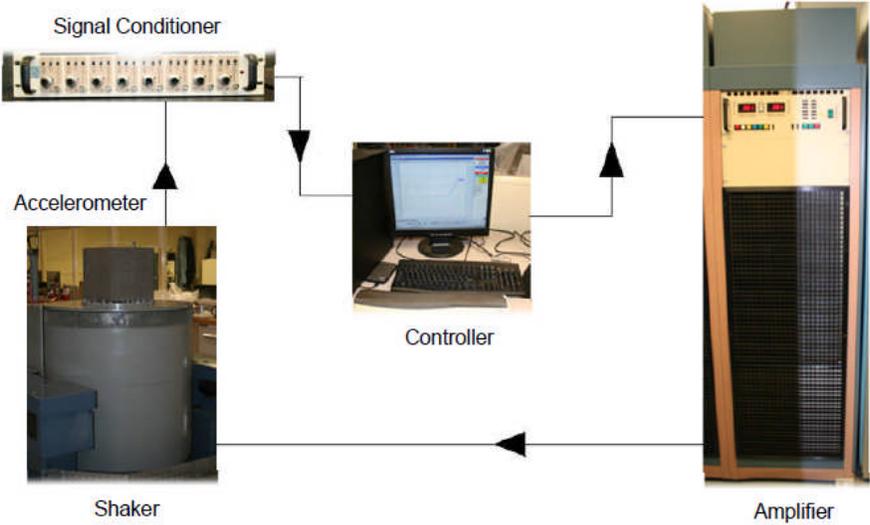
The Medium/22k Shaker Table and its associated instrumentation, also called the Unholtz-Dickie Model 2XSAI240-T-1000-32LH/ST Electrodynamic Shaker System, are located in the Vibration Laboratory in Building M7-0557 at Kennedy Space Center.

Figure 3. Medium/22k Shaker system.

- Generated force, continuous rating 22,000 lbs peak for Sine tests; 20,000 lbf RMS for Random tests (based on flat spectrum 20-2,000 Hz with 1,000 lb payload)
- 480 kVA Amplifier
- 200g max free table acceleration
- 70 inches/sec maximum velocity
- 2 in peak-to-peak shaker stroke
- 100 lb. 17.5" Diameter armature
- Natural frequency $F_n = 2,320$ Hz
- 48"x48" slip table with 140,000 in-lbs. of pitch moment
- 48"x48" expander head
- 16-channel controller

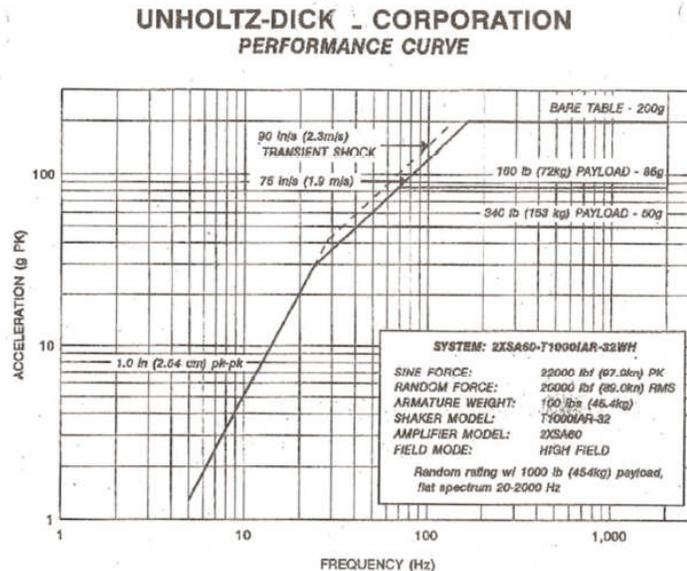
Figure 4. Sine/Random Vibration Performance Curve

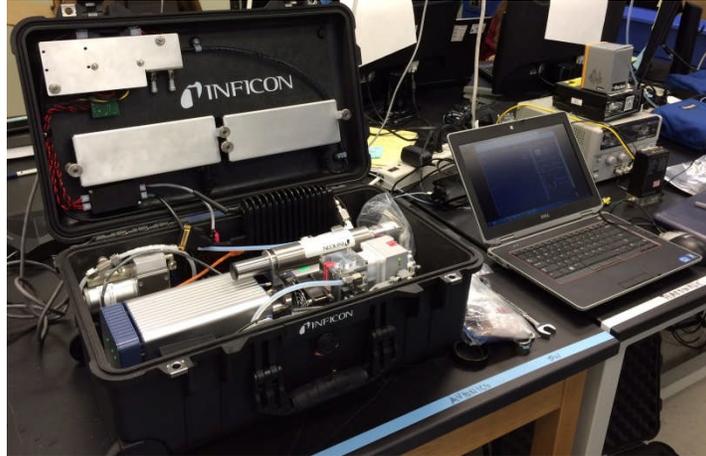
The portable vacuum system and supporting laptop provided by INFICON was used to establish sensitivity of each MPH with room air sample before and after vibration testing. Optionally, it was used after the Z-axis vibration test.

Figure 5. Portable Vacuum System and Supporting Laptop.

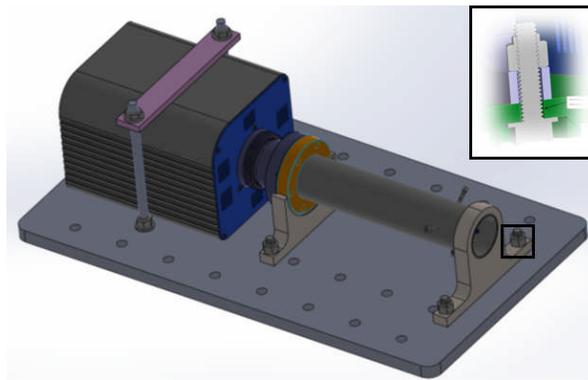
Mounting hardware was provided by INFICON. Holding the electronics to the plate was a bracket and threaded rod. The sensor extension flange had welded mounting brackets that were secured by M8 x 1.25" serrated cap screw and locking nut onto the mounting plate, as shown below in Figure 6.

The mounting plate was designed and fabricated by the Prototype Laboratory at KSC. It was fabricated from 1/2" thick aluminum with counterbore on the backside for the head of the serrated cap screw. The test article (either Crossbeam MPH or Open Ion MPH) and the mounting plate and hardware constitute the test assembly.

Figure 6. Model of INFICON Transceptor MPH with mounting plate and mounting hardware.

Following its Pre-vibration Functional Test, the Open Ion MPH was installed in the mounting bracket as shown in Figure 6.

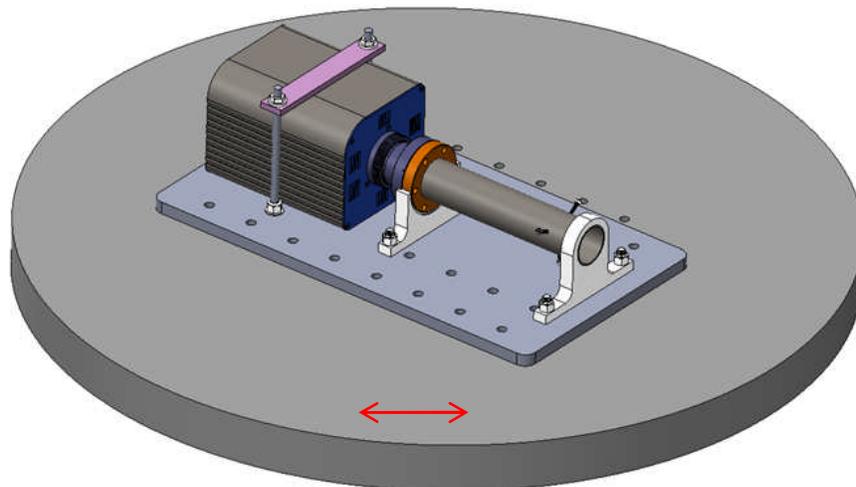
For the Z-axis, the test assembly was mounted on the Medium/22k shaker table using a secondary attachment fixture called the 32" expander head, as shown in Figure 7. The test assembly mounting screws were torqued down to 300 inch lbs.

Figure 7. Z-axis configuration using the 32" expander head.

The horizontal plane is shown by the arrows on Figure 7, Figure 8 and Figure 9

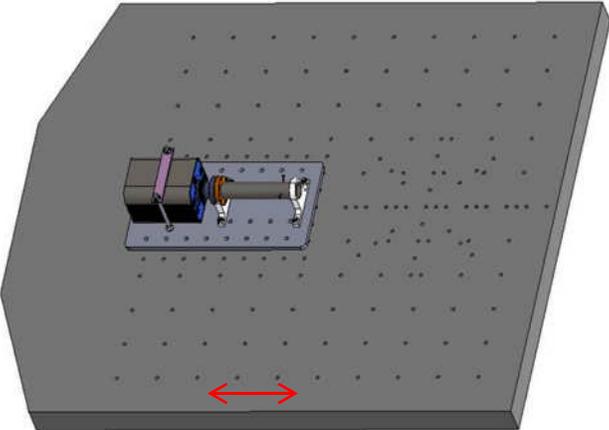
For the X and Y axes, the test assembly was mounted directly on the slip table as shown in Figure 8 and Figure 9, with screws torqued down to 300 inch lbs.

Figure 8. X-axis mounting configuration.

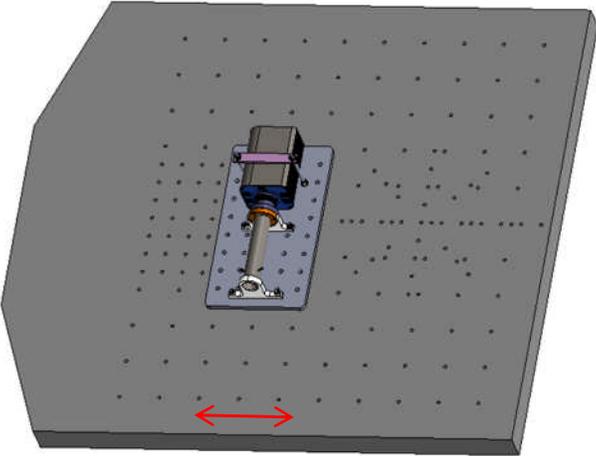
Figure 9. Y-axis mounting configuration.

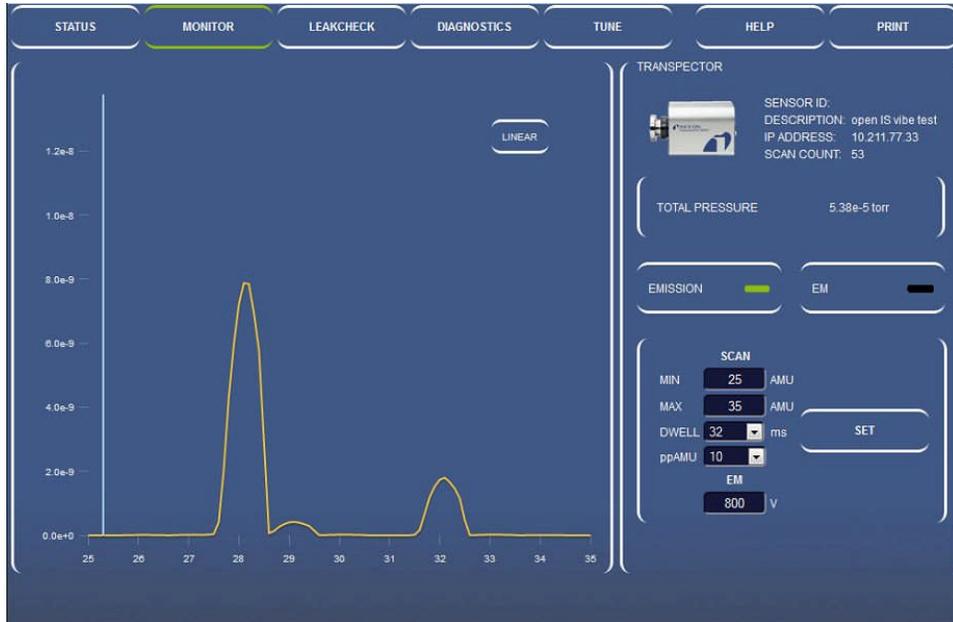
Figure 10. Open Ion MPH Pre-Vibration Functional Test with Room Air.

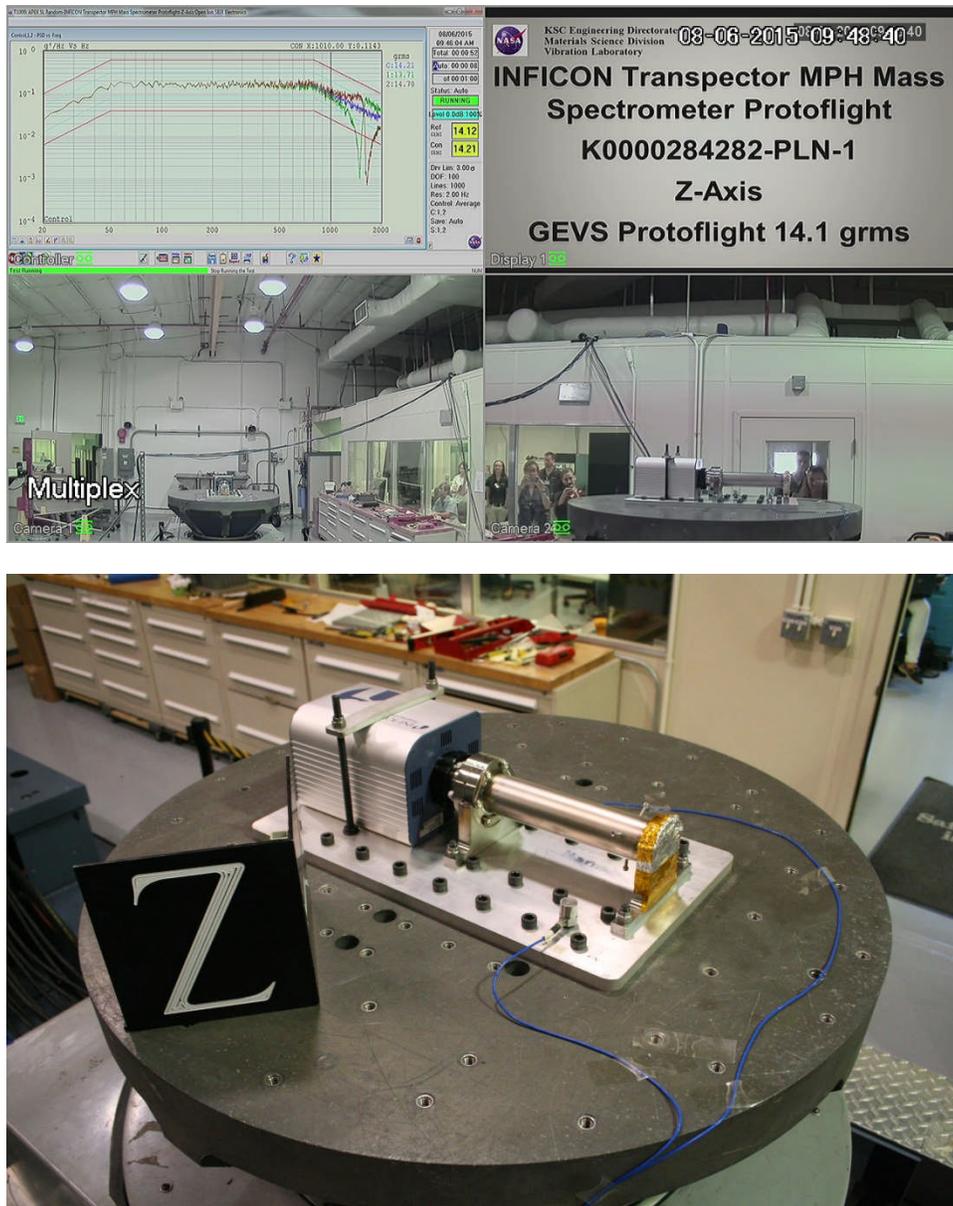
Figure 11. Open Ion MPH Z-Axis Vibration Test Screenshot and Photo.

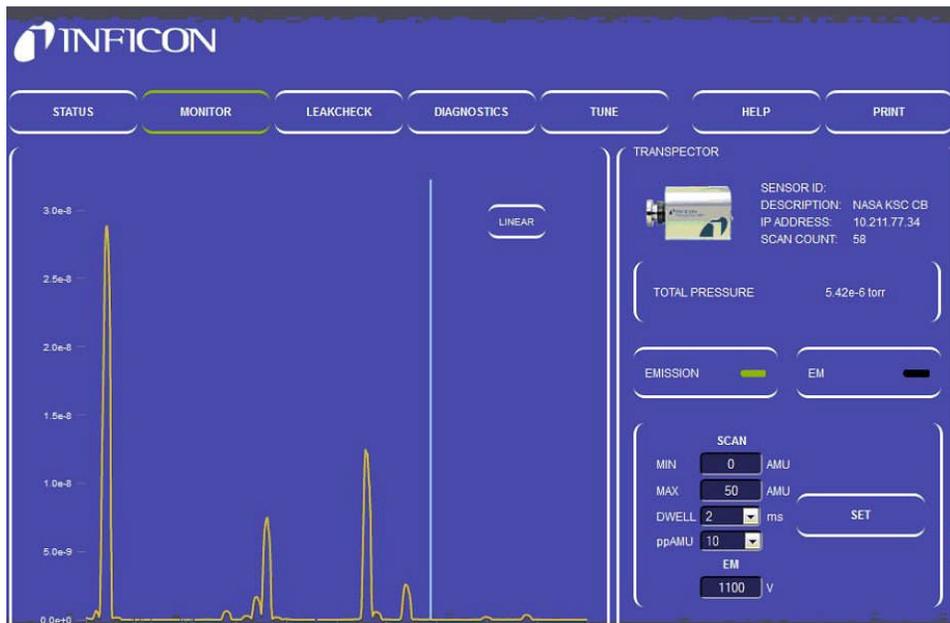
The Open Ion source was tested with vacuum-tested electronics and determined to be healthy. For the remaining Y- and X-axes, the SBIR electronics was again paired with the SBIR electronics, including the damaged RF board.

Figure 12. Open Ion Source Post-Z-Axes Functional Test with Room Air.

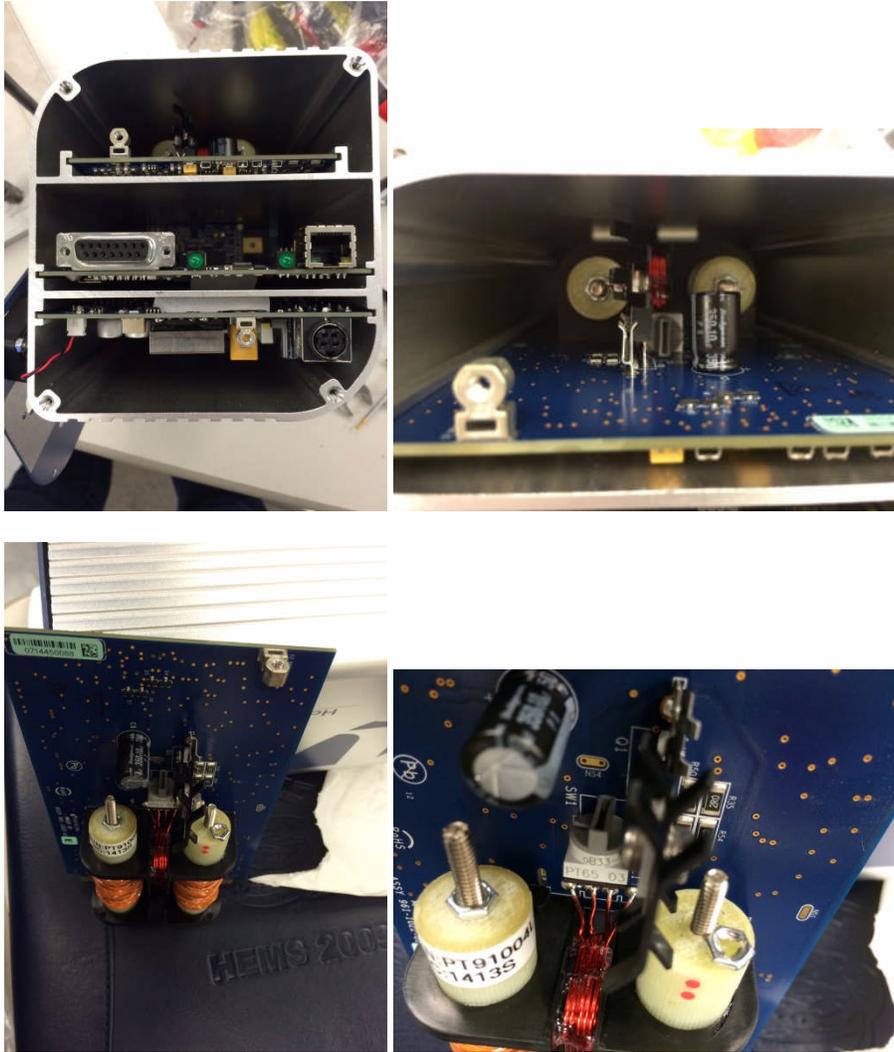
The SBIR electronics failed during Z-axis Vibration Testing. The damage was narrowed down to the RF board by swapping a known working RF board temporarily with the SBIR electronics' RF board and testing the electronics. Upon closer inspection, a nut was found to have shaken loose, allowing the coil to move and be damaged during vibration testing.

Figure 13. RF board inside the SBIR electronics enclosure (top) and disassembled for inspection (bottom).

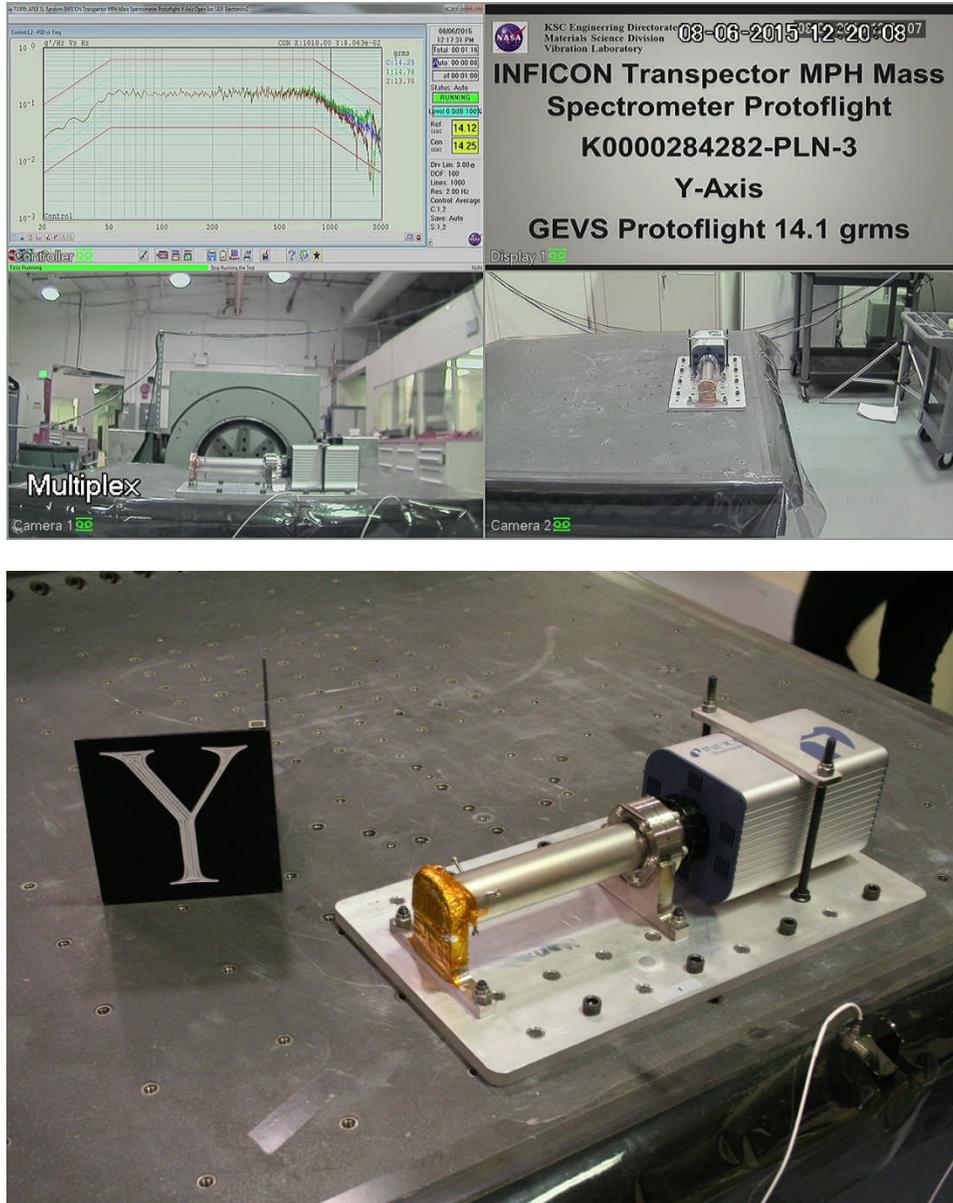
Figure 14. Open Ion MPH Y-Axis Vibration Test Screenshot and Photo.

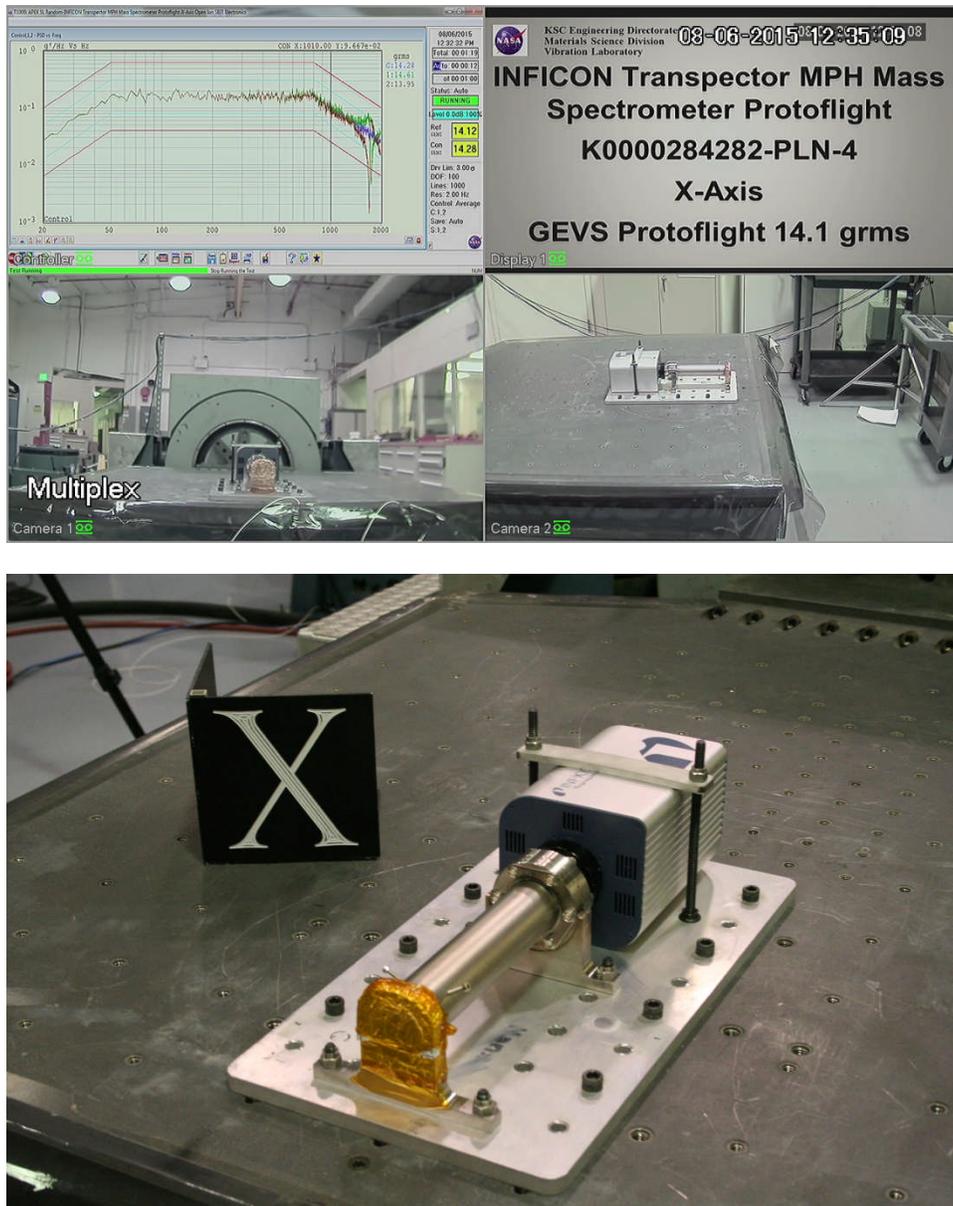
Figure 15. Open Ion MPH X-Axis Vibration Test Screenshot and Photo.

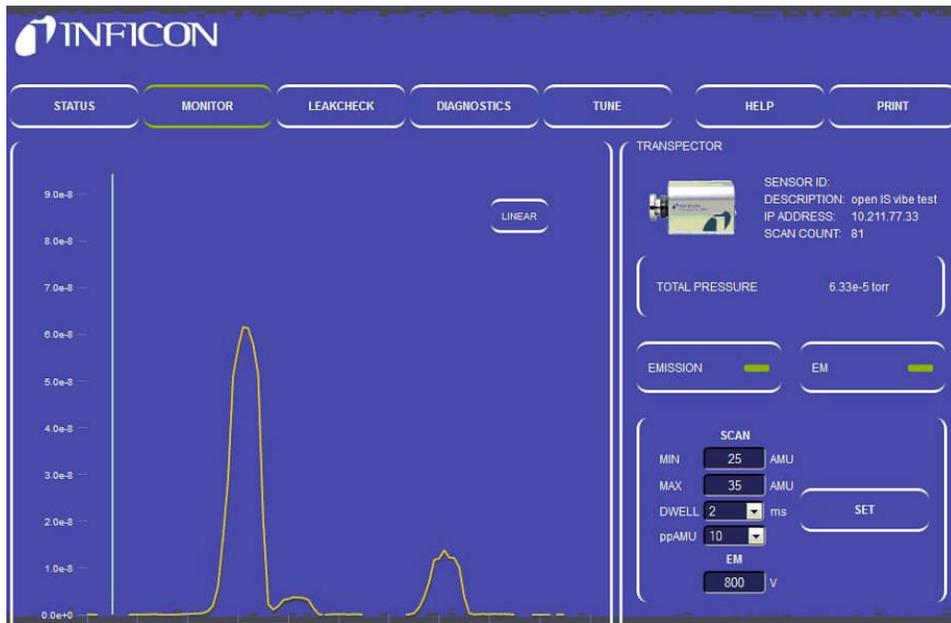
The Open Ion source did not perform as expected with EM OFF. All other testing was done with EM OFF. Low intensity peaks were observed when the test was performed in emission mode (EM ON). Emission mode has a higher sensitivity that was able to pick up signal despite the damage. Note the unusual shape of the water peak in Figure 16.

Figure 16. Open Ion Source Post-Y and X-Axes Functional Test with Room Air.

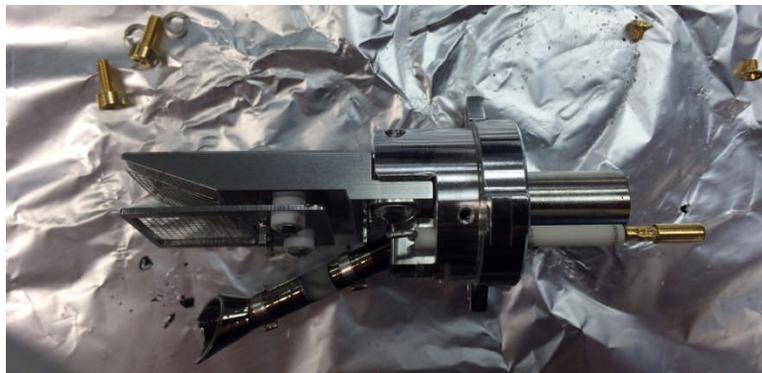
Upon disassembly and inspection, it was discovered that the detector was damaged in an area where it was spot welded.

Figure 17. Damaged detector.

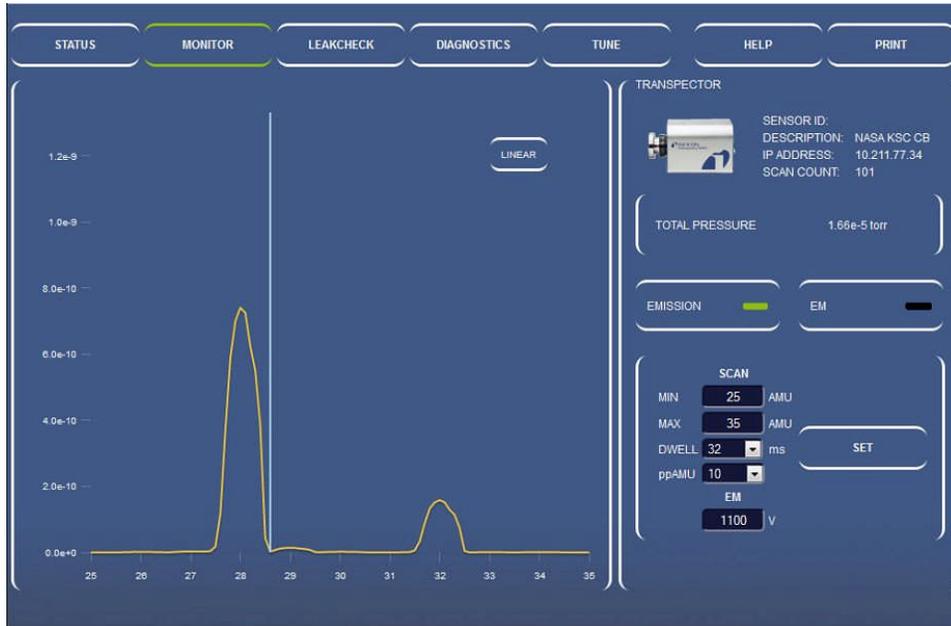
Figure 18. Crossbeam MPH Pre-Vibration Functional Test with Room Air.

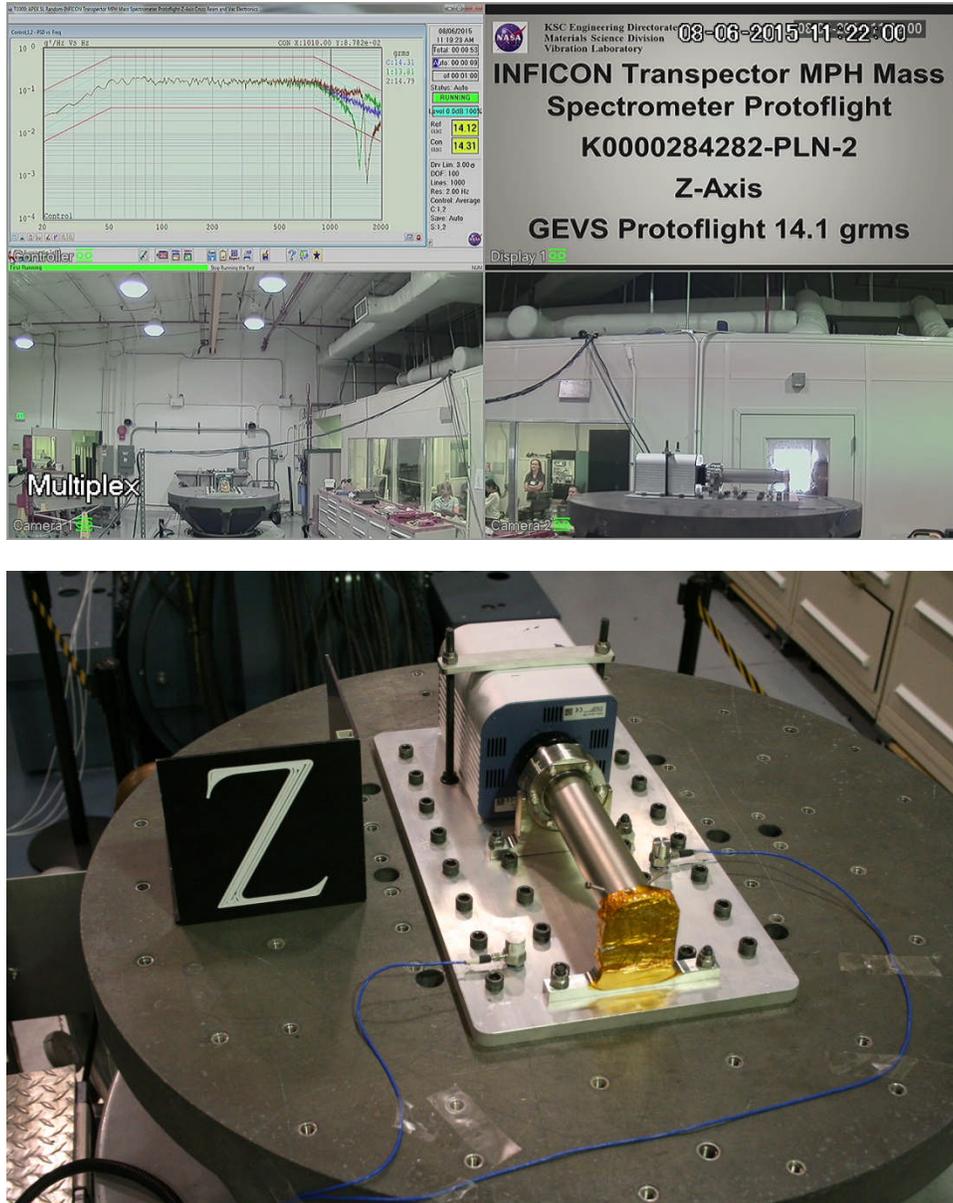
Figure 19. Crossbeam MPH Z-Axis Vibration Test Screenshot and Photo.

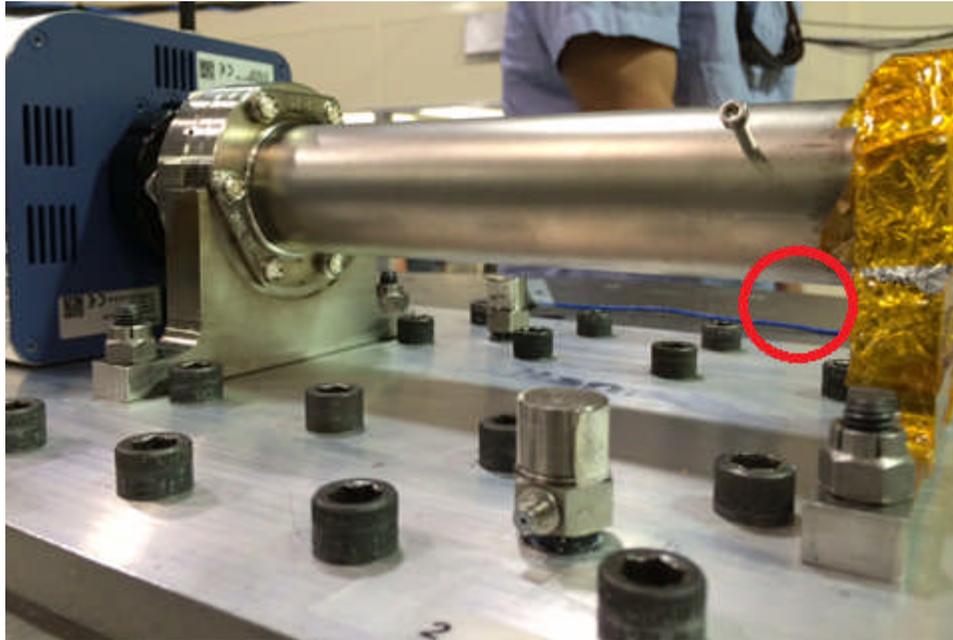
One external set screw fell off during the test. That screw is one of three that secure the detector inside the sensor extension flange.

Figure 20. Missing external set screw location depicted in red.

The external screw that fell off did not affect the functionality of the test article.

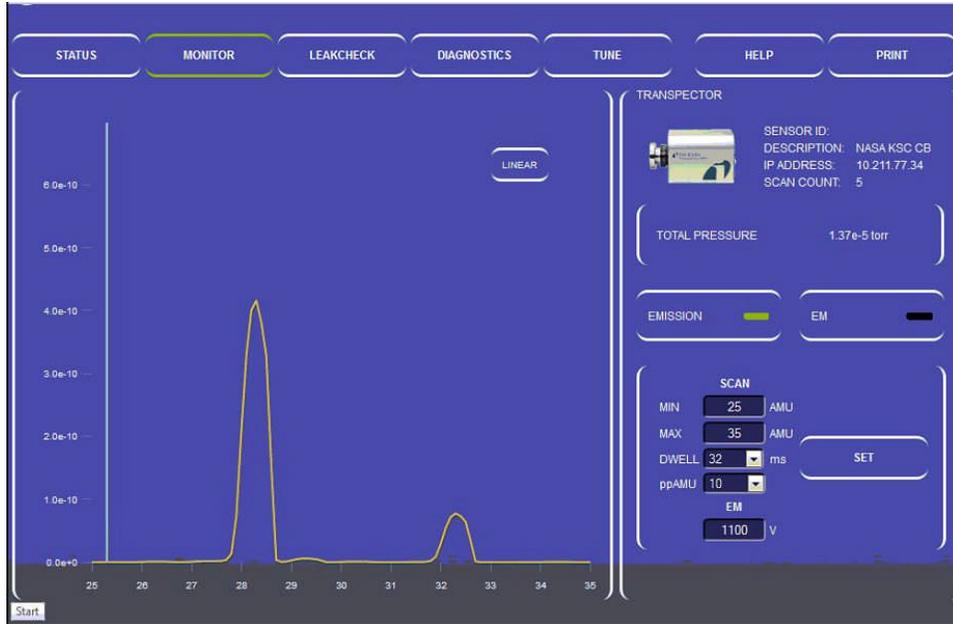
Figure 21. Crossbeam MPH Post-Z-Axis Functional Test with Room Air.

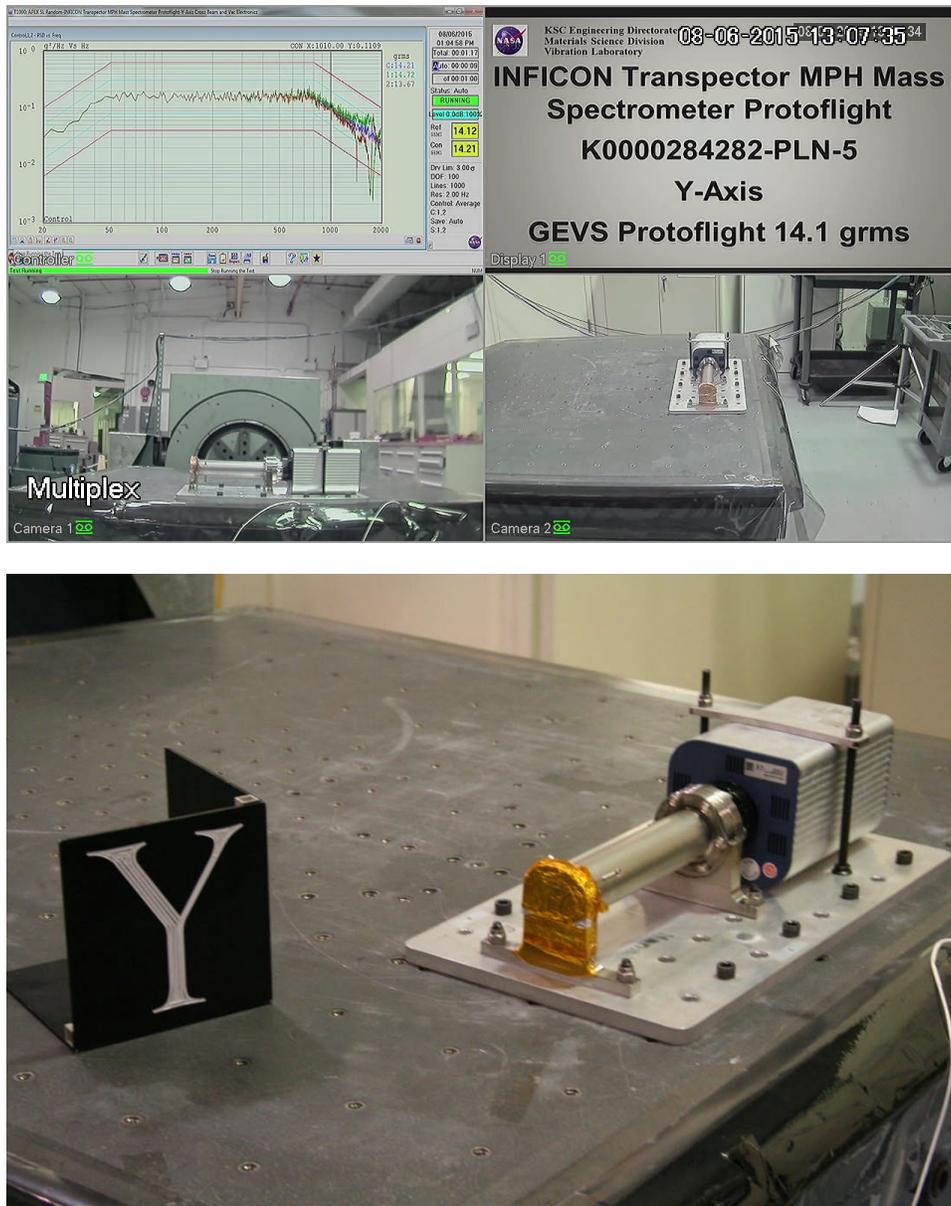
Figure 22. Crossbeam MPH Y-Axis Vibration Test Screenshot and Photo.

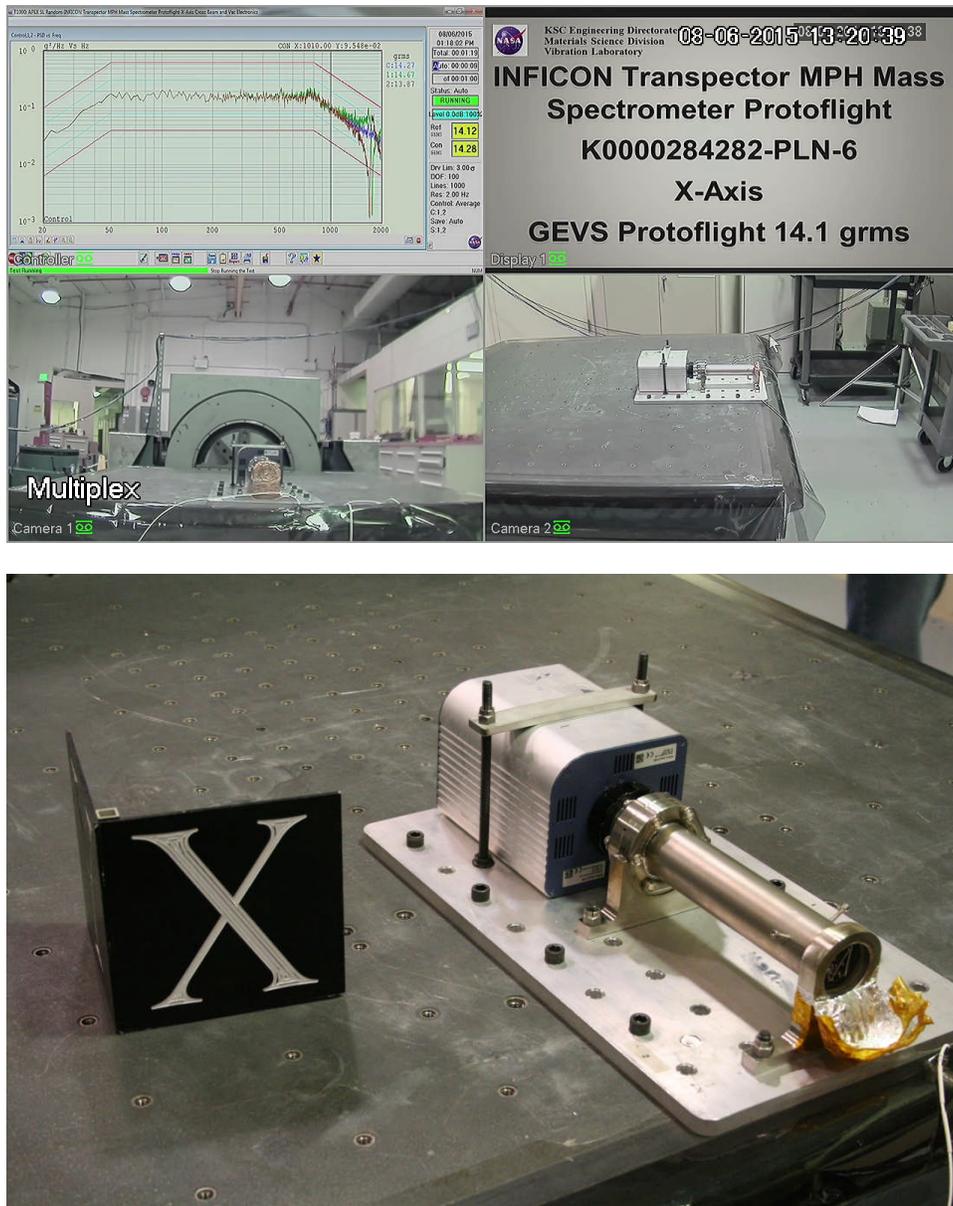
Figure 23. Crossbeam MPH Y-Axis Vibration Test Screenshot and Photo.

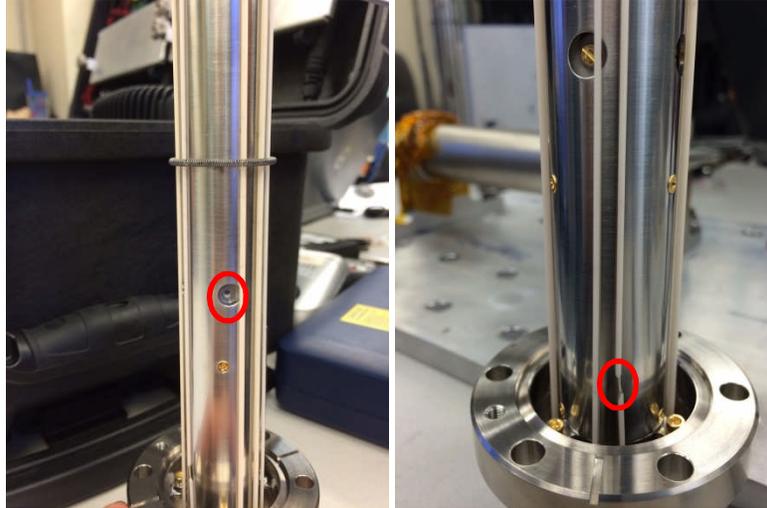
One set screw, out of four holding the RF shunt together, came off. The screw was replaced before being functionally tested. The test article responded nominally. There was also a ceramic sheath that was damaged, but did not seem to affect functionality.

Figure 24. RF shunt showing a missing screw (left) and broken ceramic sheath (right).

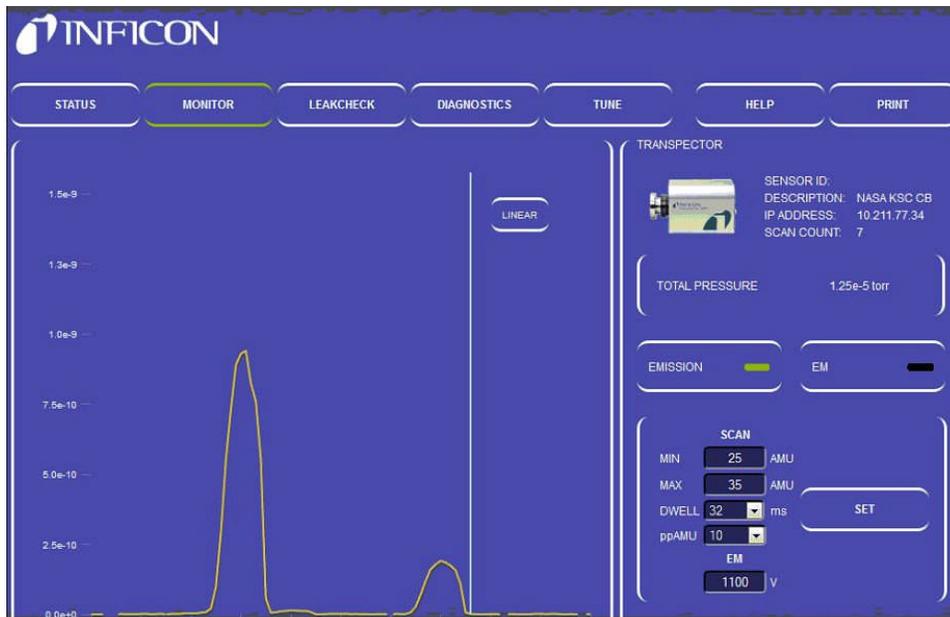
Figure 25. Crossbeam MPH Post-Y and X-Axis Functional Test with Room Air.
