Designing for Reliability and Robustness in International Space Station Exercise Countermeasures Systems

As spaceflight durations have increased over the last four decades, the effects of microgravity on the human body have become far better understood, as have the exercise countermeasures. Through use of a combination of aerobic and resistive exercise devices, today's astronauts and cosmonauts are able to partially counter the losses in muscle strength, aerobic fitness, and bone strength that otherwise might occur during their missions on the International Space Station (ISS).

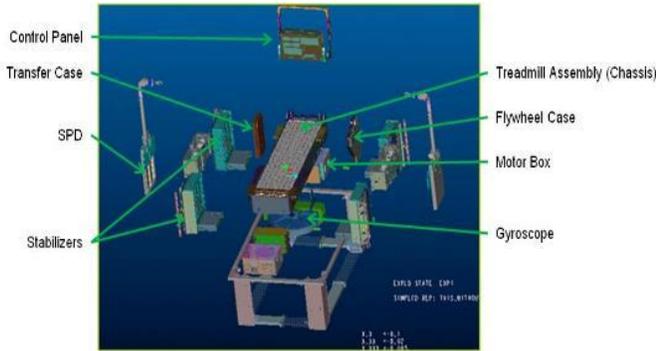
Figure 1. TVIS System

stabilizers, four motor controllers and a VIS controller. The running surface of the treadmill was used in much the same way as any conventional terrestrial treadmill, except the user was held to its surface by the Series Bungee System (SBS) and/or the Subject Load Device (SLD), which each attached to the Treadmill Harness to counter the microgravity environment. TVIS served on ISS until 2013, at which time it was replaced with the Russian BD-2 treadmill. Figure 1 shows a schematic of the TVIS, while Figure 2 shows the TVIS in use on ISS, including the SBS. [1]

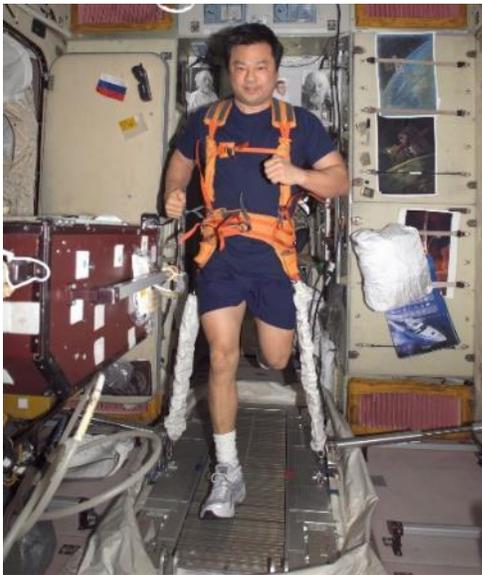
Figure 2. TVIS in use on ISS

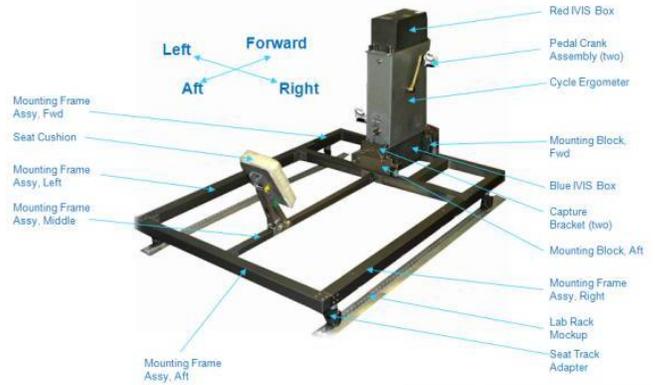
Figure 3. CEVIS System

While the TVIS provides the ability to run and walk in microgravity, the CEVIS system provides cycling aerobic exercise, in either a recumbent or upright posture. CEVIS is also used for pre-breathe operations prior to an EVA, periodic fitness evaluations, and pre-landing fitness evaluations. The CEVIS Ergometer can be controlled electronically via protocols in a control panel, or it can be manually controlled by the subject. The Control Panel displays real-time subject data, including heart rate, speed, and workload. Two Inertial Vibration Isolation and Stabilization (IVIS) Boxes are attached at either end of the Ergometer and provide passive mechanical

counter-inertia to the forces imparted by the riding subject. These minimize forces imparted into the CEVIS frame and hence into the ISS structure. CEVIS was deployed on ISS in March 2001 and continues in service currently. Figures 3 and 4 show the CEVIS schematic and the CEVIS in use in an recumbent posture, respectively. [2]

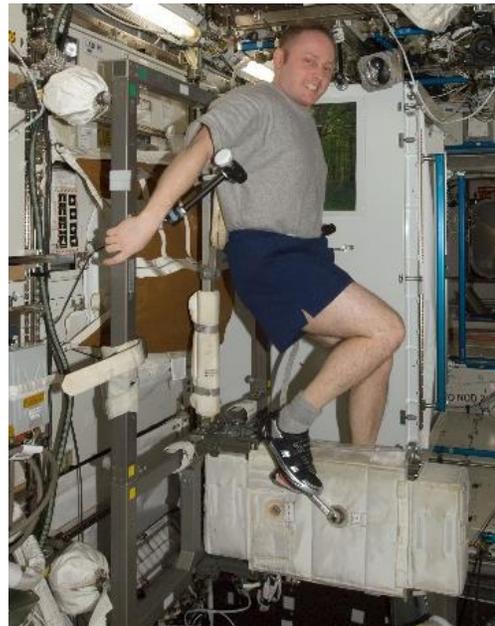
Figure 4. CEVIS in use on ISS

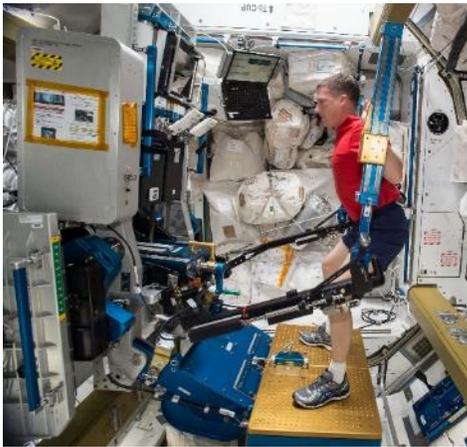
Figure 5. ARED in use on ISS

The ARED is the primary resistive exercise device on ISS utilizing two vacuum cylinders to provide workload. The ARED system incorporates multiple improvements to its predecessor, the Interim Resistive Exercise Device, including increased load from 320 to 600 pounds, a more desirable load characterization, vibration isolation, lower maintenance requirements, and greater ease of use and reliability. It provides bar and cable (rope) exercises, much like ground gym equipment, and it contains an inertial flywheel system to simulate the feel of 1-g free-weights. ARED was deployed in January 2009 and continues in service currently. Figure 7 shows the ARED in use on ISS. [3]

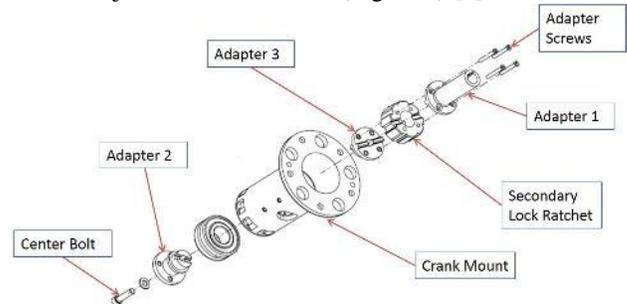
Figure 7. Exploded View of ARED Crank Handle Internal Mechanism

position of the slider (Figure 8). The crank handle requires two auto-locking mechanisms to be disabled in order to adjust the resistance. First, the crank handle is spring-loaded to prevent inadvertent slipping of the crank load adjustment mechanism. Second, a trigger mechanism in the handle requires the disengagement by the crewmember prior to adjusting the load. The assembly consists of a stack of keyed parts that transmit the load to the adjustment mechanism (Figure 7) [3].

The first series of ARED crank handle failures occurred at approximately 2 years of service in January 2012. Until then, no maintenance had been required or performed on it. The crew experienced spontaneous increase in dialed load while turning the crank handle, which is only possible if something in the stack of keyed parts or safety latches were to fail. The crew removed the crank handle from the load adjustment unit and found that the key that connects adapter 1 to the ball screw shaft was sliding into adapter 1 and disengaging the ball screw. This was remedied by inserting a small socket into adapter 1 behind the key to prevent it from sliding. Next the crew discovered the locking pin in the crank handle was worn down to where it would not engage the catch reliably. Another successful workaround was devised to replace the pin with a bolt. The third and final failure on this unit occurred when, again, spontaneous load increase occurred. When the crew disassembled the crank handle the final time, they found that the keyed interface

between adapters 2 and 3 had sheared off, allowing the stack to spin freely and bypassing the protective latch mechanism. ARED was declared NO GO until a replacement was delivered. The socket inside adapter 1 was reapplied to the replacement unit and continues to be in use.

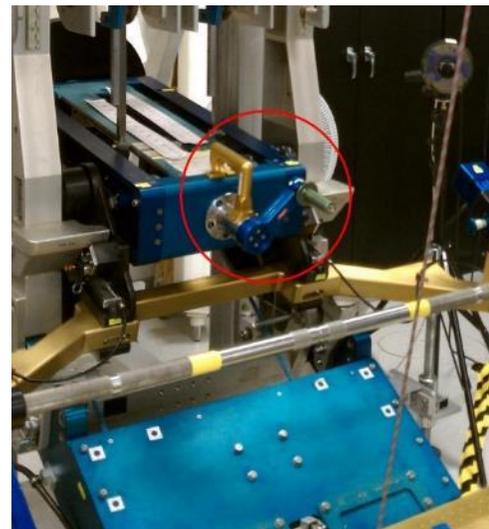
Figure 8. ARED Crank Handle Location

The ARED arm base assembly is the connection point between the bar or cable actuated by the crewmember to the piston shafts that supply the load. It allows the user to adjust the load by turning a crank handle attached to the end of a screw assembly. The crank handle serves as the crewmember interface to the load adjustment mechanism, and it allows the crewmember to select the amount of resistance by adjusting the

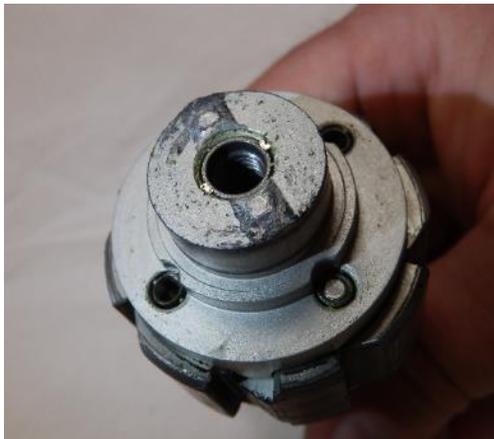
Figure 9. Adapter 3 Key Damage

The second crank handle unit remained in service until a failure in October 2014. The crew reported a slight spontaneous load increase, so troubleshooting was conducted on-orbit. The crew found that three of four fasteners that connect adapters 1 and 3 were completely backed out and free-floating in the assembly housing. The crank handle was replaced with a spare and returned to the ground for assessment, where it was discovered not only had the fasteners backed out, but the keyed interface between adapters 2 and 3 was sheared off. This damage can be seen in Figure 9 below. This last failure initiated a change request to redesign the internal parts of the crank handle to eliminate possibilities for fasteners becoming loose or interfaces from fracturing [9-14].

The second crank handle unit had an anomaly occur in July 2013. The crew reported the handle was loose. Upon inspection they determined that the center bolt was loose. The ARED engineers developed a procedure to properly tighten the bolt, and a routine maintenance activity was added every 6 months to prevent the center bolt from loosening again.

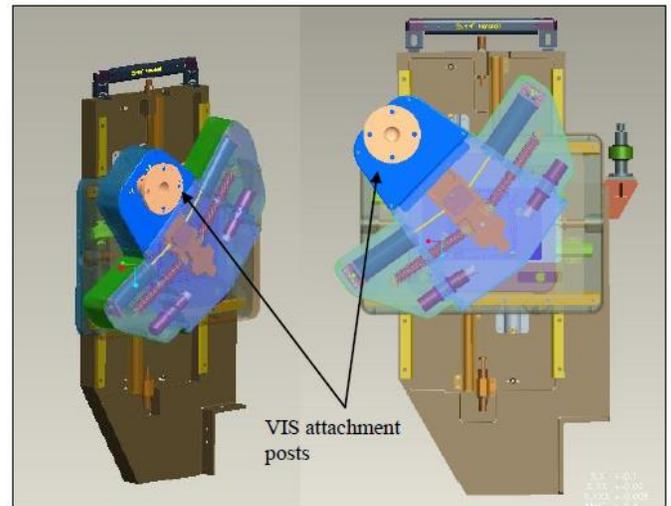
Figure 10. ARED VIS System

The ARED Vibration Isolation System (VIS) has three major components: X-rotation, Y-translation, and Z-translation (Figures 12 and 14). After approximately 6 months of use, the crew identified damage to X-rotation dashpots, which was not previously seen in ground life cycle testing, including a separated rod end and cracked glass housing. ARED was declared NO GO, and the damaged dashpots were replaced

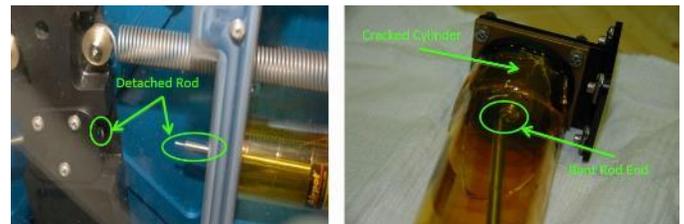
Figure 11. -Rotation Dashpot Rod End Failure (left) and X-Rotation Dashpot Glass Breakage (right)

approximately a month later after spares arrived on board. It was determined that the rod end pulled out of the swage fitting and the paddle of the dashpot impacted the loose end, causing it to bottom out and crack the glass housing (Figure 13). Three subsequent failures occurred over the next 3 years, all exhibiting the same failure mode, but spares were pre-positioned on ISS to provide immediate recovery of operations. A design change was initiated on the interface of the rod end and swage to provide a stronger connection. This design has since been life-cycle tested and certified for flight and has proven to survive cycles that equate to the end of the ISS life currently set to 2024. Spares will still be flown to minimize risk of system down-time [15].

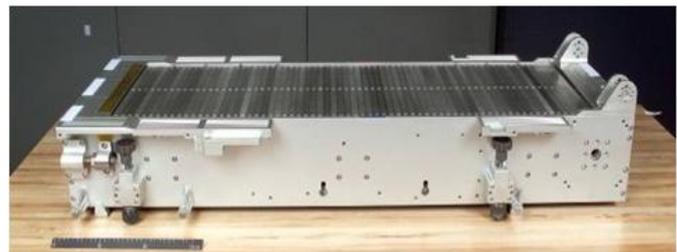
Figure 13. Treadmill Assembly (Chassis)

The treadmill chassis (Figure 13) consisted primarily of a four-sided rectangular aluminum box with two long side panels and two end panels. The internal chassis support assembly (ICSA) as seen in Figure 16, the main subassembly of the chassis, contained 50 roller assemblies mounted in two aluminum channels that provided support to the tread belt and absorbed the footfall force. Eight roller assemblies were mounted to the three cross support beams, which along with an additional four black side roller assemblies mounted in the side panels, provided support to the tread belt [1].

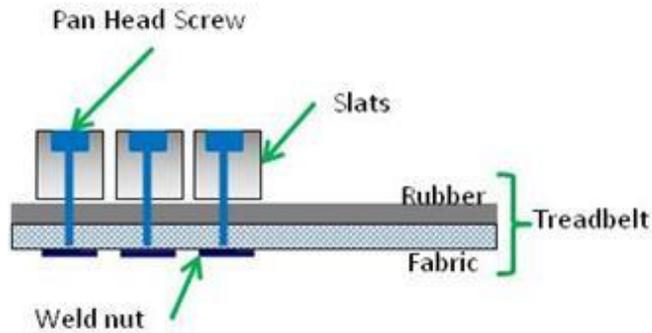
Figure 15. Tread Belt Stack-up Nominal Configuration

The running surface of the treadmill, the tread belt assembly, was composed of several subassemblies, which included the endless belt, slat assembly, pan-head screws, and weld nuts. The tread belt assembly consisted of a flexible belt with 159 individual rigid slats, which were attached to the upper Neoprene rubber side of the belt (Figure 17).

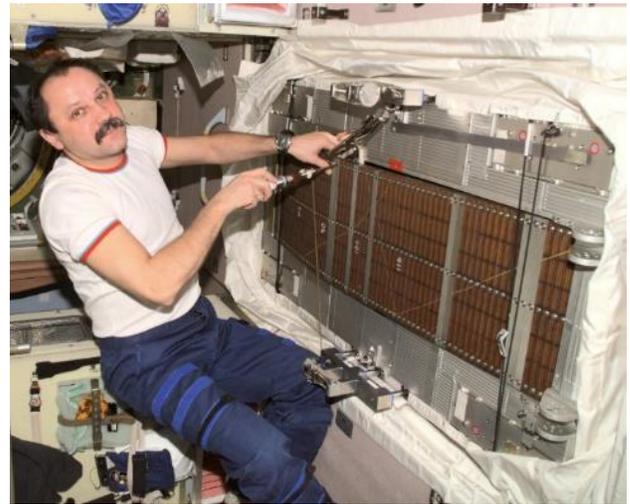
Figure 16. TVIS Chassis on ISS

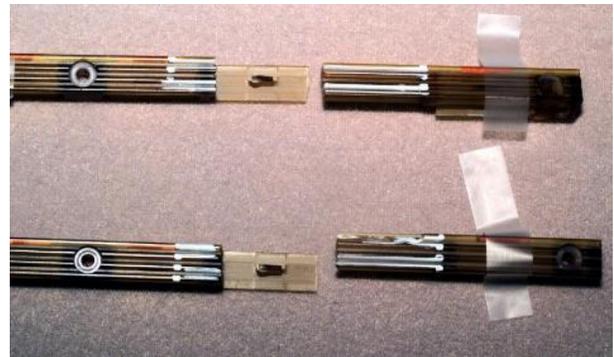
Figure 17. Broken Ultem 2000 TVIS Slats

In March 2001, the crew reported that some Ultem 2000 slats on the TVIS chassis had cracked during use (Figures 18 and 19). Pictures were sent to the ground for evaluation, and TVIS was declared NO GO for use. Upon evaluation, engineers on the ground determined that the slat design had negative margins of safety for stress and fatigue. The slats were subsequently redesigned and machined from aluminum (Figure 20). The aluminum slats were certified, flown and installed, and never experienced this failure again in the lifetime of TVIS operations [17].

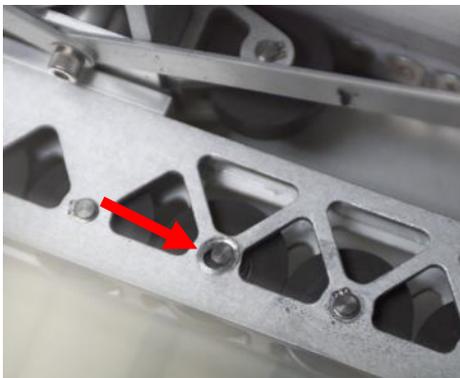
Figure 19. ICESA Damaged due to Seized Bearing

First, during post-flight visual inspection of the chassis in July 2002, an egg-shaped hole was found in the truss where a roller shaft mounts (Figure 21). On-orbit troubleshooting revealed two similar holes in the truss on-orbit. The root cause of the damage was determined to be a failed bearing that seized on its shaft. When the bearing failed, it caused the shaft to begin spinning within its mounting hole. The steel shaft began to eat

away at the aluminum truss and created the egg-shaped hole. The failed bearings were sent to the NASA Materials and Processes (M&P) group for analysis, and they determined that the bearings had insufficient lubrication and were underrated for this application.

After the following corrective measures (design changes and procedure changes) were implemented with the new roller assembly design used in the -309 chassis, this anomaly did not reoccur:

- The ICESA was redesigned to eliminate lightening pockets and to use a stronger material (Aluminum 7075).
- D-shaped aluminum bushings on the outboard side were added to increase the load-bearing capacity of the truss as the shape prevents the rotation of the bushing.
- The new truss was designed to allow for on-orbit roller bearing replacement of the bearings that see the greatest load on-orbit.
- The steel bearing shaft was secured to a locking nut.
- Rheolube 2000 was used as a bearing lubricant.
- Crew procedures were modified to regularly inspect for failed bearings [19].
- Treadmill usage was closely tracked and roller assemblies were replaced prior to bearings reaching end of life.

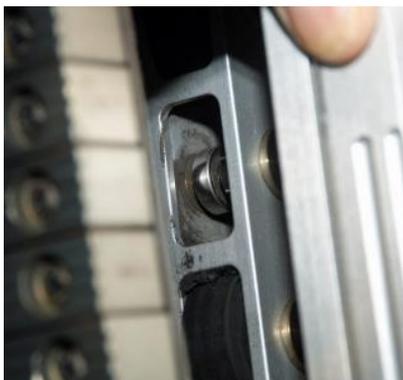
Figure 20. Roller Damage

Second, the crew reported a failure with the chassis rollers in October 2007. The ICESA with the missing roller can be seen in Figure 22 below. They had approximately 660 hours of use (2 years) at the point of failure, but were certified by analysis to a limited life of 2000 hours. That analysis was based on KC-135 test flight data that demonstrated the loads observed at the rollers within the treadmill. Using that data in an analysis, the center 10 rollers on each side of the chassis would need to be replaced every 500 hours, whereas the remaining rollers should last 2000 hours. Since a roller outside the center 10 rollers failed on-orbit after 660 hours, it was concluded that the analysis assumptions were incorrect, and the design did not have enough margin to accommodate the actual loads applied on-orbit. A design change was made to the roller material and larger bearing in 2009 using a modified skateboard wheel, and the design proved to be robust, never failing or needing replacement. The limited life was set to 500 hours, the same as the previous black roller design since no testing was done. The performance of the new design was trended and monitored, but no damage or significant wear was ever observed, as seen in Figure 23 below, so the life was extended to 1000 hours, and it continued in use without a failure until the TVIS retirement in 2013 [18].

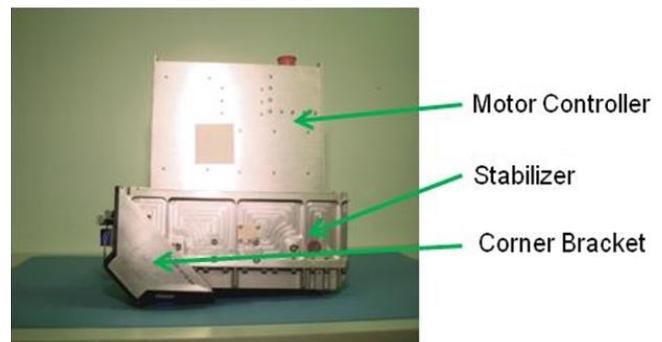
Figure 22. Stabilizer Assembly

The four stabilizer assemblies were used to stabilize Z-axis and pitch motion of the TVIS System. The stabilizer assemblies were installed onto the treadmill via two captive bolts at each of the four corners of the treadmill chassis. The three main subassemblies of the stabilizer assembly were the motor controller, clamp rope assembly, and the stabilizer (Figures 24 and 25) [1].

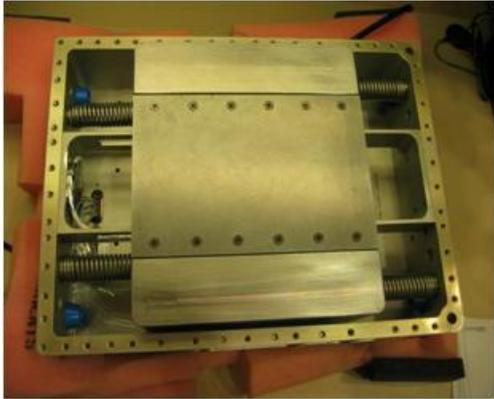
Figure 24. Stabilizer – Cover Removed

The stabilizer was comprised of an aluminum housing, rare earth magnets with a stainless steel back plate, and stainless steel bearings. The stabilizers had an actively controlled mass spring motor system with a natural frequency near the average running frequency (~3.3 Hz). The stabilizers contained a brushless DC linear motor equipped with linear bearings lubricated with Braycote 601, which moved the mass-spring system to provide an equal and opposite force to the footfall forces and to help stabilize above the natural frequency. The internal components of the TVIS stabilizer can be seen in Figure 26 above. The motor controllers contained all of the electronics that controlled the motor movement within the stabilizers.

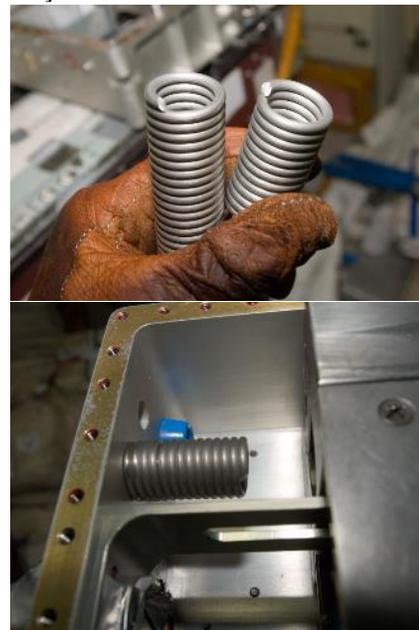
Figure 25. Broken TVIS Stabilizer Springs

On June 5, 2009 the forward and aft right stabilizers were disconnected from the TVIS System by the ISS crew, and their covers were removed. Internal inspections of the forward right stabilizer revealed that one of the four springs had failed and the spring/flange connector fasteners that attached the spring to the throw mass had also failed (Figure 27). The spring/flange connector fastener heads and spring/flange connector with part of the broken spring were removed from the forward right stabilizer and the cover was reinstalled. No damage was found during internal inspection of the aft right stabilizer. Both stabilizers were reinstalled on June 2009, and an ACO consisting of a “shake test” for all four stabilizers was conducted to identify any additional loose parts within the cavities. Following the unmanned and manned ACO, the TVIS System was put back into use on-orbit; however, the system was in a degraded state until ground spares could be assembled and flown.

In order to prevent additional spring failures and to return the TVIS System to a nominal operating configuration, four spare springs were flown on flight 2J/A and installed in the forward right stabilizer in September 2009. During the April 2010 Annual Maintenance, a new forward right stabilizer assembly was installed and springs were changed-out with flown spares in the remaining three stabilizers. Additionally, during the scavenge activity on the forward right stabilizer assembly, the crew reported an additional failed spring, which was removed prior to re-stowing the stabilizer on-orbit as a “scavenge-on-need” spare unit. Engineering believes that the possible cause of the additional failed spring in the stabilizer was due to two broken springs identified in the forward left stabilizer during the change-out activities. The forward left stabilizer spring failures potentially caused the remaining stabilizers to work harder (increasing load and spring extension and decreasing the natural frequency of the VIS System) and may have contributed to the premature failure of the spring in the forward right stabilizer [20-22].

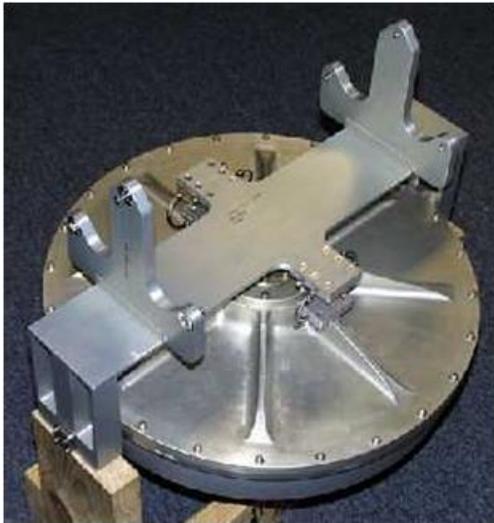
Figure 26. Gyroscope assembly

The gyroscope assembly (Figure 28) was used to stabilize the TVIS System from excessive roll during operation and provided current peak smoothing of the TVIS System power sources. The gyroscope flywheel was housed in an aluminum housing. It was designed to spin at approximately 2400 rpm and provided the restoring torque to counter roll torque inputs by the crewmember. An integral brushless DC motor was used to spin the flywheel. Power and speed control for the gyroscope was provided from the VIS controller assembly. The gyroscope was located beneath the treadmill chassis in an area inaccessible to the crew during nominal operations and was attached to the chassis side plates. The gyroscope had a vertical spin axis and pivot bearings positioned in the pitch direction to allow for the required precession during operation. The gyroscope incorporated two (one per side) swaged wire rope assemblies that aided in restoring the gyroscope back to its neutral position and prevent excessive movement [1].

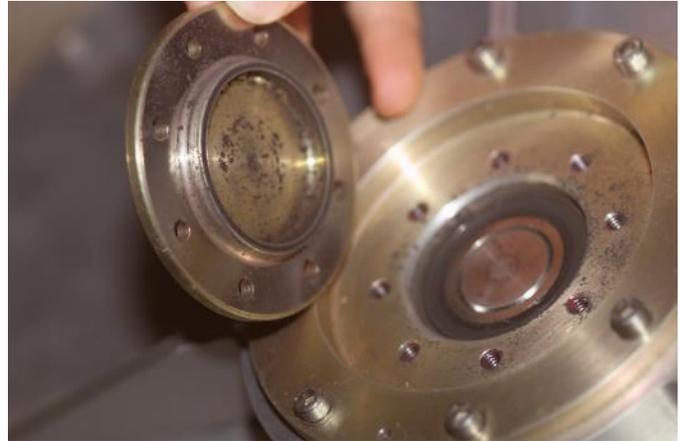
Figure 27. Gyroscope Bearing Debris

On November 17, 2003, the crew reported a metal scraping/screeching noise coming from the gyroscope. An In-Flight Maintenance (IFM) was conducted in December 2003 to disassemble the gyroscope. The crew identified that the bearing was degraded (Figure 29), and an investigation of the spare ground gyroscope revealed a similar problem on bearings that had only been used approximately 20 hours. NASA M&P investigated the problem and determined that the grease inside the bearings had been contaminated and was breaking down and also that the Nitrile material used to seal the bearing has a shelf life of 3 to 5 years. The manufacturer of the bearings initially packed the bearings with a hydrocarbon-based grease. The instructions in a drawing Flag Note indicated that this grease should be removed and the bearings repacked with Braycote 601 grease, but testing showed that the hydrocarbon-based grease was not completely removed on the failed bearings. The remnants of this grease chemically reacted with the Braycote 601, decreasing its effectiveness. This contamination caused the bearings to fail prematurely. This information was not previously identified by the bearing vendor or found during

certification of the hardware. The failed bearings were 7-years old. It is believed the seals failed, allowing the grease to escape, which led to rapid mechanical degradation of the bearings. The TVIS System engineering team assembled a gyroscope repair kit and an in-depth procedure to allow the crew to disassemble the gyroscope and install new bearings. The crew repaired the gyroscope in March 2004, and it operated nominally until it was replaced by a new gyroscope in December 2006. The newly delivered gyroscope included several design improvements. The bearing seals were made of Viton, which did not have a shelf life. Also, the bearing grease was changed to Rheolube 2000 [23-24].

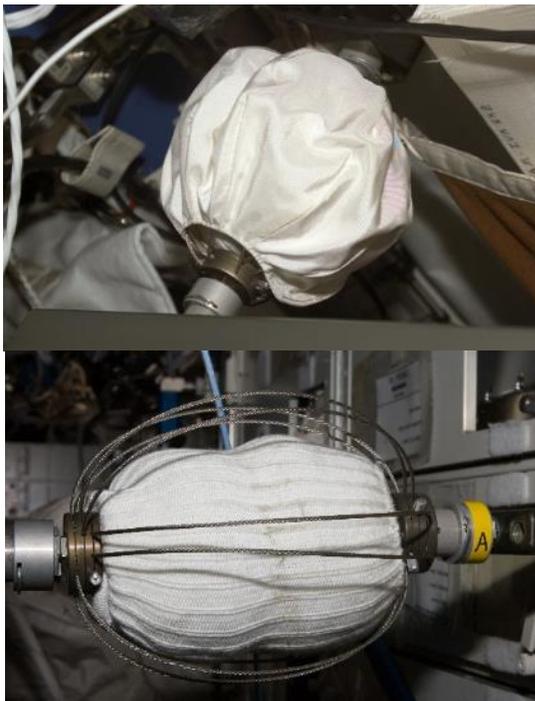
Figure 28. CEVIS Isolators on ISS

every 3 months to check the status of the isolators. The wire ropes have periodically broken due to fatigue at the clamp point, as a stress concentration exists at that point when the wire ropes are flexed, but they can remain in service if eight or fewer wires are severed. Once the eighth wire breaks, the unit is replaced. The crew on Expedition 6 added rolled sock-balls inside the wire cage to help reduce movement during the EVA exercise pre-breathe activity, which purges the system of nitrogen before a spacewalk is conducted. This requires rigorous pedaling and movement with the arms, which makes the CEVIS riding very unstable without the socks. They also act as bump stops and prevent severe bending of the wire ropes.

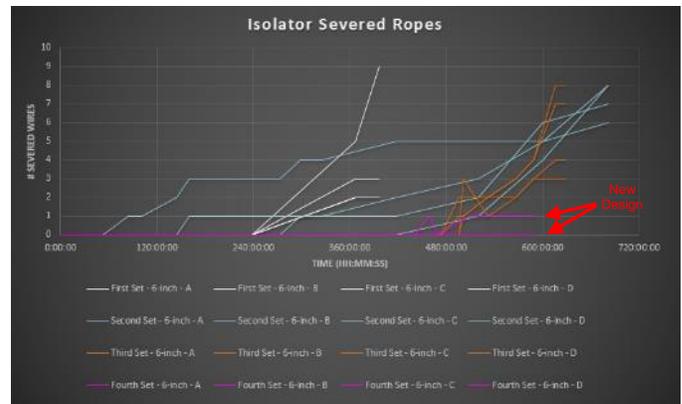
Figure 29. CEVIS Isolator Performance History

The clamp plates of the CEVIS isolator were redesigned in 2011 to add a chamfer to the edge of the hole where the wire rope passes through the plates, thus reducing the stress concentration at that point. Figure 32 below shows the outlet hole of the isolator before the design change, and Figure 33 shows the updated design with the chamfered edge. This small change has increased service life of the isolators substantially, and the true service life is still being evaluated, as only one wire has failed on one isolator in almost 4 years of use. Per Figure 31, it is evident that the effects of the new design (magenta lines) are a dramatic improvement [25].

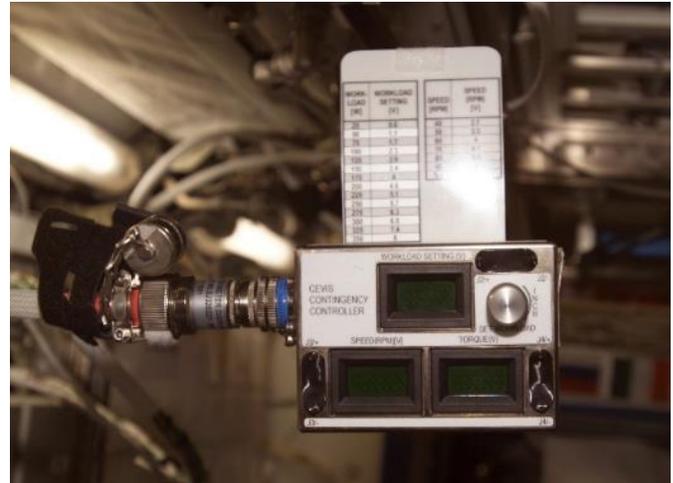
Figure 32. CEVIS Contingency Controller

A workaround was developed that enabled the crew to resume powered CEVIS exercise. Using on-orbit power

supplies and wire, the crew was able to input voltages to regulate the CEVIS workload and receive feedback data via on-orbit voltmeters. A replacement control panel was launched on ULF1.1, and the CCC (Figure 34) was subsequently designed, tested, and certified in case another unexpected control panel failure occurred. The CCC remains stowed on ISS currently [26].

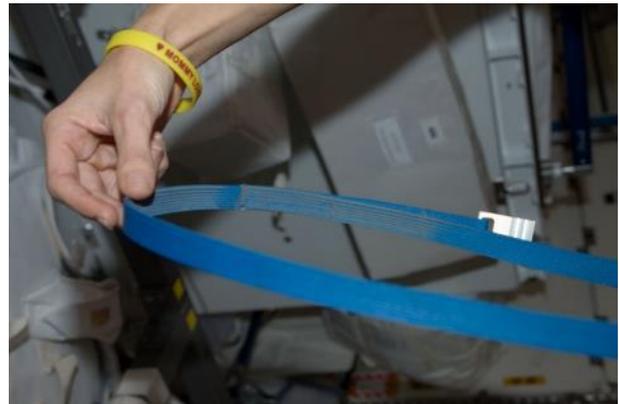
Figure 34. Dirty CEVIS Braking Band

During the new CEVIS control panel activation and checkout in March 2009, the crew reported seeing the manual control knob message appear when the load decreased from a high workload to a low workload in protocol mode. A review of the new control panel activation and check-out data, PFE and subsequent exercise data revealed a gradual increase in workloads over time with rest periods not returning to baseline. The manual knob function was checked later during ACO and

verified to be nominal. Subsequent data analysis showed that actual load was not following target workload. When target workload changed from high workload levels to low workload levels, actual workload was significantly greater than target workload. This load discrepancy increased with time over the course of an exercise session. On April 9, 2009, troubleshooting isolated the problem to the ergometer. The crew was directed to stand down on CEVIS operations because load discrepancy indicated potential internal ergometer damage, and the risk associated with continued nominal usage prior to an ergometer internal IFM could result in irreparable hardware damage or failure. Trending data analysis from March 29, 2009 to April 8, 2009 showed the anomaly to worsen over the span of a protocol. Several IFM activities were performed in May 2009 to disassemble the ergometer. Internal sub-assemblies were inspected and determined to be nominal. The braking band, fan, guide rod, and flywheel were all cleaned of dust and debris. The braking band contained some embedded dirt that was later partially removed by brushing and vacuuming. Several internal components were inspected and photographed before reassembling the ergometer. After the ergometer was reassembled, several protocols were run, and the workload drift anomaly and manual knob messages disappeared. Data was analyzed on a weekly basis, and no major issues were identified in the data between June 2009 and middle August 2009. During review of the CEVIS data downlinked in early September 2009, actual workload data did not return to target load as commanded when stepping down from high workload to lower workload. On September 15, 2009, the crew noted that 'Manual Knob Activated' message was displayed on the CEVIS control panel during a large delta in workload. The direct cause of the workload drift was due to the excess friction force from a heated, dirty and worn braking band (Figure 34) to the flywheel, adding additional mechanical resistance to the system. The CEVIS ergometer braking band was replaced with the new braking band that was launched on 17A during an IFM activity on October 5, 2009 (Figure 35). The braking band had been in use on-orbit for approximately 7 years before it was replaced. Data processed weekly since October 2009 supports that the anomaly had been remedied by replacement of the braking band. A braking band limited life of 382 hours was added to the Government Certification Acceptance Request (GCAR) and began to be tracked by the CEVIS team. It is acceptable to exceed the 382 hours if no signs of the anomaly are present [27-28].

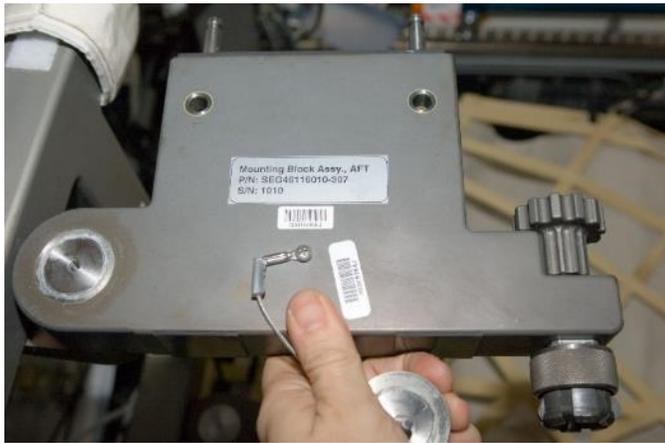
Figure 35. CEVIS Mounting Block

In May 2002 the Expedition 2 crew reported that the CEVIS was becoming more difficult to rotate into operational configuration. They heard a “scraping/crunching” noise, at which point they stopped and notified the ground. The crew confirmed that the CEVIS was deployed in the operational position, not in the stowed position. Engineering determined that there was binding in the guide pins causing friction during rotation and developed a troubleshooting procedure to help the crew assess the problem. The crew verified that the mounting block was stuck to the mount pins. Engineering determined that the only solution for resolving the issue was replacement of the forward frame, guide pins and mounting blocks. Operations concluded that this configuration was acceptable since it does not impede emergency egress and only slightly impinges on the nominal crew translation path. A material analysis was

performed on the ground at JSC, which concluded that materials selected in this application did not have good compatibility for galling prevention. The damaged guide pin and mounting block bushing can be seen in Figures 39 and 40 below. The materials group recommended the use of a lubricant, Braycote 601EF, to reduce the risk of galling in the future. Before on-orbit implementation, the revised configuration with Braycote 601EF was successfully cycle-tested on the ground the equivalent of 2 years on-orbit use. From the time of failure in 2001 until 2006, the crew used CEVIS in the deployed position, and it was kept in operational position until the new frame was flown on ULF1.1. Yearly maintenance to lubricate the guide pins and mounting block bushings was implemented in July 2006 and continued every year thereafter [29].

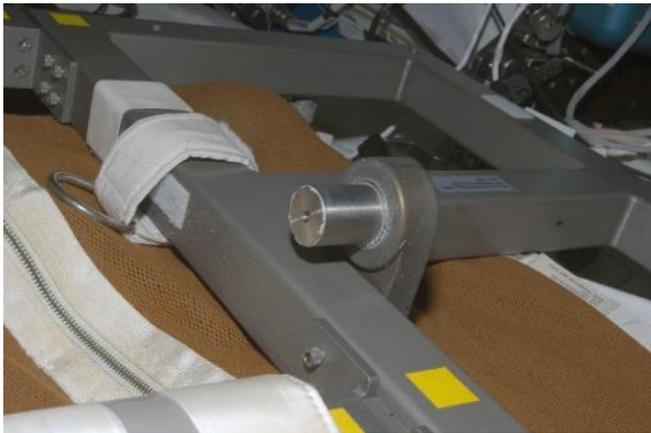
Figure 36. CEVIS Guide Pin
