NASA TECHNICAL NOTE

NASA TN D-6724

APOLLO EXPERIENCE REPORT - LUNAR MODULE ENVIRONMENTAL CONTROL SUBSYSTEM

APOLLO EXPERIENCE REPORT

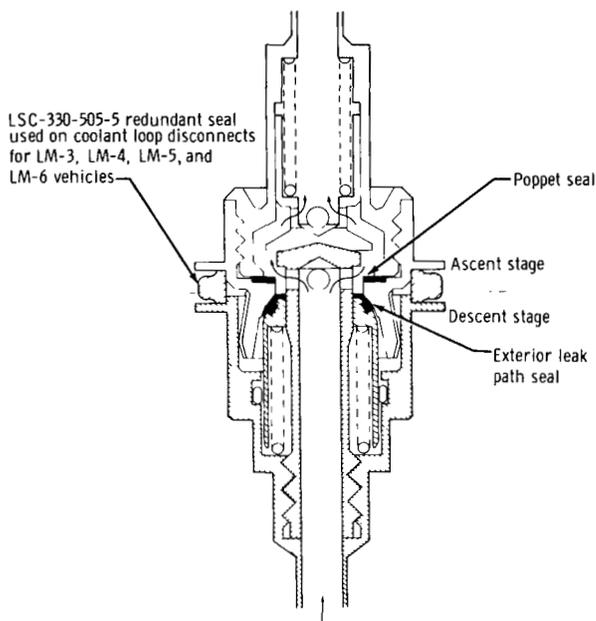
Figure 5.- Original design of interstage disconnect.

The original design used a single compression seal and was successfully certified
with flight bracket assemblies. From the beginning of vehicle assembly and checkout at
the manufacturer's plant, it was noted that this particular design was susceptible to
damage during vehicle installation unless extreme care was taken. Subsequent installa-
tion efforts at the NASA John F. Kennedy Space Center (KSC) verified the damage

susceptibility; and it was necessary to add a redundant seal (fig. 5) to the LM-3, LM-4, LM-5, and LM-6 coolant-loop disconnects to ensure no external leakage. The redundant seals were not used on the oxygen disconnects because the higher pressure (900 psia) provided a much better seal than the lower pressure (20 psia) glycol disconnects. It was also found that the redundant-seal method used was ineffective at pressures above 50 psig. Starting with the LM-7 vehicle, a redesigned disconnect (fig. 6), which had built-in redundancy and also provided better protection to the sealing surfaces, was used. This design was certified by test and installed in the remaining vehicles. To date, this design has shown a high resistance to handling and installation damage.

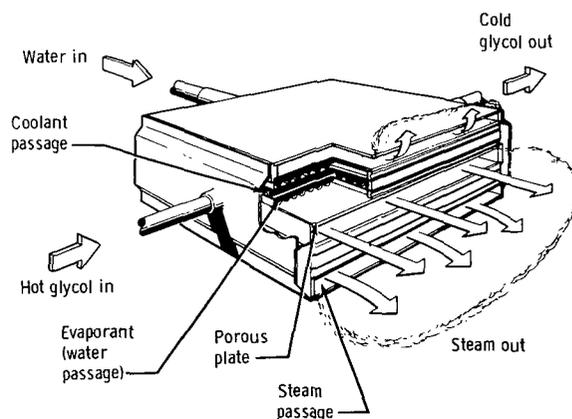
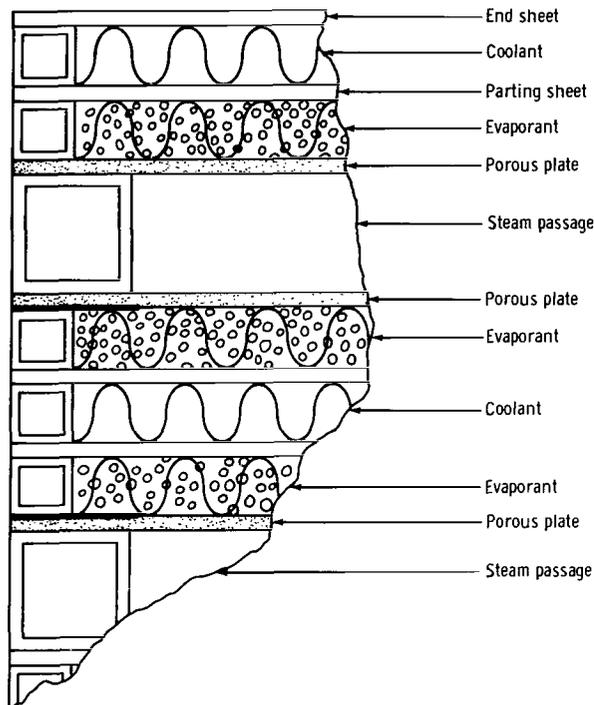
Figure 7. - Cutaway view of water sublimator.

Sublimator developments. - The development of the sublimators for heat-load rejection caused probably the most significant design problems of the LM ECS. The relative simplicity of sublimator operation might give a misleading impression of the difficulties involved in the design and manufacture of the device. Simplicity is apparent in the cutaway view (fig. 7) and in the expanded section shown in figure 8. The early problems were difficulty in brazing the porous plates and in achieving a good bond without plugging the pores with braze material. Materials were changed as were brazing techniques. The early units were also showing performance degradation rates (with usage time) that were not encouraging; and, also, the initial performance was below expectations. Loss of porosity of the plates directly reduces performance, and this seemed to be the problem.

Porous plates with higher permeability were used; and several other improvements in fabrication were tried, including welding of fins to the porous plates to eliminate brazing problems. Performance improvements were made by increasing the density of heat-transfer fins in the coolant passages. Additionally, to meet performance requirements, it was required to control the installation of porous plates so that the finer pore orientation was always facing the steam vent passage.

Chlorine was added to the stored water to act as a biocide. The chlorinated water produced unacceptable performance in the sublimators. Formation of a chlorine-based residue on the steam-passage side of the porous plates caused a depression of the freezing point, and water breakthrough occurred. Testing was performed by using iodine as the biocide, and these tests showed that iodine was acceptable.

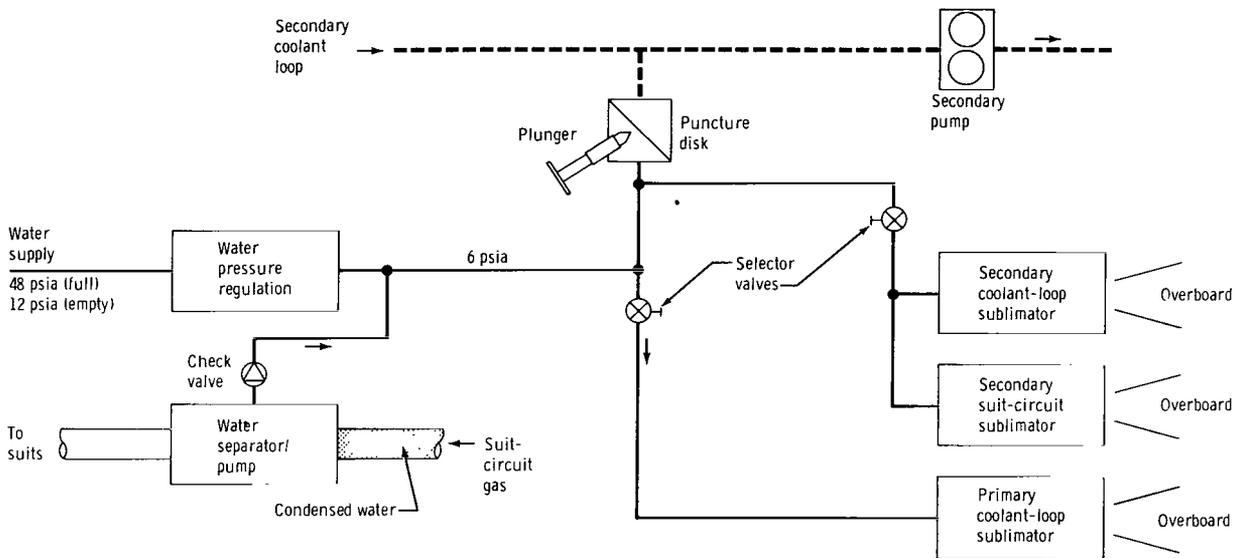
Figure 10. - Simplified diagram of original design of redundant cooling loop/water system.

Figure 10 illustrates the general arrangement of the redundant cooling system and the water system. The interface of these two systems is at the puncture disk, and activation of the secondary cooling loop included puncturing of this disk so that the water system could serve as an accumulator. The use of ganged valves ensured that the selection of the proper water valves drove a pointed plunger through the puncture disk. Because this was an irreversible step that left the systems with some intermixed fluid and required special cleaning, the actuating mechanism was arranged to prevent inadvertent puncturing of the disk. Despite this design and the use of warning flags during ground operations, there were several instances early in the program when the disk was punctured during factory operations.

This configuration was sensitive to the absolute pressure in the water/glycol loop. A high pressure caused water/glycol to enter the waterline feeding the secondary sublimators. Development testing indicated that the sublimators had an acceptable tolerance to the ethylene glycol (commonly used as "permanent" antifreeze). The pressure in the secondary water/glycol system was established by filling it with hot, deaerated water/glycol and then sealing it off. When the system cooled to ambient temperatures, it was at a subatmospheric pressure (approximately 5 psia).

Thermal-vacuum testing on a lunar module test article (LTA-8) provided the first opportunity for testing with complete spacecraft systems. A very slight leak existed, and the pressure that was locked off in the secondary coolant loop slowly rose. During the "hot case" secondary loop operation, the disk was punctured and the secondary sublimators failed. The glycol had caused sufficient lowering of the freezing point of the sublimator feedwater to prevent an ice layer from forming, allowing the water to break through and to freeze in the steam duct. To eliminate this interface

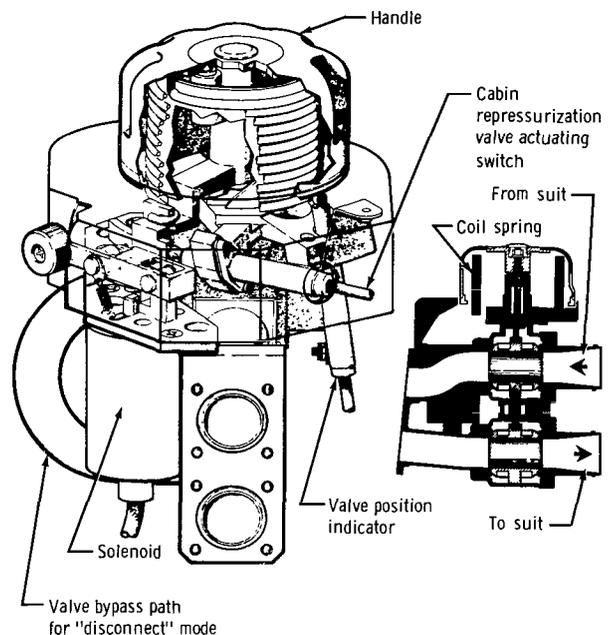
Figure 14. - Suit-isolation valve (item LSC-330-138).

Suit-isolation valves. - During the safety reassessments following the Apollo spacecraft fire in 1967, a completely new valve was developed and provided for isolation of the suit gas umbilical hoses. The change provided electrically actuated, fast-acting valves that automatically closed both supply and return hoses of both crewmen if suit-circuit pressure dropped below a safe level. Use of the valve guaranteed that at least one crewman would be protected (pressurized) and enabled to reopen his hoses manually, to close the hatch (which was presumably open in order to get a low cabin pressure in the first place), and to repressurize the cabin. The previous design was manually actuated only and provided protection for one less failure than the solenoid actuated design. This change was made rather late in the program and proceeded without major problems. Sluggish operation on several units required a minor change of materials to retain clearances after repeated usage.

A cutaway view of this valve is shown in figure 14. The cabin repressurization valve could be automatically actuated by means of the switch shown on the cutaway only if the repressurization valve was in the automatic mode. This switch was later removed as an unnecessary function.

Actuation of the suit-isolation valves was initially achieved by a suit-pressure transducer, which activated relays through signals from the caution and warning subsystem. This design was changed to activate the relays directly from a snap-acting pressure switch. This change improved the reliability and simplified the overall design. Originally, the transducer signal was compared with a preset voltage level in the caution and warning subsystem, which triggered the relay that applied the voltage to the isolation valves when the suit-circuit pressure decreased below the present level.

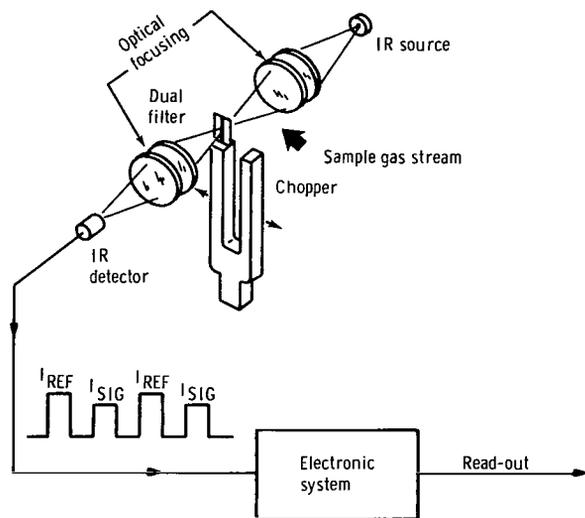
Figure 15. - Simplified system diagram of a CO_2 sensor.

If water entered the unit, it could bridge a narrow gap and set up a galvanic corrosion cell, which would then degrade the optical filter layers and seriously degrade the sensitivity of the unit. An epoxy-type coating was added to cover the metal surface near the filter and thus eliminate the galvanic cell action.

The unit was mounted on vibration isolators to help attenuate the vibration environment. In addition, a more rugged infrared (IR) source (lamp) was used; and the unit

case was ruggedized. The unit was designed to have a dc ground; but, because this was incompatible with the LM caution and warning system, an ac ground (resistance-capacitance network) was added to delete electromagnetic interference (EMI) sensitivity.

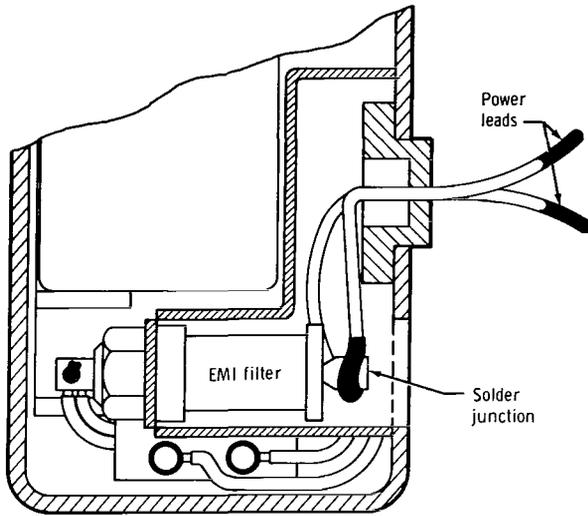
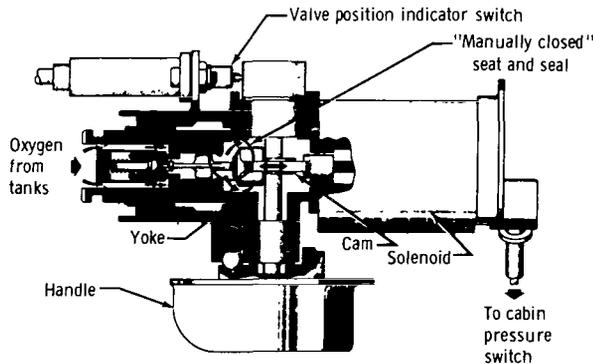
Figure 19. - Suit fan EMI filter configuration.

In late 1968, an EMI suppression filter within a suit fan electronics package was found to have an intermittent open circuit during KSC checkout. The problem was traced to overheating of the EMI filters when heavy electric leads were soldered on. The overheating caused failure of a solder joint within a capacitor. The change to heavy-gage wire was made as a result of wiring safety reviews following the spacecraft 204 accident at KSC in 1967. The configuration of the radial flow fan-motor assembly is shown in figure 17 and a motor cutaway view in figure 18. Details of the EMI filter configuration and wiring arrangement are shown in figure 19.

The design solution for the filter problem was to move the heavy-wire connection point farther from the capacitor lead and to install a wiring lug that was better suited to the heavy wire. A method was developed to remove the suit fans (two per vehicle) from the vehicle installation and to replace them with redesigned

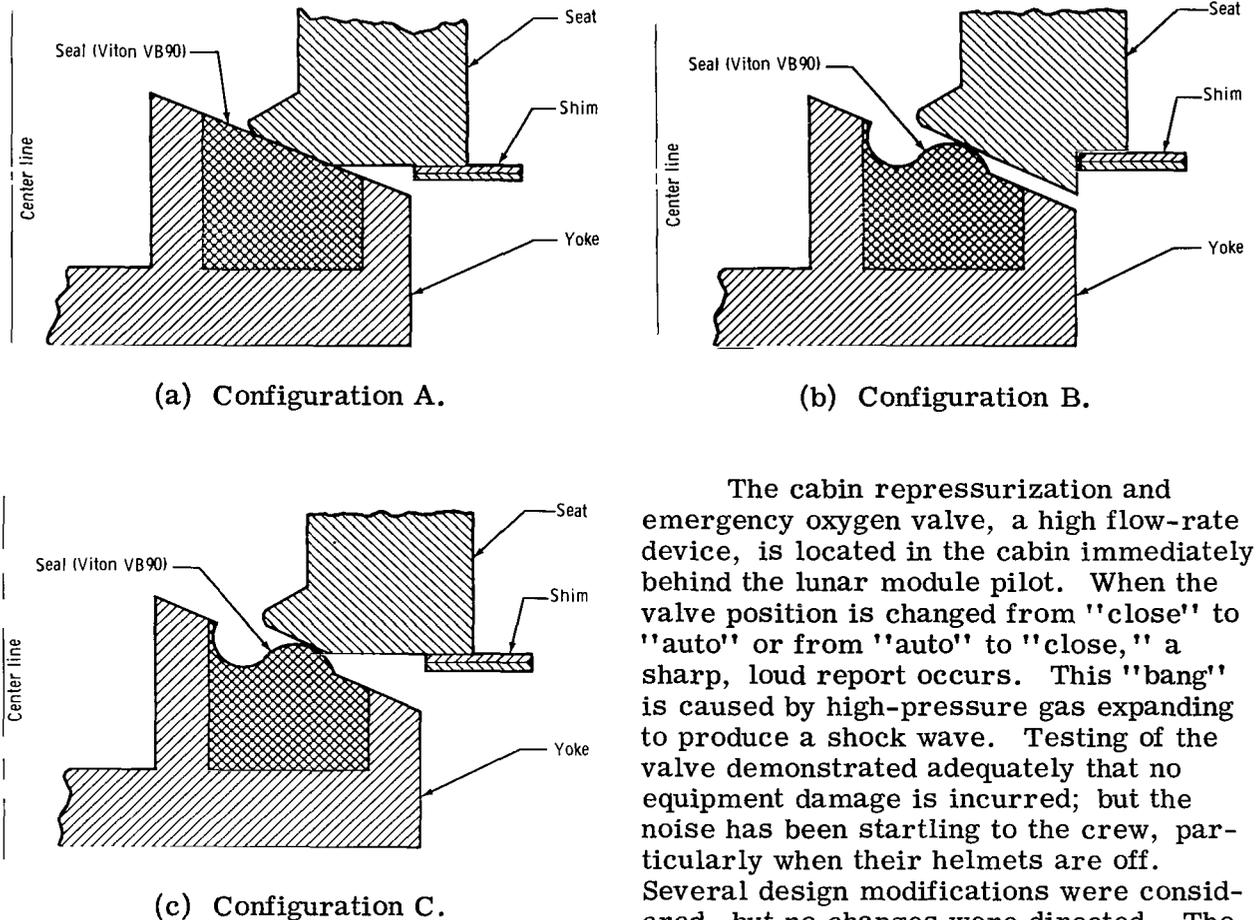
Figure 21.- Seat and seal details — cabin repressurization and emergency oxygen valve.

Cabin repressurization and emergency oxygen valve. - The cabin repressurization and emergency oxygen valve is used to repressurize the cabin and can be actuated manually or automatically by a solenoid in response to low cabin pressure. During design feasibility testing, the manual-close seat was found to be susceptible to permanent setting, and the seat material was changed from Viton B to Viton VB90. The configuration is illustrated in figure 20 and is designated configuration A (fig. 21(a)).

During production acceptance testing prior to the endurance phase of qualification, leakage again occurred in the manual-close mode. Inspection revealed that the seat had cracked as a result of compressive loads. The seat was redesigned to a wave-type shape (configuration B, fig. 21(b)) to allow required compression with lateral material expansion. This configuration was subjected to verification tests followed by formal certification tests. During the vibration-temperature testing of the certification program, the valve again leaked in the manual-close mode. It was determined that tolerance buildup was allowing the valve poppet to load unevenly and to move laterally during vibration. A design

change was made to the seat length to provide better centering and to resist lateral movement. Certification testing was completed with no additional leakage problems. Configuration C (fig. 21(c)) is the final seat and seal design.

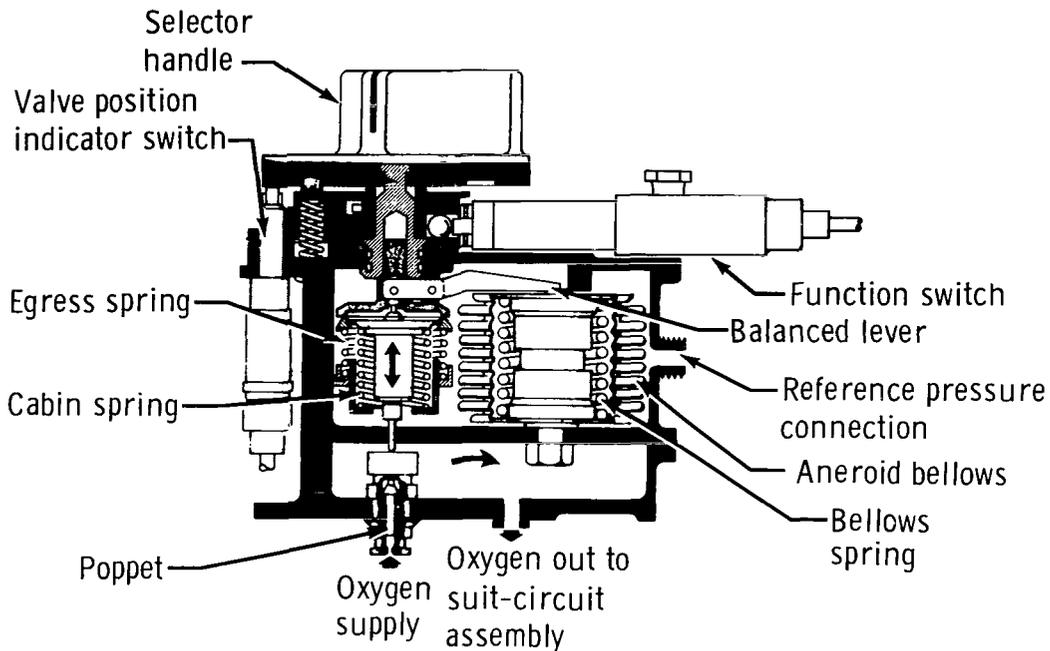
Figure 22.- Cutaway view of oxygen demand regulator.

The original design was highly sensitive to vibration while the demand regulator was operating within its pressure-control regions. Various aneroids and mass-balancing techniques were employed before the design was acceptable. The final design did not completely eliminate the increased leakage during vibration, but the suit-loop oxygen volumes are such that negligible pressure rise would occur during the vibration periods.

On several occasions, the oxygen demand regulators were contaminated by water, which produced corrosion following system checkout problems at the factory. These problems, which were always associated with testing the suit circuit "wet" by using the metabolic simulator (which introduces steam into the ECS), were identified only after some length of time following the incidents. In some cases, excessive water has been introduced as a result of metabolic simulator problems or by test errors with other related ground-test equipment that blocked the water discharge from the separators. The result was that water collects at the low point in the system where the oxygen regulator discharge tube attaches to the suit circuit. Testing is performed at 5 psia; and, at the completion of testing, water is driven upward into the demand regulators when the pressure is returned to sea level. Subsequent drying operations (evacuation and purge) were ineffective in removing the water from the regulators; and corrosion resulted, particularly on the aneroid bellows. The relationship between the water separator area of the suit circuit and the oxygen demand regulators is shown in figure 23. The use of steam in the metabolic simulator was finally discontinued during all factory operations to avoid moisture problems.

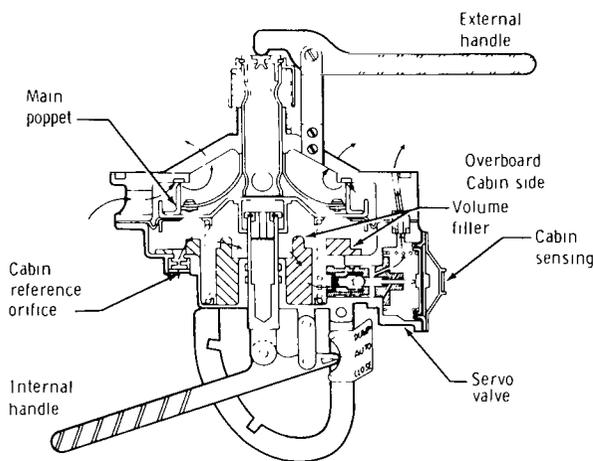
Figure 24. - Cabin dump and relief valve (item LSC-330-307).

Cabin dump and relief valve. - Two (redundant) cabin dump and relief valves (LSC-330-307) are used in each LM vehicle. Each valve provides cabin pressure relief at 5. 6 ± 0. 2 psid and is sized to prevent overpressurization of the cabin from any single failure of high-pressure oxygen lines or components. Manual actuations are provided to allow depressurization of the cabin when desired and also to close off the main poppet if the servo control fails open. A section view of the valve is shown in figure 24. The cabin dump and relief valve has three modes of operation, as follows.

Stability. - The cabin dump valve (LSC-330-307) main poppet spring preload was increased to meet vibration requirements. (See fig. 24.)

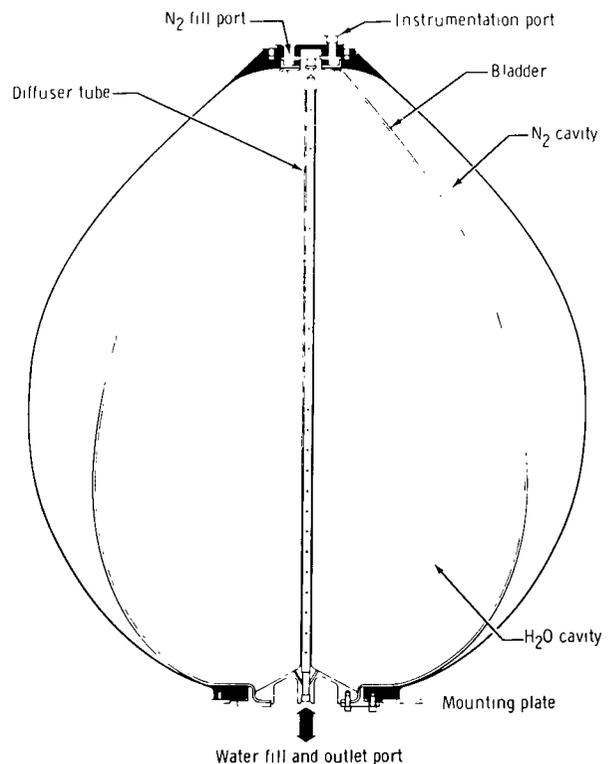
Figure 26.- Descent water tank (item LSC-330-404).

The mechanism of iodine depletion was found to be the diffusion of iodine vapor from the water, through the silicone rubber bladder, and into the surrounding nitrogen gas space. Water vapor also permeates the bladder, as does the nitrogen pressurant gas. The humid iodine vapor attacks the anodized aluminum tank wall; and, as the anodized coating is corroded, more 6061-T6 aluminum is exposed. The exposed aluminum readily reacts with the iodine. As the iodine is depleted, the vapor pressure is reduced and more iodine vapor permeates the bladder to maintain an equilibrium vapor pressure, thus depleting the iodine in the water. The anodized aluminum standpipe that is immersed in the liquid side is consistently uncorroded, but the tank walls show definite corrosion with the amount dependent upon exposure time.

Exposure history was not readily apparent as the cause of iodine depletion, because of the many variables of testing. Tank shells and tank bladders were often shifted from test to test (because not many test items were available for use) and reexposed. Exposure times and concentrations of iodine varied considerably. It was felt for a time that the bladder material reacted with the iodine, and "seasoning" of bladders was tried at several hundred ppm. Bladders which had been exposed to ethyl alcohol appeared for a time to cause fast iodine depletion. Until that time, the iodine was introduced in tincture form (iodine in ethyl alcohol) because the ease of dissolving iodine in alcohol made the testing more convenient. Testing was changed to use water solutions of iodine only. Only after the tank shell exposure histories were carefully arranged in order did the depletion test results appear consistent.

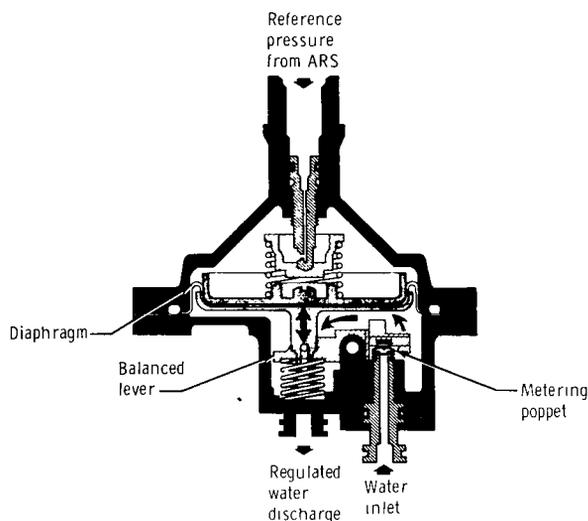
Figure 27.- Water pressure regulator — functional schematic.

During checkout of the LM-4 vehicle at KSC, a water pressure regulator malfunctioned; and corrosion of some of the internal parts was apparent. During the investigation of the problem, the sensitivity of the regulator design to particulates was a major finding. Several bench test series were run with water which was intentionally contaminated. The tests imposed difficult conditions by varying system parameters and by running for long durations. The general findings were that, even though analysis showed that the design was sensitive to malfunctions caused by particulates, the units functioned satisfactorily in test. Two regulators in series apparently provided sufficient redundancy that additional protection (waterline filters) could not be justified. The primary water system already contained two regulators in series, but the backup system had only a single regulator. A redundant regulator in the backup system was added at that time, effective on the LM-5 and subsequent vehicles. This was a field modification kit added downstream of the LSC-330-490 water control module. The redundant regulator (designated LSC-330-433) had interior working parts identical to the existing LSC-330-415 regulators. A schematic view of the regulator is shown in figure 27.

Water pressure regulators that would meet the tight specification performance requirements were difficult to manufacture and assemble. The large counterbalanced diaphragm assembly would sometimes become misalined, and disassembly and hand matching of parts was the practice. Once a unit had passed acceptance testing (indicating that all specifications were met), the subsequent performance was good. Flight performance was without flaw.

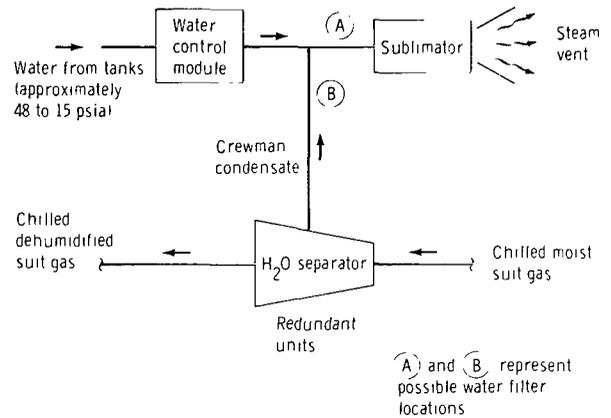
Figure 28. – Water bacteria filter locations.

A small-pore (0.22 micron absolute) filter was developed for the waterline to retain the bacteria mechanically. The unit was to be placed in location A as illustrated in figure 28. Placement in location B was also possible but would require twice as many filters for the redundant water separators.

Problems with gas blockage, which increased the pressure drop and effectively blocked the fine filter, were encountered. The gas in the water came from the water-supply tank, which became saturated with nitrogen at approximately 48 psia shortly after filling. The water pressure regulator settings could not be increased to force more water through the filter because of the limitations imposed by the sublimator and by the water separators. Additional pumping head requirements on the water separators would increase the suit-circuit gas pressure drop and thereby require revision to the suit fans. High water-supply pressure would cause sublimator breakthrough.

The Interagency Committee on Back Contamination (ICBC) reviewed the status of the developments and recommended relaxing the requirement concerning bacterial deposits from this source. A bacterial filter was used on the LM cabin dump valve for the Apollo 11 mission. The requirement for this filter was deleted for later missions, and the cabin gas was dumped directly overboard at the times of lunar exploration.
