The International Space Station Solar Alpha Rotary Joint Anomaly Investigation

Abstract

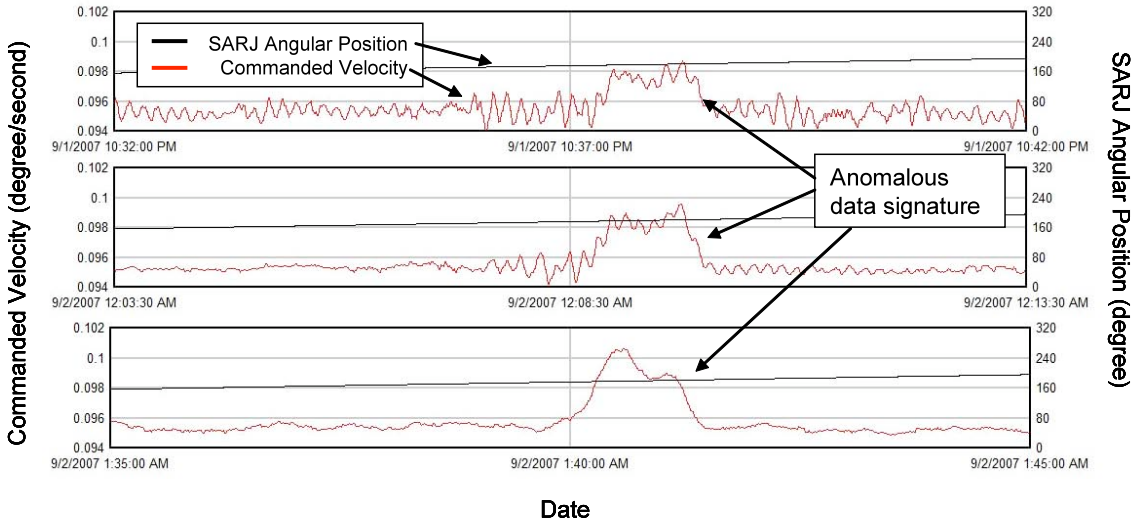
Figure 4. Anomalous Data Signature from the SARJ Controller

The SARJ software provides continuous status on most of the system's performance parameters. These parameters include, but are not limited to, position, speed, motor current draw, target tracking accuracy, and hardware temperatures. This telemetry is reviewed continuously to ensure the health and effective operation of the mechanism. The first indication of anomalous behavior came from unexpected changes in the Starboard SARJ telemetry. In early September 2007, the ISS operations team raised a concern that the difference between the commanded and actual velocity of the SARJ was increasing. The SARJ controller software uses the difference between commanded and actual velocity to determine how much current to provide to the mechanism's drive motor. The change in velocity profile prompted a detailed review of the SARJ operational data. From this review, engineers determined that subtle changes in SARJ performance could be noted starting on September 1st. Figure 4 shows the onset of the anomalous data signature. There are two pieces of telemetry shown. The first is the joint position and the second is the commanded velocity of the mechanism. The three plots depict ten minutes periods of time from three consecutive orbits. Two observations can be made from these data: (1) the irregular data signature initially occurred at a specific angular position of the joint, and (2) the magnitude of the irregularity is

increasing with time. The frequency of the data spikes increased with time such that after a few days the commanded velocity at all SARJ angles was off nominal.

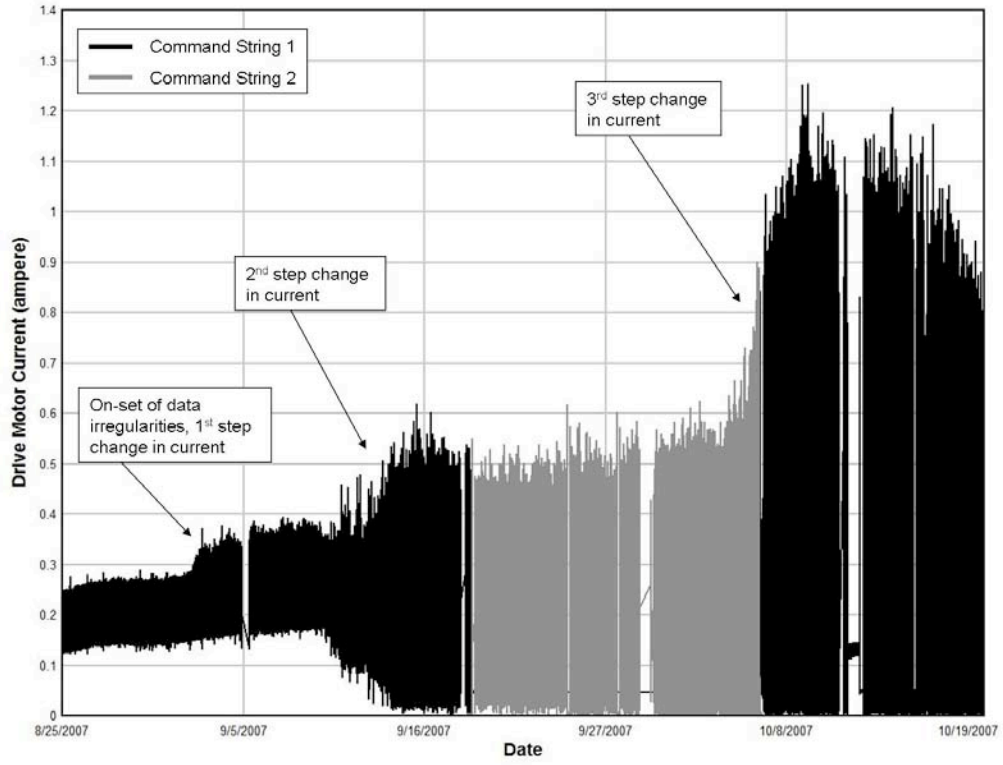
Figure 5. Starboard SARJ Drive Motor Current Changes during the Course of the Anomaly Investigation

Prior to the anomaly peak motor currents of 0.25 ampere were nominal. This corresponds to joint drag of approximately 790 N·m (590 ft·lbf). During the initial investigation, the peak currents increased to levels as high as 0.60 ampere, or 1910 N·m (1410 ft·lbf) of joint drag. The system capacity is 1.4 amperes. While the increase in drag was over 100% of the nominal value, it was still well within system capacity with a torque margin of 1.33. The drive current readings remained steady for two weeks at the increased level. The system experienced another drastic increase in drive motor current in the first week of October. The multiple changes in drive motor current throughout the course of the investigation are shown in Figure 5. After the 3rd step change drive motor currents were over 1.2 amperes, or 3810 N·m (2810 ft·lbf) of joint drag. In a one week period, the torque margin for the mechanism had decreased from 1.33 to 0.17. There was a risk that with another step change in required current there would be an unrecoverable stall of the mechanism.

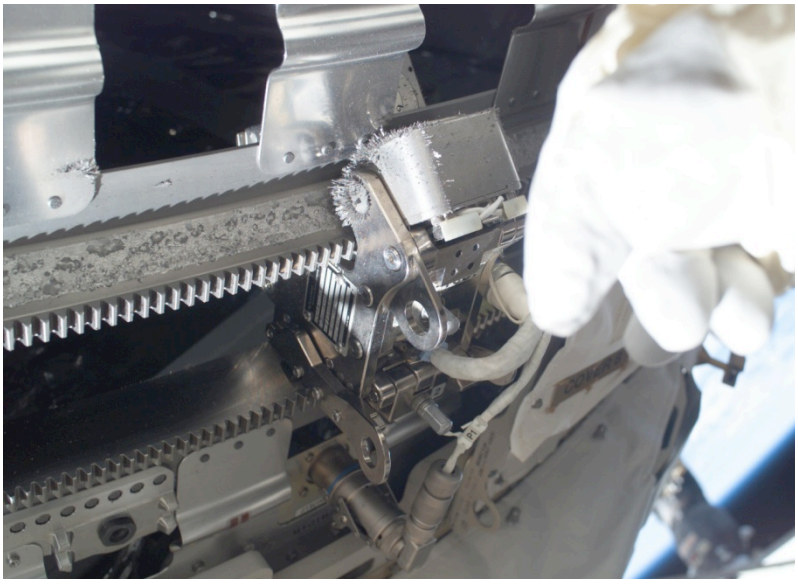
Figure 6. Astronaut Inspecting the Starboard SARJ During an Extra Vehicular Activity

Nothing off nominal was noted during the external survey. The crew had sufficient time to remove a MLI cover for additional inspection. Upon removing the cover the astronaut immediately noticed that there were fine metal shavings across the outboard bearing race surface. Additionally the astronaut noted that the TBA roller housing was acting as a magnet and collecting metal shavings. Samples of the debris collecting around the TBA housing were gathered and returned to ground for analysis (results discussed below). A characteristic picture of the condition of the mechanism can be seen in Figure 6. The outboard race ring, and specifically the outer canted surface, appeared discolored and mottled and there was debris on much of the surrounding hardware.

The root cause of the damaged bearing race was not immediately known. It was clear, however, that the mechanism was mechanically damaged and operating in a significantly degraded condition. There was concern that continued operation could exacerbate the problem. Also, the vibrations caused by rotating the joint had become severe enough that accelerated hardware fatigue was a concern. The anomaly investigation team recommended that operation of the Starboard SARJ be halted immediately until the root cause of the anomaly was known.

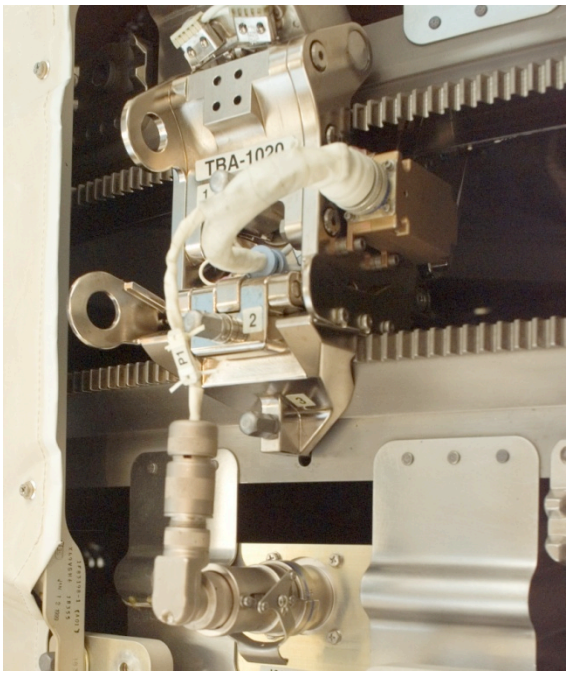
Figure 7. Astronaut Inspection of the Port SARJ During an Extra Vehicular Activity

inspection was executed on the following EVA. The astronaut determined that the Port SARJ race rings looked pristine. The inspection confirmed that the damage was confined to the Starboard SARJ. Figure 7 shows a picture of the mechanism taken during the inspection. There is no apparent damage or debris accumulating around the bearing race surfaces or the TBA.

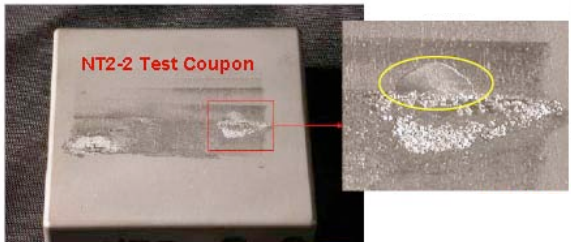
Figure 8. Trundle Test Rig Coupon Showing Fingernail Type Spalling [7]

The anomaly team postulated that increased friction between the roller/race interface could cause a stress field with the maximum shear stresses at the nitride case/15-5PH core interface. The team also determined that the solid film gold lubricant was not properly adhered to the rollers [6]. Without the gold lubricant in place, the system becomes susceptible to increased shear and normal stresses. The high shear stresses at the case/core interface could lead to subsurface initiated spalling of the case material. Multiple tests were performed over several months in an attempt to reproduce this failure mechanism. Tests performed at the LMSSC facilities in Sunnyvale on a Trundle Roller Rig were successful in recreating the spalling effect observed on-orbit [7]. The test rig loaded a 440C roller against a nitrided 15-5PH coupon. The roller was then rolled in a reciprocating motion along the coupon's surface. Figure 8 above shows a test coupon from the rig. The inset in the figure shows an example of a "fingernail" type spall. Spalls of this type were also noted in on-orbit inspection photos.

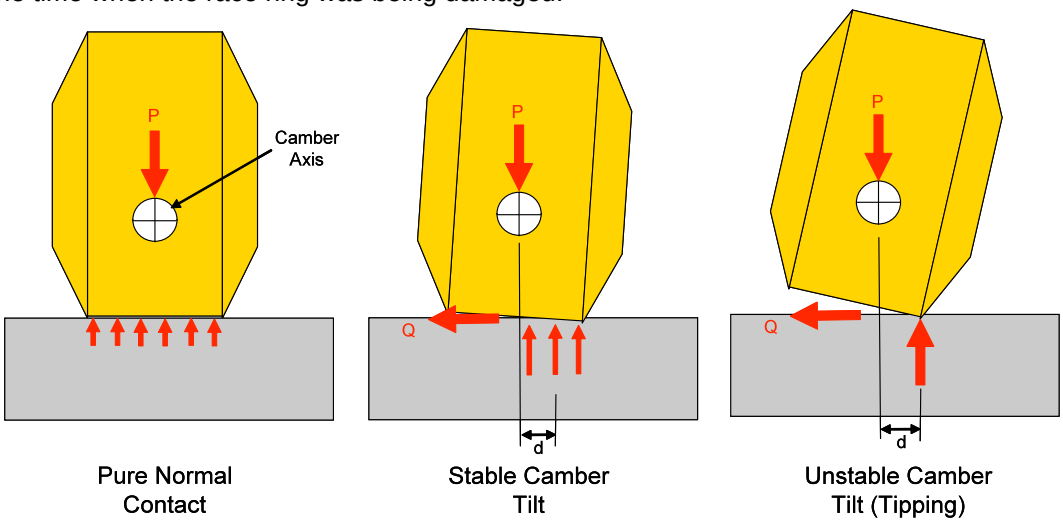
Figure 9. Trundle Bearing Roller Stability

The mistrack or “toe” angle of a TBA roller is the misalignment of the roller due to rotation about an axis normal to the race ring surface. The existence of some small mistracking angle is inherent in the hardware build process. The metrology laboratory at MSFC performed detailed measurements of the mistrack angle of the Starboard SARJ TBA rollers after they had been returned from orbit. Mistracking between the roller and race creates a friction force on the roller in the thrust direction, denoted Q in Figure 9. This yields a moment about the camber axis, which is reacted by the normal load between the roller and race. As the magnitude of the thrust friction increases, the load distribution on the roller becomes unevenly distributed to react the induced moment. The distance *d* in Figure 9 denotes the lateral distance from the camber axis to the center of normal pressure of the contact. In stable tilting, the distance *d* increases with increasing camber tilt, offsetting the camber moment generated by an increasing thrust friction *Q*. However, after a certain camber angle threshold is reached, *d* begins to decrease with increasing camber angle, causing the roller to enter into unstable tilting. The analysis and inspection of the Starboard SARJ TBAs shows that the outer canted rollers remained in the regime of stable tilting during the time when the race ring was being damaged.

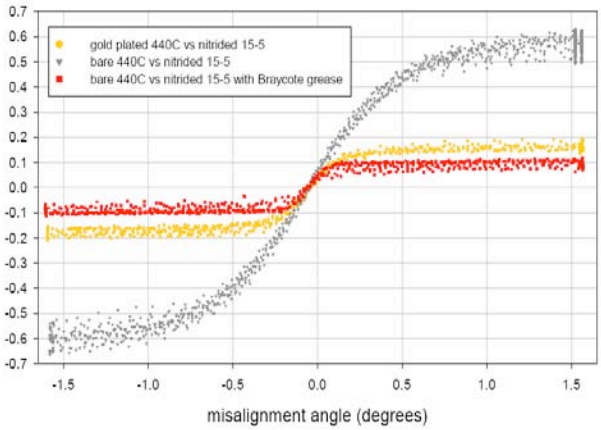
Figure 10. Comparison of Thrust Curves from Analytical Results and VRR Test Data [5]

In order to investigate the effect of roller mistracking on the contact forces, a numerical boundary element analysis tool was developed by researchers at Purdue University and Boeing. This tool was rigorously validated against closed form solutions and also shows excellent agreement with the traction results obtained through testing at Glenn Research Center (GRC) [5]. GRC was able to quantify the friction-mistracking relationship in a Vacuum Roller Rig (VRR). The VRR replicates the flight-like rolling interface and materials in a vacuum environment. A comparison between traction curves developed by test at GRC and via analysis is shown in Figure 10. One will note that the analytical results closely match the test data. It is also worth nothing that the VRR rollers do not have identical degrees of freedom to the TBA rollers and therefore the TBA rollers must be addressed by a modified thrust curve (discussed below, see Figure 13).

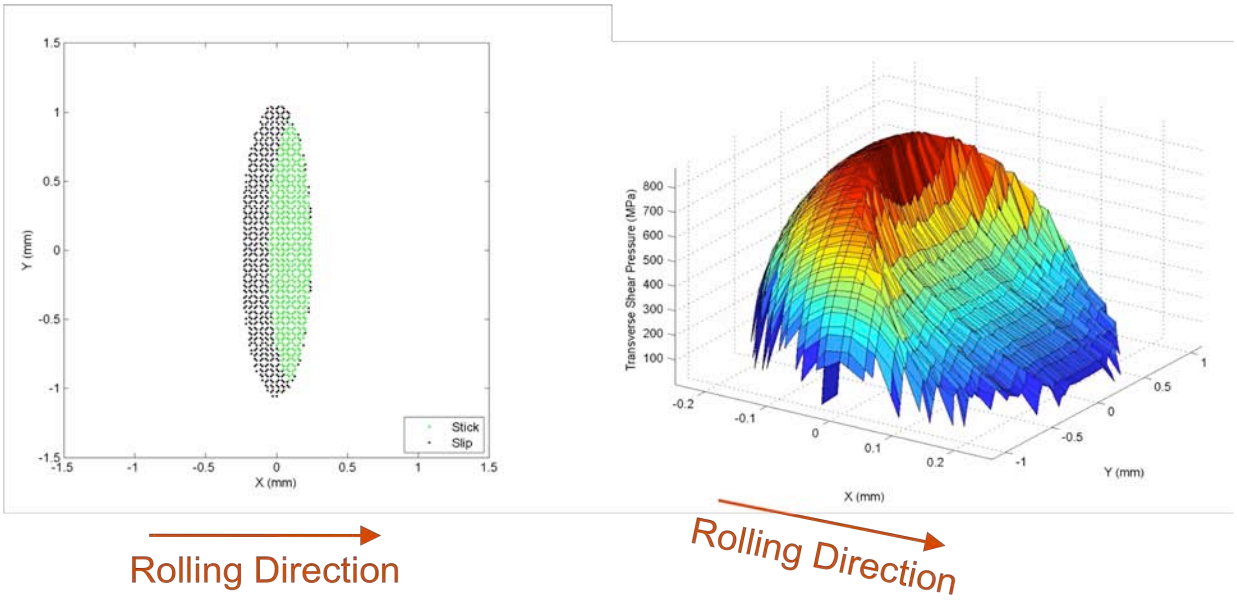
Figure 11. Shear Traction Distribution for GRC Test Rollers, *Q/P* = 0.4

Figure 11 shows the transverse shear traction distribution on the GRC test rollers for a representative misalignment case. The plot on the left shows that the contact area is divided into regions of stick and slip. The stick region, shown in green, is located at the leading edge of the contact. As the unstressed material of the test rollers enters into the contact patch, the shear deflections and tractions between the two rollers build until the shear tractions reach the limiting value of friction defined by the coefficient of sliding friction, μ, times the normal pressure. As material moves through the trailing end of the contact, slipping occurs between contacting points on the rollers, and the shear tractions remain at the limiting value of friction.

For increasing mistrack angles, the stick region gradually decreases in size until the total thrust load equals μ times the normal load, at which point the entire contact region is in slip. For small mistrack angles such as those observed on the Starboard SARJ TBAs, the rollers remain in partial sliding, and the total frictional force is less than the limiting value of sliding friction.

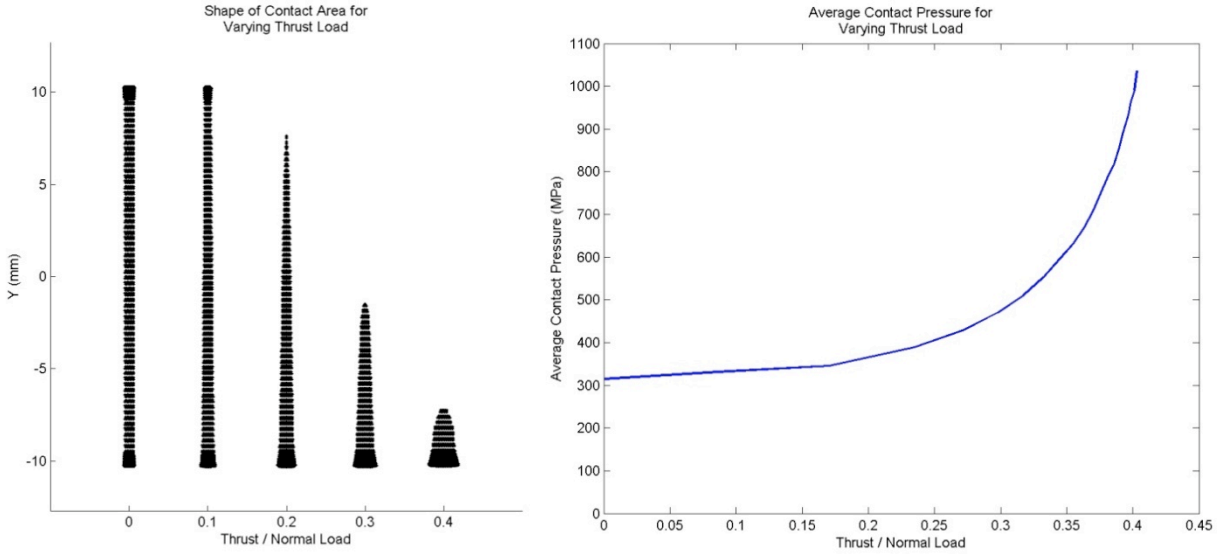
Figure 12. Contact Patch Dimensions and Average Contact Pressure for TBA Roller

result, the size and shape of the contact patch for a TBA roller vary dramatically depending on the thrust loading and camber angle of the roller. The contact patch dimensions are plotted in the left portion of Figure 12 for increasing values of thrust load. This plot shows that as the TBA roller tilts on edge due to the thrust loads, the area in contact with the race ring is reduced. The right portion of Figure 12 shows that the average normal contact pressure increases dramatically as a result of the reduced contact area.

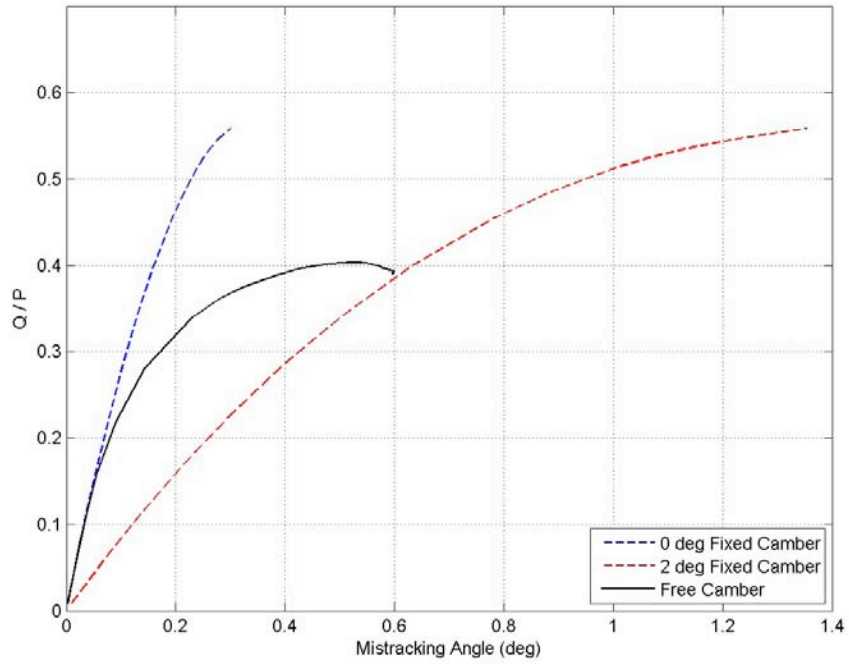
Figure 13. Traction Curves for Outer Canted TBA Roller

In the study of rolling contact mechanics, the relationship between the transverse rolling creep (related to the mistrack angle) and the traction ratio *Q/P* is known as the traction curve. The analysis of the SARJ TBA rollers found that the shape of the contact patch caused by cambering has an influence on the traction curve for the roller. This effect is such that as a TBA roller begins to tip about its camber axis, the frictional loads are less severe than they would otherwise be, thereby mitigating the tipping phenomenon. The blue dotted line in Figure 13 shows the traction curve for the flight TBA roller if the camber axis were fixed at 0°. The red dotted line shows the traction curve if the camber axis were fixed at 2°. In the actual TBA, where the camber axis is free to rotate, the traction curve follows the 0° fixed camber curve for small mistrack angles. However, for larger mistrack angles the changing geometry of the contact patch causes the thrust friction loads to be less severe than in the fixed camber case, as shown by the solid black line in the figure. Despite this phenomenon, thrust loads as high as 0.4 times the normal load can be generated with mistrack angles less than 0.5°.

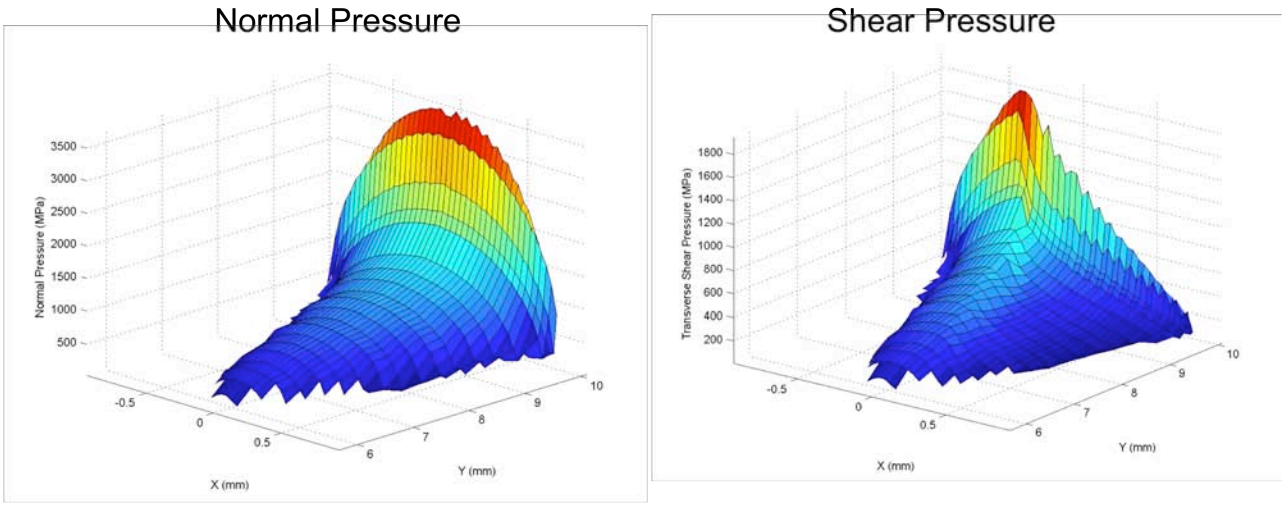
Figure 14. Distribution of Normal and Shear Pressure for 0.36° Mistracking, TBA Outer Canted Roller

Detailed measurements and tolerance analysis of the Starboard SARJ TBAs identified an approximate worst case mistrack angle of 0.36°. The normal and shear pressure distributions at the contact are shown in Figure 14 for that mistrack case. As a result of camber tilting, only about one quarter of the width of the roller is in contact with the race ring surface. The resulting stresses at the interface between the race ring case material and the parent material were found to exceed the yield strength of the parent material.

Max Normal Pressure: 3.67 GPa
Total Normal Load: 3.66 kN

Max Shear Pressure: 2.83 GPa
Total Shear Load: 1.41 kN

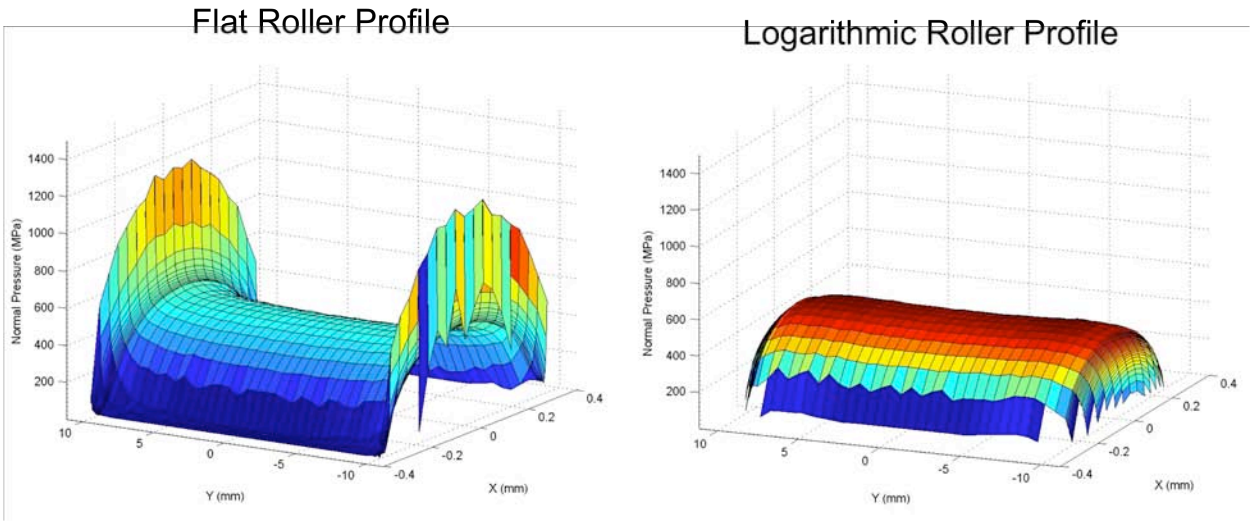
Figure 15. Normal Contact Stress Distribution for TBA Roller, P = 4.36 kN (980 lb)

The root cause team further found that the bearing edge stresses were exacerbated by the flat, un-crowned profile of the TBA rollers. The roller geometry made the system sensitive to non-Hertzian effects, which gave rise to high pressure points at the edges of the rollers during the initial run-in period of the mechanism. These high pressure points are visible in the contact stress profile of the TBA rollers shown in the left side of Figure 15. Part of the recurrence control plan for the SARJ is to modify the rollers on any spare TBAs to include logarithmically crowned rollers. The logarithmic roller profile is a shape that has been mathematically optimized to eliminate the high pressure points that ordinarily occur at the edges of cylindrical roller bearings.
