Technical Report No. 32-875

Fill Valve Development for the Advanced Liquid Propulsion System (ALPS)

W. F. MacGlashan, Jr.

JET PROPULSION LABORATORY
CALIFORNIA INSTITUTE OF TECHNOLOGY
PASADENA, CALIFORNIA

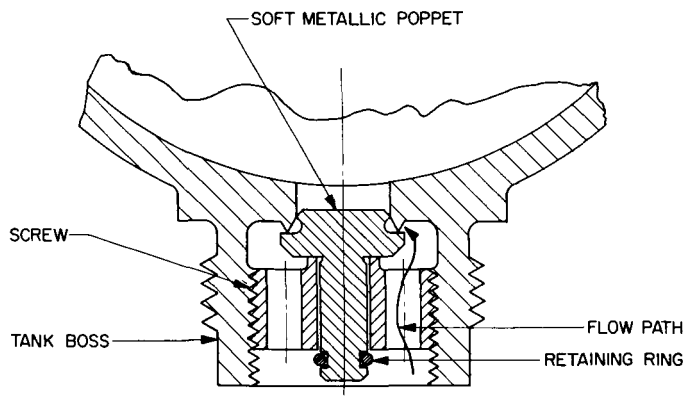
Fig. 1. Knife-edge fill-valve cross section (ground fitting not shown)

The valve with the titanium boss passed the liquid-nitrogen test but developed a leak while returning to ambient from the 250°F oven test. The probable cause of failure was the almost 3-to-1 thermal expansion ratio (aluminum-vs-titanium), which was too great to allow a seal to be maintained over the extreme temperature range.

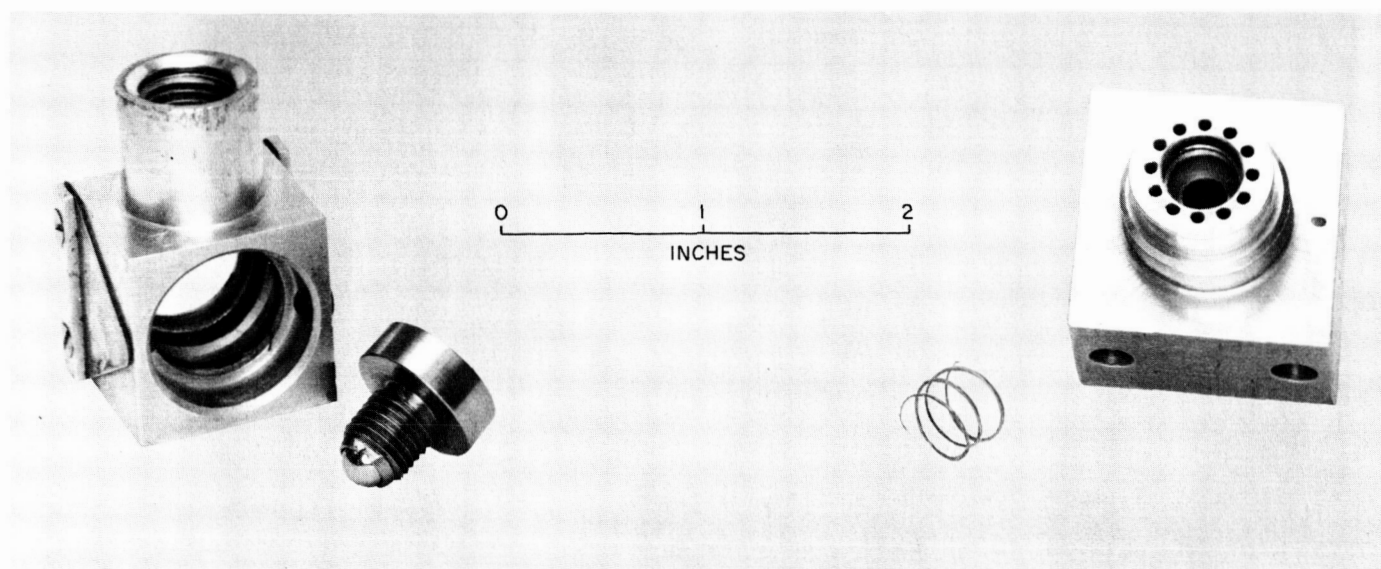
Fig. 4. Ball fill-valve thread failure at 7200 psi during burst test with ground fitting engaged

Figure 4 shows a spiral of aluminum thread which was sheared from the boss as a result of a burst test. Failure occurred at 7200 psi with the ground fitting attached and with the seat opened 1½ turns. This test was conducted before Heli-coil inserts were used for this application.

The abrasion of metal chips from the aluminum female threads during cycling in N_2H_4 and N_2O_4 was a cause of seat damage. Heli-coil thread inserts of 18-8 stainless steel were effective in reducing the formation of metal chips during cycling. Apiezon L grease was found to be an excellent lubricant for nitrogen and N_2H_4 service.

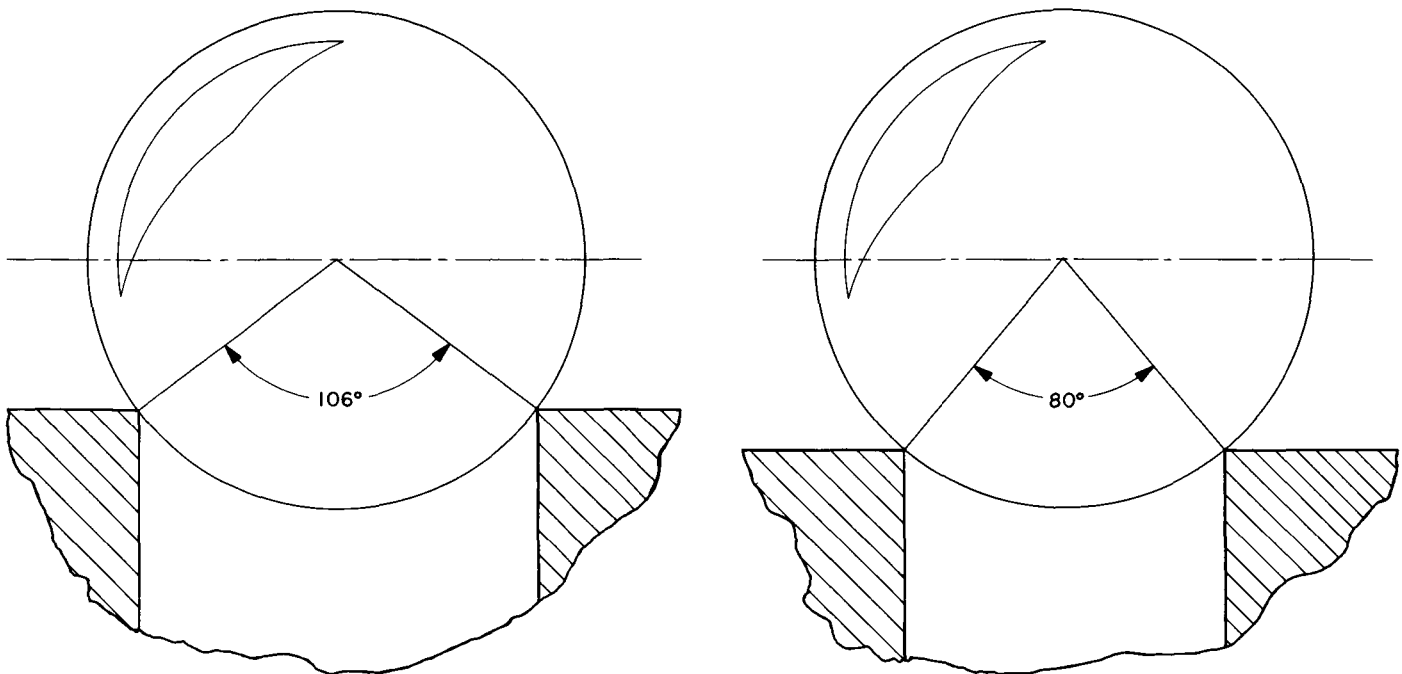
The effects of burnishing ceramic balls with Molykote Microsize (1-μ molybdenum disulfide, MoS_2) and the reduction of the contact angle (Fig. 9) of the ball with the seat were tested and the results are shown in Table 4. The seat was lapped before each of the tabulated tests. The Molykote Microsize-burnished ball picked up metal from the 106-deg contact-angle seat (¼-in. ball on ³⁄₁₆-in.-diam. seat) after 1500 cycles. With the 80-deg contact-angle seat (¼-in. ball on ⁵⁄₃₂-in.-diam. seat), both the untreated and the Teflon-burnished ball picked up metal after 700 cycles, but the MoS_2-burnished ball was still uncontaminated after 2700 cycles. From this test it was concluded that the MoS_2 surface treatment for the ball and the reduction of the ball and seat contact angle were both very effective in reducing metal pickup, which is the main cause of seat failure.

Fig. 9. Contact angles of the ball with the seat

Molykote Microsize-burnished ceramic balls were proved to be effective in preventing metal pickup when the valve was cycled in nitrogen tetroxide, hydrazine, and nitrogen gas. Although Molykote Microsize is not compatible with hydrazine, no difficulty was experienced because of the minute amount of MoS_2 involved. Molykote Microsize-burnished sapphire balls were tested in hydrazine, but no improvement over ceramic balls was indicated.
