EFFECT OF NUCLEAR RADIATION ON MATERIALS AT CRYOGENIC TEMPERATURES

LOCKHEED NUCLEAR PRODUCTS

QUARTERLY REPORT NO. 3

January 21, 1966 Through April 21, 1966

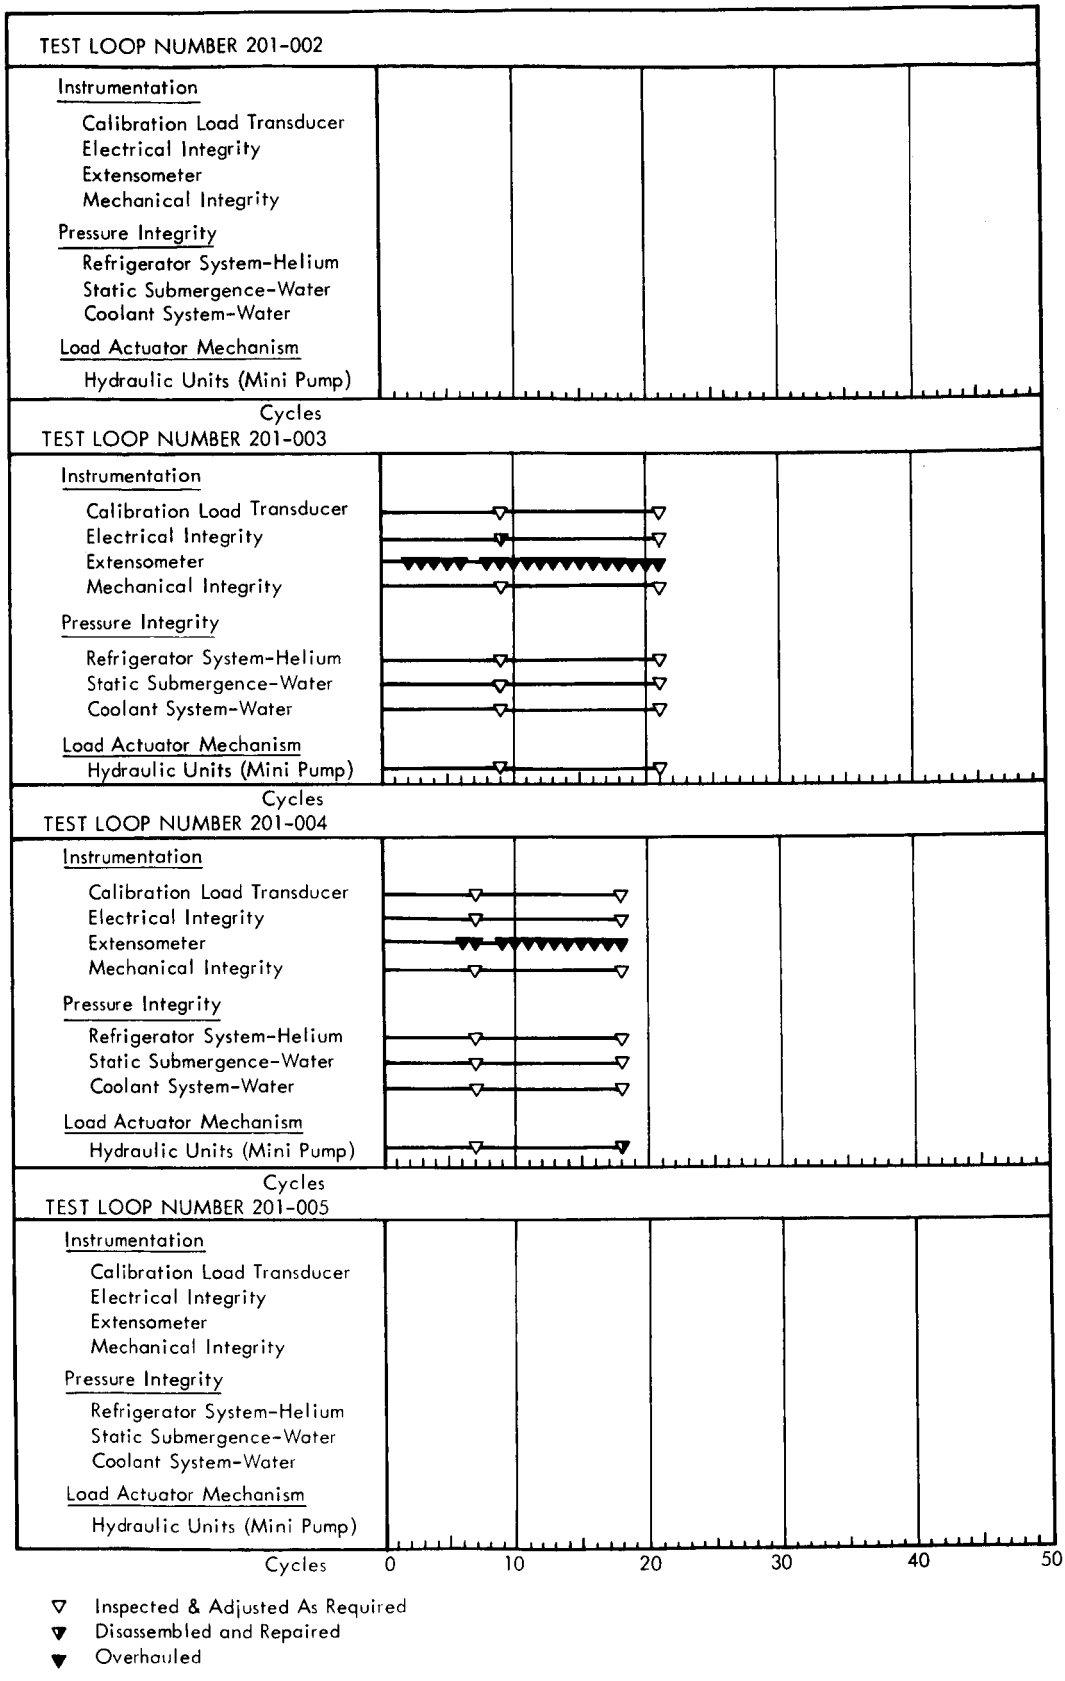
FIGURE 11 MAINTENANCE HISTORY - TEST LOOPS 201-002, 201-003, 201-004 AND 201-005

During this reporting period, no malfunctions occurred during the performance of in-pile testing; however, there were indications of leakage in the specimen loading actuators and the loops were transferred to the hot laboratory area where the actuators were removed. The units were disassembled, inspected and new seals installed prior to reassembly. Each unit was hydrostatically and dynamically tested prior to reinstallation into the loop. Scheduled maintenance of the test loops was performed concurrently while the loops were in the hot laboratory.

As previously reported (refs. 5 and 6), leakage in one of the refrigerant lines was noted in test loop 201-002. Further efforts during this reporting period enabled a more precise determination of the position and nature of the leak. It appears to be a circumferential crack in the weld of the aft joint between the bellows assembly used to compensate for the change in length between the inner and outer helium lines and the inner wall of the annular vacuum space insulating the refrigerant lines.

As reported in section 3.2.1, test loop 201-004 developed leakage in the specimen loading actuator. This leakage, first observed during operation in reactor cycle 44P, was not considered sufficient to appreciably affect the load rate and therefore, the loop was retained in service throughout the reactor cycle. During reactor down cycle 45S, the loop was removed from the quadrant and transferred to the hot laboratory work area.

Inspection of the actuator in the test loop indicated the difficulty was associated with the rod end seals. These seals were replaced, the actuator was rebuilt and reinstalled in the test loop and tested. The loop was returned to quadrant D and is ready for operation in reactor power cycle 45P, scheduled for early in the next reporting period.

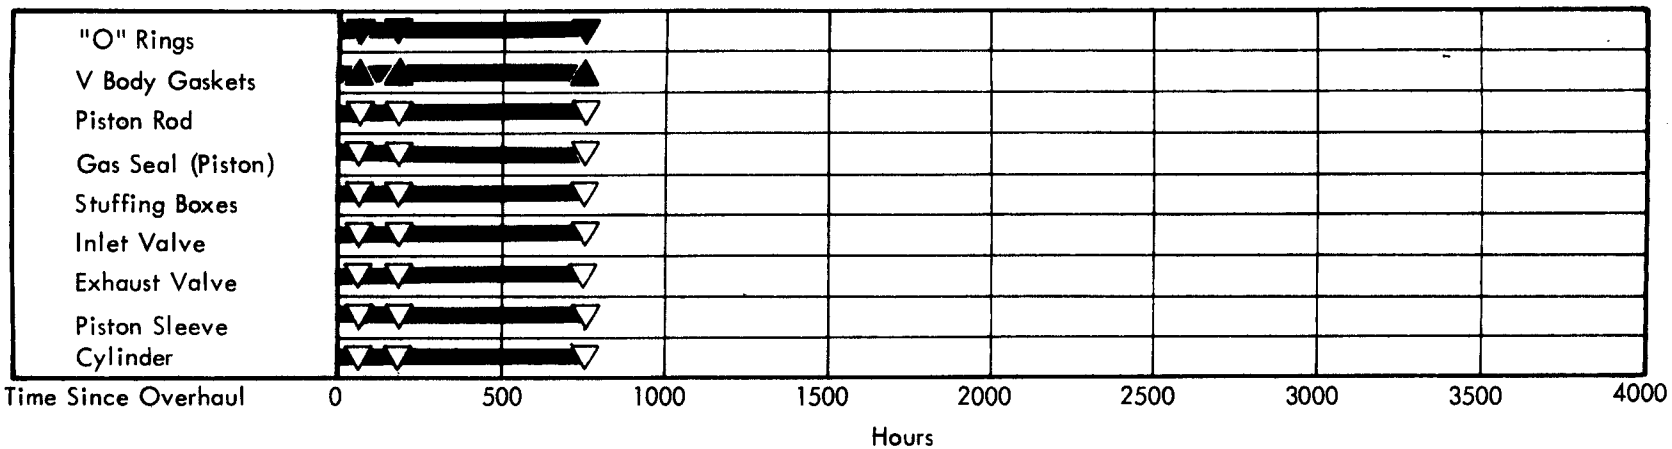
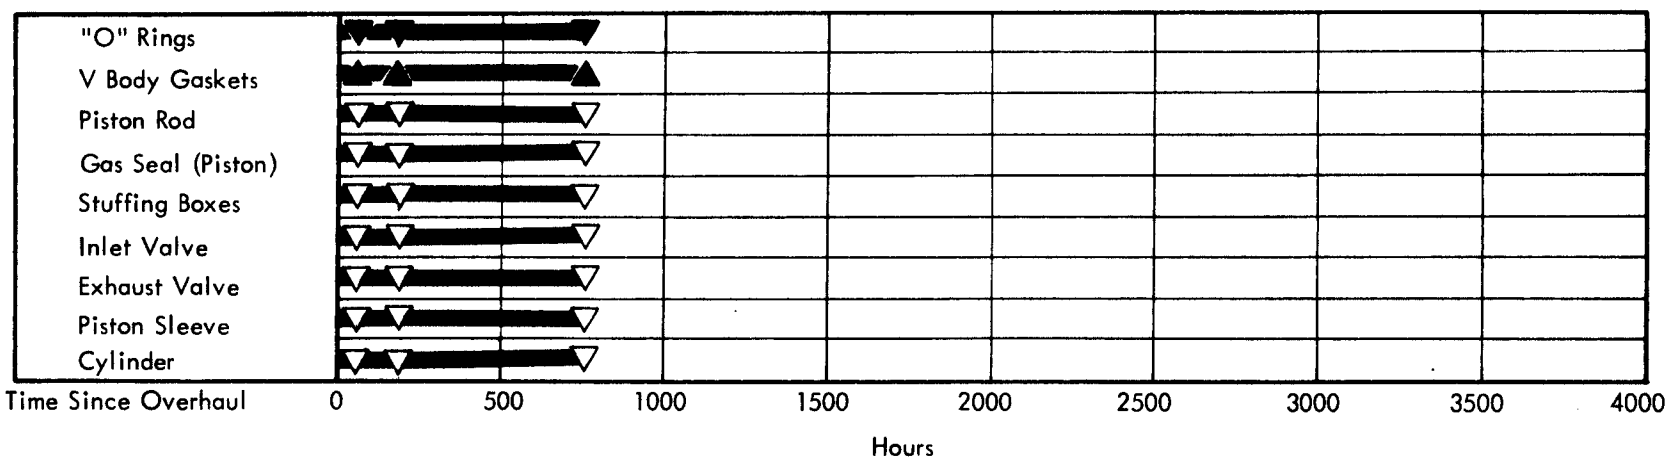
FIGURE 12 MAINTENANCE HISTORY - EXPANSION ENGINES NO. 1 AND NO. 2

The refrigeration system has operated a total of 2493 hours (743 hours this reporting period) since the system was overhauled. The increased operating time (from 500 to 743 hours) between the scheduled maintenance was permitted to provide additional time histories for future reliability analysis of the system. The extended operating period was justified in that any malfunction could be repaired without jeopardizing the testing schedules and that prior performance history (since overhaul) indicated that the system would perform beyond the 500 hour period without malfunctions.

Piston rods have been replaced in all of the engines now in service and those removed will be inspected ultrasonically to establish their integrity. If these tests indicate the rods are satisfactory, they will be reinstalled during future maintenance periods.

In an effort to reduce observed helium leakage into the vacuum powder insulation of the engine pods, the seal surface for the flange body gasket had to be refaced. This required the fabrication of special holding fixtures and meticulous alignment to perform the required machining. The results observed after installation of the engines so modified have shown a significant reduction in the vacuum that can be maintained, which is, in turn, reflected in total refrigerator capacity for a set of operating parameters.

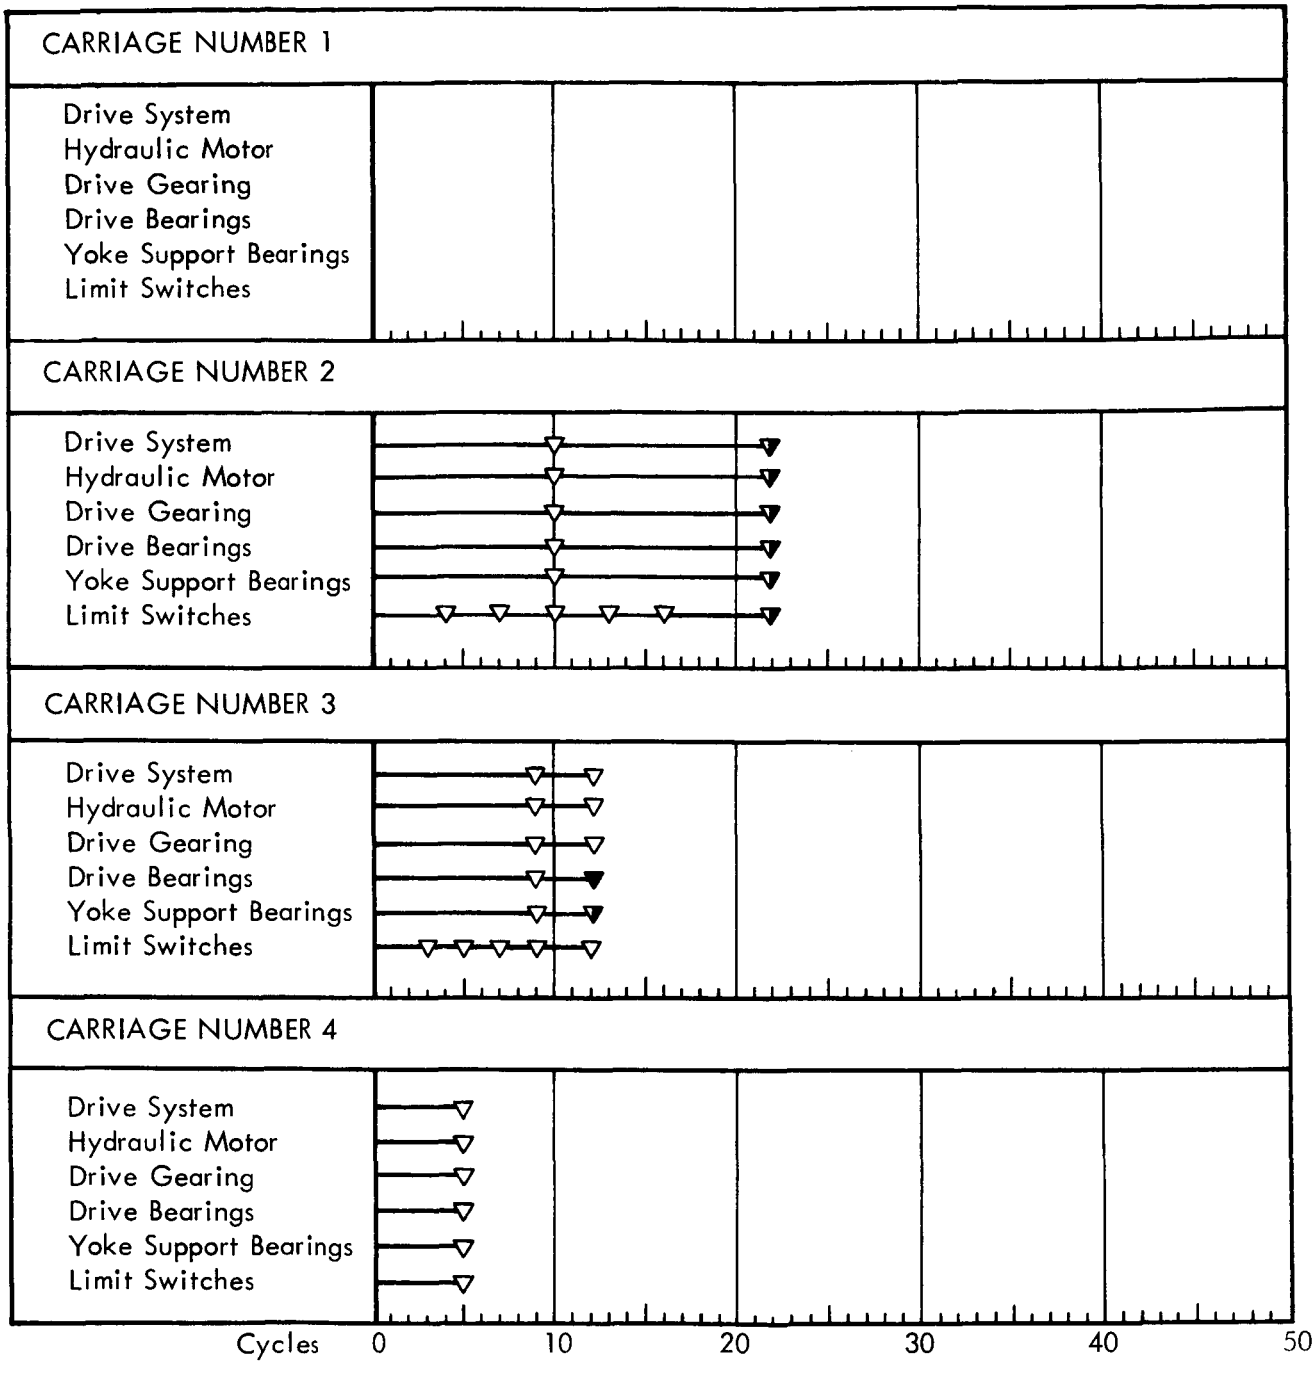
FIGURE 15 MAINTENANCE HISTORY - TEST LOOP CARRIAGES

A summary of the scheduled maintenance of the test loop carriages as projected in figure 8 is shown in figure 15. During this reporting period, carriages number 2 and 3 were removed from the quadrant for the performance of scheduled maintenance. Drive system bearings were replaced in carriage number 3 and other components in both carriages were replaced after inspection. Both carriages were tested and subsequently returned to the quadrant for use in the transfer system.

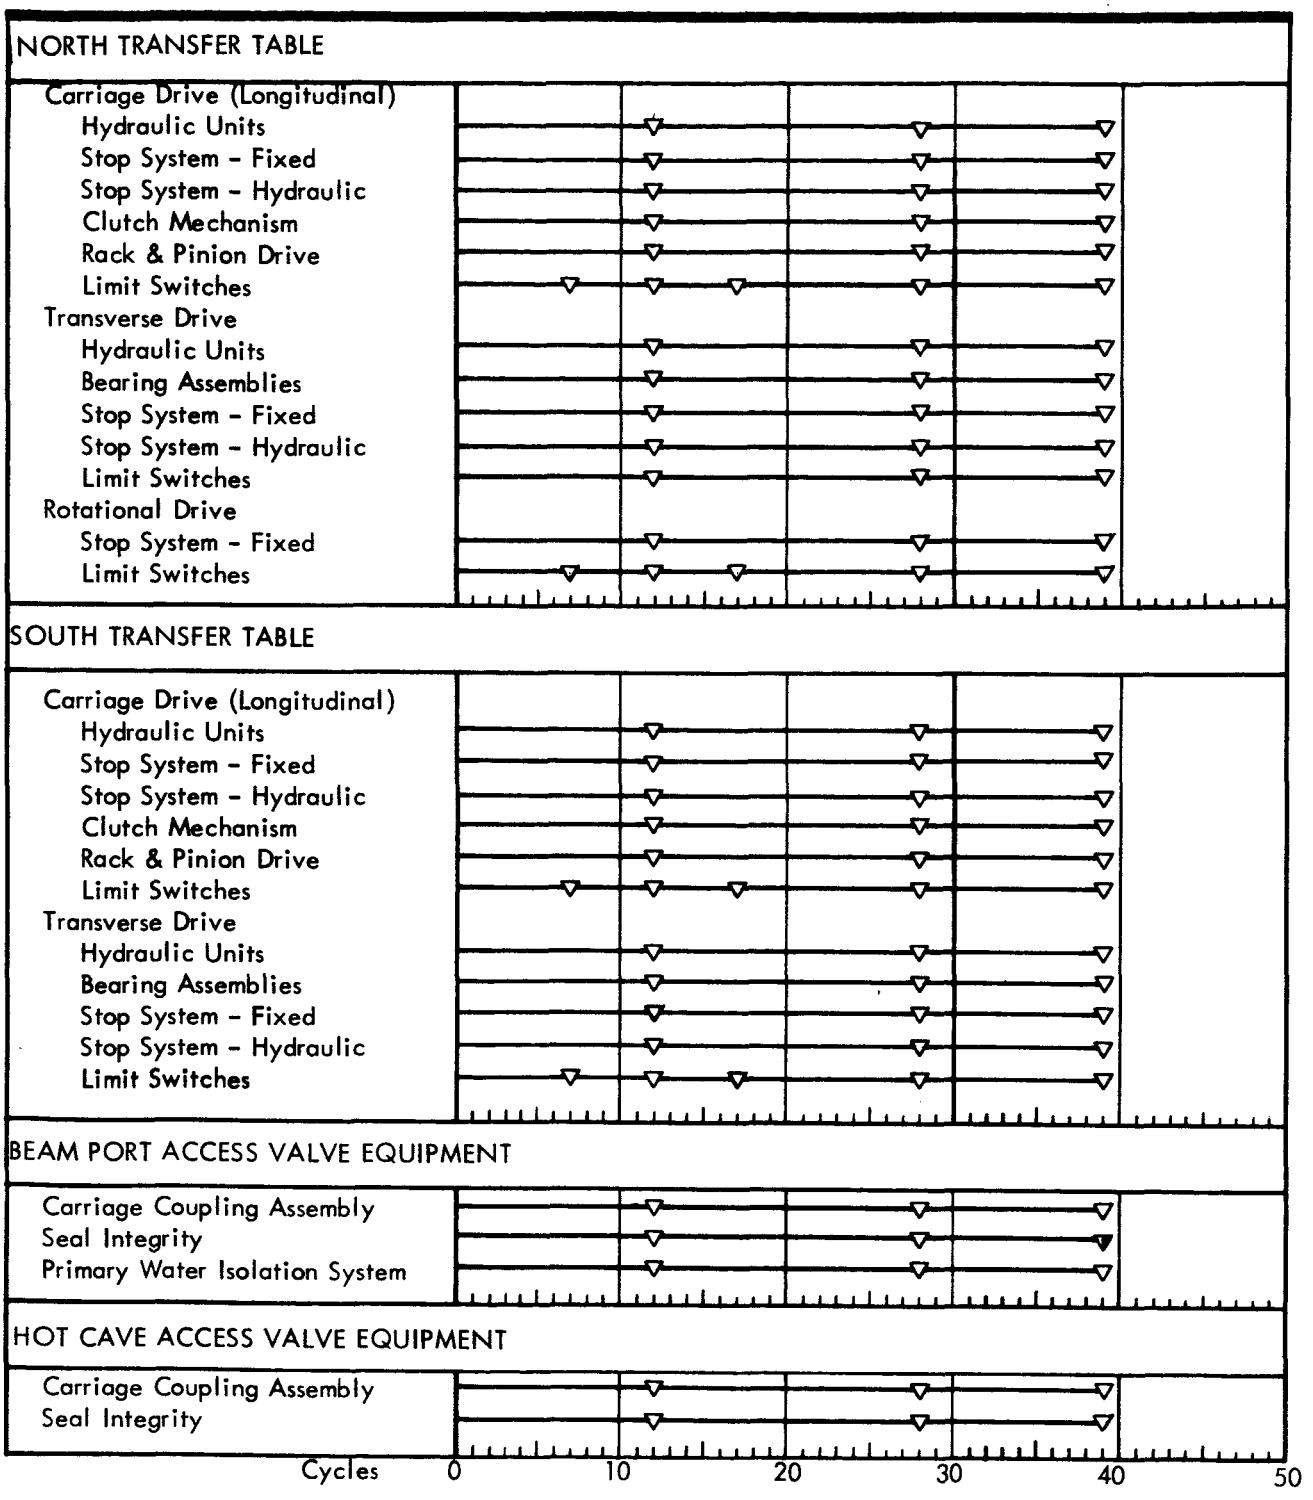
FIGURE 16 MAINTENANCE HISTORY - TRANSFER TABLES - BEAM PORT AND HOT CAVE ACCESS EQUIPMENT

A summary of the scheduled maintenance of the transfer tables as projected in figure 8 is shown in figure 16. During this reporting period, inspection and adjustments were made but no repairs were required.

this reporting period, routine inspections were made and the chevron seals at the beam port valve were replaced while the quadrant was drained. These were not required by the schedule but were performed to minimize the possibility of malfunction.
