PRODUCTION OF A LARGE, ROLLED RING FORGING OF "200" GRADE MARAGING STEEL

FINAL TECHNICAL REPORT

February 29, 1968

CONTRACT NAS 3-7966

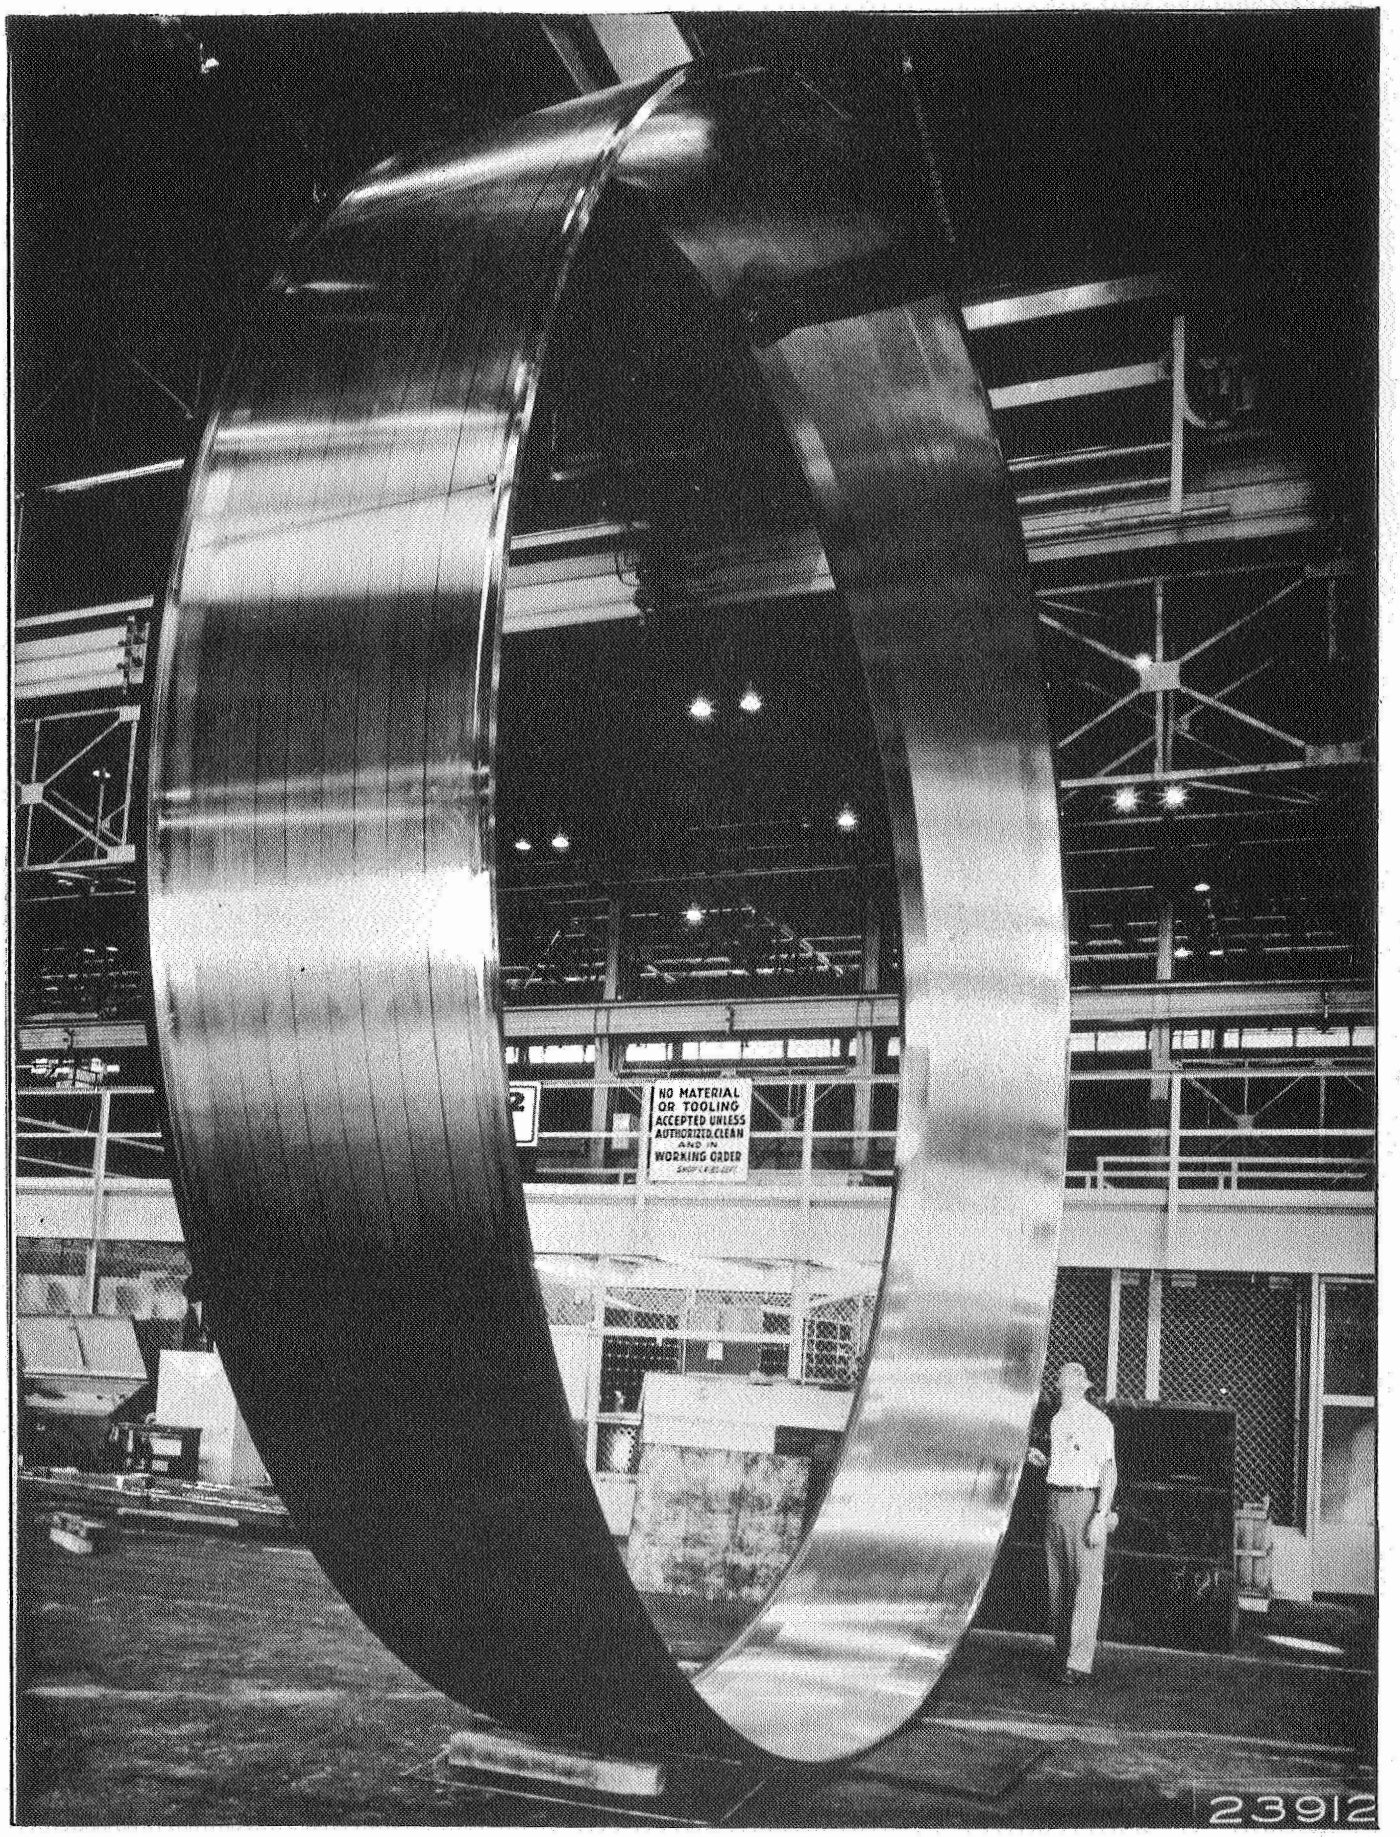
FIGURE 3

All surface areas of the machined blank were subjected to a dye-penetrant inspection in accordance with Ladish Co. Quality Assurance Procedure No. 9-Q-108 and no defects were observed. The results of this inspection and the procedure are reported in Appendix II.

Ultrasonic inspection of the machined blank was completed using longitudinal-wave inspection procedure. Standards for this inspection were 3/64- and 5/64-inch flat-bottomed-holes in separately-forged reference blocks. The inspection located four areas of indications and all indications in each area were well within previously-established 5/64- and 8/64-inch flat-bottomed-hole standards for the 260-inch-diameter SL Motor Case Program. Section IV contains all pertinent discussions of this ultrasonic inspection. Since the indications were small and discontinuous in nature, no significance was attached to them at this time. The machined blank, shown in Figure 3, was released for roll-forming.

ROLL-FORM BLANK AFTER MACHINING

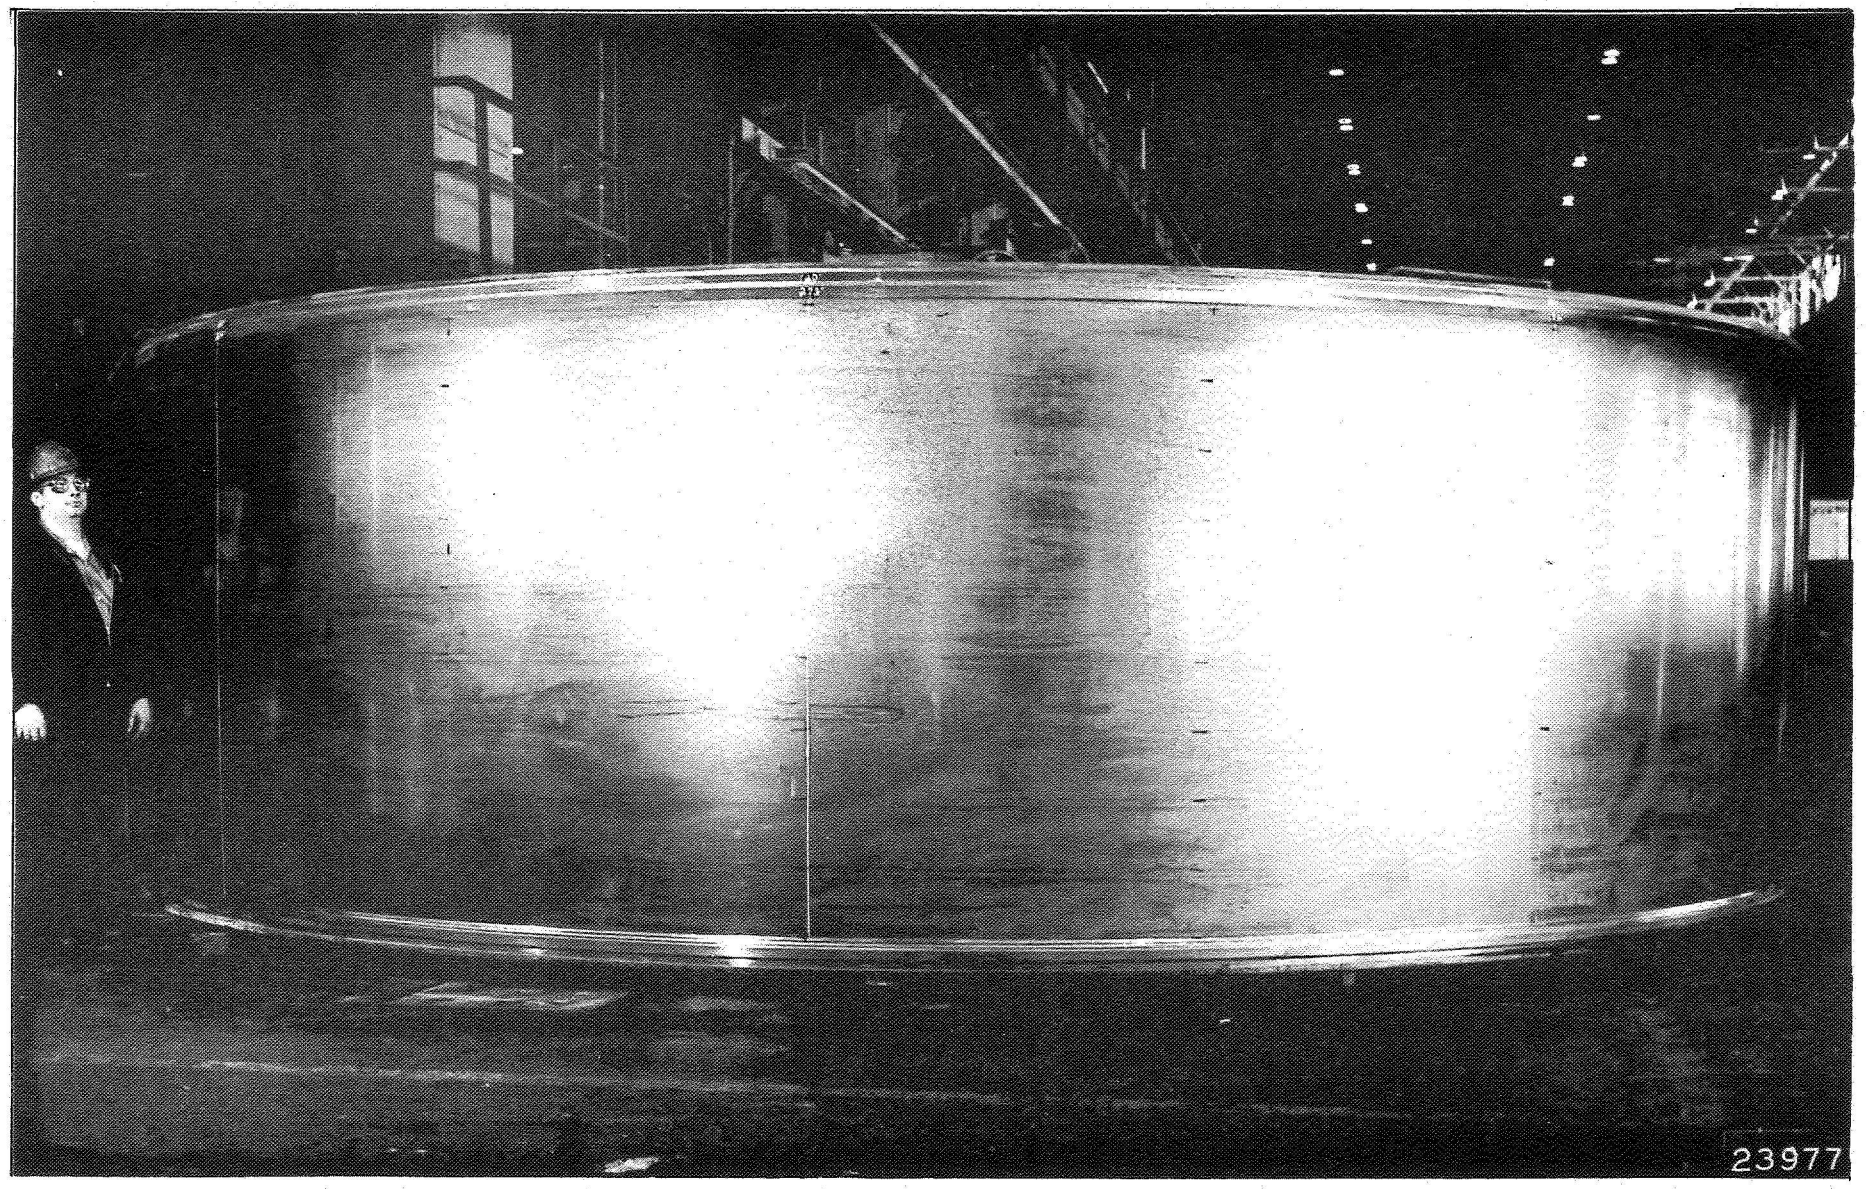
FIGURE 4

A 51-per-cent total wall reduction from 1.260 inches to 0.610 inch was accomplished by roll-forming, with a simultaneous lengthening of the face height from 42 to 79 inches. The roll-forming process was conducted at room temperature without intermediate annealing cycles. Figures 4 and 5 show the 79-inch-high cylinder after roll-forming. (In the Ladish Co. process, one end of the blank is held to the roll-forming machine. This end is referred to as the "clamping end;" the opposite end is referred to as the "free end.")

79-INCH FACE HEIGHT ROLL-FORMED CYLINDER

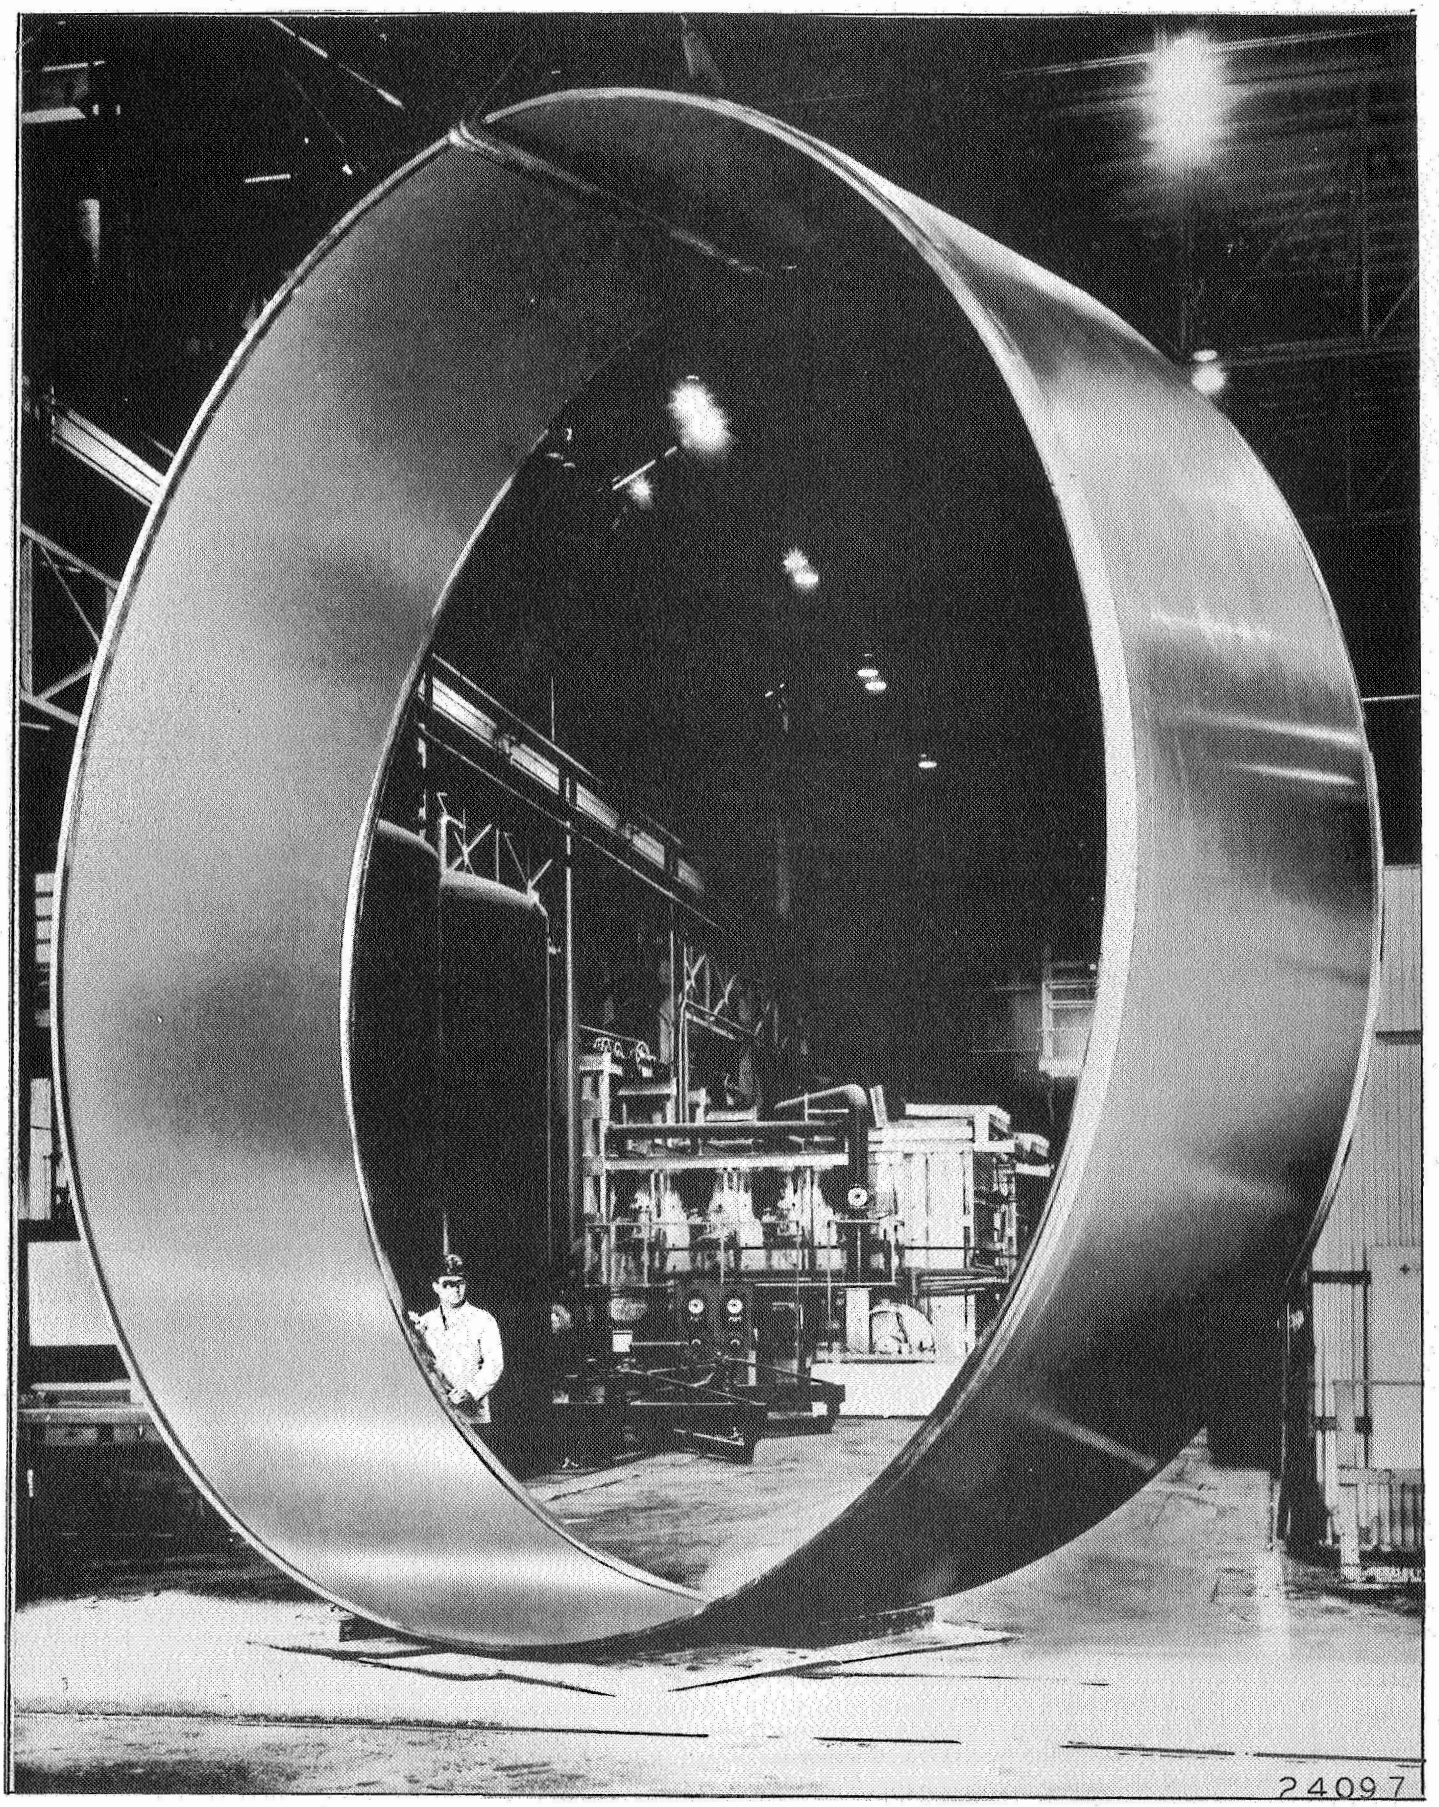
FIGURE 5

ROLL-FORMED 260-INCH-DIAMETER CYLINDER

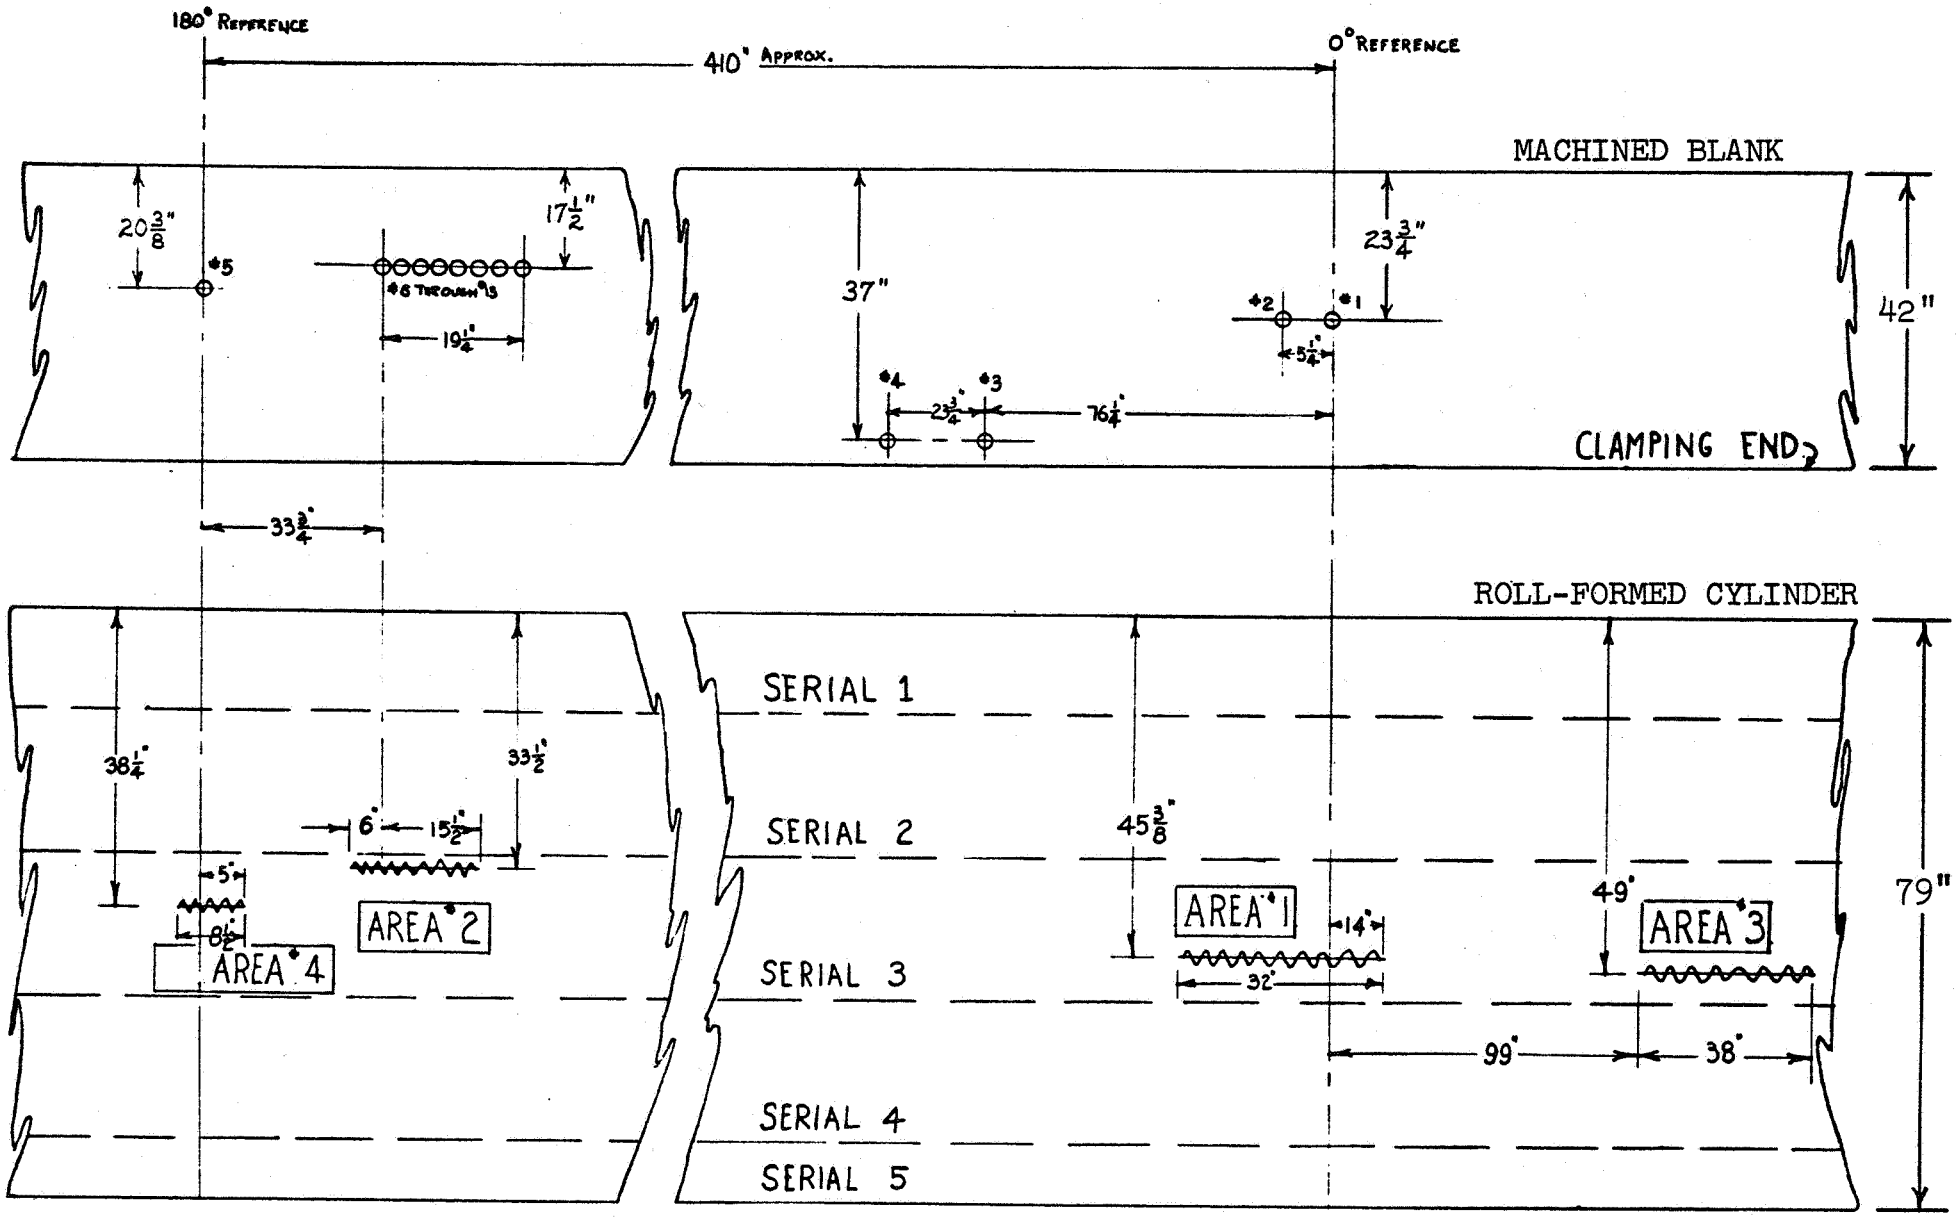
FIGURE 11

Three of the four indication areas were correlated to the location of the minor indications detected in the piece prior to roll-forming. The fourth indication area appeared in a location previously considered sound, but was definitely associated with the surface indentation observed during the third roll-forming pass. A plot of all encountered indications and their relationship prior to and after roll-forming is shown in Figure 11. An analysis of this figure reveals that the ultrasonic techniques used up to this point did not relocate indications numbered 3 and 4 observed in the machined blank.

SKETCH SHOWING LOCATIONS OF ULTRASONIC INDICATIONS DETECTED PRIOR TO AND AFTER ROLL-FORMING

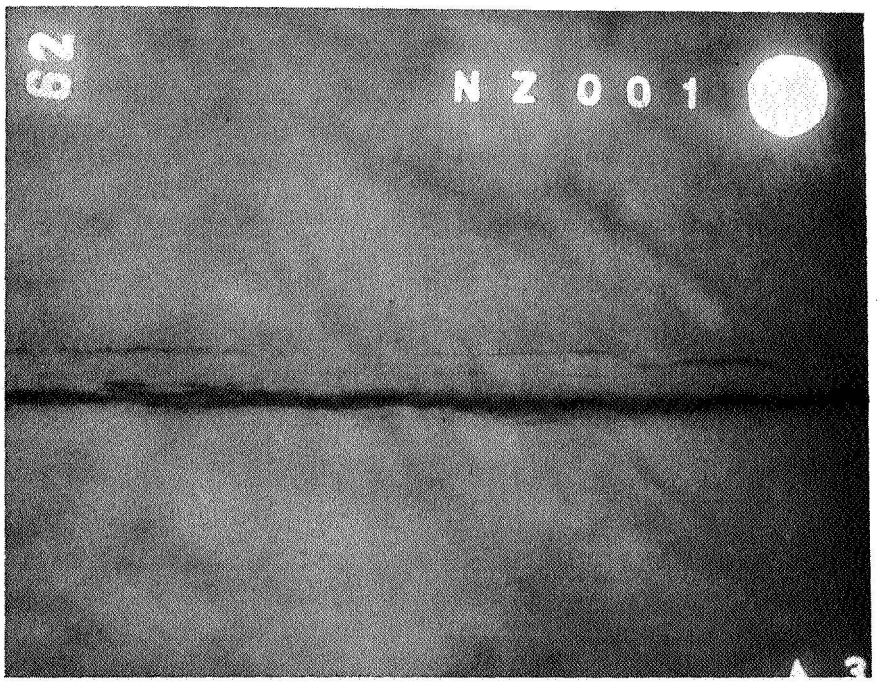
FIGURE 12

To confirm the indications, radiographic inspection was employed. Two of the four areas detected by ultrasonic inspection as having defects were confirmed by the X-ray inspection. However, the X-ray operation was performed on the cylinder in an open shop area with some adaptations in technique to accommodate the large size and lack of shielding. Section IV continues with the discussions on ultrasonic indications and investigative work completed by Ladish Co.

REPRODUCTION OF RADIOGRAPHIC FILM CONFIRMATION
ULTRASONIC INDICATION AREA NO. 3

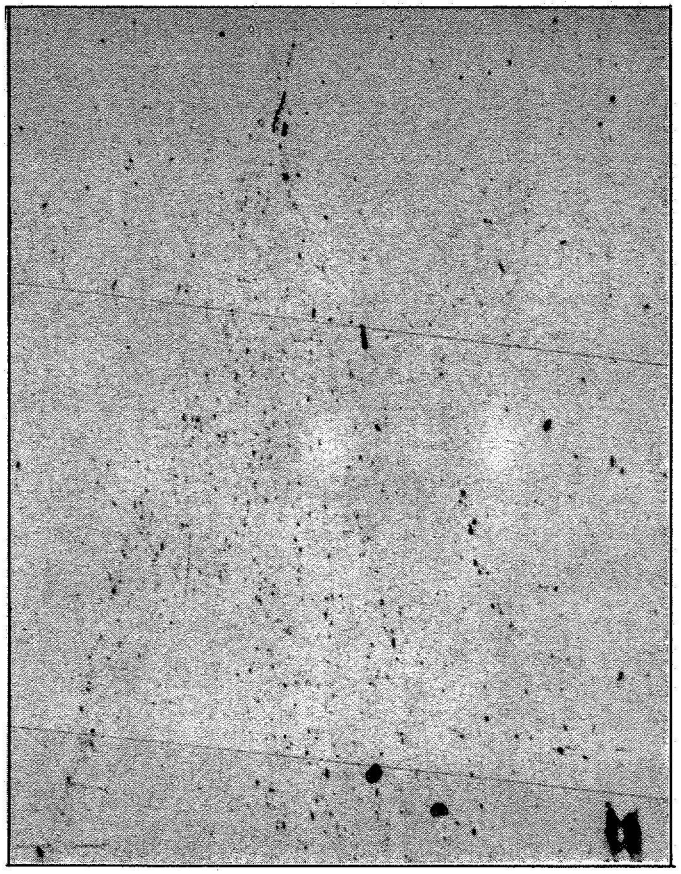
Each of the indication areas had varying degrees of inclusions and ruptures as shown in Figures 14 and 15. The left photomicrograph in Figure 14 shows the progression of the resulting rupture in Area 1, while the photomicrograph on the right shows only a slight hint of inclusions in Area 2. In Figure 15, a photomicrograph of an as-polished surface from Area 3, different than that of Figure 13, is shown. This photomicrograph is near one end of the rupture and shows the distribution and size of inclusions and voids found.

FIGURE 15: CROSS SECTION OF ULTRASONIC INDICATION AREA 3 IN THE AS-POLISHED CONDITION SHOWING VARIOUS-SIZED VOIDS AND INCLUSIONS IN BOTH ORIENTATION AND RANDOM DISTRIBUTION PATTERNS. (MICROSPECIMEN NO. G-9909 AT A MAGNIFICATION OF 25X.)

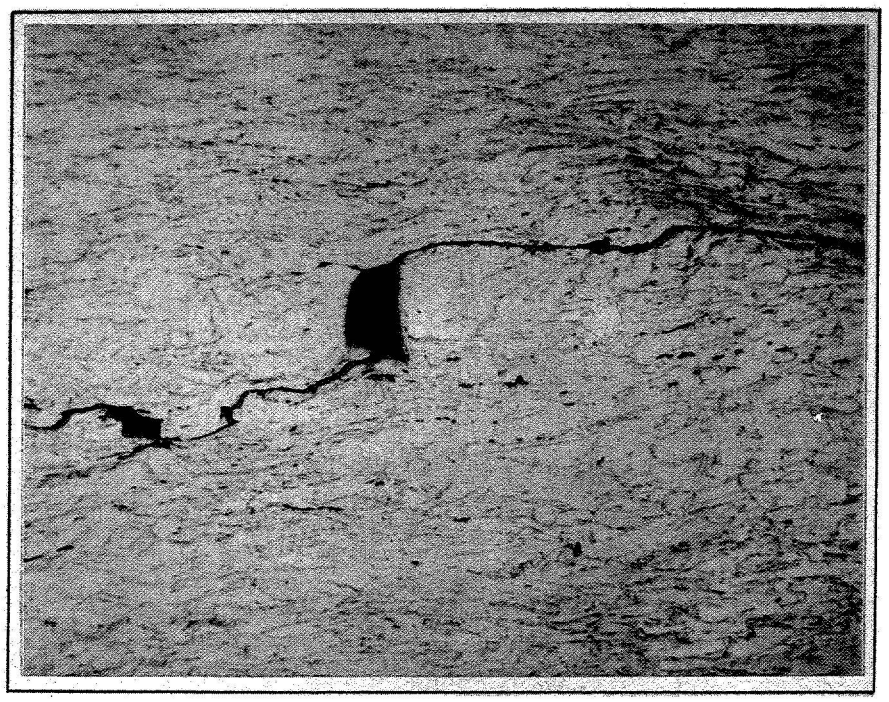
significance must be placed upon the finding of equiaxed grains in some areas, as shown in Figure 16. In this photomicrograph from Area 4, equiaxed grains of hot-working can be seen next to the rupture and confirms the ultrasonic inspection finding that some of these indications existed prior to roll-forming.

FIGURE 16: CROSS SECTION OF ULTRASONIC INDICATION AREA 4 SHOWING MIXED STRUCTURE OF BOTH ELONGATED AND EQUIAXED GRAINS. (MICROSPECIMEN NO. G-9979.)

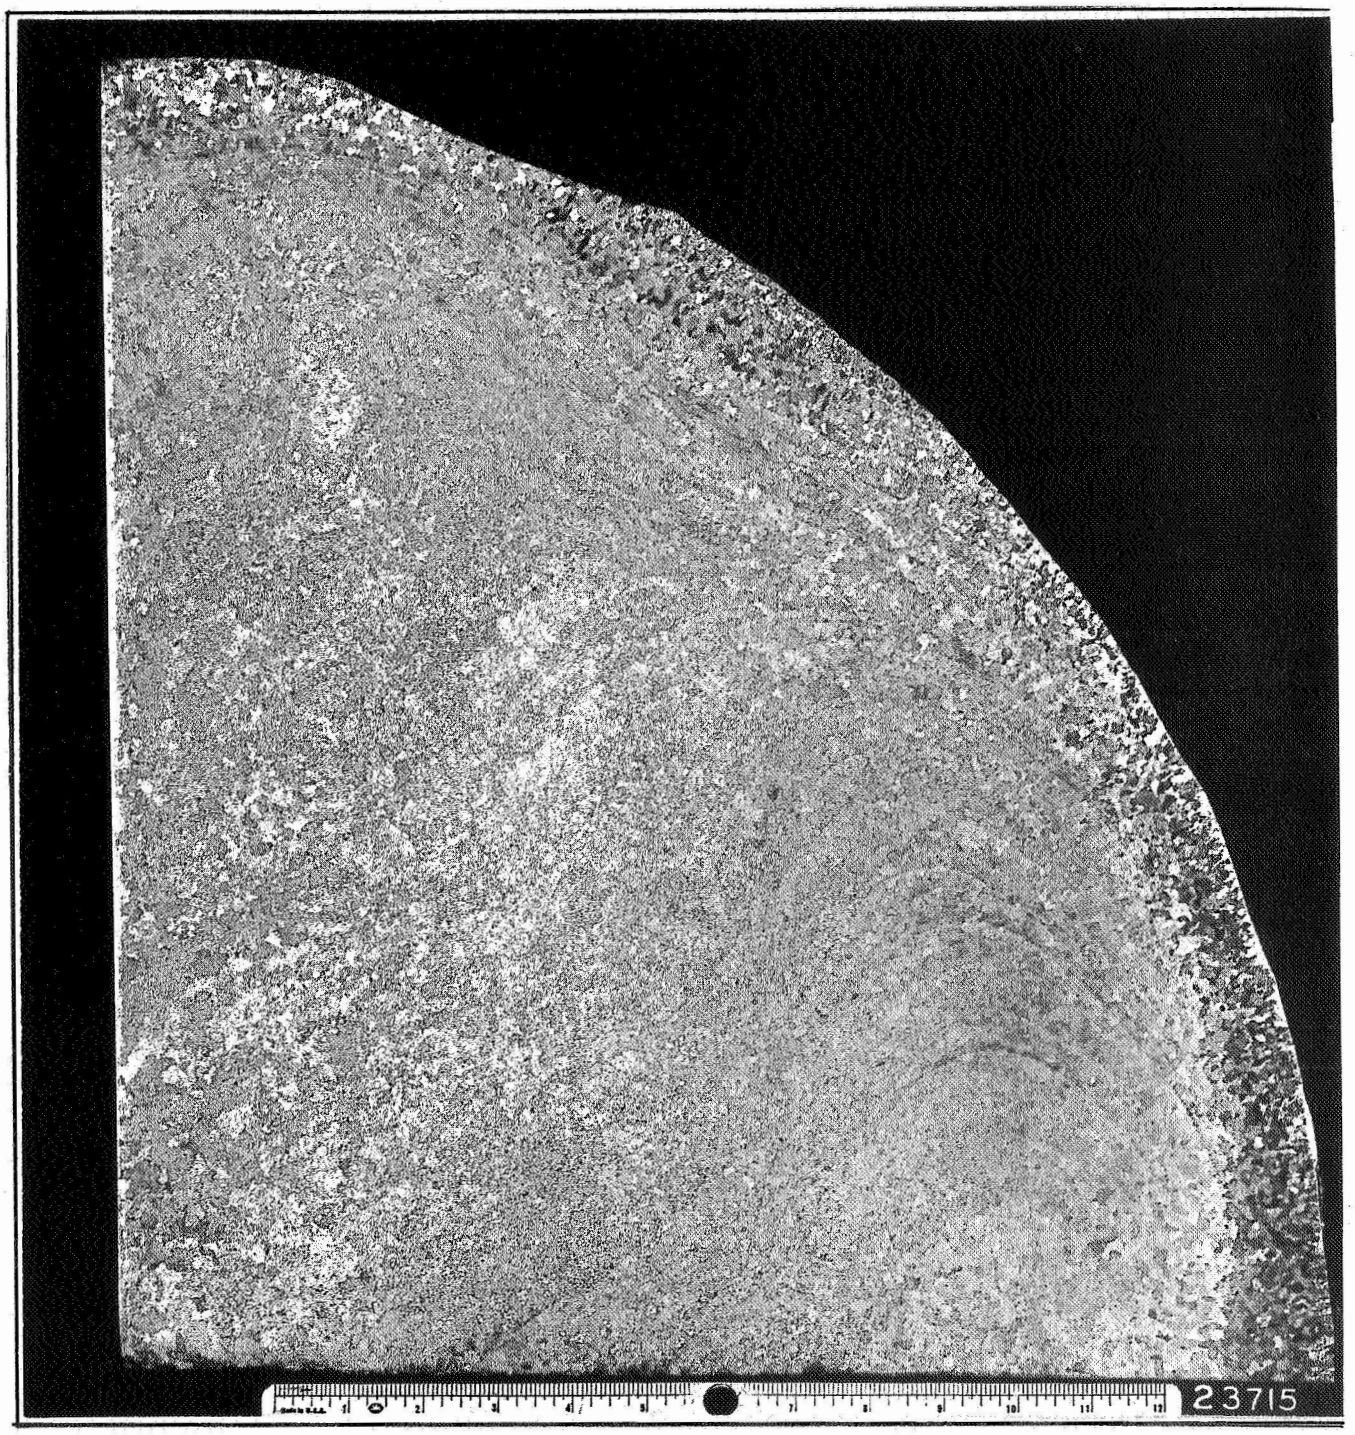
FIGURE 17

The chemistry check analysis by Ladish Co. was acceptable and is shown in Table VI, along with the specification chemistry and mill certification of chemisty. A photograph of the macroetch is shown in Figure 17. No unusual characteristics were observed.

Magnification 1X (reduced for printing); etchant $HCl-HNO_3$.

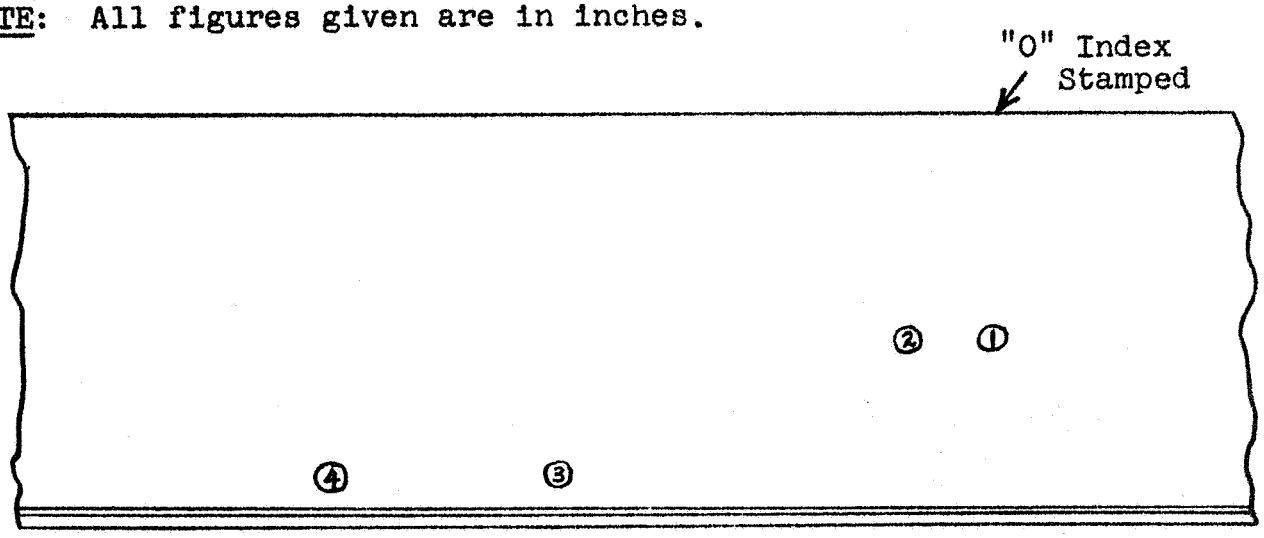
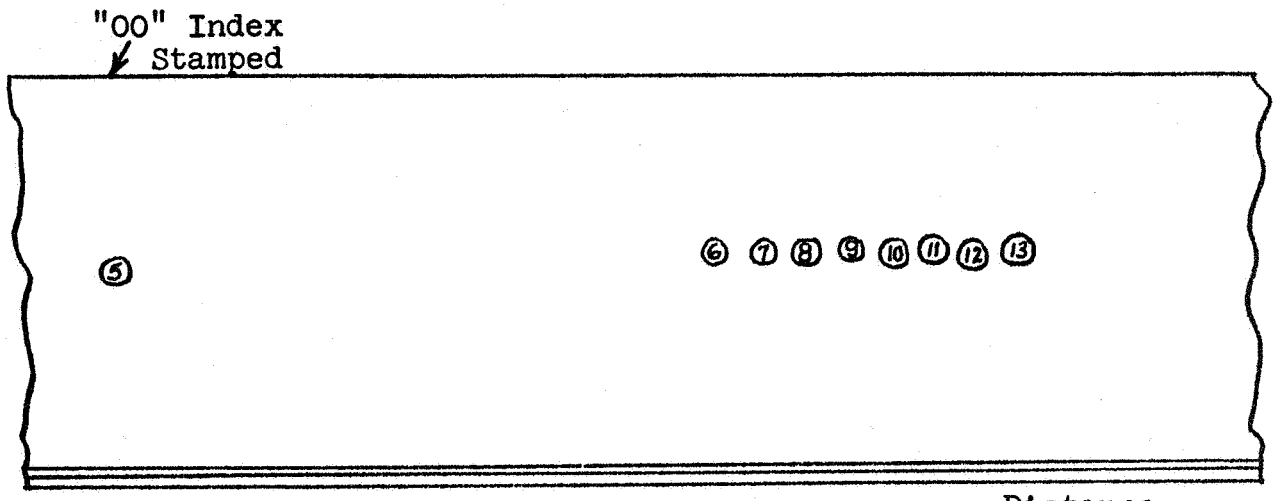
Indication No.	Size	Depth from OD	Distance from Bottom	Distance Clockwise from "0"
1	+3/64; -5/64	1/2	18-1/4	0
2	" "	1/2	18-1/4	5-1/4
3	" "	3/4	5	76-1/4
4	" "	3/4	5	100

Indication No.	Size	Depth from OD	Distance from Bottom	Distance Counter-Clockwise from "00"
5	=5/64	1/2	21-5/8	0
6	+3/64; -5/64	1 - 1-1/8	24-1/2	33-3/4
7	" "	1 - 1-1/8	24-3/8	36
8	" "	1 - 1-1/8	24-1/4	38-1/8
9	" "	1 - 1-1/8	24-1/2	42-3/4
10	" "	1 - 1-1/8	24-1/2	45
11	" "	1 - 1-1/8	25	46-3/4
12	" "	1 - 1-1/8	25	51-1/2
13	" "	1 - 1-1/8	24-5/8	53

All indications spot type; area from No. 6 to No. 13 showed some very small scattered indications in between recordable indications.

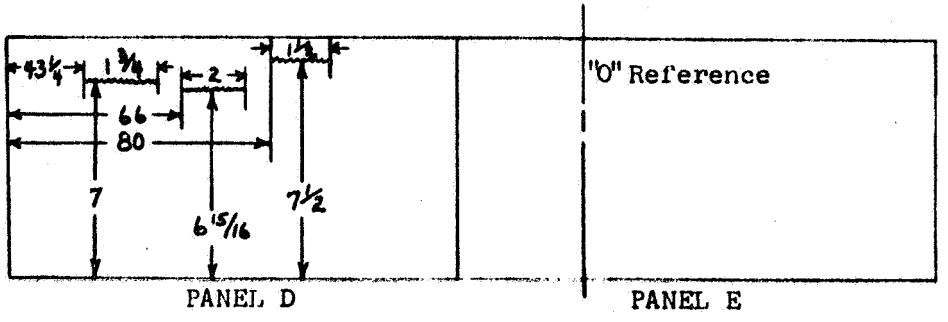
Three stringer-type indications observed at approximately mid-wall in Test Panel "D".

All indications show amplitudes in excess of calibration setting.

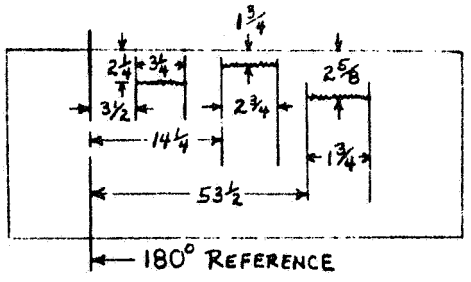
Three stringer-type indications observed at approximately mid-wall. All indications exceed limits considered to be acceptable.

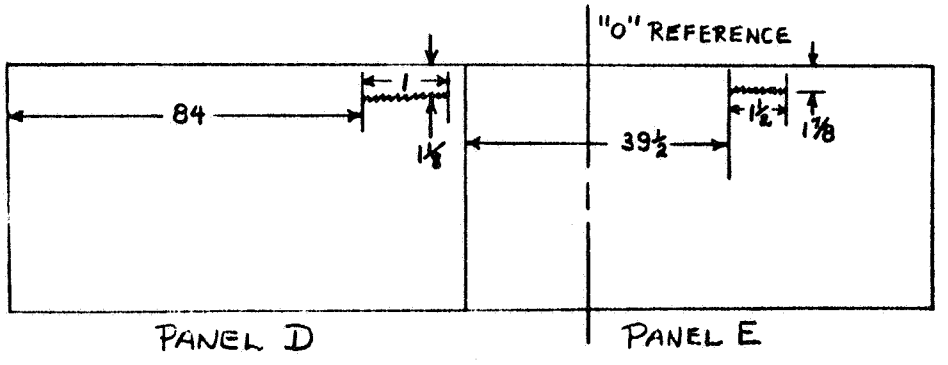
Two stringer-type indications observed at approximately 2/3 wall. All indications exceed limits considered to be acceptable.
