HYDRAZINE ELECTROLYSIS CELL
SAFETY LIMITS TESTS

SUMMARY REPORT

TASKS VII AND VIII

JPL CONTRACT No. 951720

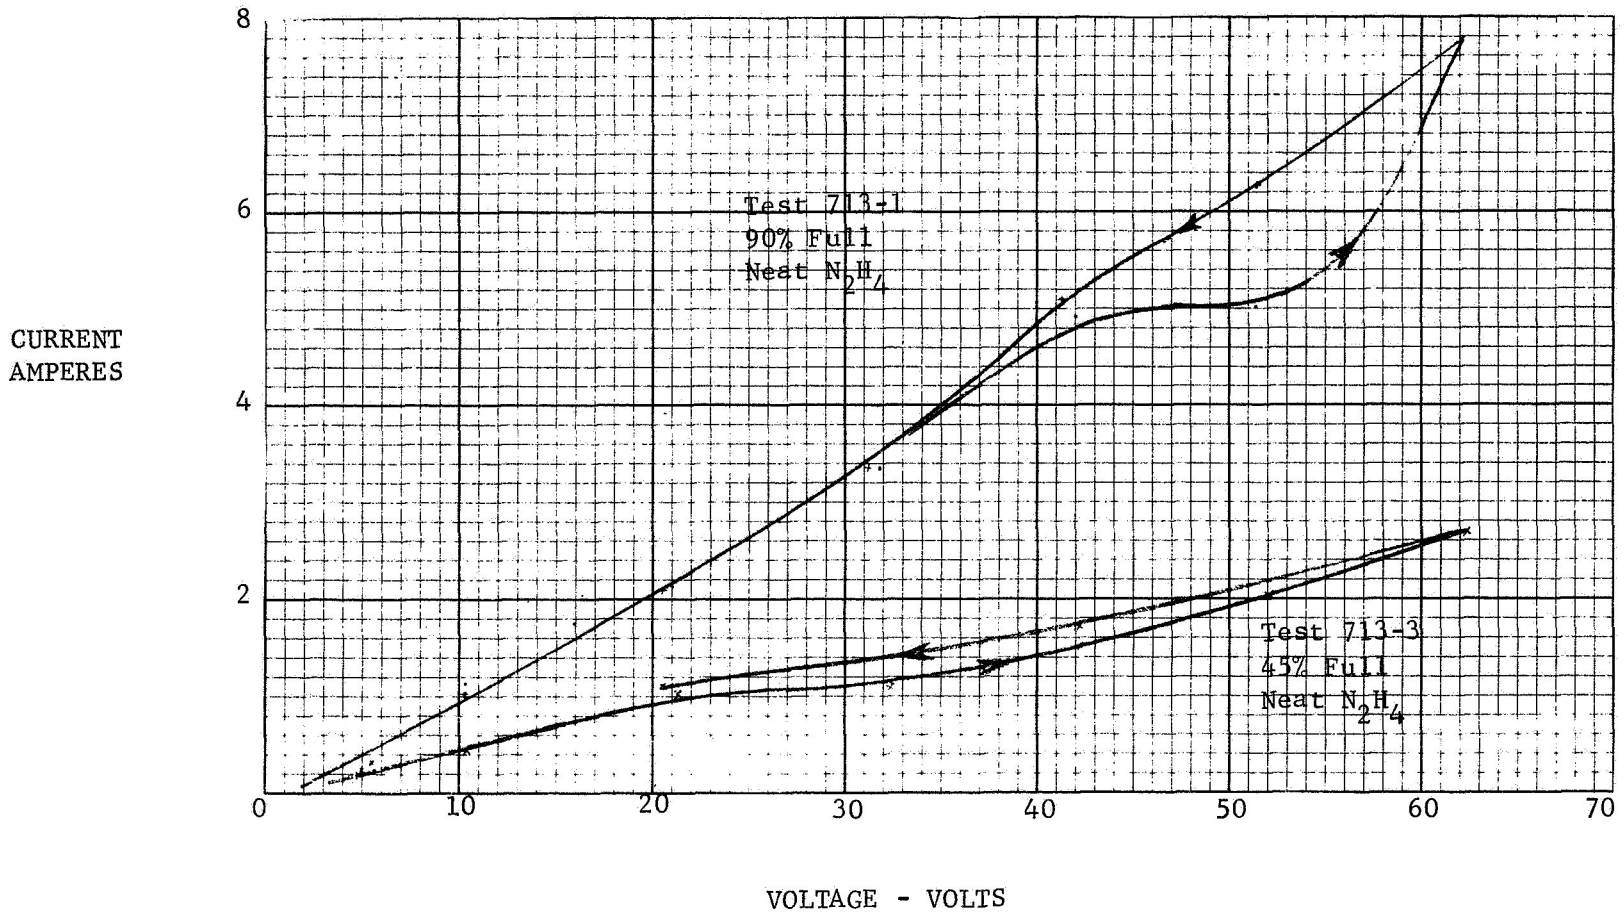
FIGURE 6

In accordance with the test plan, the first test was a survey of voltage-current characteristics with the tank 90% full of neat hydrazine. At this loading the liquid level was approximately one inch below the top of the anode. The data from this test are plotted in the upper curve of Figure 6. The inflection and hystersis in the curve is not unusual and is caused by polarization characteristics of the electrolysis cell and by variation in effective electrode area due to formation and expulsion of gas bubbles in the wick/electrode interface.

The raw test data from Tests 713-1, and -2 and -3 are plotted in Figure 6, 7 and 8. These raw data do not show any unusual characteristics or departure from anticipated performance of the electrolysis cell at high voltages. However, as previously reported, the actual pressure increase measured during Test No. 713-2 was significantly greater than could be accounted for. Based on the current-time- temperature history recorded for that test, the pressure rise due to gas generation by electrolysis and to temperature rise was calculated as 274 psi. up to the point at which the relief valve first vented. The actual measured pressure rise during the same time period was 757 psi. Applying the same analysis to the meager amount of data obtained during Test 713-3 before failure gave a possible pressure rise of 0.4 psi,whereas the test data showed 7 psi. The gas generation rate,when compared to the predicted rate increased with power level from 150 to 400% during Test 713-2 and to almost 900% immediately prior to failure in Test 713-3. Possible explanations for these discrepancies include:

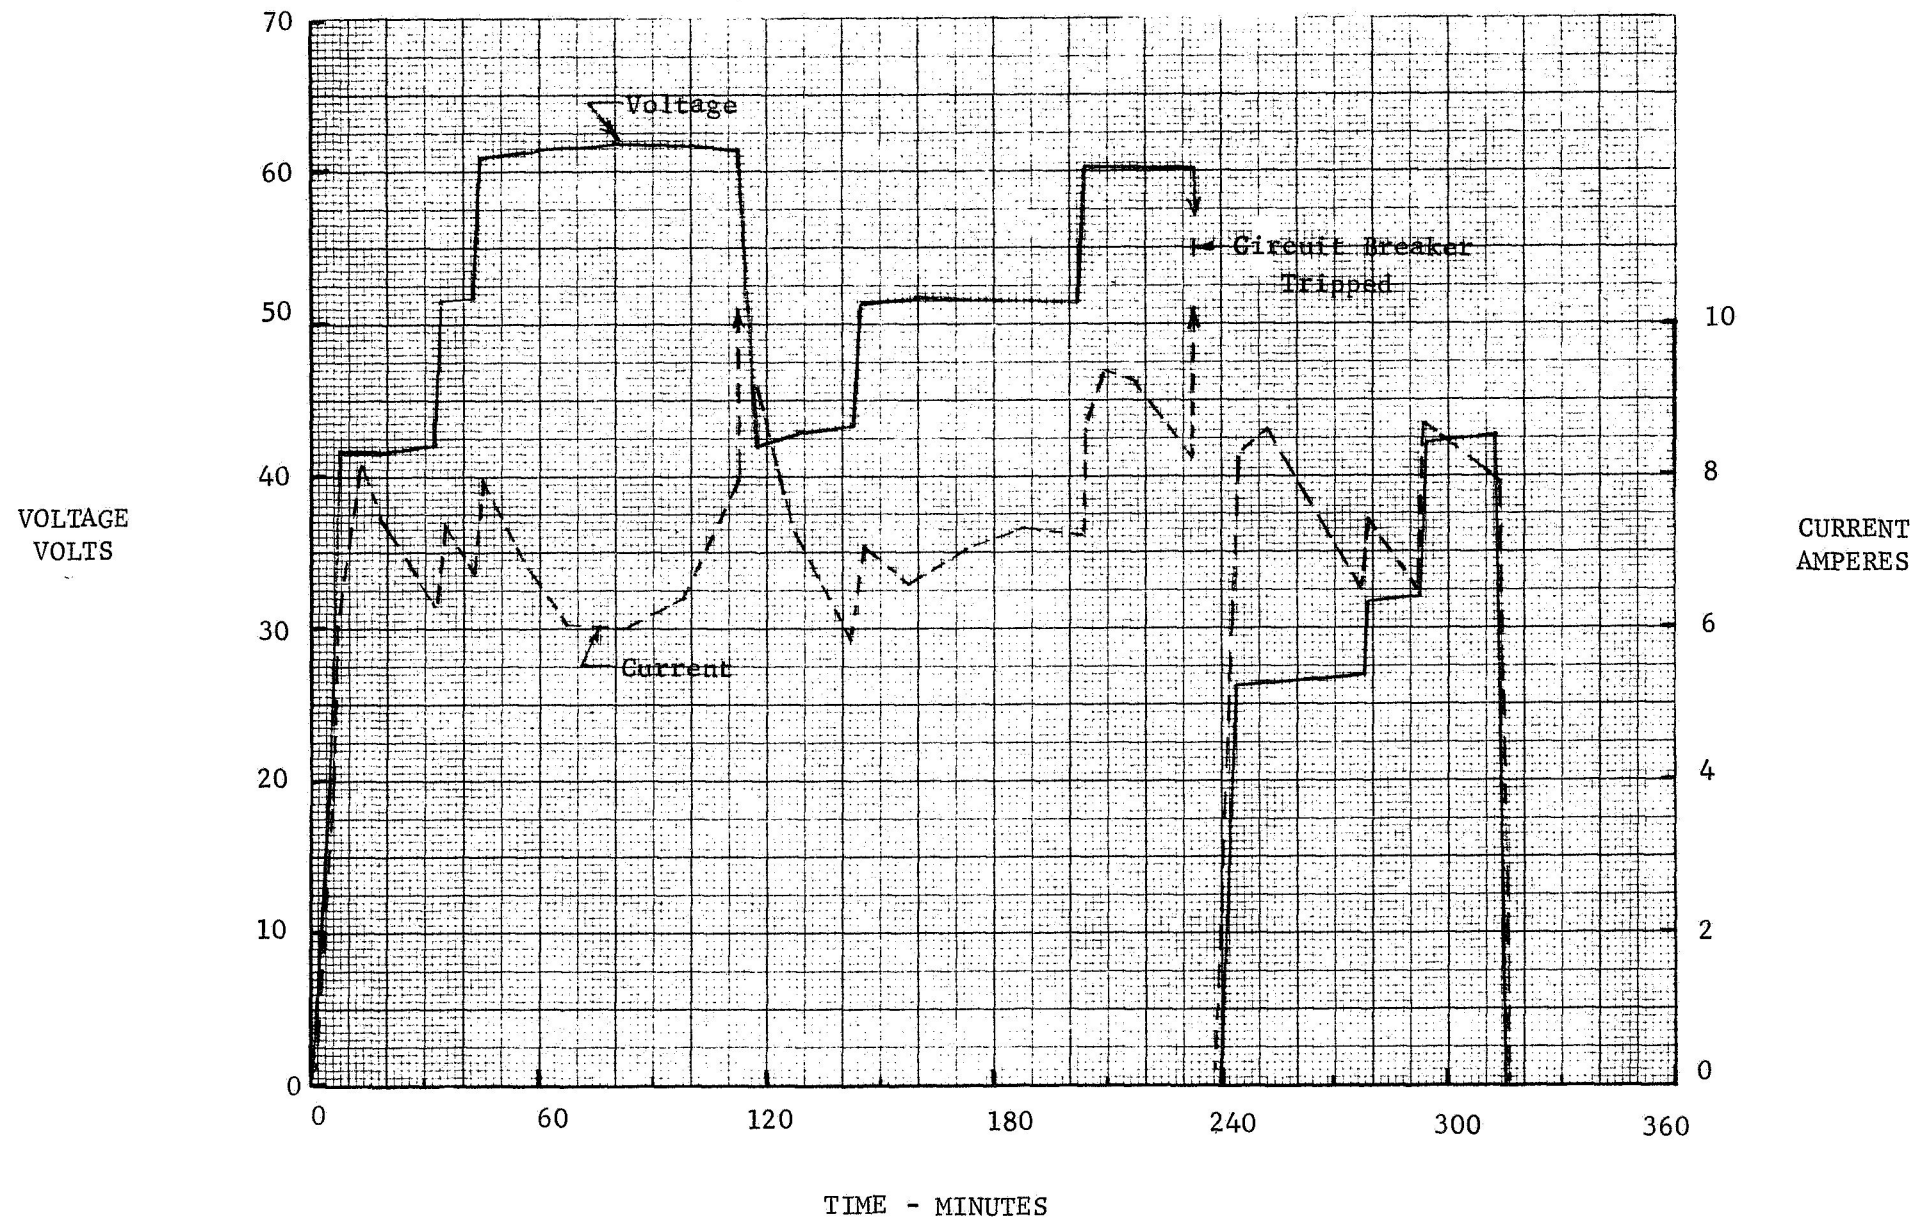
FIGURE 7

During this test an unexpected current increase occurred on two occasions. After 118 minutes of operation it was noted that the current was increasing and exceeded 10 amperes. This necessitated a reduction of voltage to keep the current below that value. Later in the test, the current suddenly increased and tripped the 15 ampere circuit breaker on the power supply. This current surge was coincident with the first vent cycle of the system relief valve.

These current surges were probable due to the near-short area of the cathode contacting the anode. It could have been caused by higher pressure, deformation of the screen at much higher temperatures, or the action of gas bubbles when the relief valve opened.

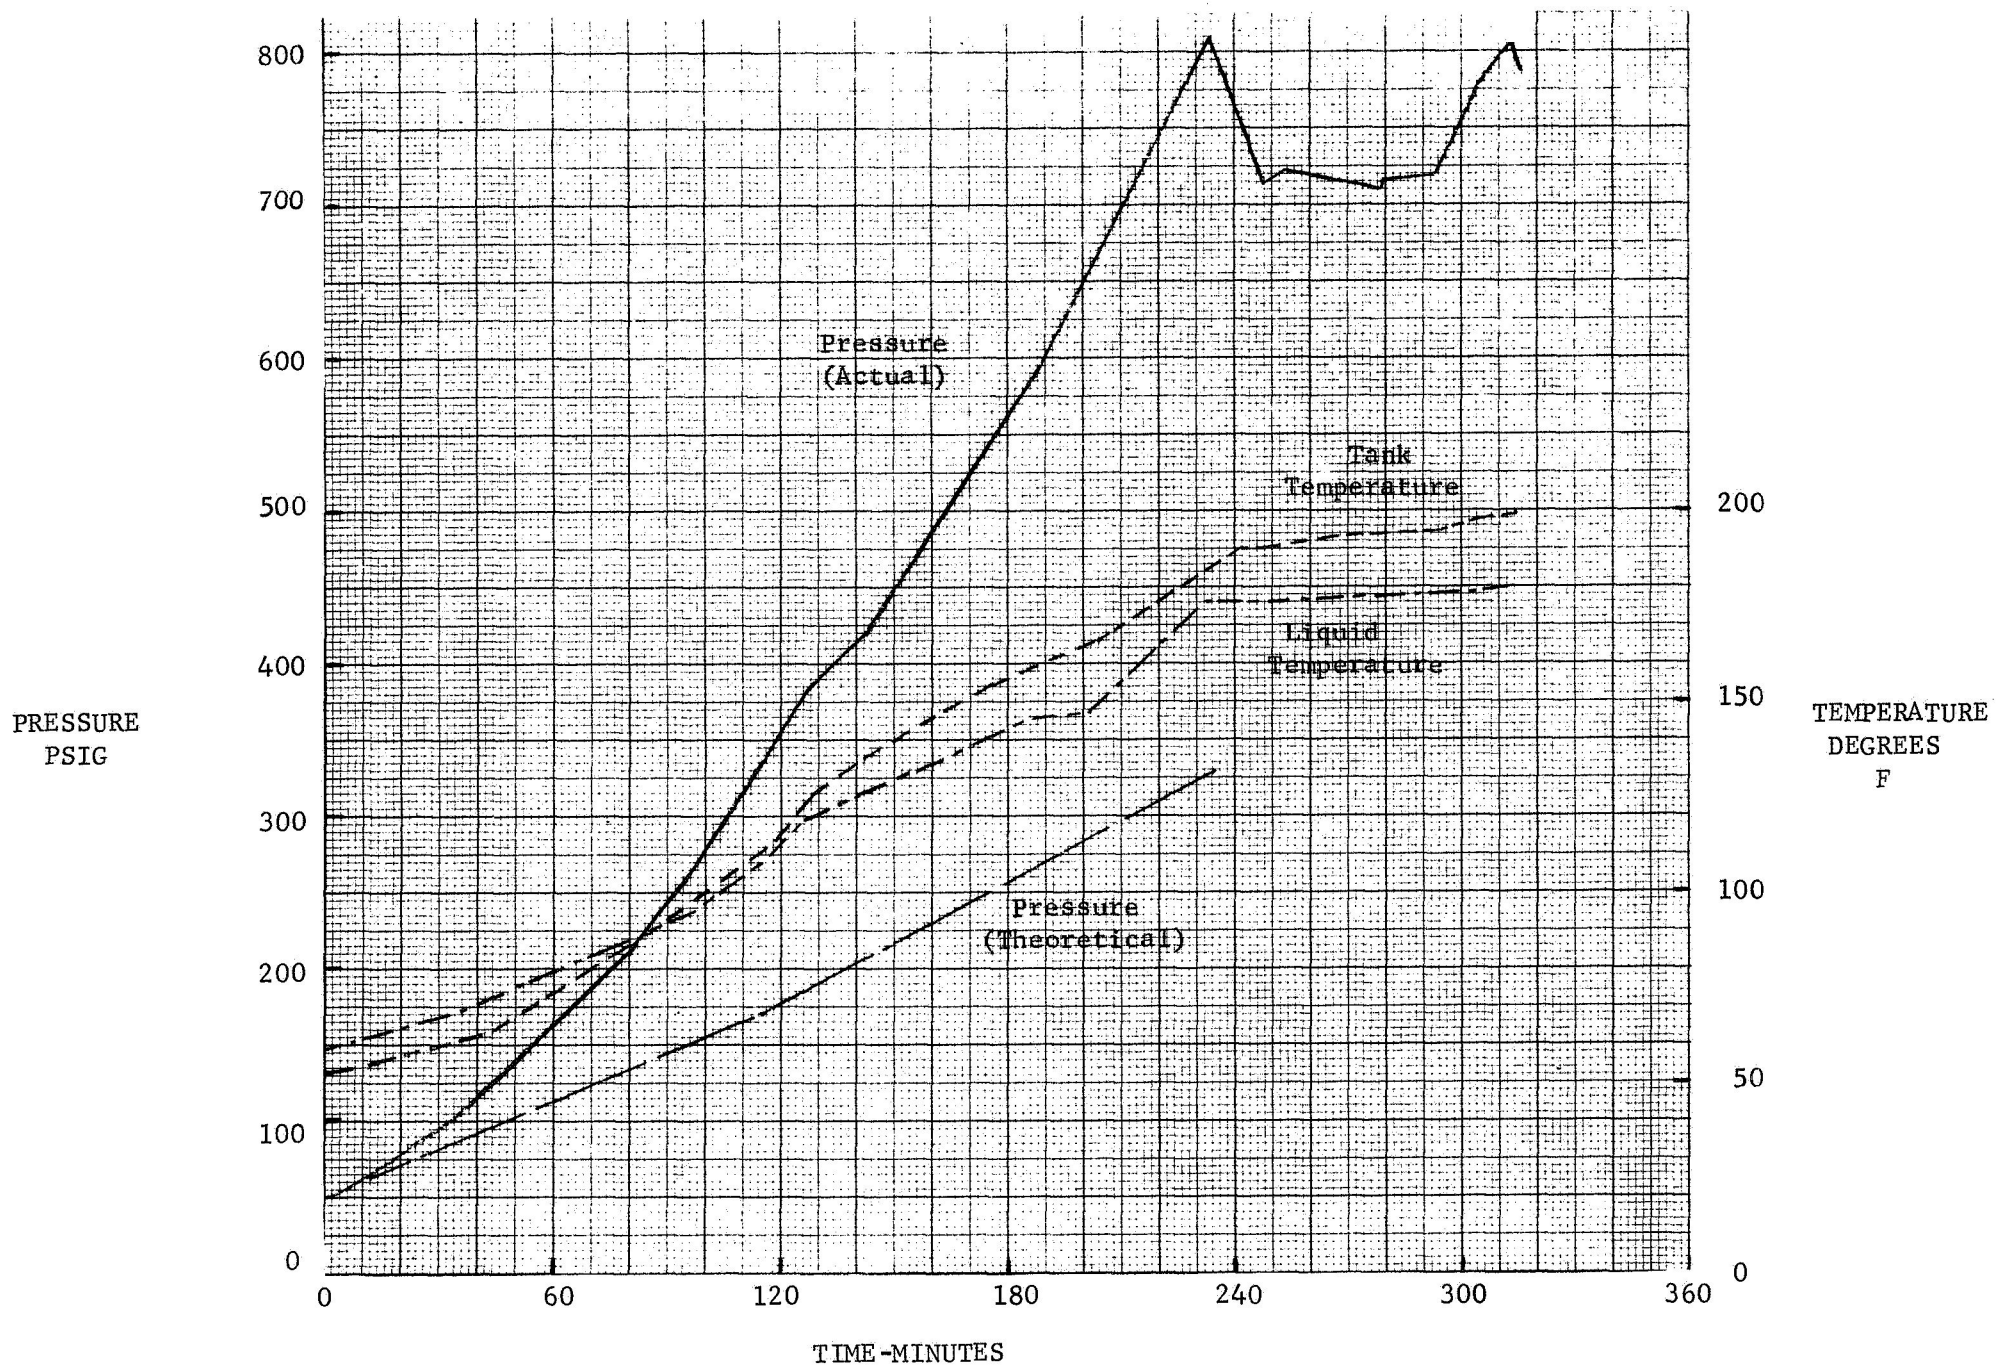
FIGURE 8

Aside from these events the operations of the cell appeared to be normal throughout this test. However, later analysis of the data showed that the actual pressure rise during the first 238 minutes of this test (i.e., up to the time the relief valve first vented) was much greater than could be accounted for by temperature rise and electrolytic gas generation. For reference purposes the pressure increase due to these two factors is plotted in Figure 8. For further discussion of this abnormal pressure rise and current surges see paragraph on "Failure Investigation".

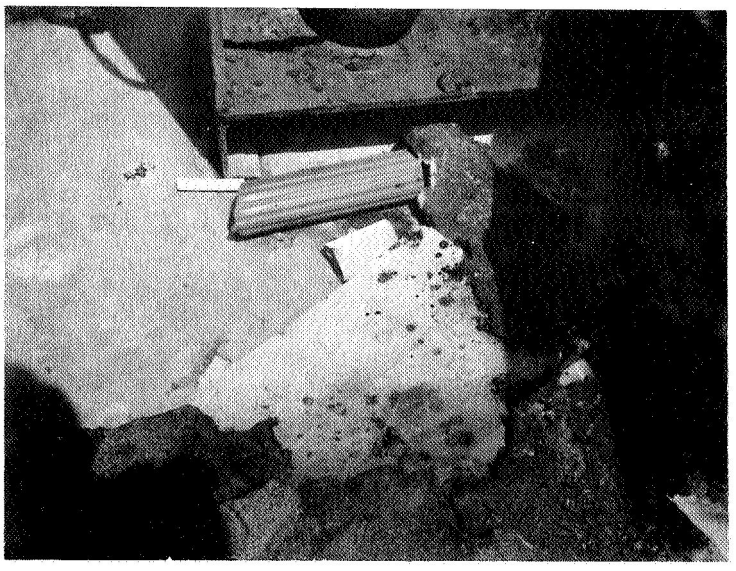
FIGURE 9

The failure investigation started by noting the location and condition of all parts of the electrolysis cell which could be found. The notes made at that time are reproduced in Appendix C. The photographs of Figures 9 through 12 show the test chamber and some of the electrolysis cell parts following the failure. Figure 13 shows all of the cell parts which could be found arranged on a display table.

TEST CHAMBER
AFTER FAILURE

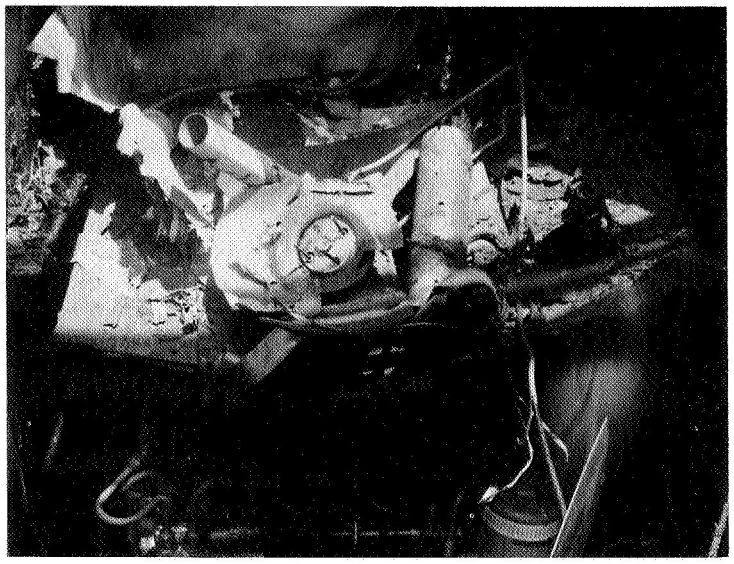
FIGURE 10

ANODE AND OTHER PARTS
AT BASE OF TEST
CHAMBER

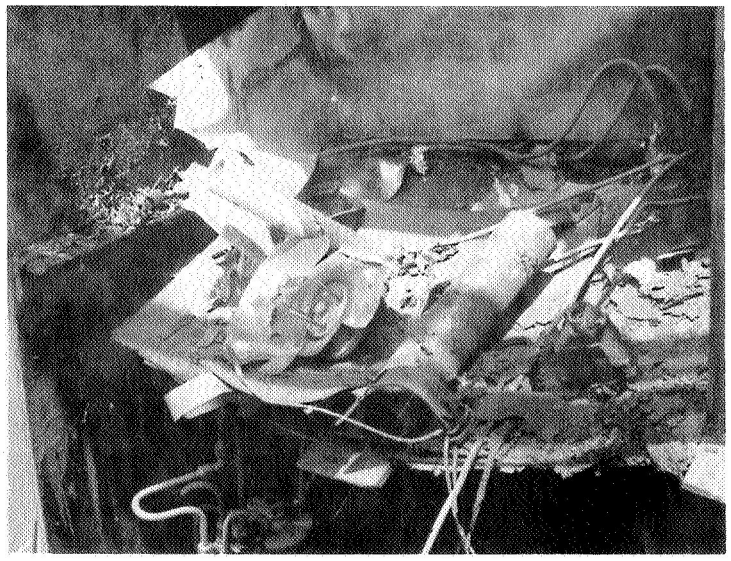
FIGURE 11

TANK FLANGE,
INNER AND OUTER
ELECTRODE ENCLOSURES

a. The outer enclosure of the electrode module was bulged out locally at its lower edge from a high internal pressure. This was a very local condition. The remainder of the part was still round and relatively undamaged except for the top edge being torn out at the attachment screw hole.

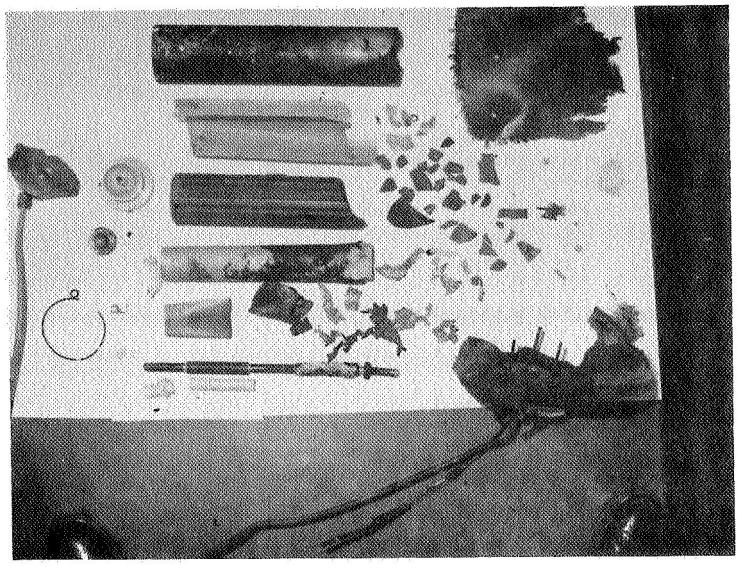
FIGURE 13

ELECTROLYSIS CELL PARTS
AND FRAGMENTS
