NASA CR-72954
DDAD EDR 7034

FINAL REPORT
EXPERIMENTAL EVALUATION OF LOW CYCLE THERMAL FATIGUE IN A TURBINE VANE FABRICATED FROM LAMINATED POROUS MATERIAL

D. A. Nealy, R. D. Anderson, and A. A. Hufford

15 March 1971

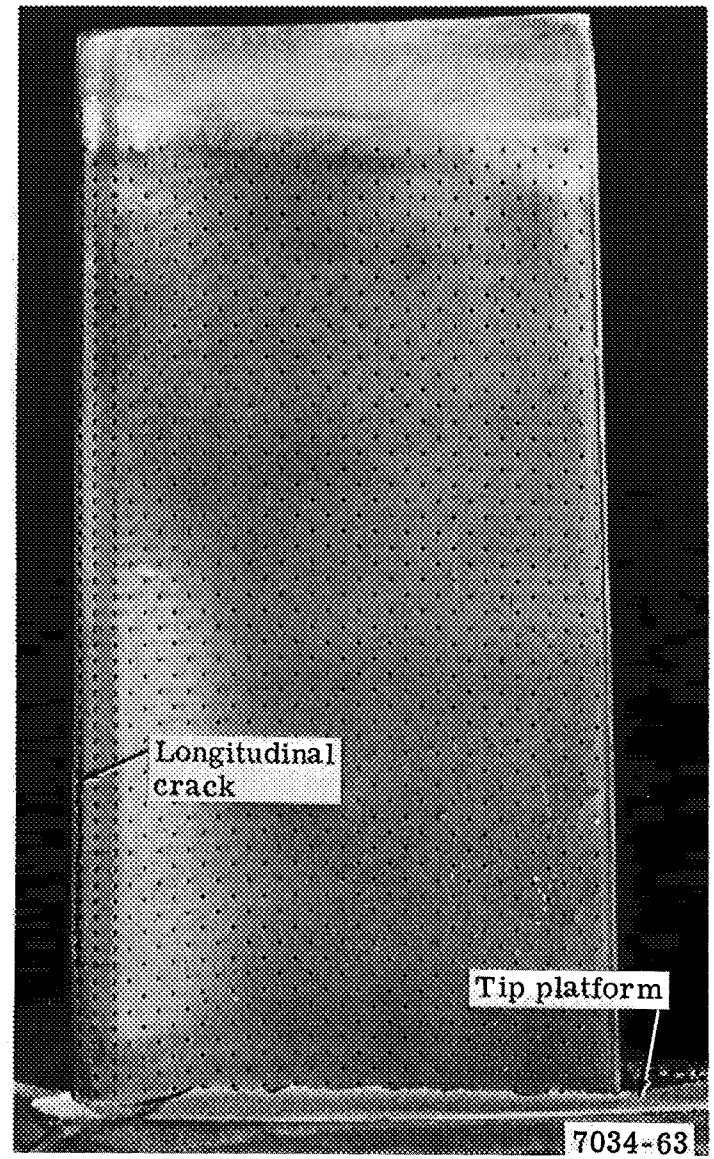
These data show that vane No. 2 increased 22% in flow during the cyclic test period. A severe crack found in the leading edge of this vane after the cyclic test tends to explain this flow increase.

Figure 46. Pressure side view of test vane No. 2 after 110 cycles.

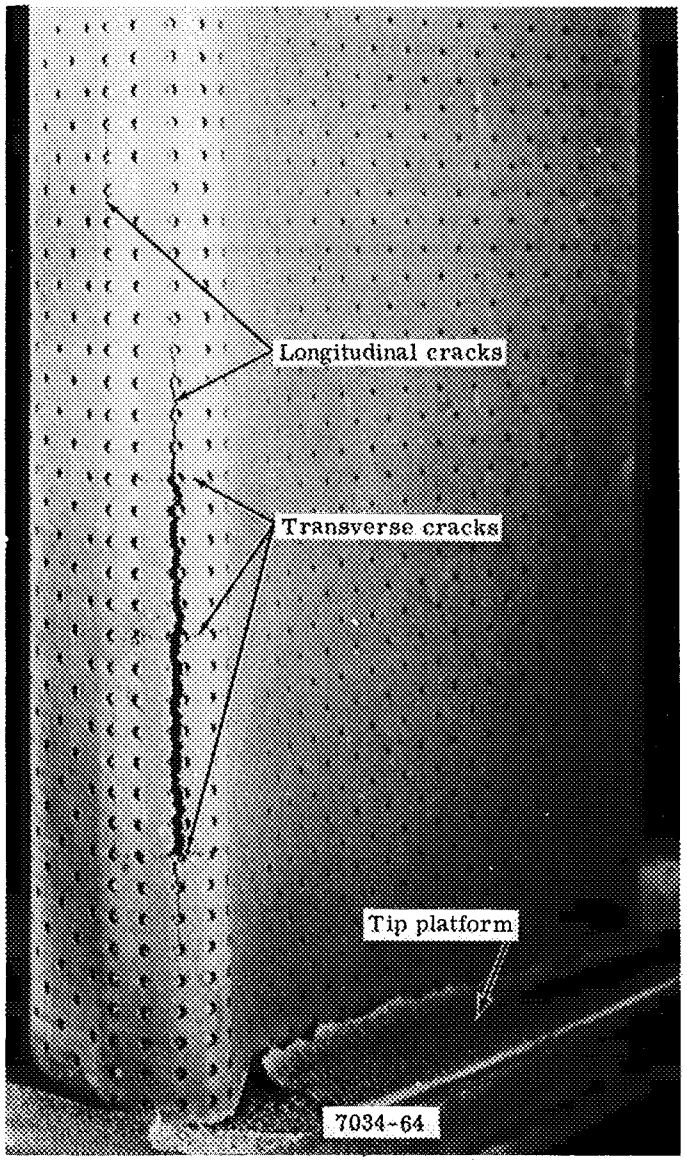
Figure 47. Leading edge cracks in test vane No. 2 after 110 cycles.

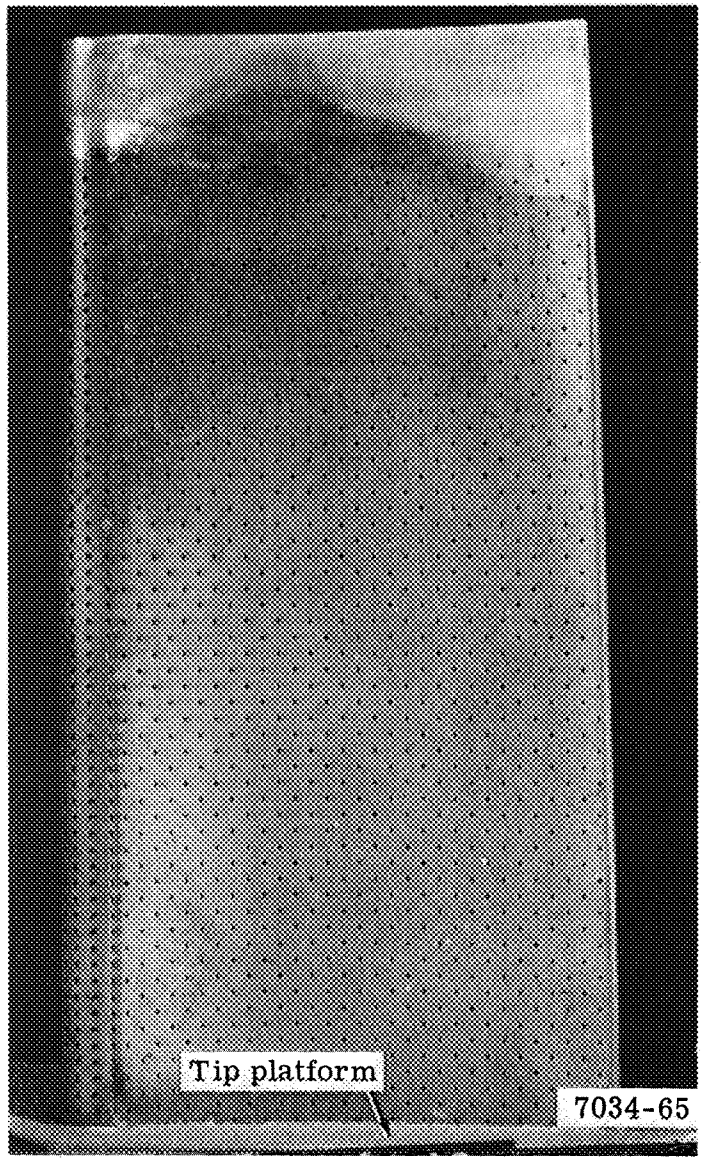
Figure 48. Pressure side view of test vane No. 3 after 110 cycles.

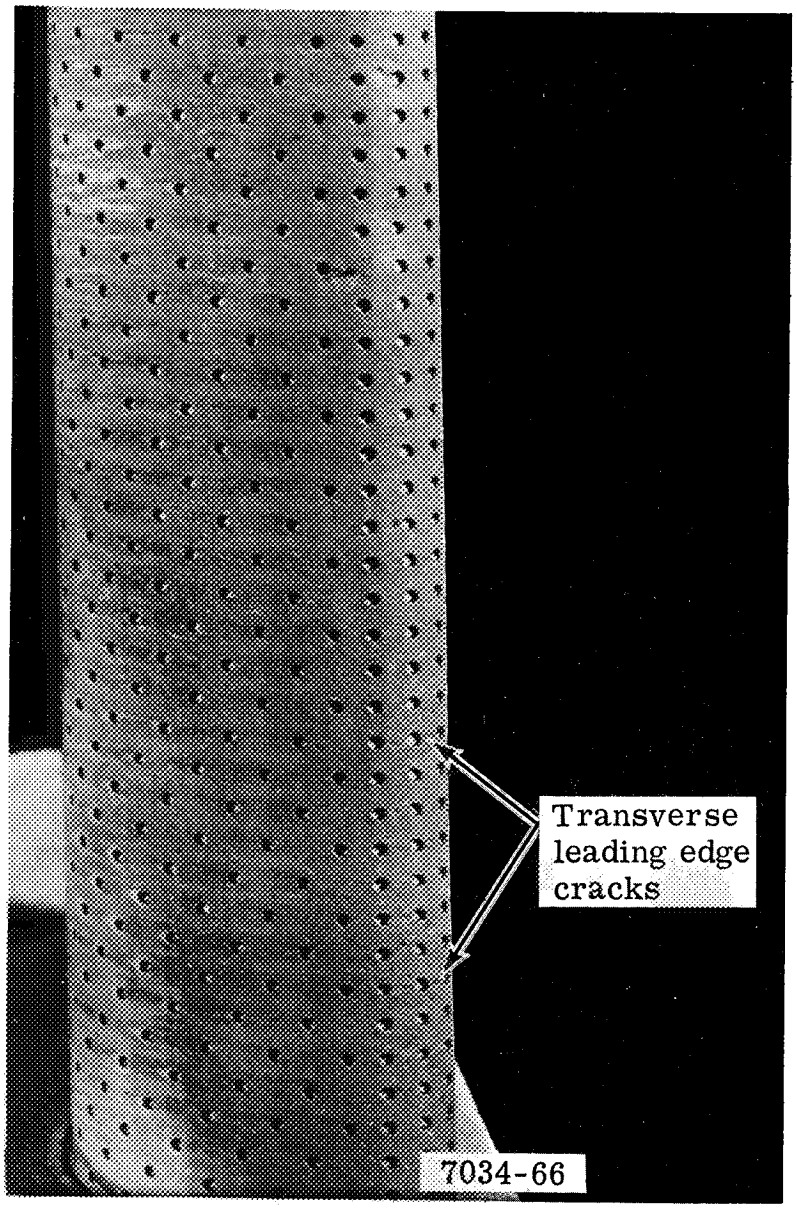
Figure 49. Leading edge and suction side view of test vane No. 3 after 110 cycles.

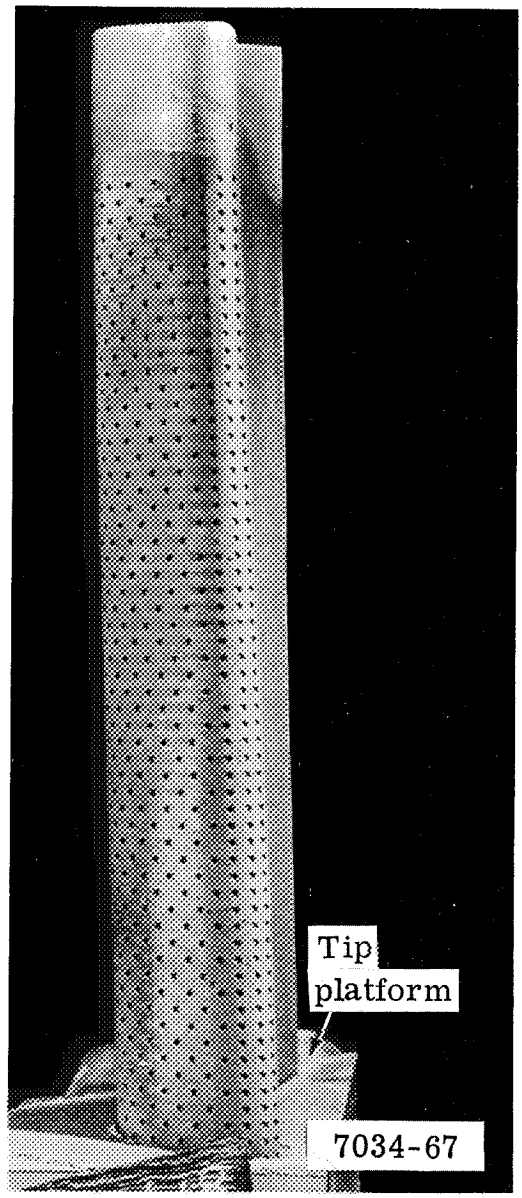
Figure 50. Leading edge view of test vane No. 4 after 110 cycles.

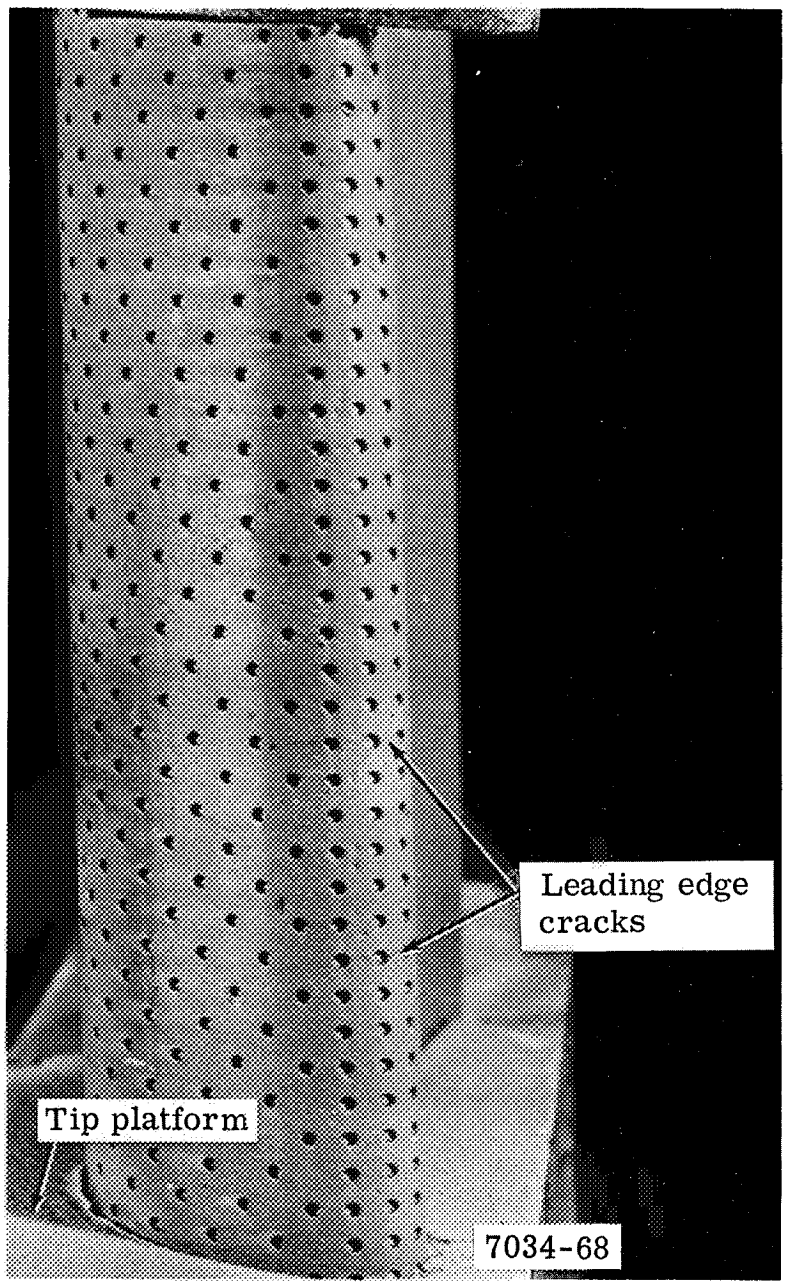
Figure 51. Leading edge and suction side view of test vane No. 4 after 110 cycles.

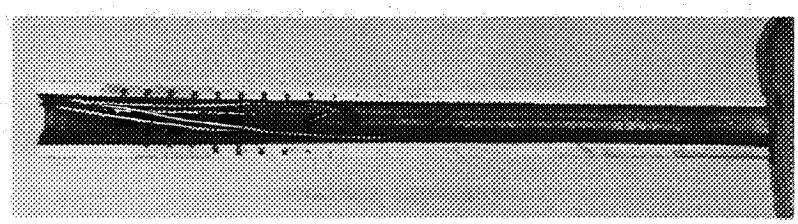
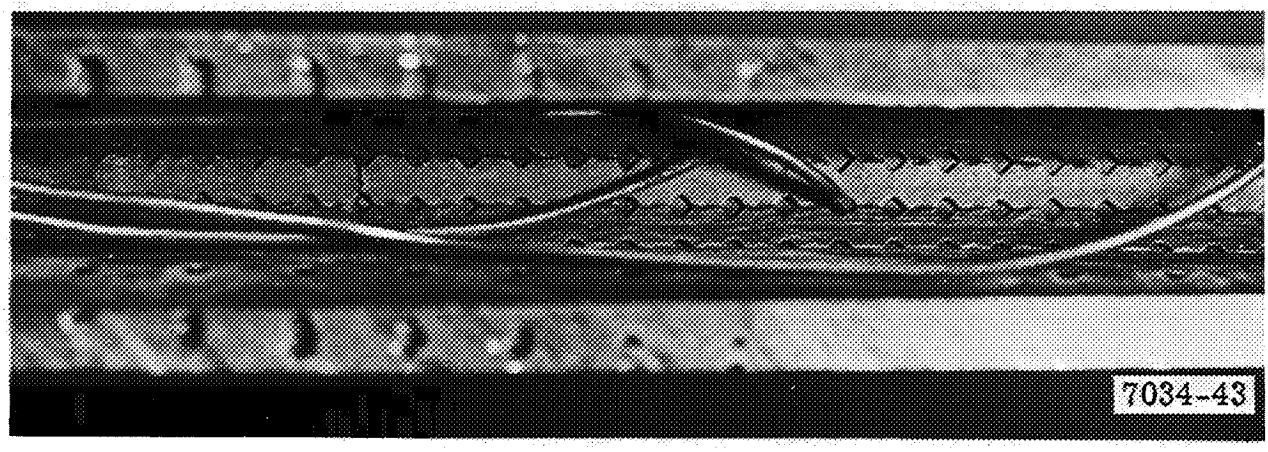
Figure 66. Photomacrograph of inside leading edge of test vane No. 2.

cracks in vane No. 2; internal views of the same vane are displayed in Figure 66. The sheathed leading-edge thermocouple wires are clearly visible in the latter photograph. It is obvious from Figure 66 that the cracks are relatively straight (hole to hole) and that the holes have become somewhat diamond shaped. This indicates that the material had been strained beyond the elastic limit in this area. This distortion, which was unique to test vane No. 2, is felt to be a result of the airfoil cold forming operation and not directly related to the cyclic cascade test. It is therefore highly probable that the yielding which occurred during the forming operation was the primary contributing factor to the longitudinal crack in test vane No. 2.

- Utilization of proved hot creep forming techniques during fabrication should help eliminate residual stresses and/or surface cracks attributable to the forming operation.

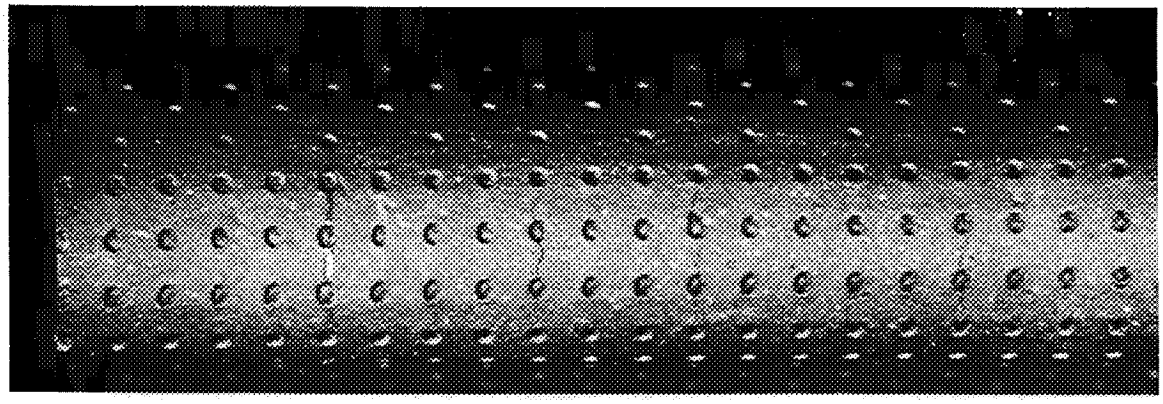
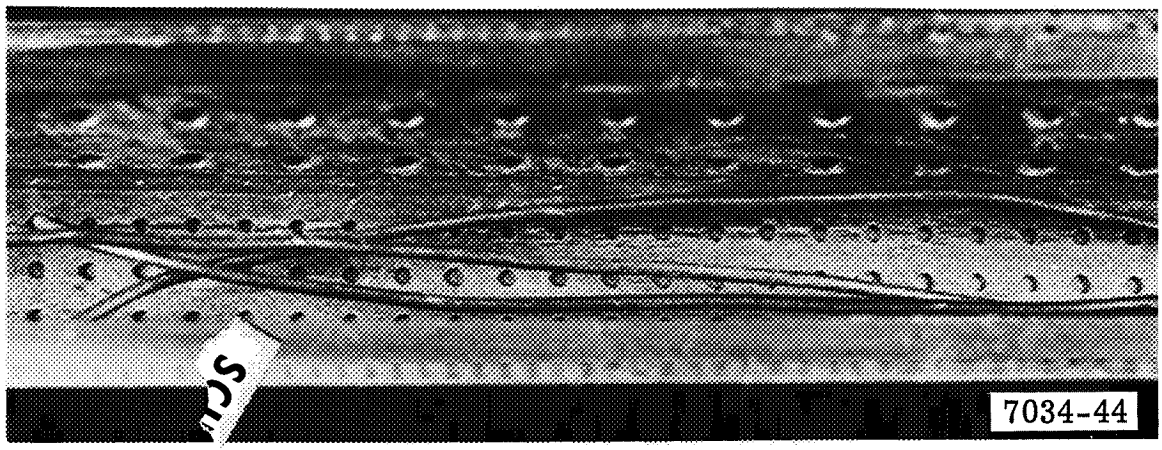
Figure 67. Photomacrographs of leading edge of test vane No. 3 (magn: 4X).

Transverse cracks in the leading edge of test vane No. 3 are illustrated by photomacrographs (Figure 67) which show that some distortion of the inner metal surface occurred during forming. However, the hole elongation is modest when compared with test vane No. 2.

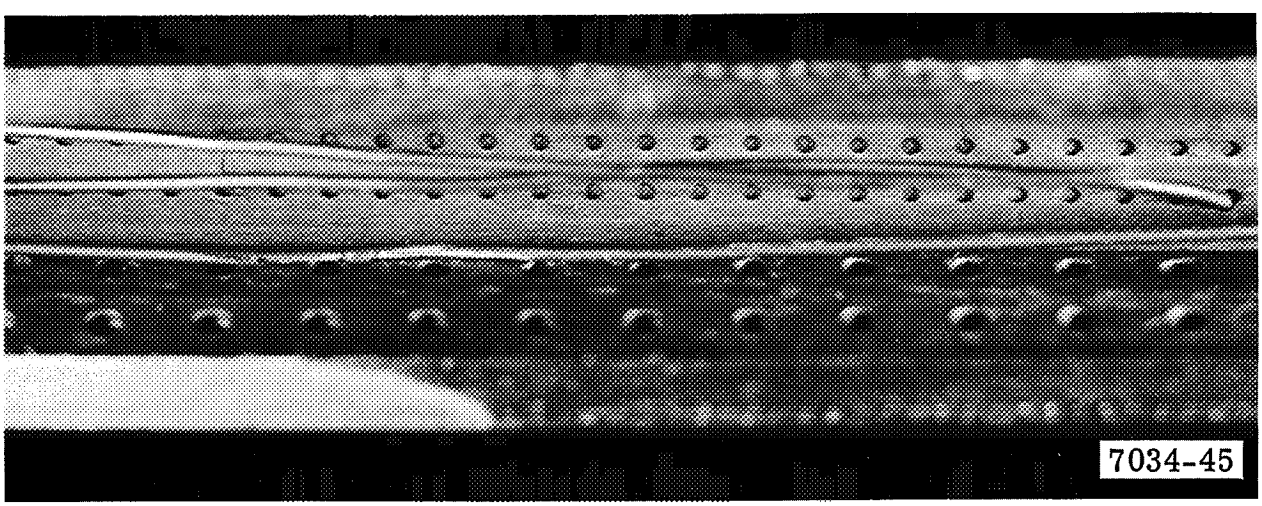
Figure 68. Photomacrograph of inside leading edge of test vane No. 4 (magn: 4X).

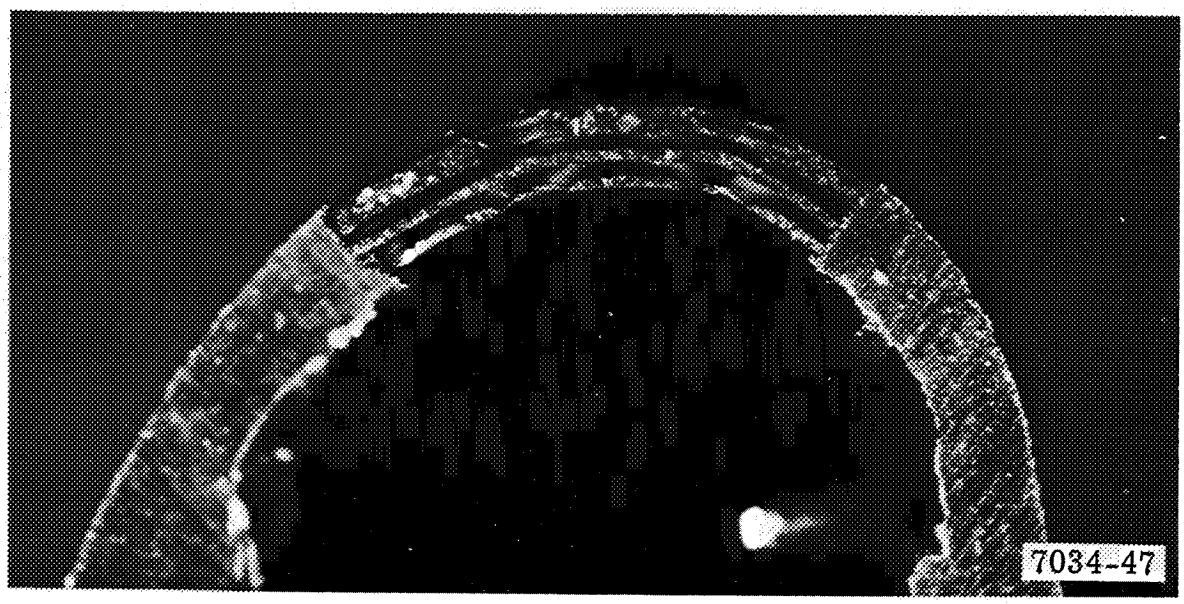
Figure 70. Photomacrograph of failure surfaces of test vane No. 3 (magn: 15X).

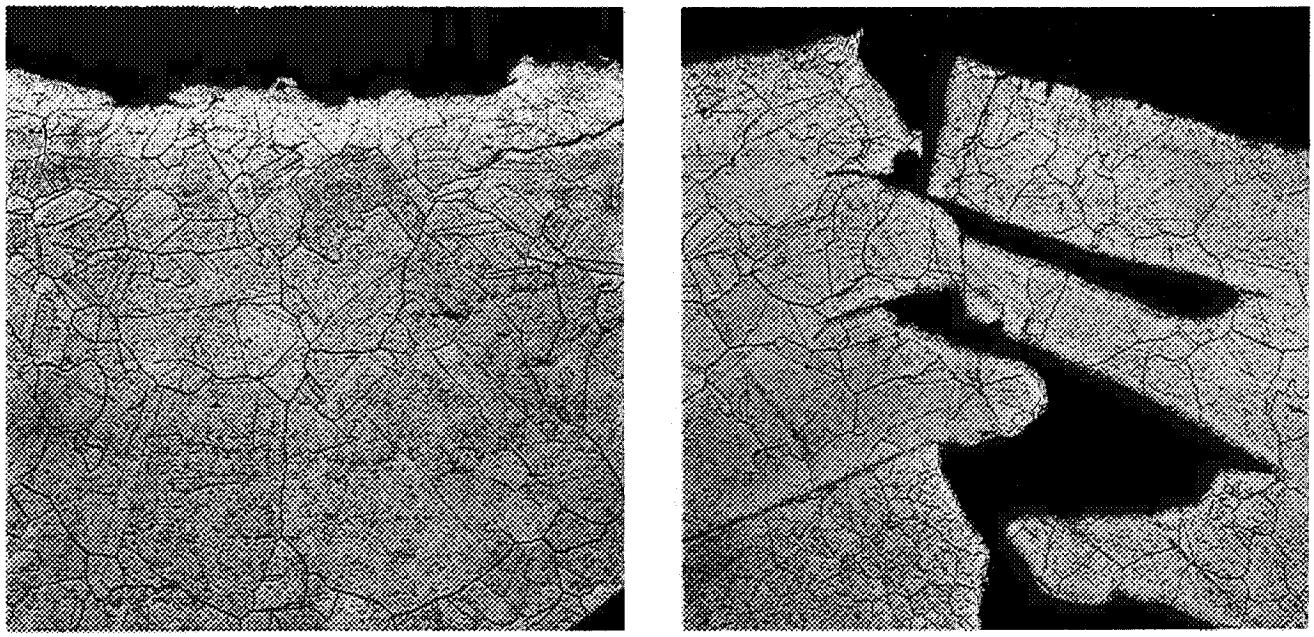
7034-48

Figure 71. Photomicrographs of longitudinal failure sections in test vane No. 2 (magn: 100X).

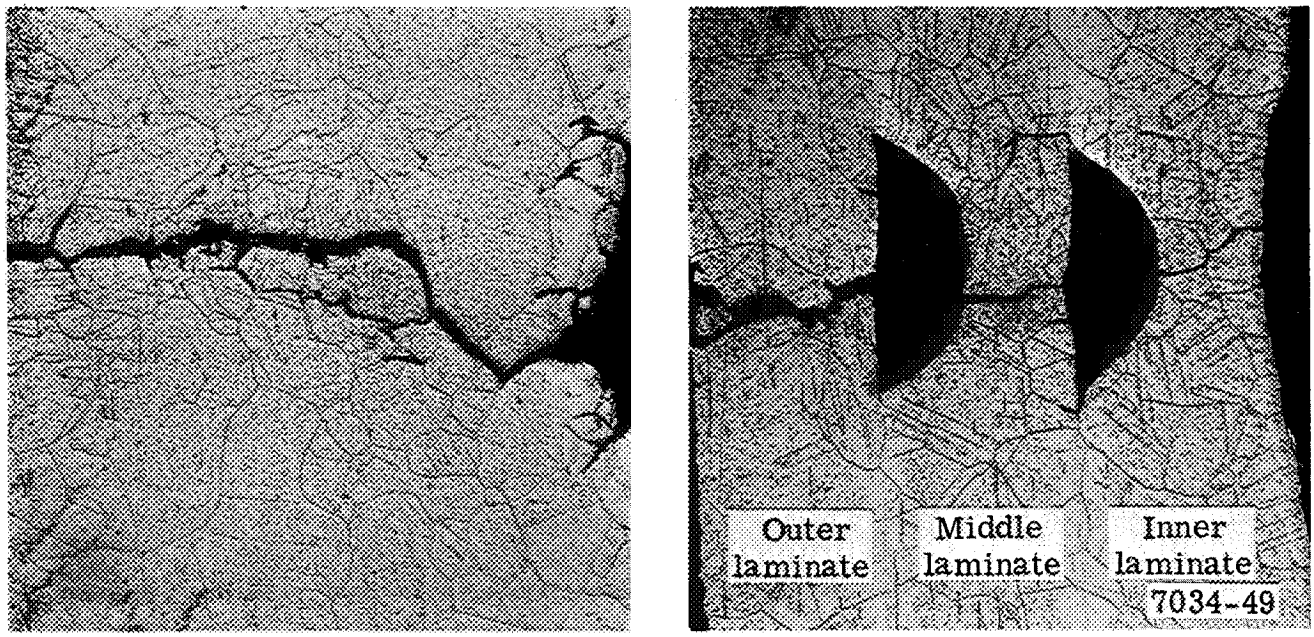
7034-49

Figure 72. Photomicrographs of transverse failure sections in test vanes No. 2 and 4 (magn: 100X).

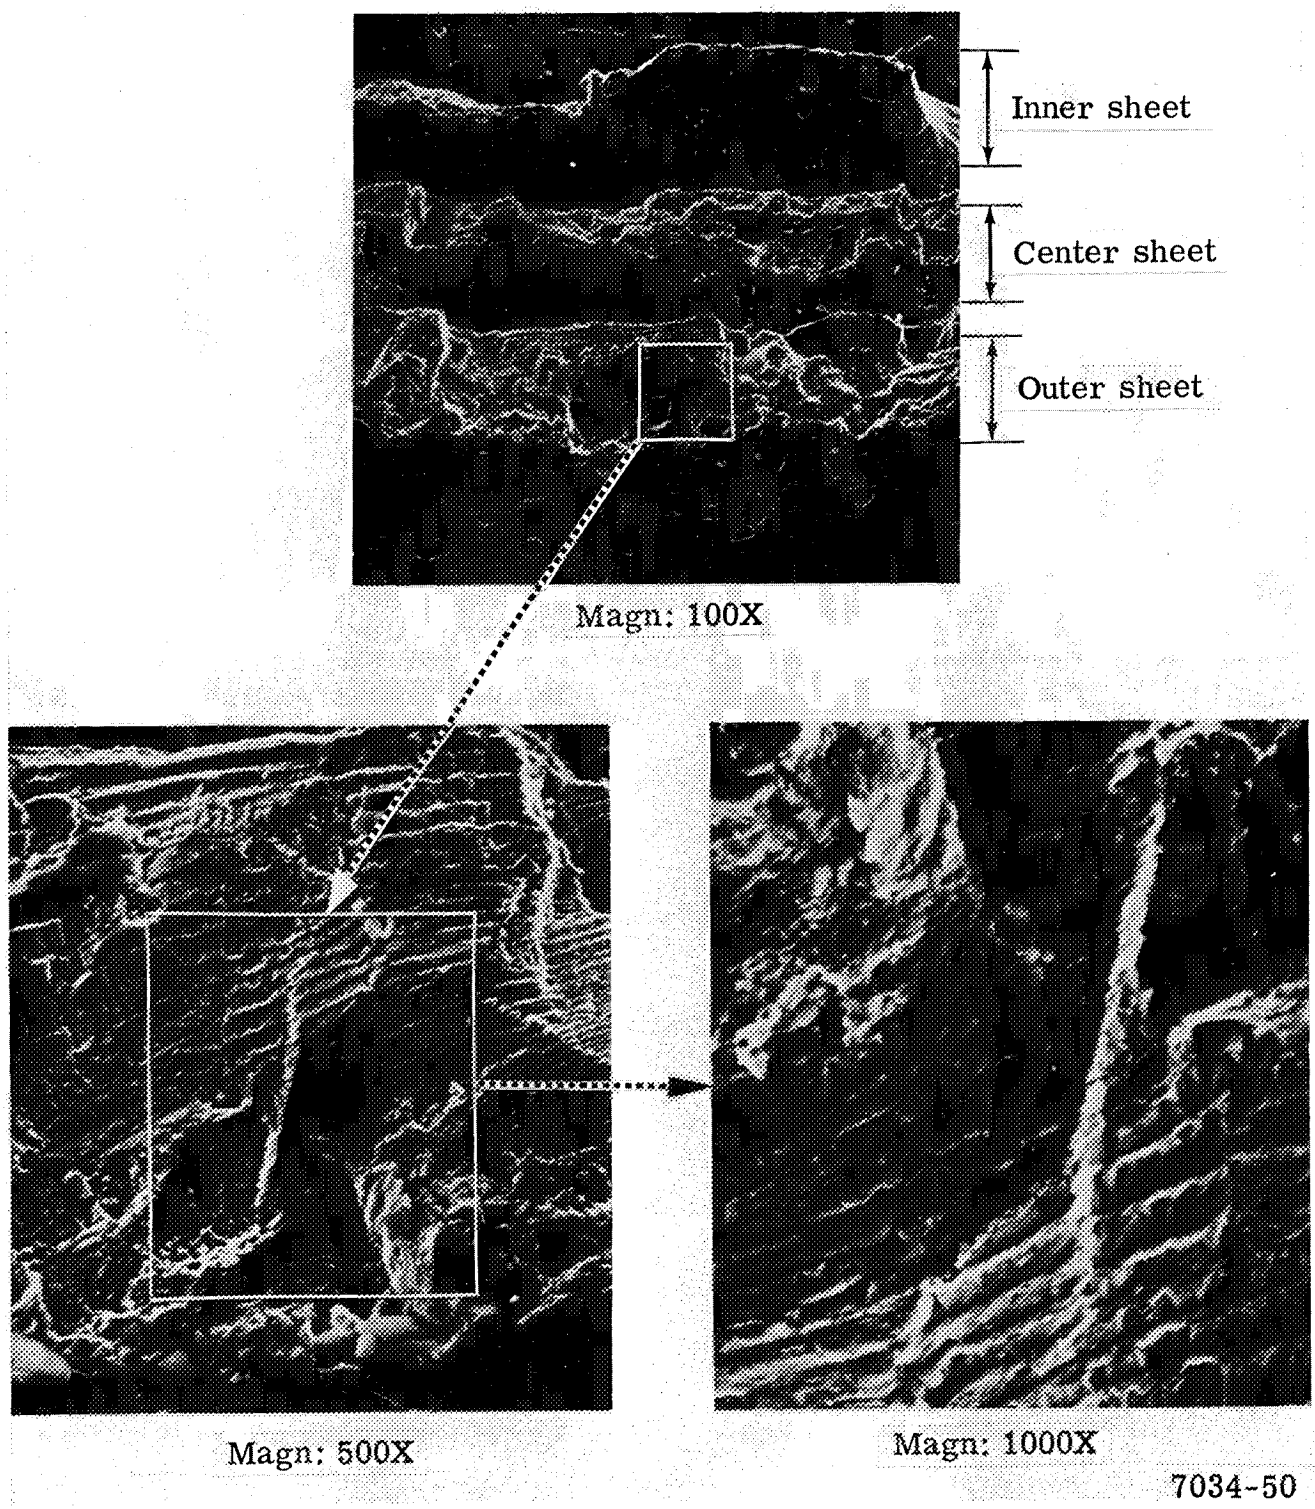
Figure 73. Electron scanning micrographs of longitudinal failure surfaces of test vane No. 2.

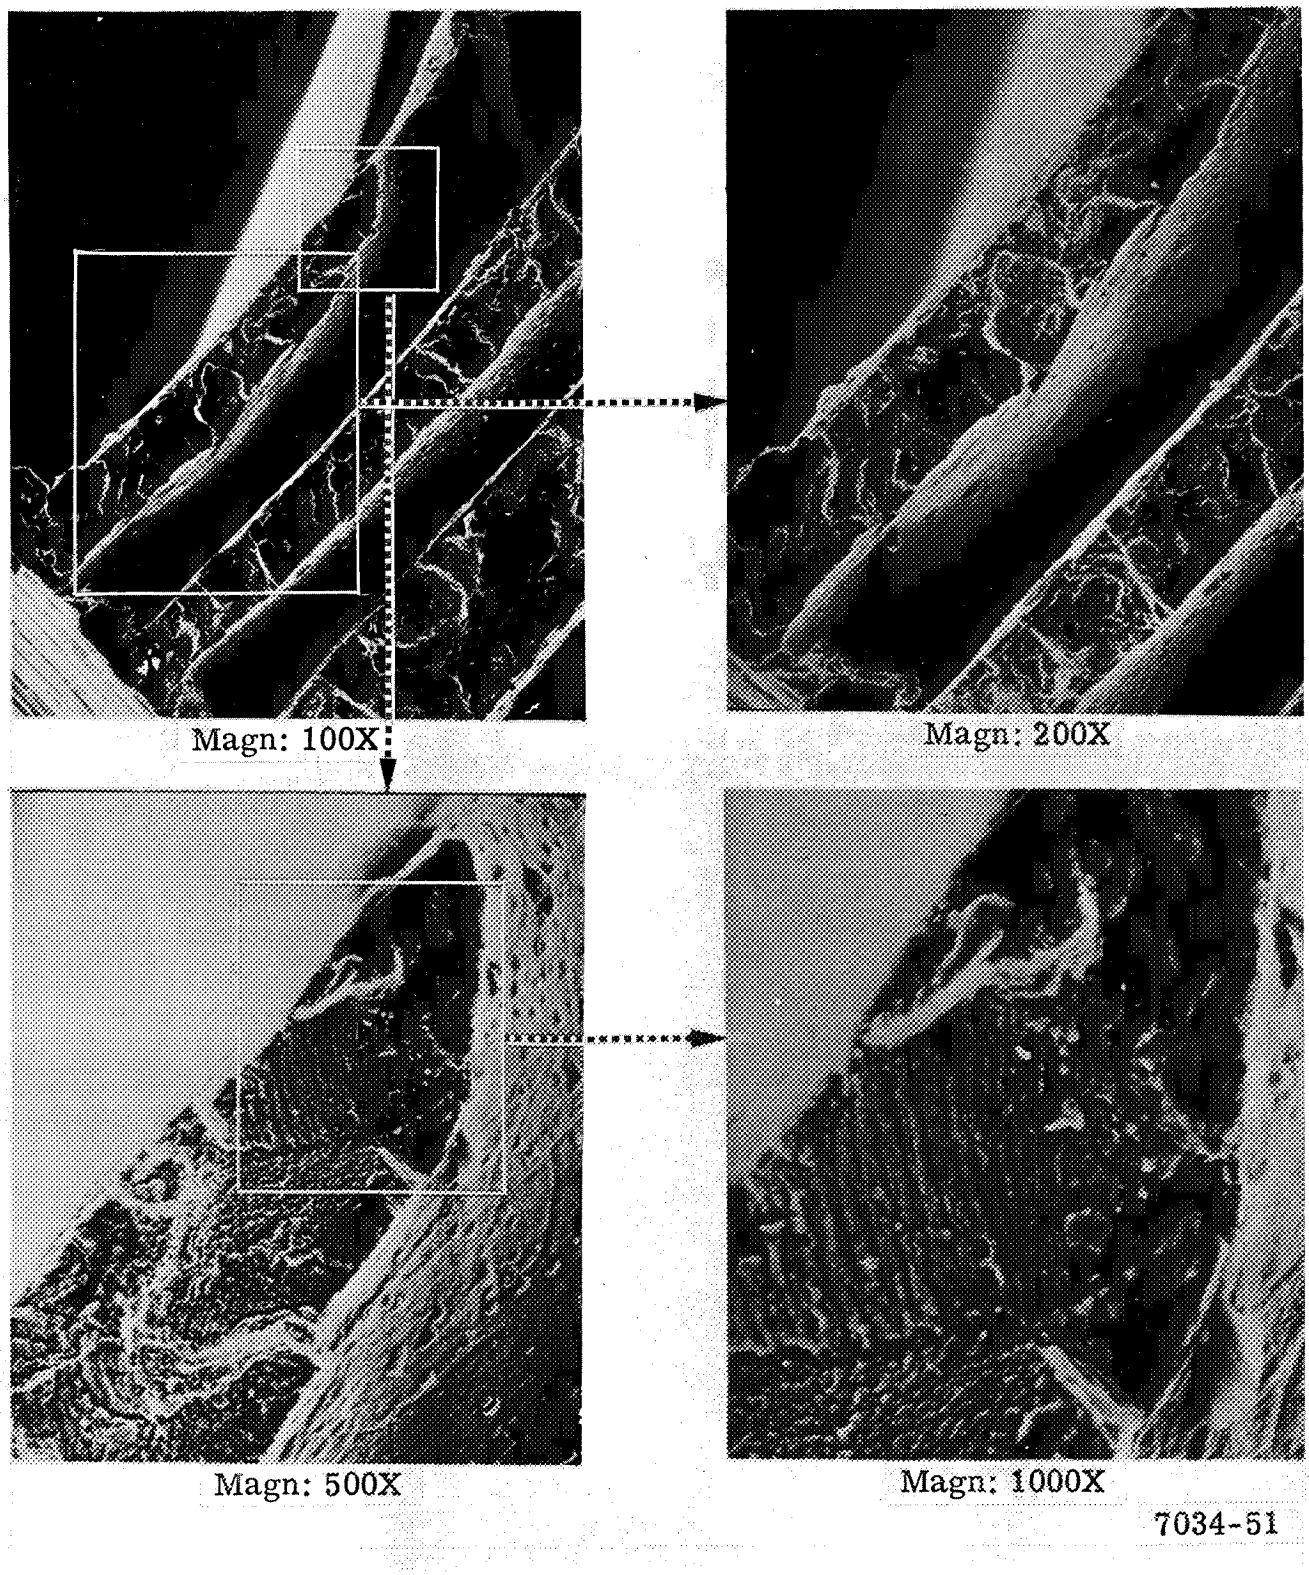
Figure 74. Electron scanning micrographs of transverse failure surfaces of test vane No. 3.

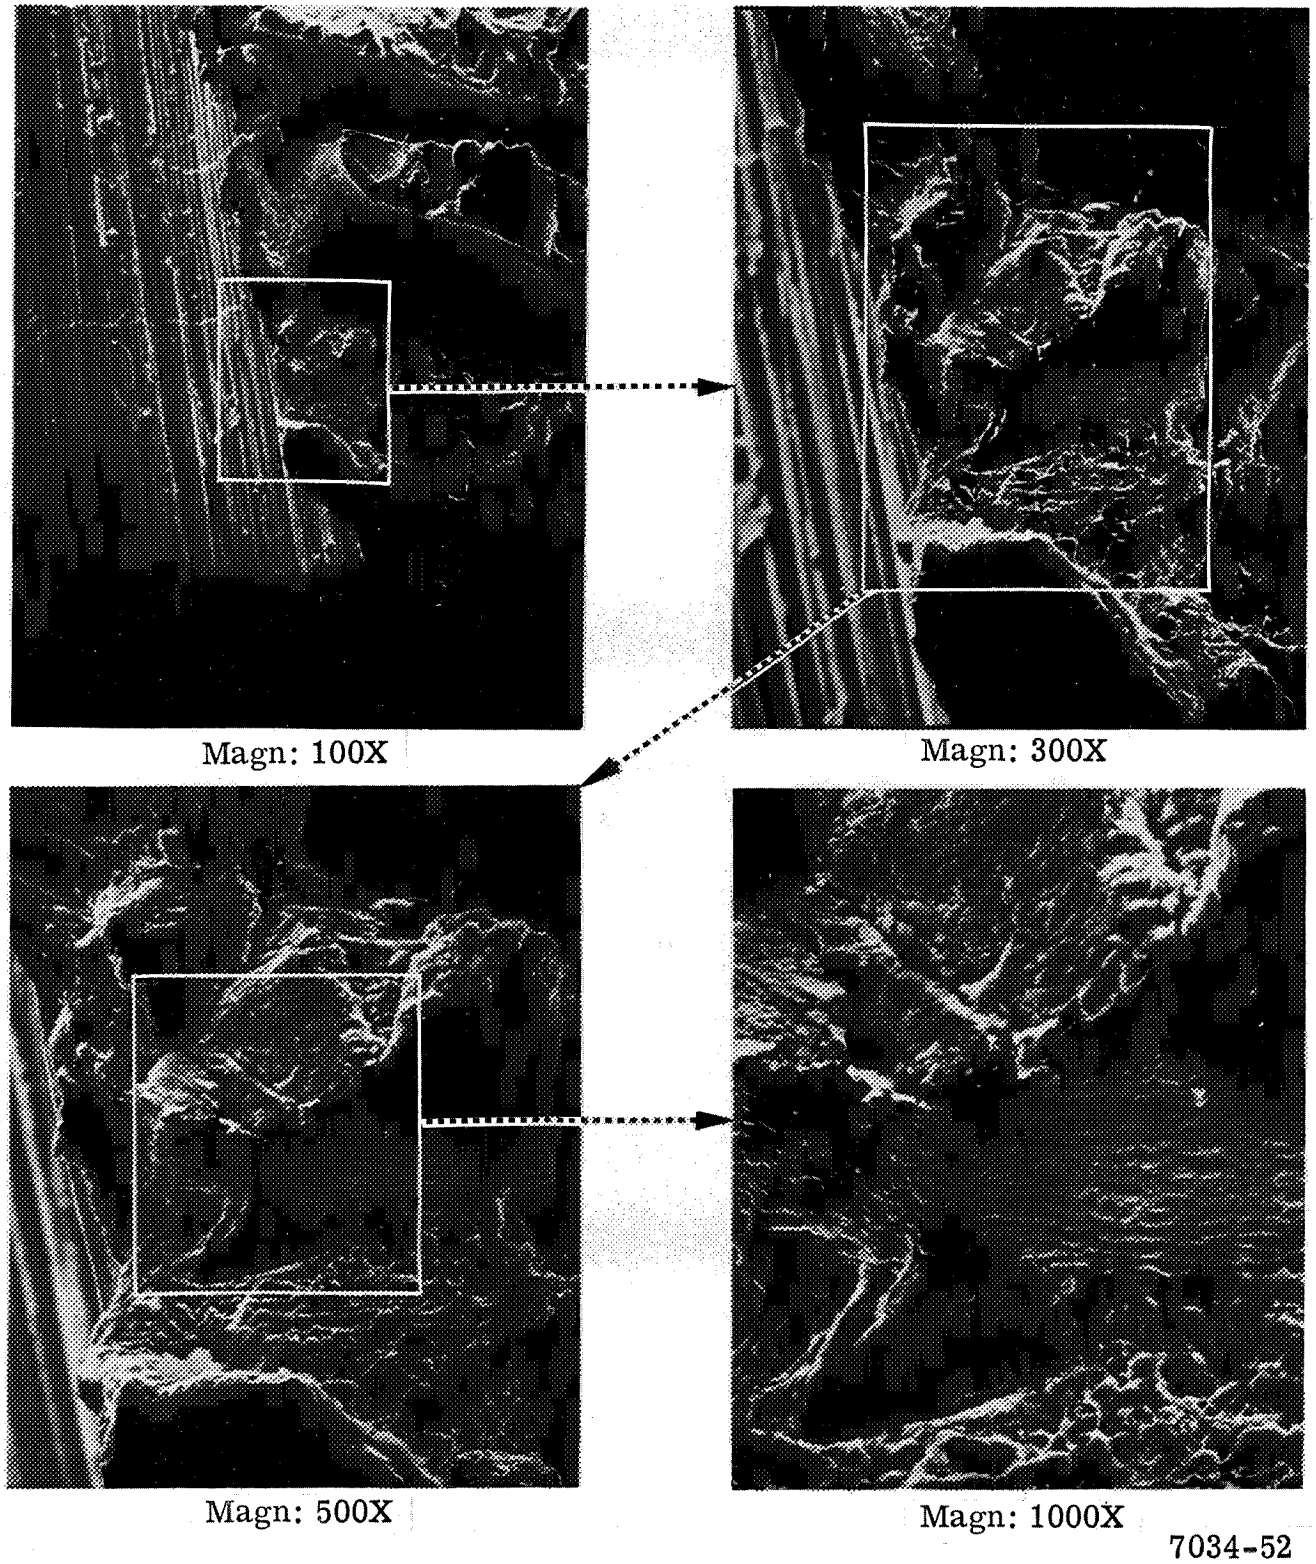
Figure 75. Scanning electron fractographs of transverse failure surfaces of test vane No. 4.
