NACA TN 2397

INFLUENCE OF TENSILE STRENGTH AND DUCTILITY ON STRENGTHS OF ROTATING DISKS IN PRESENCE OF MATERIAL AND FABRICATION DEFECTS OF SEVERAL TYPES

By Arthur G. Holms, Joseph E. Jenkins, and Andrew J. Repko

Lewis Flight Propulsion Laboratory
Cleveland, Ohio

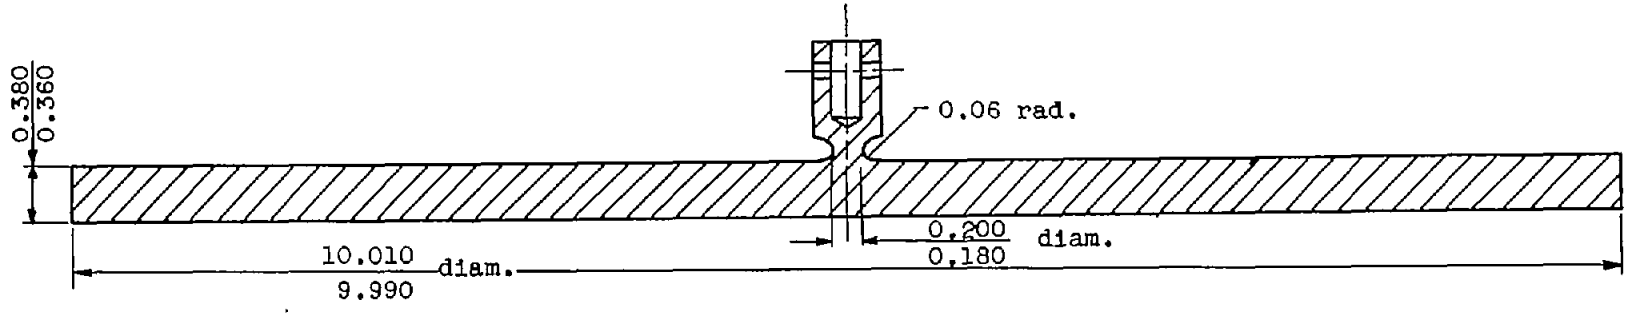
(b) Solid disk.

Figure 1. - Disk designs. (Dimensions in inches.) Thickness of cast beryllium copper disks was 0.497 to 0.570.

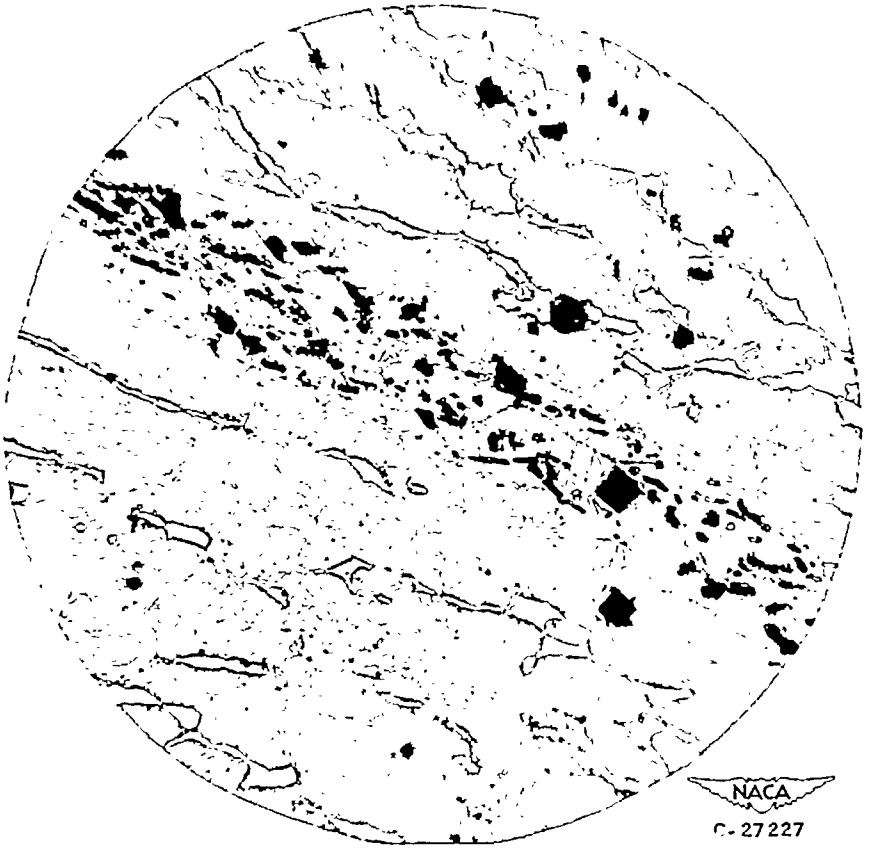
(a) Overaged specimen; tensile strength, 163,900 pounds per square inch.

A photomicrograph in the region of one of these indications is shown in figure 3. The type of irregularity that produced the indications observed with magnetic-particle inspection is shown greatly enlarged by the band of dark particles extending across the upper part of the photomicrograph. The band probably contains segregations of inclusions and undissolved carbides. The narrow well-defined bands in the lower part of figure 3 are probably delta ferrite. Photomicrographs of the alloy in the overaged condition and when aged for maximum strength properties are presented in figures 4(a) and 4(b), respectively. The dark square-shaped areas are hardness impressions made with a Vickers type diamond pyramid indenter in a Tukon microhardness tester. The hardness is conventionally regarded as being inversely proportional to the diagonals of the impressions squared. When these impressions (fig. 4) are compared, it may be seen that the segregated areas are softer (have larger indentations) than the matrix, although in figure 4(a) the matrix has been overaged. The segregations in the age-hardenable 18-8 stainless steel are probably areas deficient in the solute phase because of the twinned structure (fig. 4(a)) characteristic of the face-centered cubic (austenitic) phase in iron and furthermore, the hardness of these segregated regions did not perceptably increase with aging, as did the matrix and the delta ferrite regions. The delta ferrite does not appear to constitute a serious metallurgical "notch" as the hardness of delta ferrite and the matrix are approximately the same as shown by the hardness impressions of

Figure 4. - Tukon microhardness survey made in segregated area of age-hardenable 18-8 stainless-steel disk electrolytically etched in oxalic acid; X250.

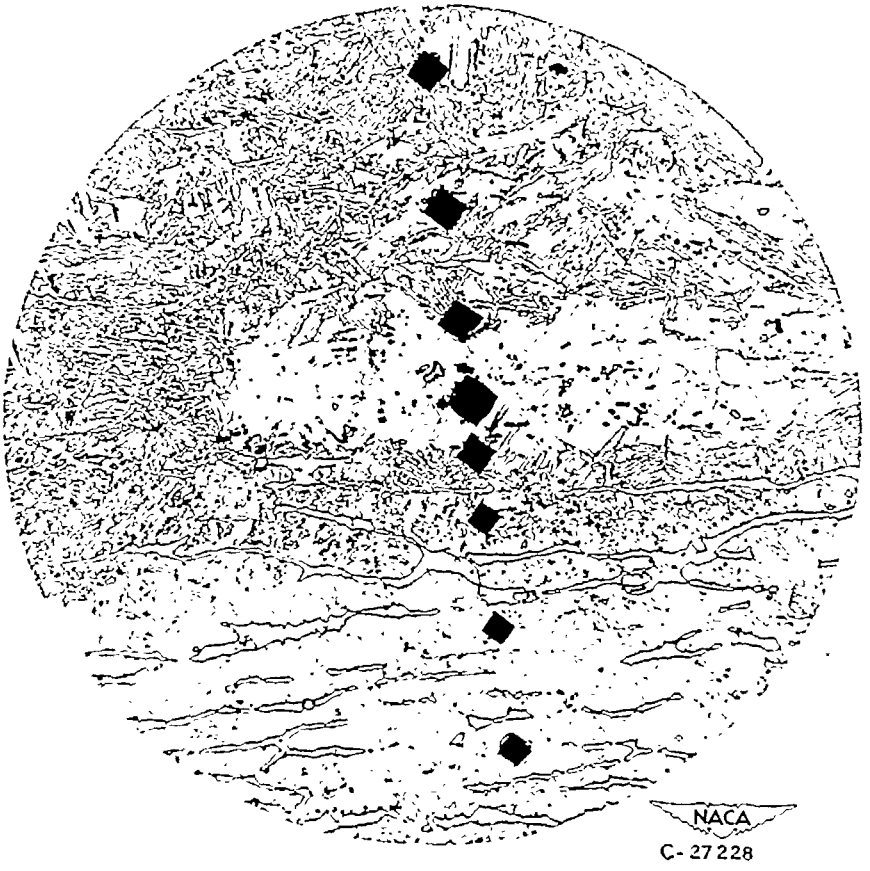
(b) High hardness specimen; tensile strength, 230,300 pounds per square inch.

Figure 4.- Concluded. Tukon microhardness survey made in segregated area of age-hardenable 18-8 stainless-steel disk electrolytically etched in oxalic acid; X250.

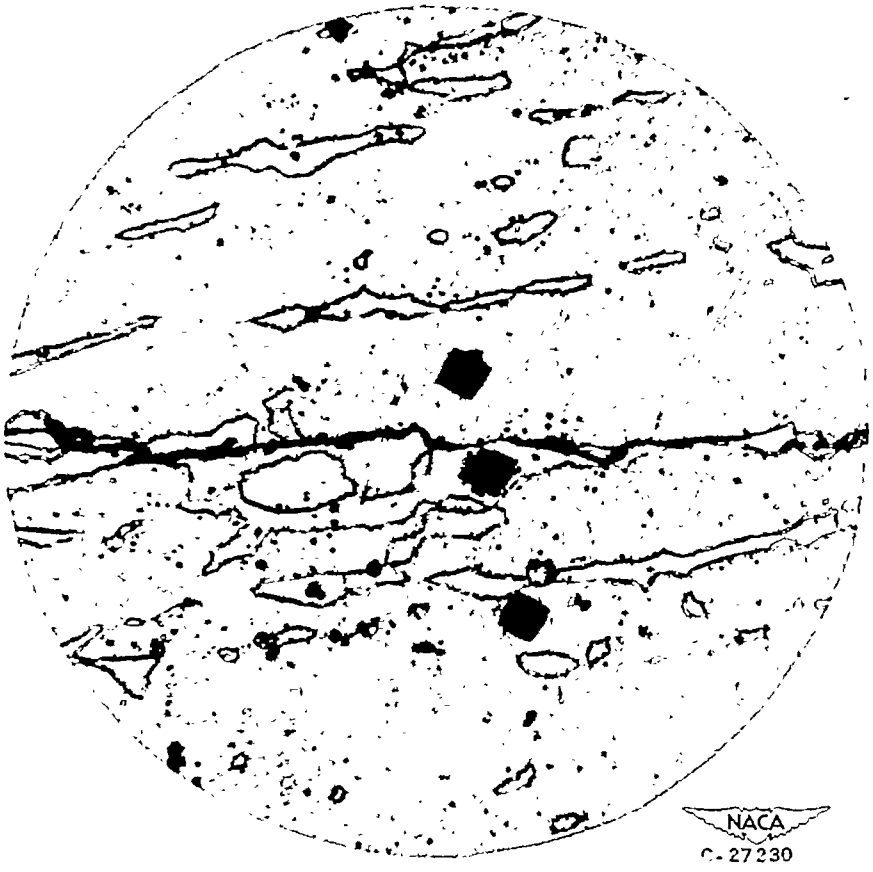
figures 4(a) and 5. The austenitic regions probably become severe stress raisers as the ductility of the matrix is decreased from 17.6-percent elongation to 0.0-percent elongation. The presence of carbides or inclusions may contribute to the effectiveness of these regions as stress raisers.

Figure 5. - Crack propagation along delta-ferrite grains of overaged (tensile strength, 163,900 lb/sq in.) age-hardenable 18-8 stainless-steel disk. Dark square-shaped areas are Tukon microhardness impressions. Electrolytically etched in oxalic acid; X500.

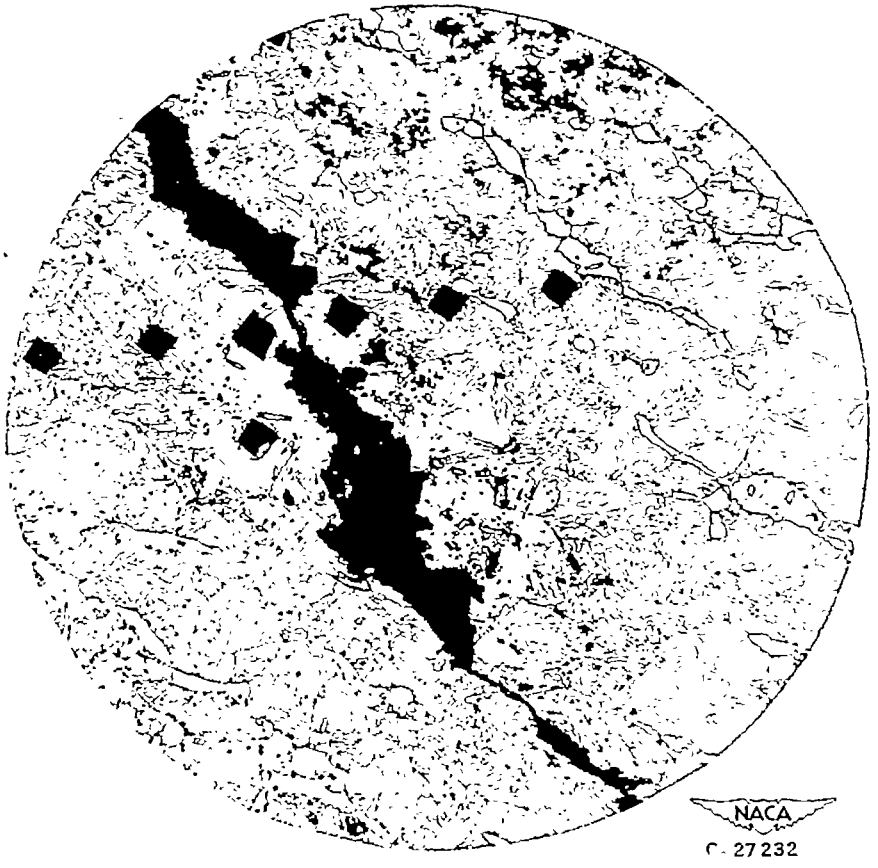
Figure 8. - Crack propagation in segregated area near center of overaged (tensile strength, 163,900 lb/sq in.) age-hardenable 18-8 stainless-steel disk. Electrolytically etched in oxalic acid; X250.

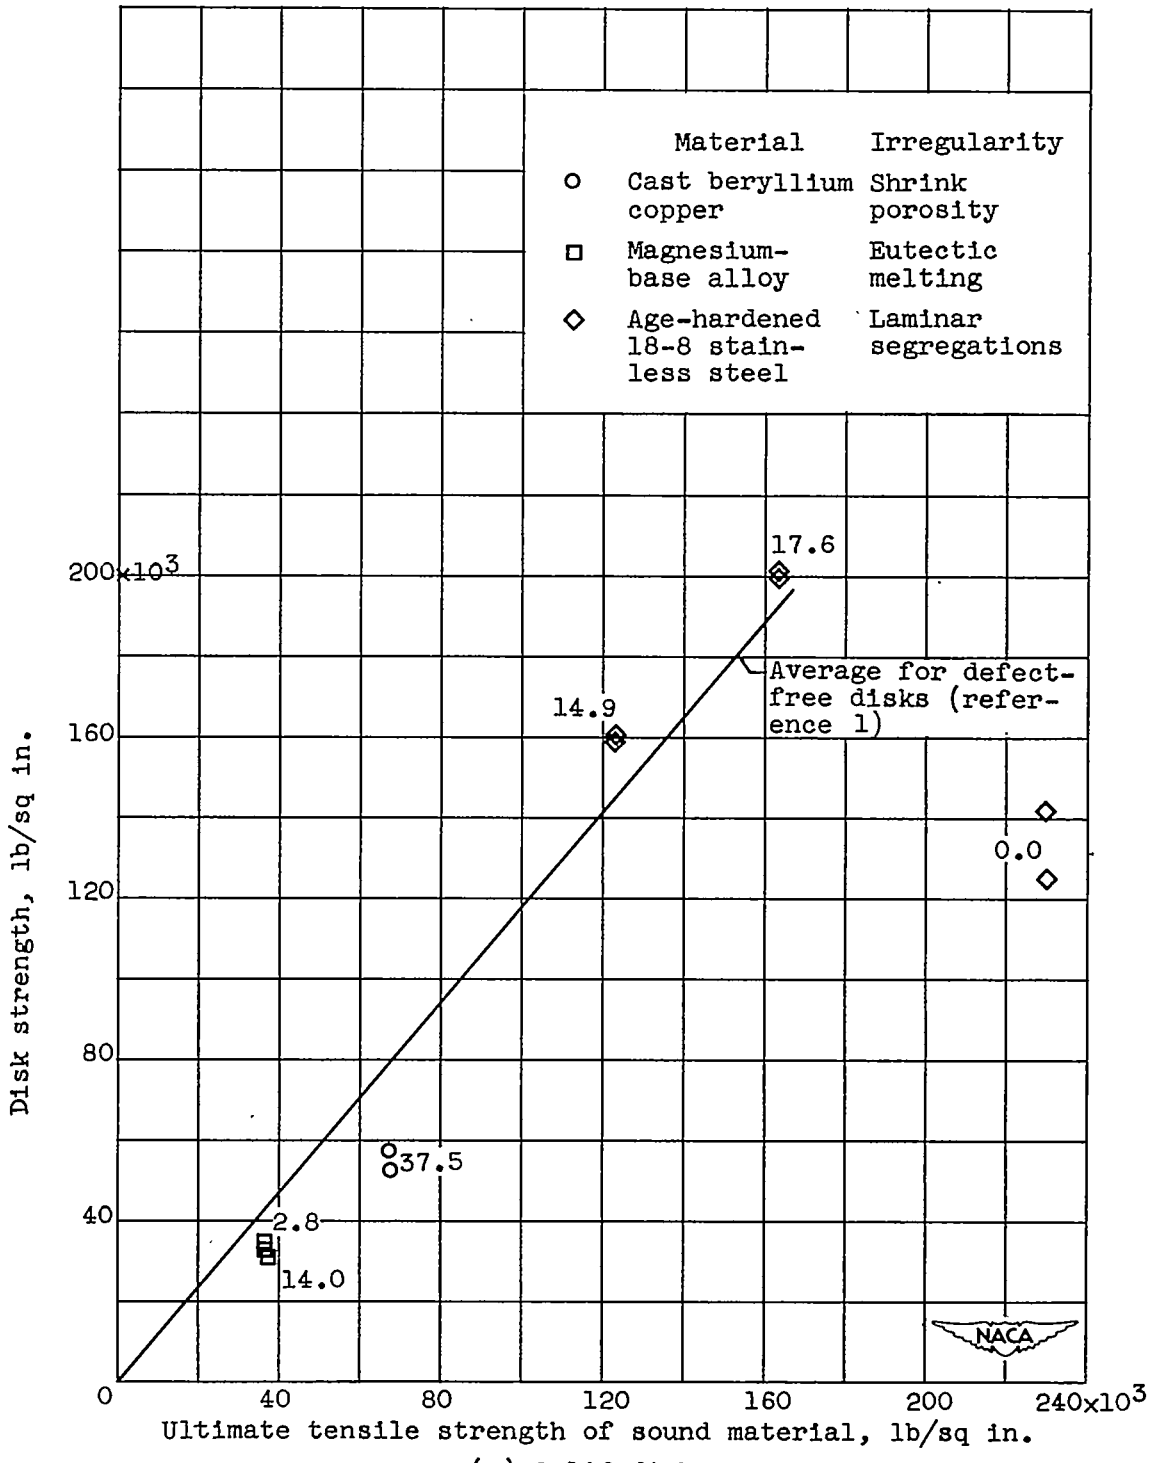
(a) Solid disks.

Strengths of disks having laminar-type defects, eutectic melting, and shrink porosity are plotted against the corresponding tensile strength of sound material in figure 11. The relation previously established (reference 1) for disks of sound material and moderate ductility is shown by the straight line. (The data for sound disks of reference 1 yield an average value of 1.152 for the ratio of disk strength to tensile strength for solid parallel-sided disks.) The disks possessing laminar-type defects (fig. 11(a)) increased in strength with increasing tensile strength for ductilities in excess of 14.9-percent conventional elongation. When the tensile strength was further increased (with a total loss of measurable ductility), a serious loss of disk strength occurred. The data points for disks containing eutectic melting (fig. 11(a)) show no significant effect on the disk strength due to a change in ductility from 2.8- to 14-percent elongation. Similarly, figure 11(b) shows no significant change in disk strength due to a change from 2.8- to 14.0-percent elongation for the disks containing eutectic melting. The disks having shrink porosity (fig. 11(b)) showed increased disk strength with increasing tensile strength until maximum disk strength was reached at a ductility of 6.8-percent elongation, after which further increase in tensile strength reduced the disk strength, corresponding to a decrease in ductility to 2.4-percent elongation. The straight line corresponds to an average value of 0.935 for the ratio of disk strength to tensile strength previously observed for sound disks with $1\frac{1}{2}$-inch-diameter central holes.

Figure 11. - Relation between disk strength at burst and ultimate tensile strength of material remote from area of defects. Values beside data points indicate percent elongation.

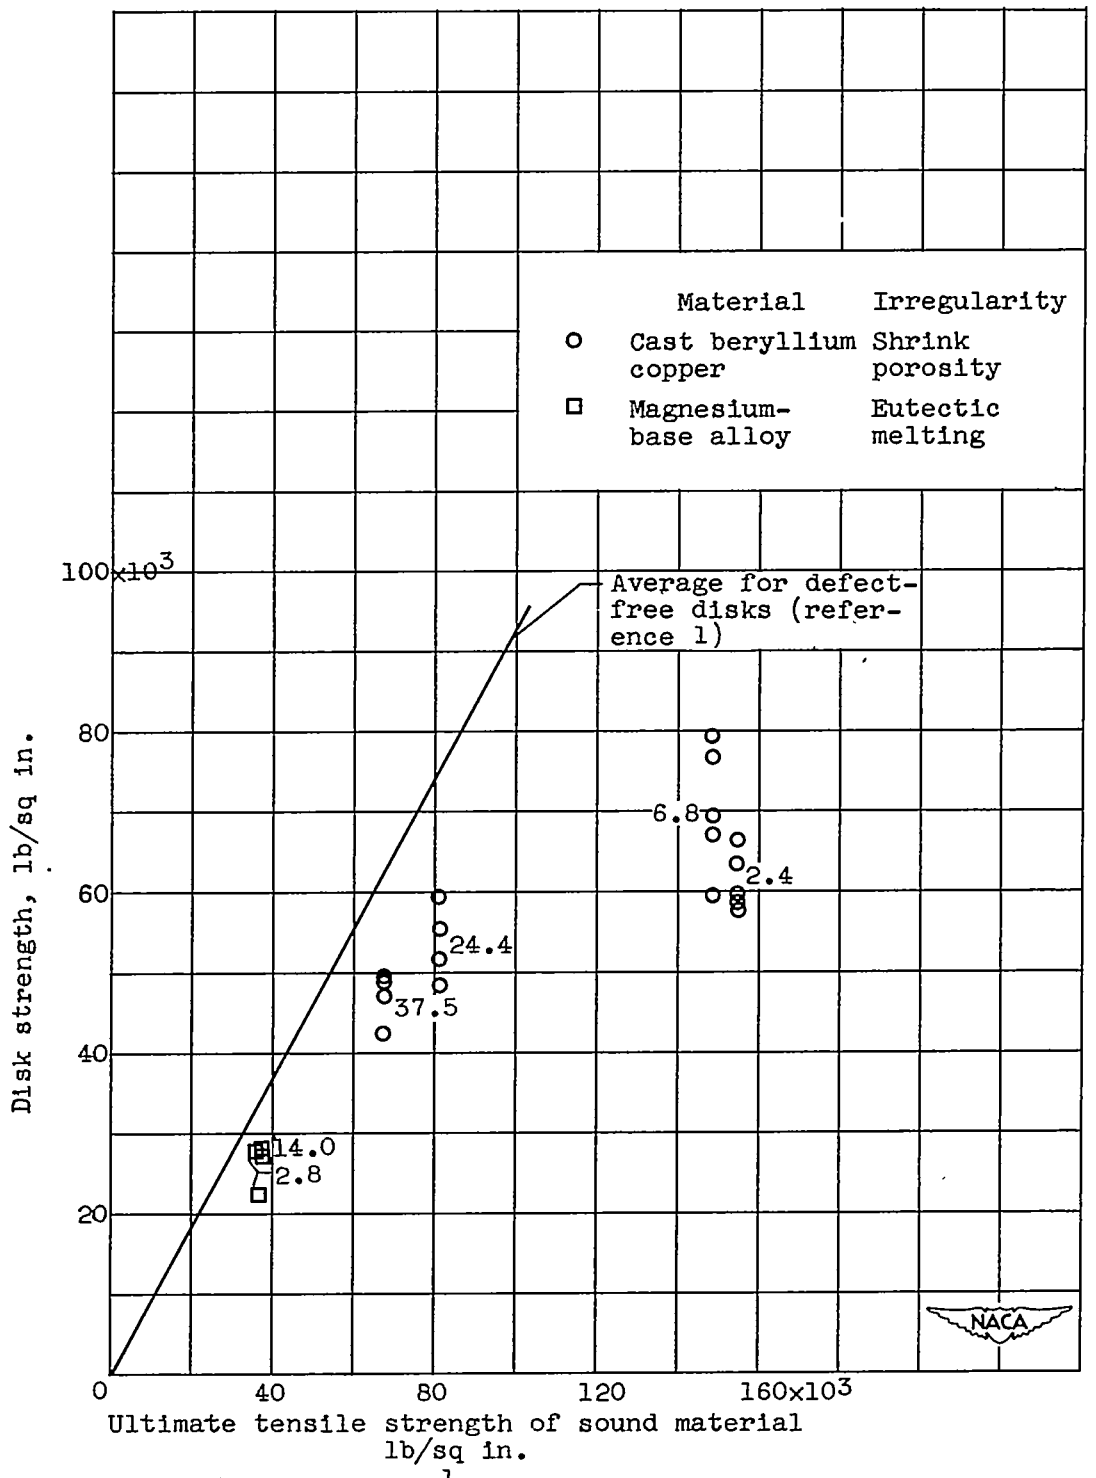
(b) Disks with $1\frac{1}{2}$-inch-diameter central holes.

Figure 11. - Concluded. Relation between disk strength at burst and ultimate tensile strength of material remote from area of defects. Values beside data points indicate percent elongation.

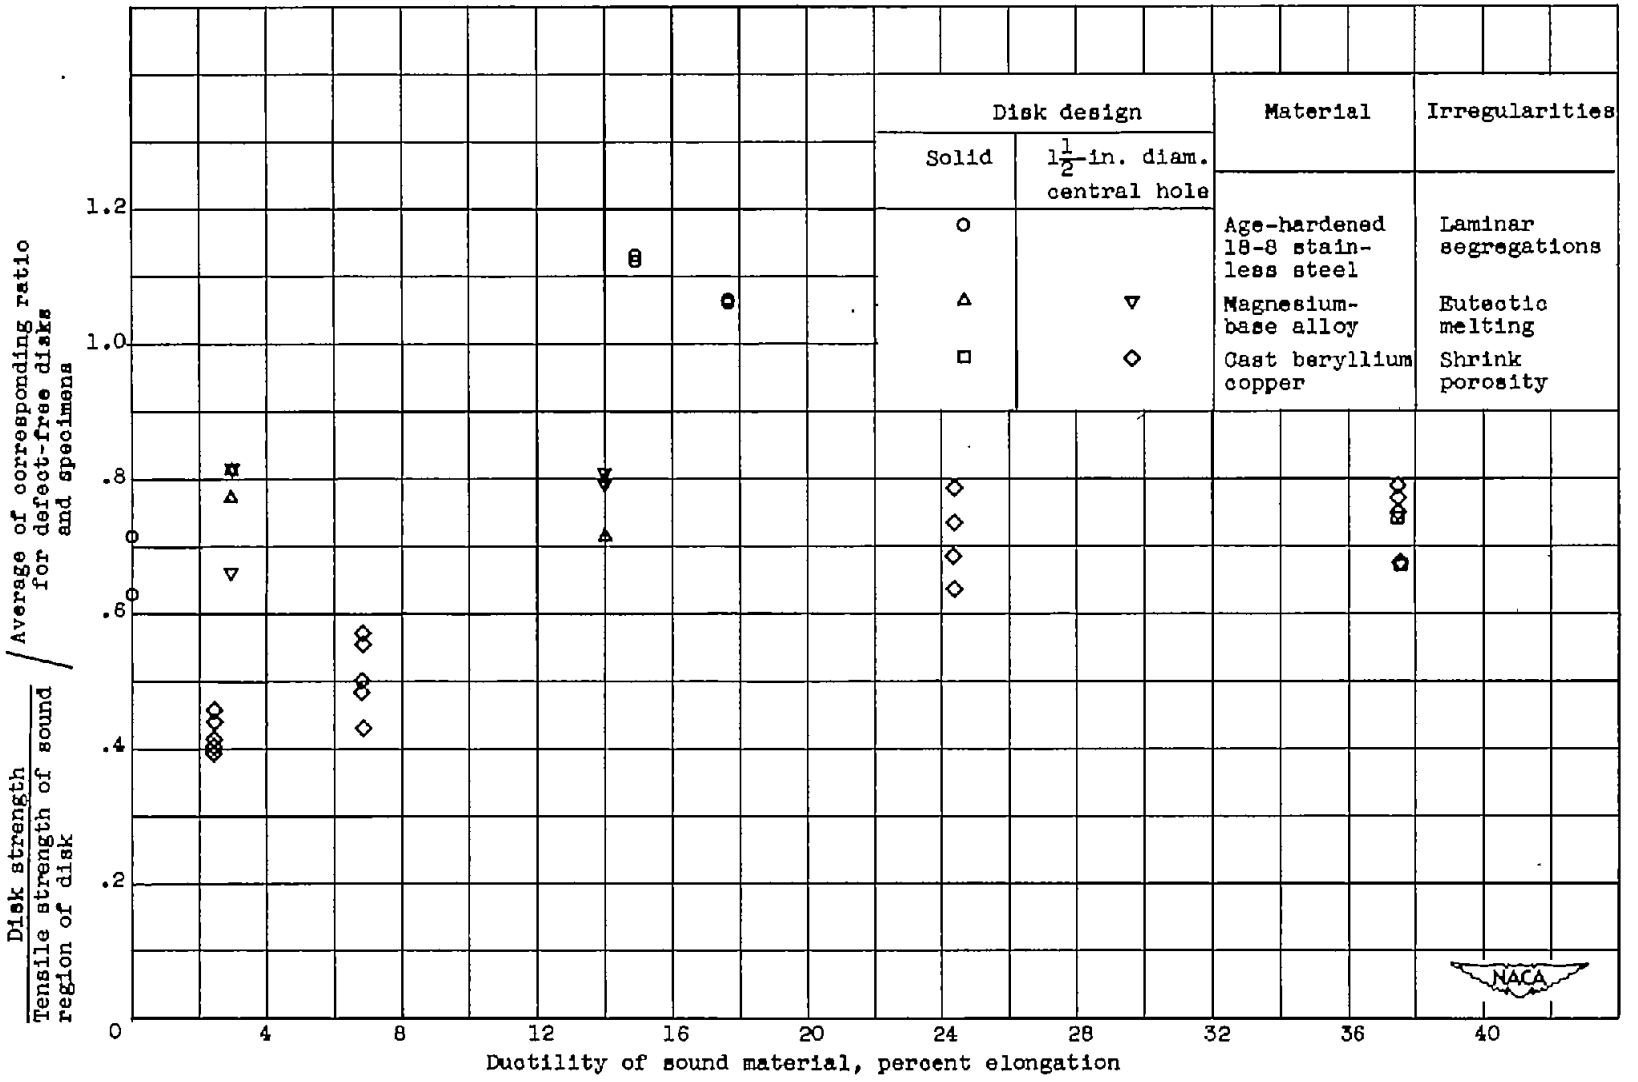
For the solid disks having measurable ductility, the ratios of disk strength to tensile strength were divided by 1.152 (the average ratio of disk strength to tensile strength of reference 1); for the disks with holes, the ratios of disk strength to tensile strength were divided by 0.935 (the average ratio of disk strength to tensile strength of reference 1) and these values were plotted against ductility in figure 12. For solid disks of zero ductility, a value of unity could be expected for the ratio of disk strength to tensile strength, and hence the values of disk strength divided by tensile strength were plotted directly on figure 12 for the age-hardenable 18-8 stainless steel with no measurable ductility.

The occurrence of plotted points of figure 12 with ordinate values significantly less than unity can be attributed to the strength-reducing effect of the defects. The greatest loss in strength (average of 58 percent) occurs for the disk containing shrink porosity and having a ductility of 2.4-percent elongation. Increasing ductility to 37.5-percent elongation steadily reduces the influence of the defects (average of 26-percent reduction in strength at 37.5-percent elongation).

Figure 12. - Relation between ductility and utilization of tensile strength.
