RESEARCH MEMORANDUM

DITCHING TESTS OF A $\frac{1}{18}$-SCALE MODEL OF THE

LOCKHEED CONSTELLATION AIRPLANE

By Lloyd J. Fisher and Garland J. Morris

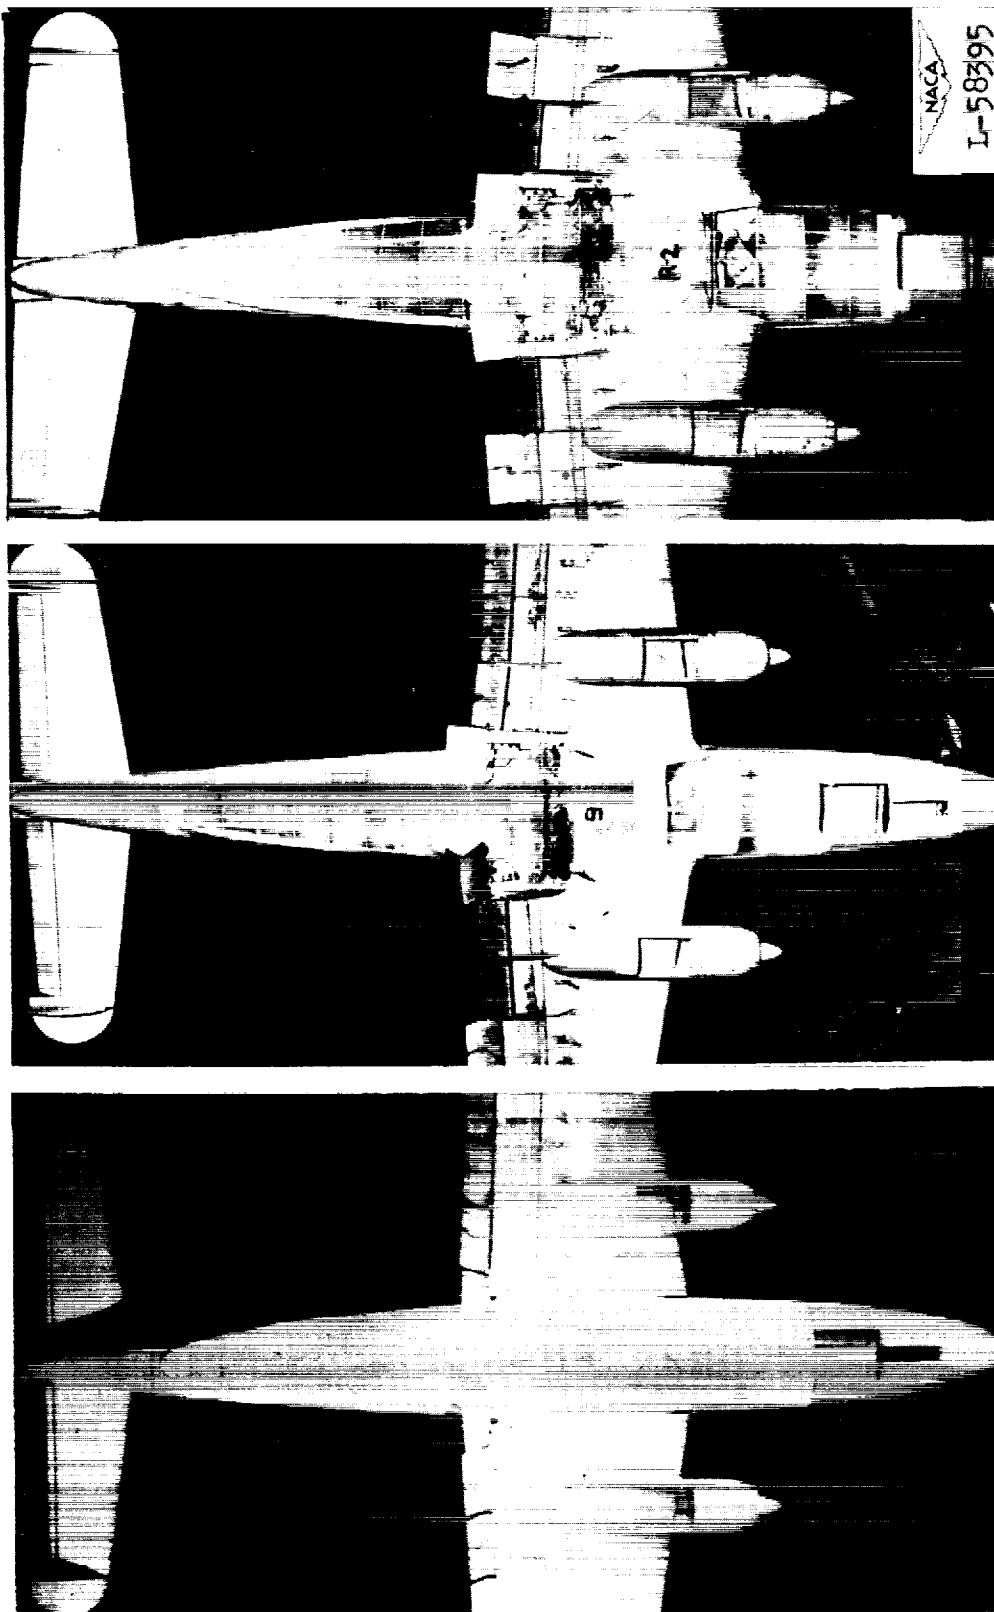
Figure 6.- Damage sustained by scale-strength bottom at 12° landing attitude with various
flap settings.

When the model was tested with a scale-strength bottom, some damage
always occurred. In general, bottom damage caused the landing runs to
be shorter and the decelerations to be higher than for similar test condi-
tions without damage. In some cases smooth runs were changed to porpoising
runs or deep runs and deep runs were changed to dives when damage occurred.
In other cases there was little difference in motion due to damage.
(See table I and figs. 6 and 7.) For certain test conditions, the
behavior of the model was characterized by two different type runs. When
scale-strength bottoms were used, these different type runs were accompanied
by different amounts of damage. Figure 6(a) shows the amount of damage
that occurred in a porpoising run and figure 6(b) shows the damage that
occurred in a deep run, both at the same landing attitude and flap
setting. Figures 6 and 7(a) show the damage sustained in 12° landings

with various flap settings. The most severe damage occurred when the
flaps were full up, probably due to the higher landing speed. The damage
sustained in landings at 12°, 9°, and 4° attitudes with flaps full down
is shown in figure 7. In each case the damage was slight even though the
motions of the model varied from a deep run to a dive.

(a) Flaps up;
porpoised.

(b) Flaps up;
ran deeply.

(c) Flaps down 60 percent;
dived slightly.

The use of flaps caused the ditching motions to be somewhat worse than those obtained with flaps up. However, the behavior with flaps down is not prohibitive. Full flaps make possible a substantial decrease in forward speed and thus lessen the possibility of excessive damage (see figs. 6(b) and 7(a)). Consequently, it is probably best that the flaps be full down in a ditching.

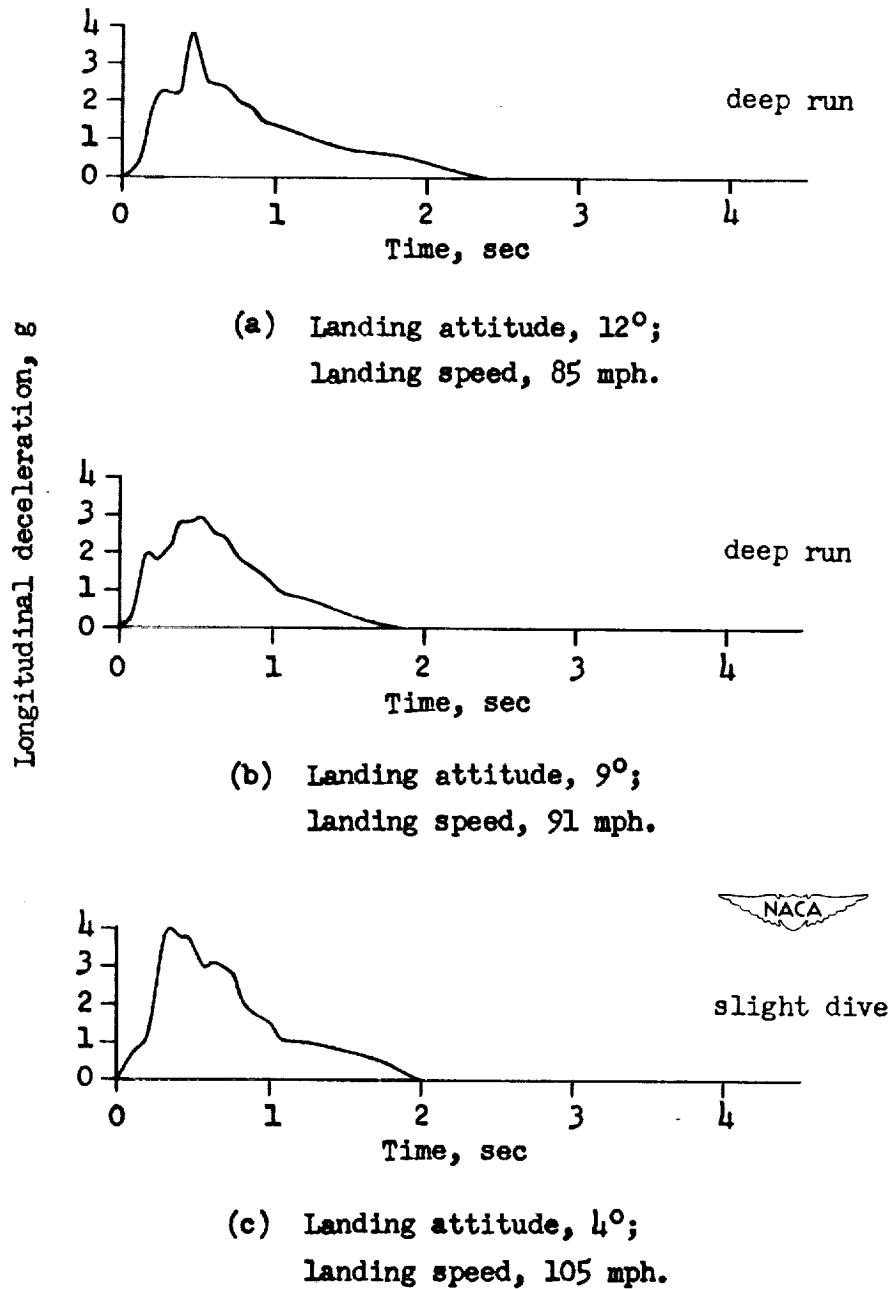
Figure 9.- Longitudinal decelerations with scale-strength bottom
   installed and flaps full down. All values are full scale.

The effect of landing attitude was most apparent in the investigation of the undamaged model. The 4° attitude produced the most severe ditchings (the decelerations were highest and the motions were most violent) and the 12° attitude produced the least severe ditching (see table I). There was little difference in the ditchings at 12° and 9° except that the decelerations were lower in a 12° landing. The landing attitude did not have as much effect on the model when ditched with a scale-strength bottom. With flaps full down, the 12° attitude resulted in the smoothest run, the 9° attitude resulted in the lowest decelerations, and the 4° attitude resulted in the most severe run (see table I and figs. 9 and 10). The landings were usually accompanied by heavy spray (see fig. 10).
