VIBRATION SURVEYS OF THE P-47-B RUDDER AND FIN-RUDDER ASSEMBLY

By Theodore Theodorsen and Arthur A. Regier

MEMORANDUM REPORT

Army Air Forces, Materiel Command

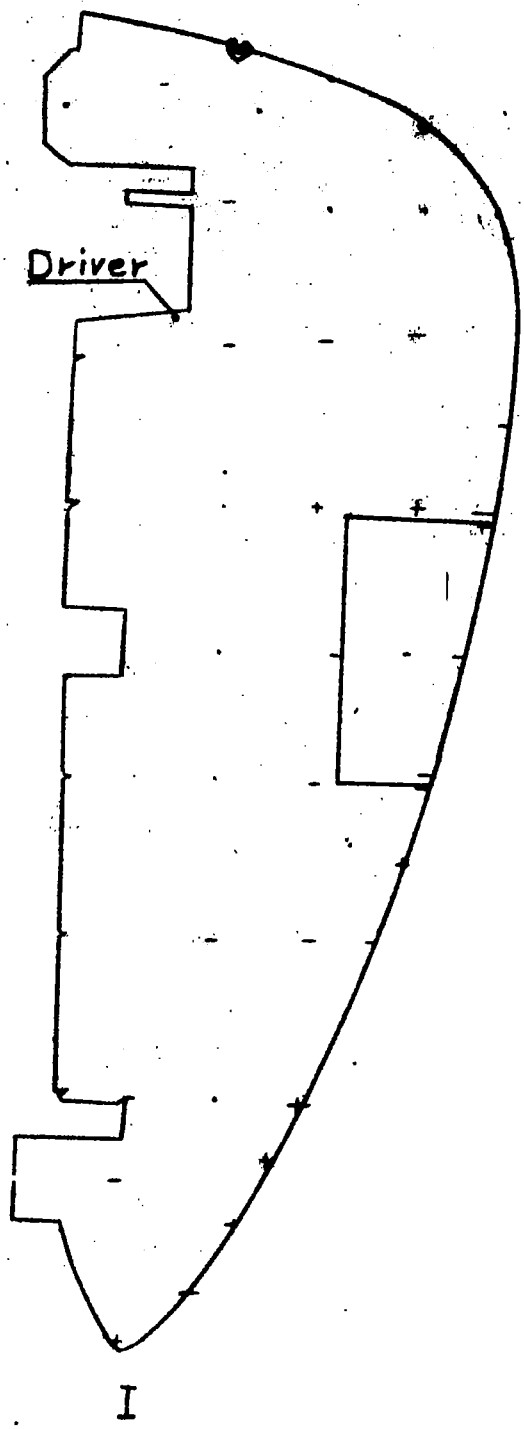
I

247 ~ Sept. 10, 1942

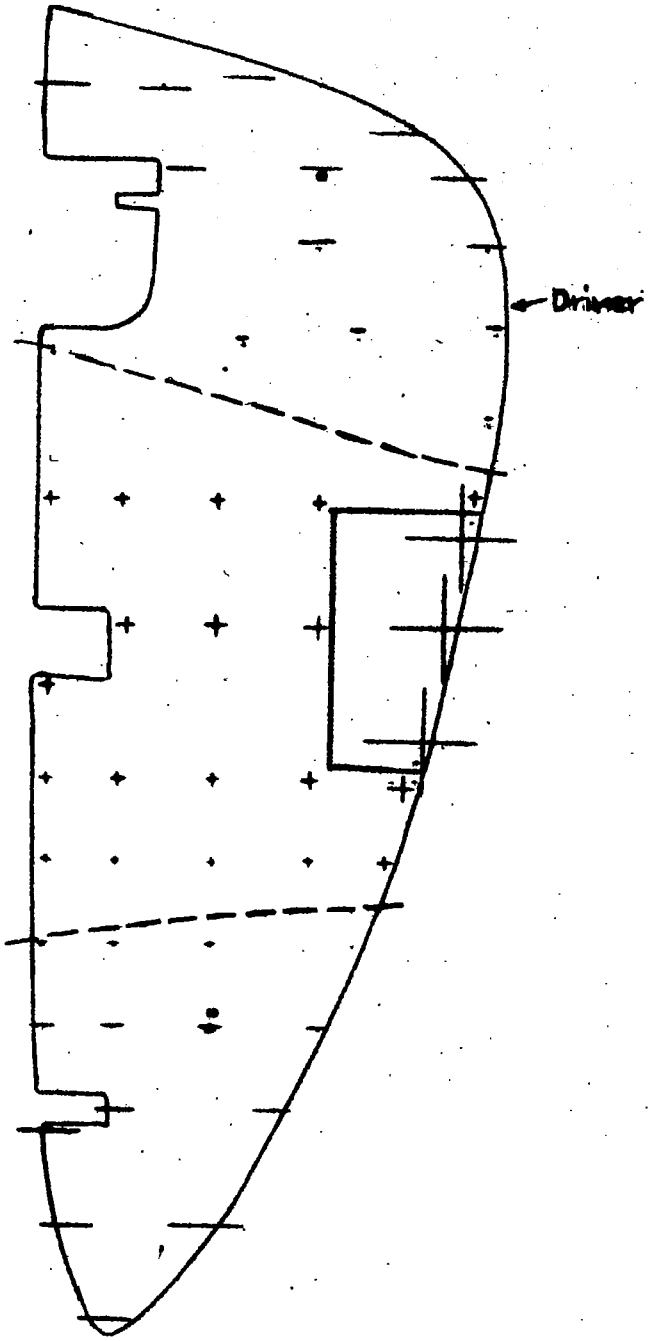
A

47 ~ Tab Locked

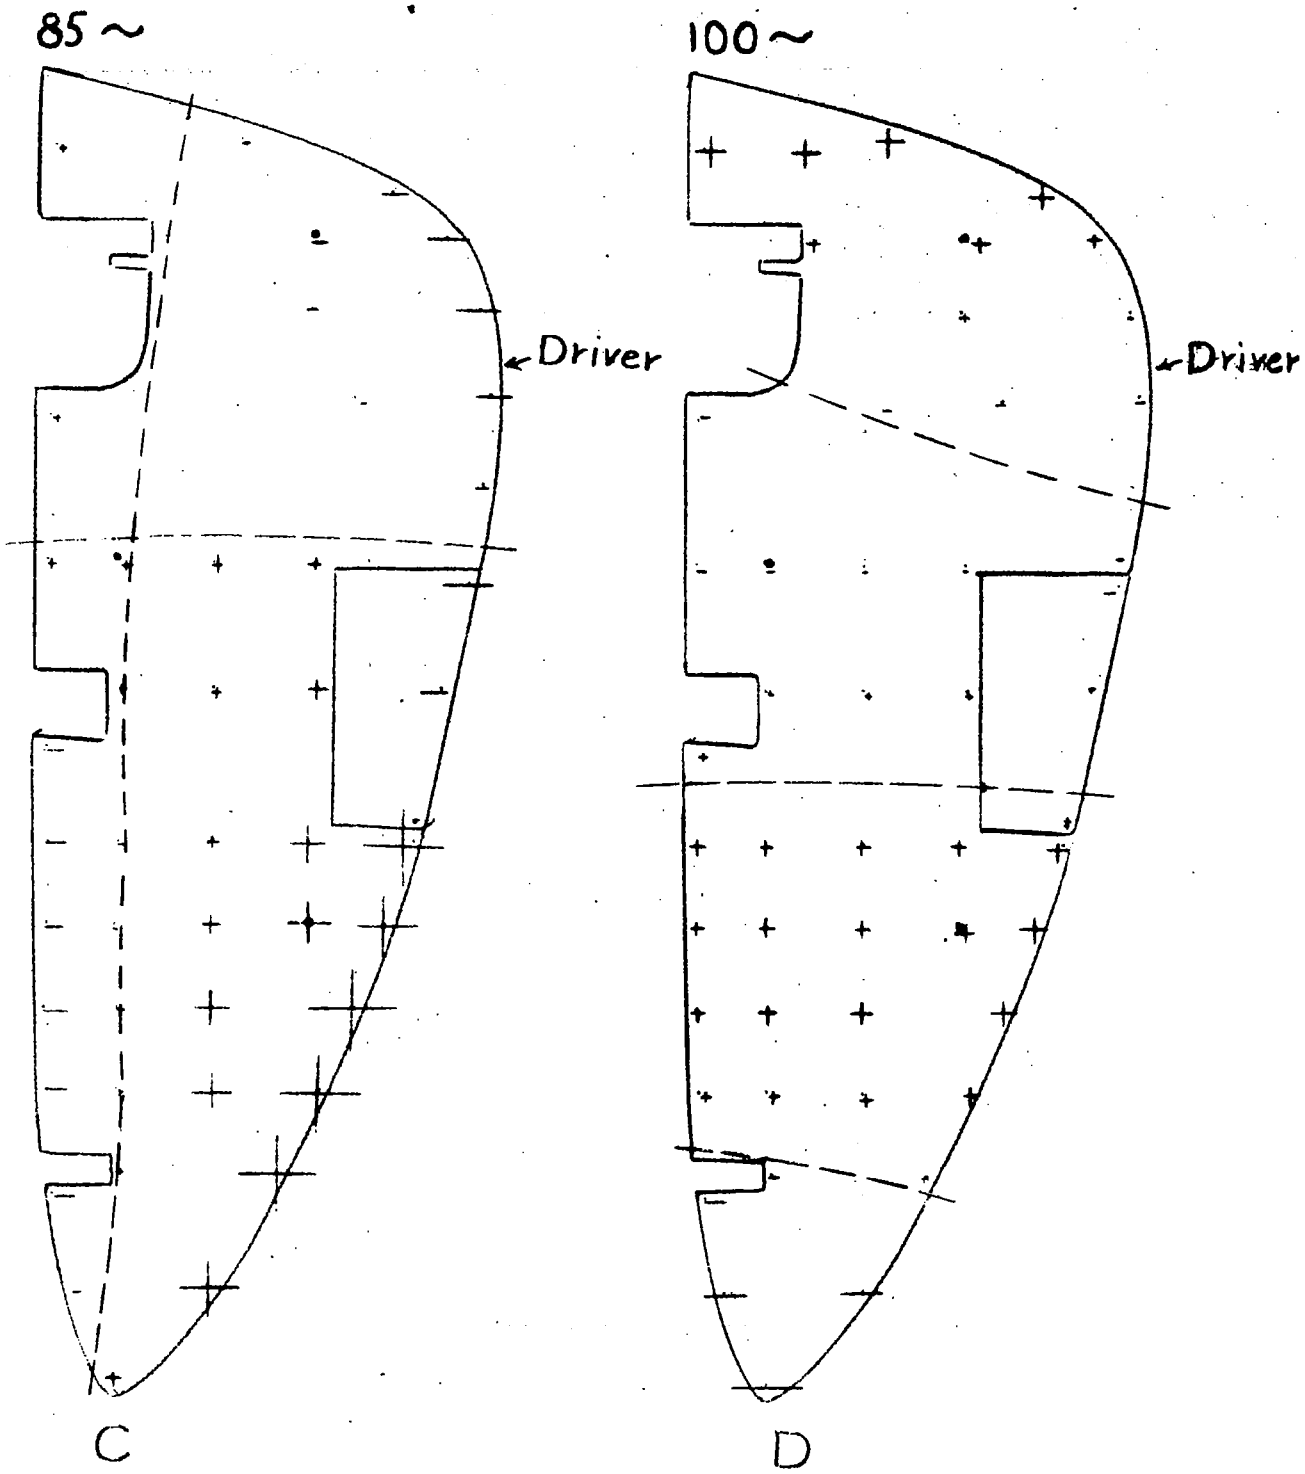
All-Metal Rudder 93R54500
Suspended in Rubber Sept 10, 1942

Tab Locked
