TESTS OF LEAD-BRONZE BEARINGS IN THE DVL BEARING-TESTING MACHINE

By G. Fischer

TECHNICAL MEMORANDUM NO. 943

TESTS OF LEAD-BRONZE BEARINGS IN THE DVL BEARING-TESTING MACHINE*

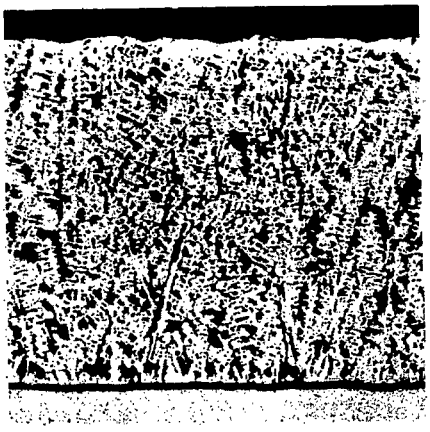
Figure 3.-Lead-bronze alloy 20 I (21.7% Pb); etched with weak acid. Magnification 50X.

Figure 5.- Lead-bronze alloy 20 IV (16.8% Pb); etched with weak acid. Magnification 50X.

Figure 4.- Lead-bronze alloy 20 III (22.6% Pb); etched with weak acid. Magnification 50X.

Figure 6.- Lead-bronze alloy 20 V 23.4% Pb); etched with weak acid. Magnification.50X. State after test run.

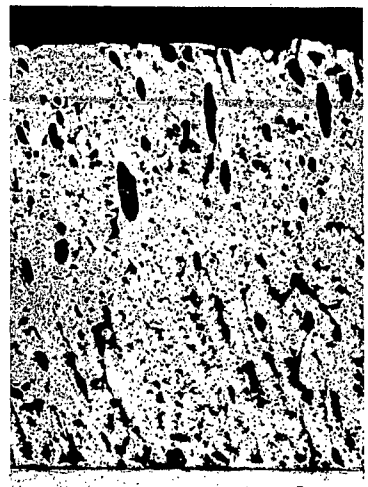
Figure 7. Alloy 30 I (25.6% Pb) Mag. 50X.

Figure 8. Alloy 30 II (32.3% Pb) Mag. 50X.

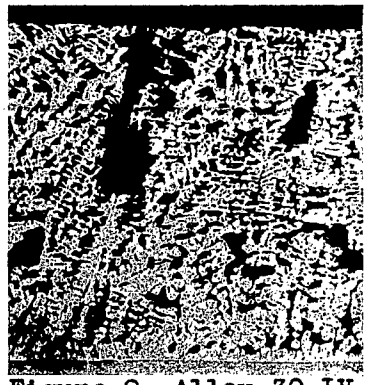
Figure 9. Alloy 30 IV (29.7% Pb) Mag. 50X.

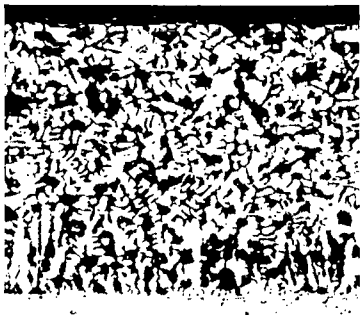
Figure 10. Alloy 30 V (27.8% Pb) Mag. 50X.

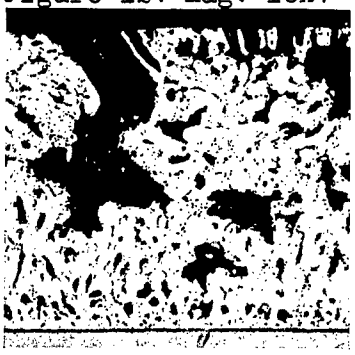
Figure 13. Mag. 50X. Alloy 40 II (38.3% Pb), for both figs.12,13.

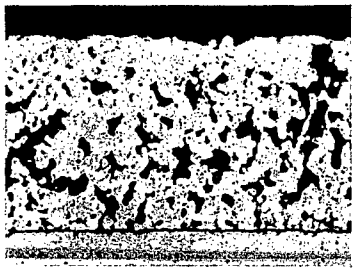
Figure 15. Alloy 40 V (38.3% Pb) Mag. 50X. State after test run.

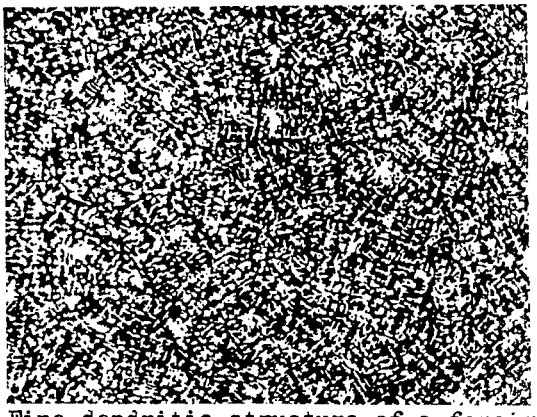
Figure 17.- Fine-dendritic structure of a foreign-made lead-bronze alloy with high lead content. Magnification 100X.

Figure 16.- Uniform and fine-globular lead distribution of a foreign-made lead bronze alloy.(70.70 Cu., 28.98 Pb.; .12 Ni.; .18 Fe;) Hardness 2.5/15.625/180 = 22Kg/mm^2. Mag. 50X.

Figure 18.- Alloy 30 IV. Showing multitude of small lead inclusions after finishing operation.Magnification 2X.

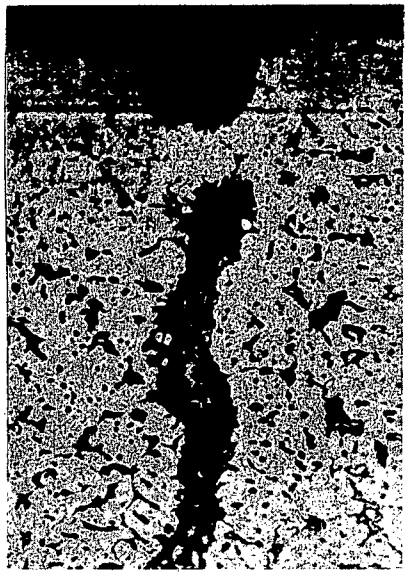
Figure 31.

the oil. Because of an eddy effect, the slowly formed cavities are more and more enlarged until finally even the base material is attacked on the border of the pores. Figures 31 and 32 show craterlike expansions of pores which have been created in the above manner. How strongly the load faculties of a bearing are influenced through lubricating disturbances caused by pores can be seen especially in the test results of bearing 332 which showed large pores only on one half of the bearing. (See also fig. 30.) Arranging these pores into the load zone, the maximum load was found after long running time under dynamic load to be 440 kg/cm^2. After turning the bearing for 180°, a maximum load of 500 kg/cm could be reached very quickly, so that in this case the actual load limit could be estimated to be substantially higher.

Figures 31,32.- Alloy 30 I (test bearing 933). Shows crater-like enlargement of pores in the running surface in the end zone of lead segregations. (The micro-photographs show cuts parallel to the direction of rotation so that the cavities do not illustrate scorings in the surface.) In illustration 32, the cutting surface is made close to the entrance of the segregation into the running surface. Magnification 200X.

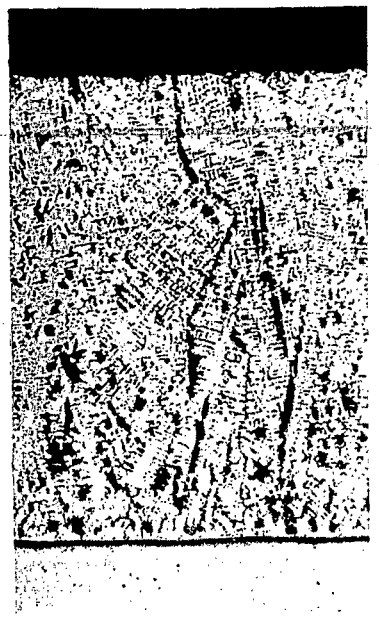
Figures 38,39.- Cracks within the alloys illustrated in figures 34 and 35 made of alloys 20 I and 30 I. Magnification 50X.

Figure 40.- Crack within the tested bearing material made of alloy 30 I (bearing 933). Magnification 200X.

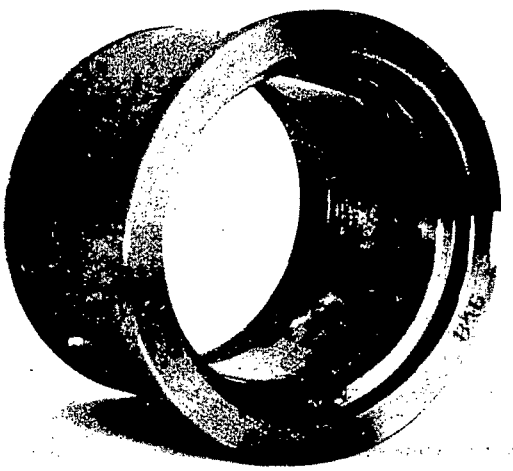
Figure 41.- Cracked surface of bearing 846, made of alloy 40 IV (42% Pb,28% Fe). State after 68 hours of dynamic test at $p = 250 Kg/cm^2$.
