Foreign Object Damage in Disks of Two Gas-Turbine-Grade Silicon Nitrides by Steel Ball Projectiles at Ambient Temperature

Sung R. Choi
Ohio Aerospace Institute, Brook Park, Ohio

J. Michael Pereira, Lesley A. Janosik, and Ramakrishna T. Bhatt
Glenn Research Center, Cleveland, Ohio

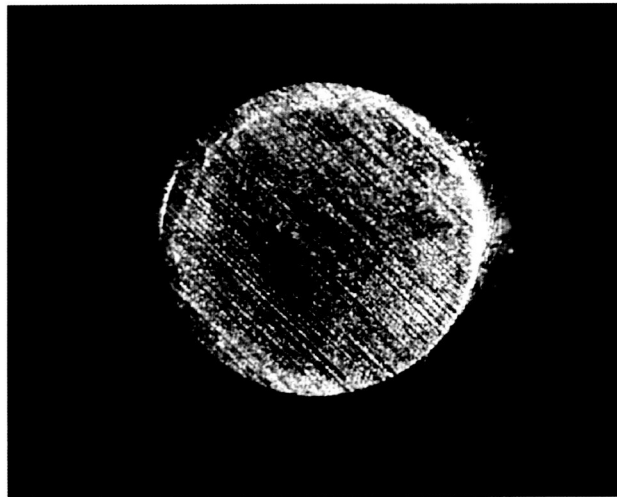
Figure 7.—Steel ball projectile after impact at velocity of 220 m/s on AS800 silicon nitride target. Note impressions from machining marks of AS800 specimen.

target specimens with a series of numerous parallel lines, indicative of the significant severity of impact involved, shown in figure 7.

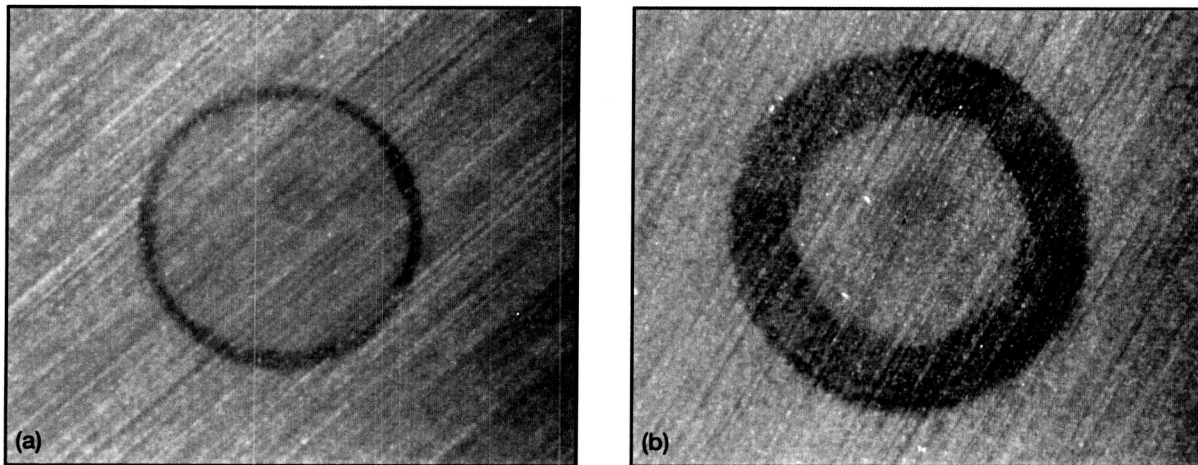
Figure 8.—Typical impression marks on AS800 silicon nitride disks showing ring shape from impact by 1.59-mm-diameter steel ball projectiles at (a) 220 and (b) 350 m/s.

figure 8. The sizes of inner and outer diameters were measured optically for the specimens impacted at and above 220 m/s. The impression marks were either not visible or not produced on the specimens impacted below 220 m/s (applied to SN282), attributed to insufficient impact force to cause cold welding. At higher impact velocities of 400 to 440 m/s for AS800, significant material transfer was observed with a sign of outward splashing of metal. The measurements of the impression marks for both silicon nitrides are shown in figure 9. The measurements were made using a total of 5 to 10 specimens at each impact velocity. The outer diameter d_o increased with increasing impact velocity for both silicon nitrides, approaching approximately the diameter of projectile; whereas the inner diameter remained almost

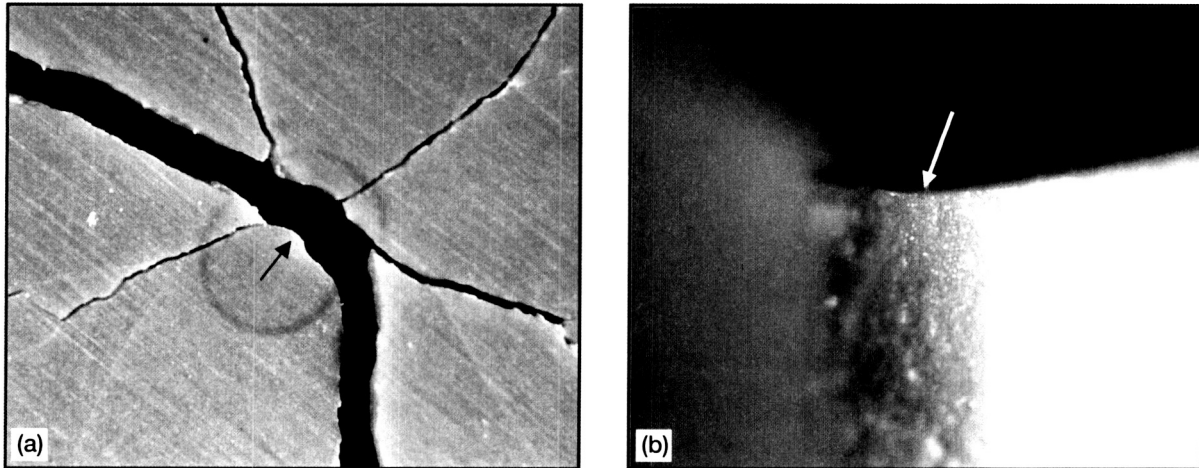
Fracture surfaces: At lower impact velocities, both AS800 and SN282 specimens failed similarly from ring cracks, in which a part of the ring contour was seen at failure origin as a small curved portion. The fracture surfaces also pertained such a curved portion, as seen in figure 10. At intermediate impact velocities for each material, both ring and radial cracks were associated with failure. The upper cones located at the impact center, whether somewhat well developed or not, seemed to be rarely associated with failure origins. Figure 11 shows failure location as a function of postimpact strength determined for the specimens failing from ring cracks, which typically impart medium to high strengths at low to intermediate impact velocities. An average value of failure location measured from the impact center was 0.28±0.07 mm (or 0.56-mm diameter). This indicates that the strength-controlling ring cracks were situated between the inner diameter (0.82 mm) of impression and the outside of the upper cone diameter (0.23 mm). The lower strength regime, typified at intermediate velocities of each material, was associated

Figure 10.—Example of AS800 silicon nitride disk that failed from ring crack in postimpact strength testing. Specimen was impacted at low velocity of 220 m/s by 1.59-mm-diameter steel ball projectile. (a) Impact site. (b) Corresponding fracture surface, with arrows indicating failure origin. Corresponding postimpact strength was 616 MPa.

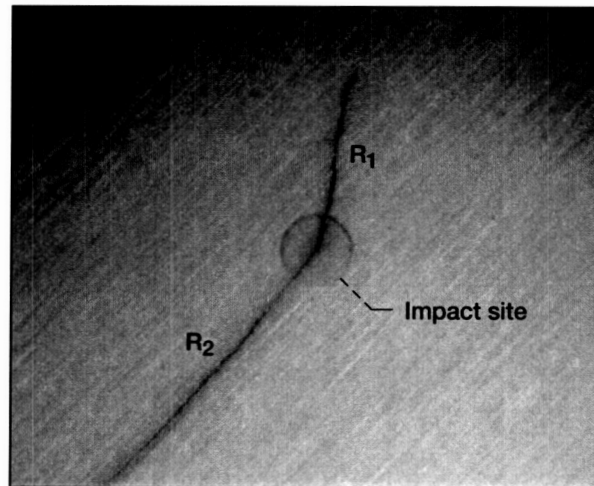
exclusively with well-developed radial cracks ranging in size from 3 to 5 mm, emanating from the impact sites, as shown in figure 12. These well-developed radial cracks resulted in the lower strength regime around 150 and 100 MPa, respectively, for AS800 and SN282. Hence, it is important to note that the existence of lower strength regime was due to the occurrence of these significant radial cracks.

Figure 12.—Example showing significant radial cracks (R_1 and R_2) in AS800 silicon nitride disk impacted at 220 m/s by 1.59-mm-diameter steel ball projectile. Resulting postimpact strength of this specimen, controlled by the 4.7-mm crack R_2, was 151 MPa.

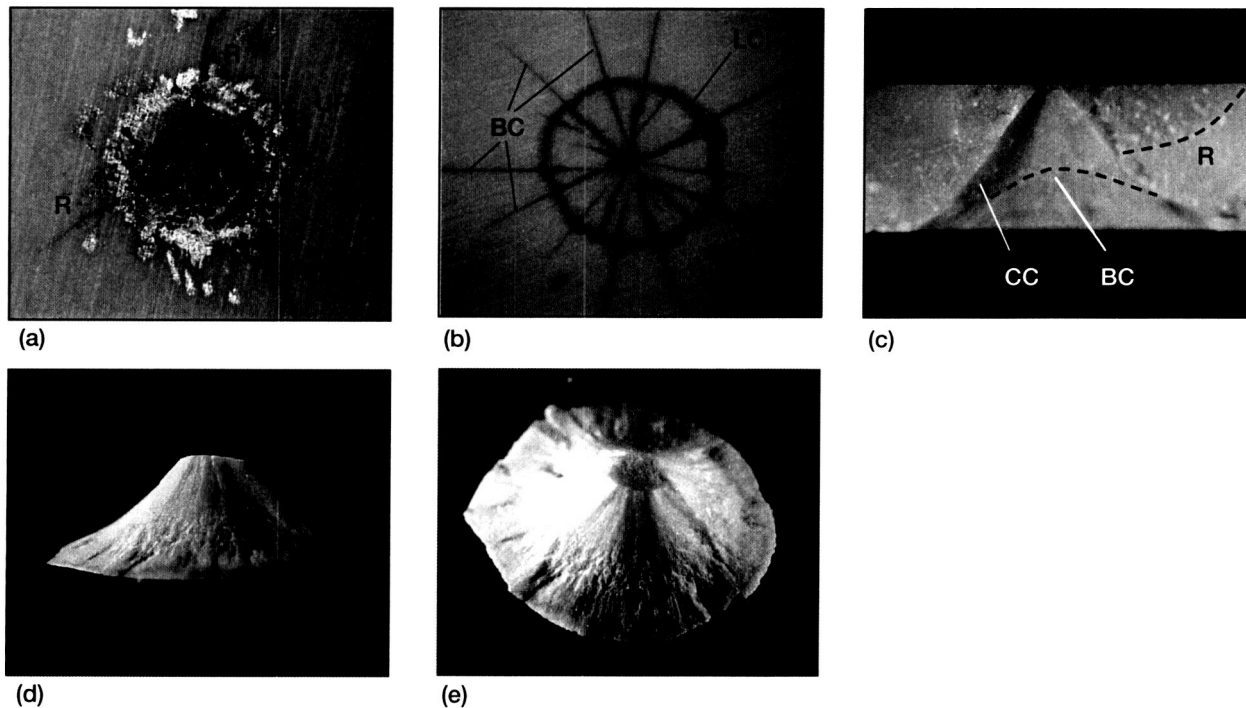
were separated from the specimen after strength testing. A typical impact site showing the impression, radial cracks, and an upper cone together with a back-side view (this will be discussed later in the section **Consideration of Back-Side Cracking**), a fracture surface, and a separated cone is shown in figure 13. The dimensions of the cones, including upper and lower diameters and heights, were determined for both silicon nitrides from either fracture surfaces or separated cones using typically seven specimens in measurements at each impact velocity. The cone angle, defined as half of apex angle, was calculated based on the determined cone geometry.[1] The result is shown in figure 14. The cone angle with an average value of $42\pm2°$ remained almost unchanged regardless of material over impact velocities from 350 to 440 m/s. There is limited information in the literature on cone angles resulting from impact of a ceramic target by steel ball projectiles, and it is available only as photographs (e.g., ref. 23), so a meaningful comparison between this work and the published data could not be made. However, it should be noted that the angle also depends on variables such as specimen geometry, type of specimen support, projectile material, and impact velocity.

Figure 13.—Examples of impact damage occurring in AS800 silicon nitride disk impacted at high velocity of 44 m/s by 1.59-mm-diameter steel ball projectile. (a) Impact site showing impression, radial cracks (R), and upper cone (UP) before strength testing. (b) Back-side view showing back-side radial cracks (BC, radiating from center) and lower diameter of a cone (LC) before strength testing. (c) Fracture surface showing cavity of cone (CC), impact-site (upper) radial cracks (R), and back-side radial cracks (BC). (d) Side view of cone separated from (c). (e) Top view of cone separated from (c). Corresponding postimpact strength of target specimen was 192 MPa.

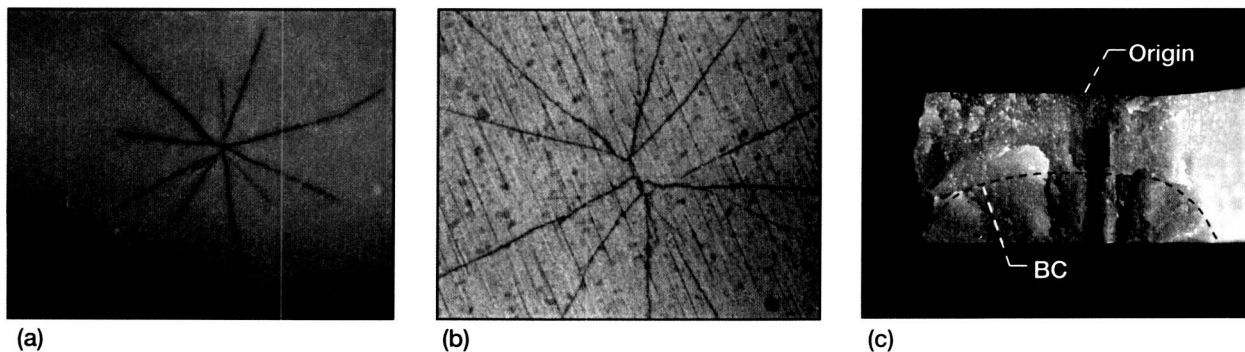
Back-side cracking: Unlike flexure bar specimens, disk target specimens exhibited a peculiar feature of back-side cracking that occurred on the reverse side of disks depending on impact velocity. Typical back-side cracking generated upon impact—but prior to postimpact strength testing—and the corresponding fracture surface are shown in figure 17. Well-defined and somewhat symmetric radial cracks originated in the reverse side of the specimen from a point just beneath the impact site. The crack configuration was semi-elliptical with a minor to major axis ratio of around 0.2 to 0.3. The occurrence of back-side cracking increased with higher impact velocity, as shown in figure 18(a). For a given impact velocity, the probability of occurrence of back-side cracking was a little greater in SN282 than in AS800, again due to lower fracture toughness in SN282 than in AS800. The sizes of back-side cracks, measured from its center, are shown in figure 18(b). AS800 showed almost consistent crack size independent of impact velocity with a mean size of around 6 mm, whereas SN282 showed a dependency of crack size on impact velocity such that the crack size increased with impact velocity. The reason for the occurrence of back-side cracking in disk target specimens, very important in view of potential structural integrity, will be discussed later in the section **Consideration of Back-Side Cracking**.

Figure 17.—Examples of well-developed back-side radial cracking and fracture surface. (a) AS800 silicon nitride disk impacted at 300 m/s (before strength testing); corresponding postimpact strength, 450 MPa. (b) SN282 silicon nitride disk impacted at 300 m/s (before strength testing); corresponding postimpact strength, 96 MPa. (c) Fracture surface of AS800 specimen in (a) showing back-side cracks (BC) and failure origin.

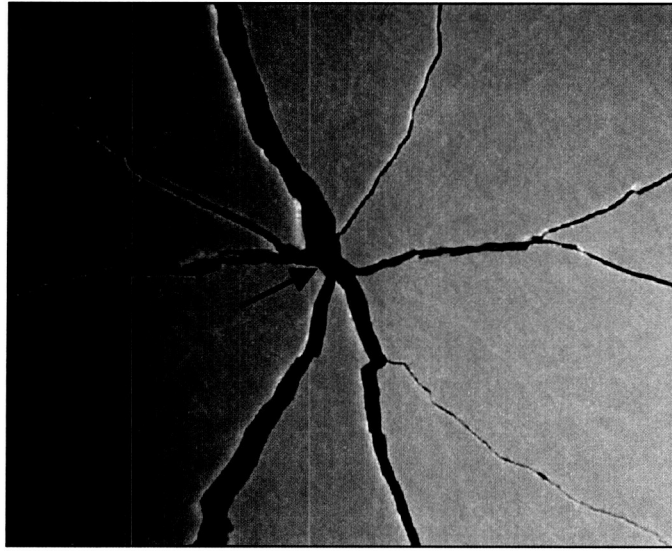
Crack branching: A typical crack branching pattern of a target specimen in strength testing is shown in figure 19, as also inferred from figure 10(a). The empirical relation between biaxial fracture strength σ_f (in MPa) and crack branching length has been shown as (e.g., ref. 24)

Figure 19.—Typical pattern of crack branching for AS800 silicon nitride disk impacted by 1.59-mm-diameter steel ball projectile. Arrow indicates failure origin.
