TECHNICAL MEMORANDUM
X-299

AERODYNAMIC HEATING TESTS OF MISSILE STABILIZERS

IN A FREE JET AT MACH NUMBER 2

By Louis F. Vosteen

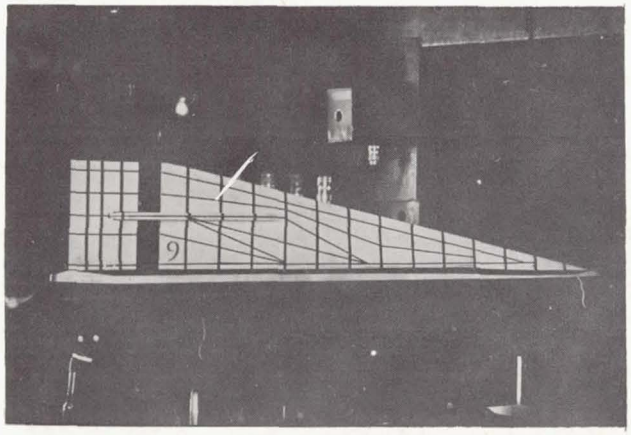
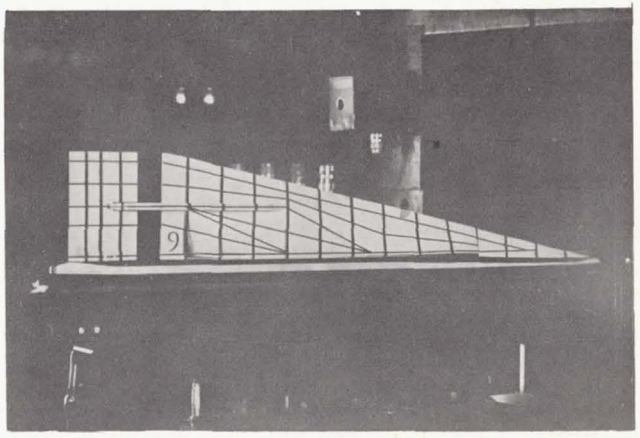
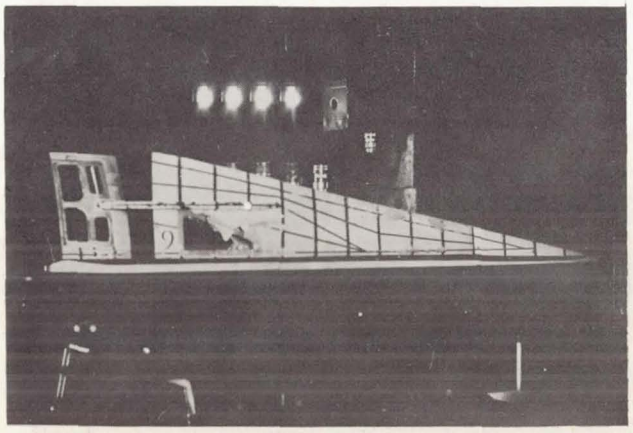
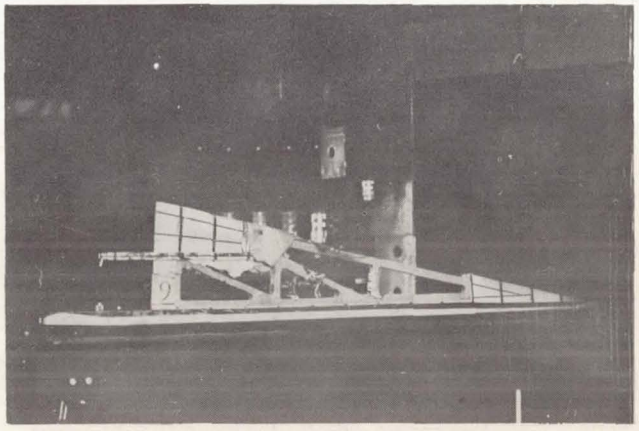
Figure 6.- Photographs of model FS-9 at several times during test.

Model FS-9.- Model FS-9 had a 0.040-inch-thick 2024-T3 aluminum-alloy skin on the forward assembly, a 0.040-inch-thick AZ31A magnesium alloy on the rearward assembly, and a 0.030-inch-thick HK31A magnesium alloy on the control surface. The bond between the skin and the frame near the root of the rearward assembly became loose just after 1 second from the time air began to flow but before test conditions were established. At 1.88 seconds, just after test conditions were established, the skins came off both sides of the control surface. Small pieces of skin on the rearward assembly near the root at the trailing edge began to break off before test conditions were established and continued to break off throughout the test. As the tunnel began to shut down, a large section of the

skin on the rearward assembly came off. Photographs which show the condition of the model at several times during the test are shown in figure 6.

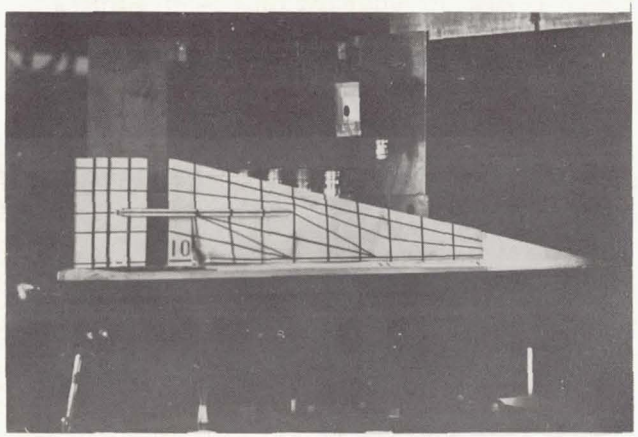
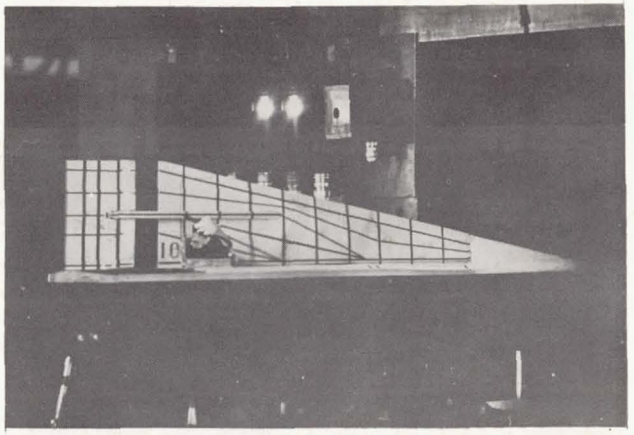
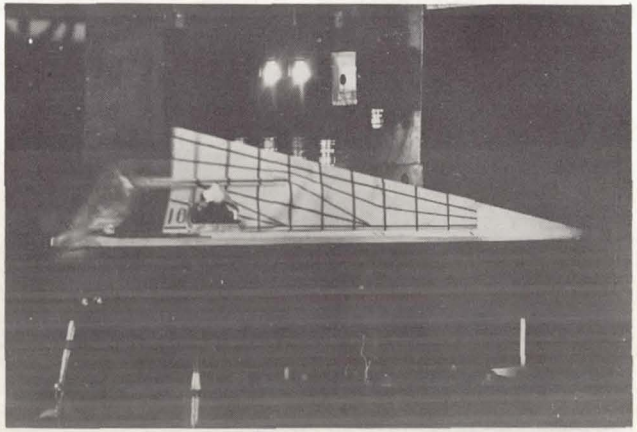
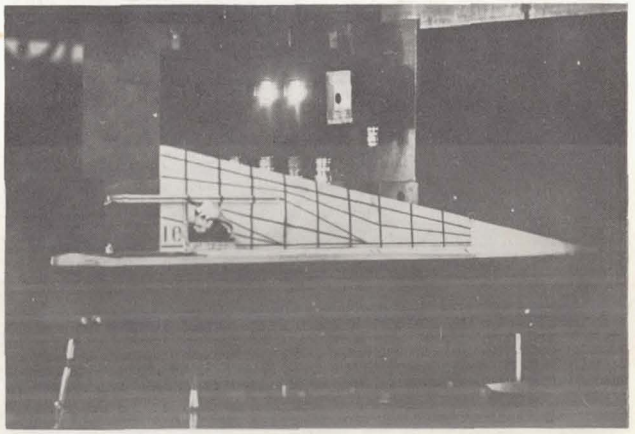
Figure 7.- Photographs of model FS-10 at several times during test.

Model FS-10.- Model FS-10 was covered with a 0.040-inch-thick 2024-T3 aluminum alloy on the forward assembly, a 0.040-inch-thick HK31A magnesium alloy on the rearward assembly, and a 0.030-inch-thick glass laminate on the control surface. The bond between skin and frame along the root of the rearward assembly came loose at 2.58 seconds. Small pieces of skin began to tear off near the trailing edge shortly after that time and continued to come off during the remainder of the test. The control surface had low-amplitude bending oscillations until 8.70 seconds at which time the skins came off. Very shortly thereafter the entire control surface failed. During the shutdown of the tunnel, a large section of skin came off the rearward assembly. Up until the time at which the skins came off the control surface, the model underwent low-amplitude vibrations which alternated between a bending of the entire assembly about the root and a torsional motion of the rearward assembly induced by a bending of the control surface and boom. Photographs of the model at various times during the test are shown in figure 7.

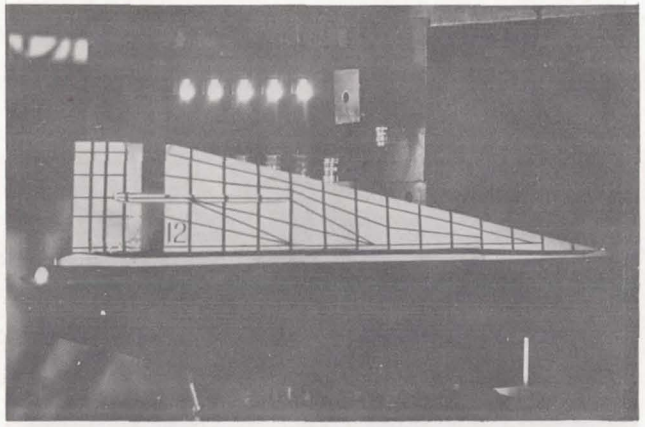
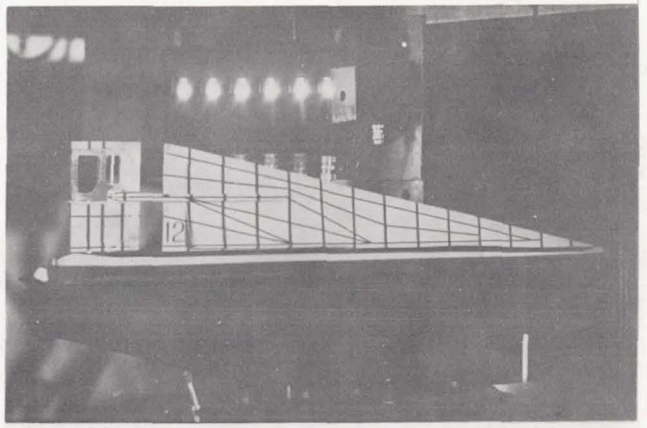
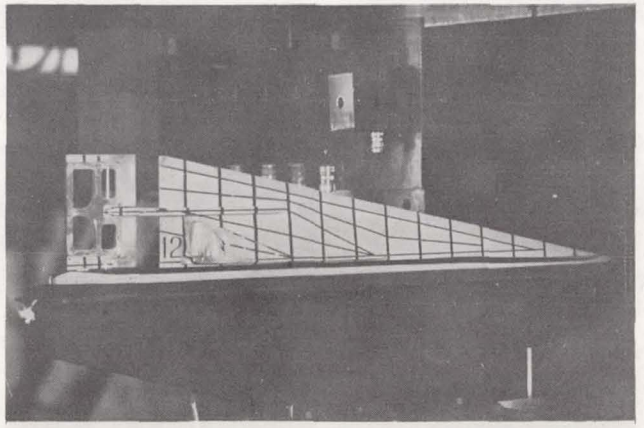
Figure 8.- Photographs of model FS-12 at several times during test.

Although there was some low-amplitude oscillation of the model during the entire test, there was no evidence of any structural failure until 7.54 seconds at which time part of one skin came off the control surface. At 10.60 seconds, the skin on the rearward assembly came loose along the root near the trailing edge. Photographs of the model at several times during the test are shown in figure 8.

Stabilizer failures resulted primarily from failures in the bond between skin and frame. This type of failure was most prevalent on the models with metal skins. In one case, the use of a filler material appeared to improve the behavior of a metal-covered model. Model FS-12, which had a foam filler and a magnesium skin on the rearward assembly, withstood the test far better than model FS-9, which also had a magnesium skin but no filler material. It should be noted, however, that the stagnation temperature during the test of model FS-12 was about 90° F lower than during the test of model FS-9.

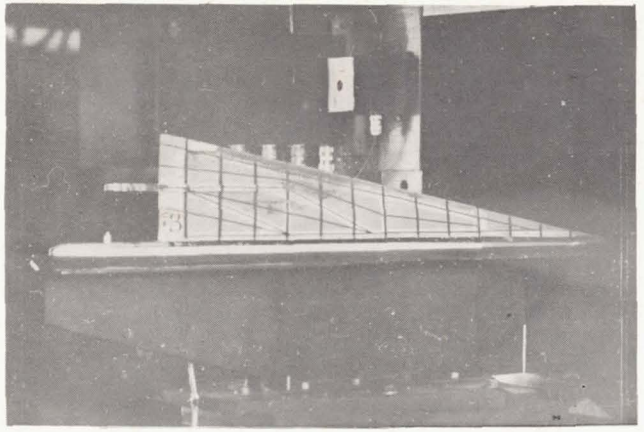
The model withstood the entire test without any evidence of structural failure. Random oscillations varying in frequency between 120 and 150 cycles per second occurred throughout the time of test conditions. The motion was primarily a bending about the root-chord line. Figure 9 shows the model after the test.

Figure 9.- Model FS-13 after test.

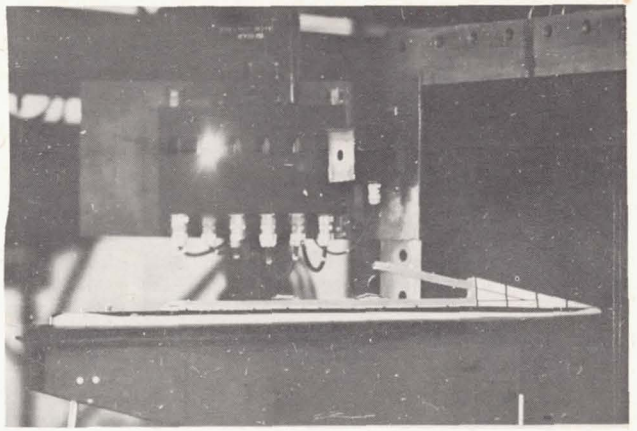
on the rearward assembly, and a 0.030-inch-thick glass laminate on the control surface. As shown in figure 1(b), model FS-14 had a modified frame and an aluminum honeycomb core. A complete failure of the model was precipitated by a loosening of the skin bond near the joint between the forward and rearward assemblies at 2.30 seconds. As shown in figure 10, only the forward assembly and the base of the frame remained after the test.

Models FS-14 and FS-15 both had metal skins, honeycomb cores, and the same type of frame arrangement. Although model FS-15 was tested without a control surface and survived the test with only minor bond failures whereas model FS-14 was tested with a control surface and failed very early in the test, an analysis of the high-speed motion pictures showed that the failure of model FS-14 was not caused by the control surface, but resulted directly from a bond failure. It is not

Figure 10.- Model FS-14 after test.

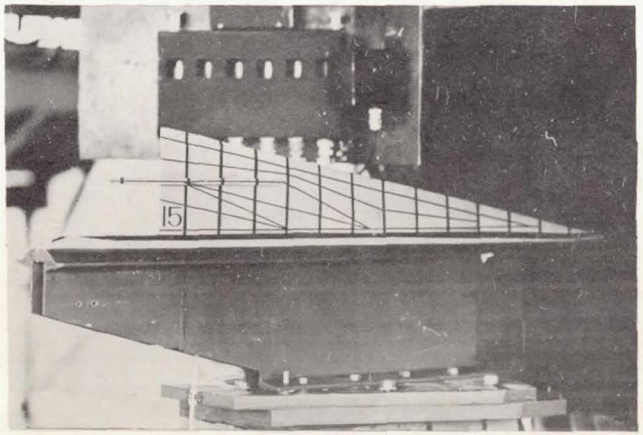
Model FS-15.- Model FS-15 had a 0.040-inch-thick 2024-T3 aluminum alloy on the forward assembly and a 0.040-inch-thick AZ31A magnesium alloy on the rearward assembly. This model had the same frame arrangement and honeycomb core as model FS-14. Model FS-15 was tested without a control surface. The model showed some low-amplitude oscillations in bending about the root at a frequency of about 110 cycles per second throughout the test. At the end of the test, the skin bond was loose along the root of the rearward assembly and near the forward joint. Figure 11 shows the model after the test.

Figure 11.- Model FS-15 after test.

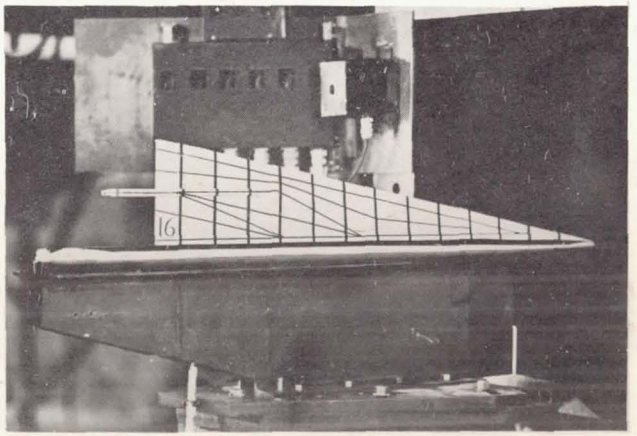
Model FS-16.- Model FS-16 was covered with a 0.040-inch-thick glass laminate on both the forward and rearward assemblies and was tested without a control surface. The frame of the rearward assembly contained one member in addition to the modified frame used in models FS-14 and FS-15. The cavities between frame members were filled with a urethane foam. The model exhibited the same type of oscillatory motion as models FS-13 and FS-15, that is, low-amplitude bending oscillations at 120 to 150 cycles per second. The model appeared to be completely sound in all respects after the test as shown in figure 12.

Figure 12.- Model FS-16 after test.
