NASA CR-217

OPERATION OF A FORCED CIRCULATION, CROLOY 9 M, MERCURY LOOP TO STUDY CORROSION PRODUCT SEPARATION TECHNIQUES

by D. B. Cooper and E. J. Vargo

A Croloy 9M, forced circulation, mercury loop was designed and operated for a total of 2918 hours at an average boiling temperature of 1074°F. Corrosion product separators were included in both the vapor and liquid sections of the system and were evaluated for their effectiveness in reducing problems associated with mass transfer in mercury systems. Corrosion data for this system were found to agree favorably with previously reported data for Croloy 9M. The greatest attack was found in the low vapor quality regions of the boiling section of the loop and in the superheater outlet where condensation is believed to have occurred. The dry portions of the superheater suffered negligible attack. The degree of corrosion which existed in the condenser and subcooler could not be detected metallographically because of the extremely rough surface of the as-received material.

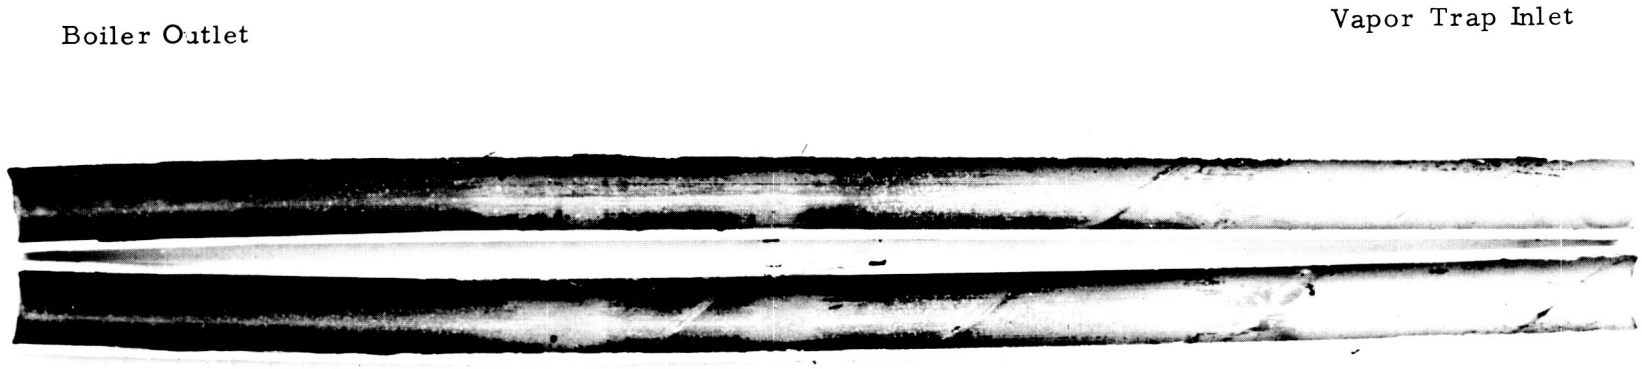
Figure 22. Appearance of Boiler Outlet and Vapor Trap Inlet Sections.

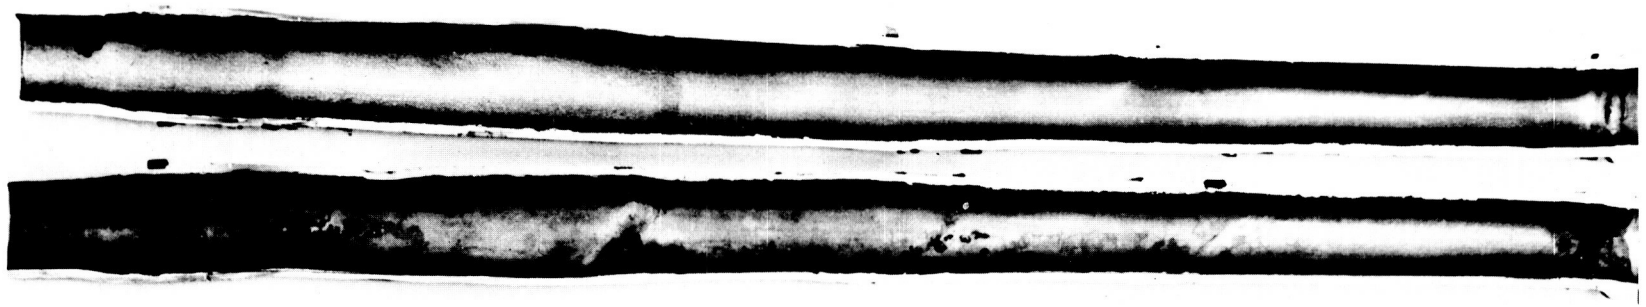
Figure 25. Appearance of Superheater Mid-Section.

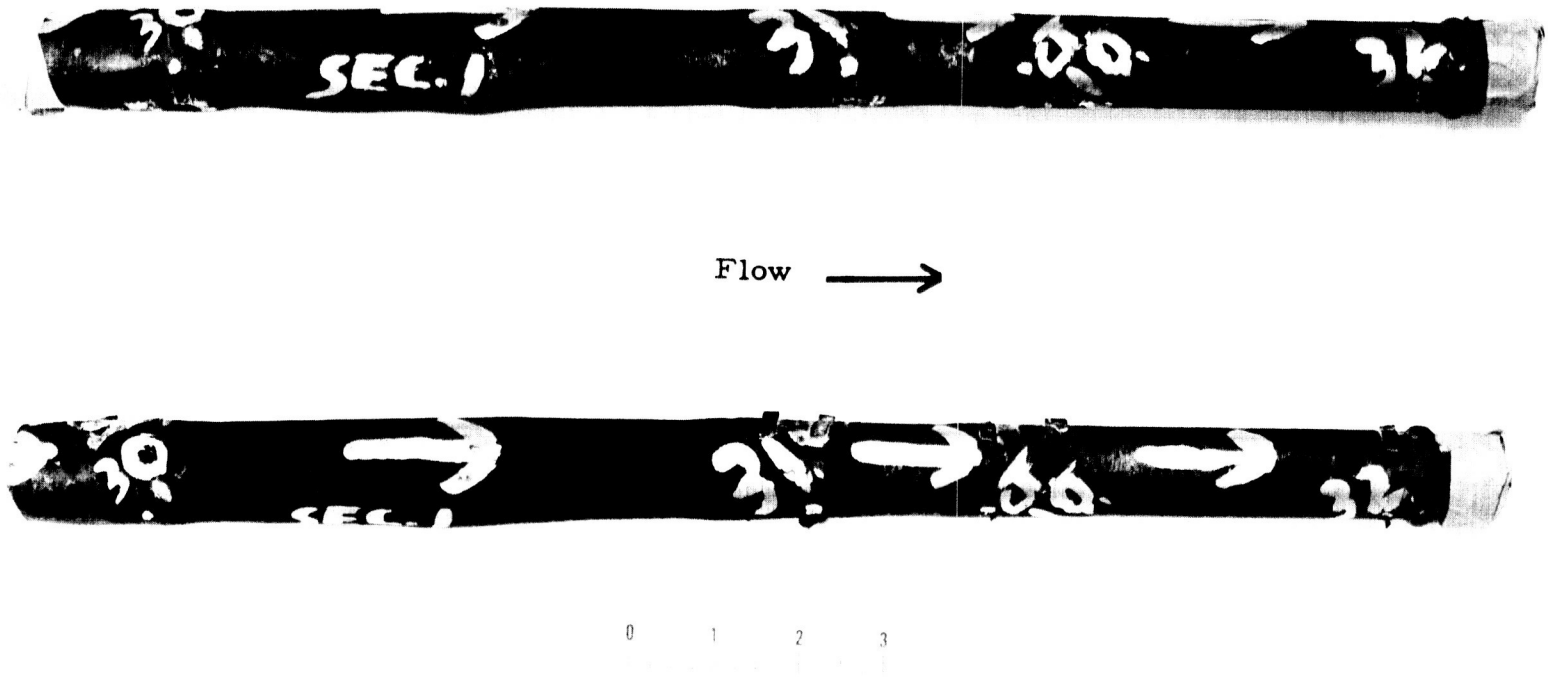
Figure 27 Appearance of the Superheater Outlet Section Showing the Deformation which Occurred.

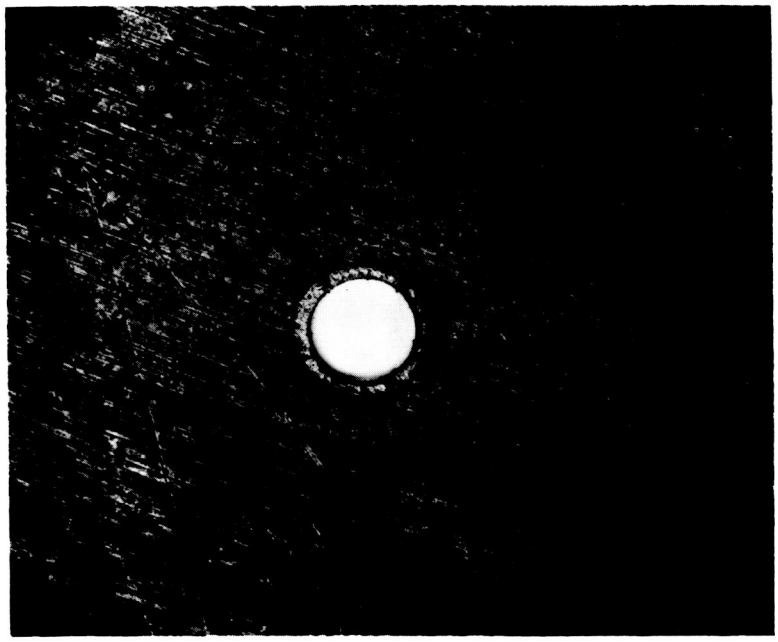
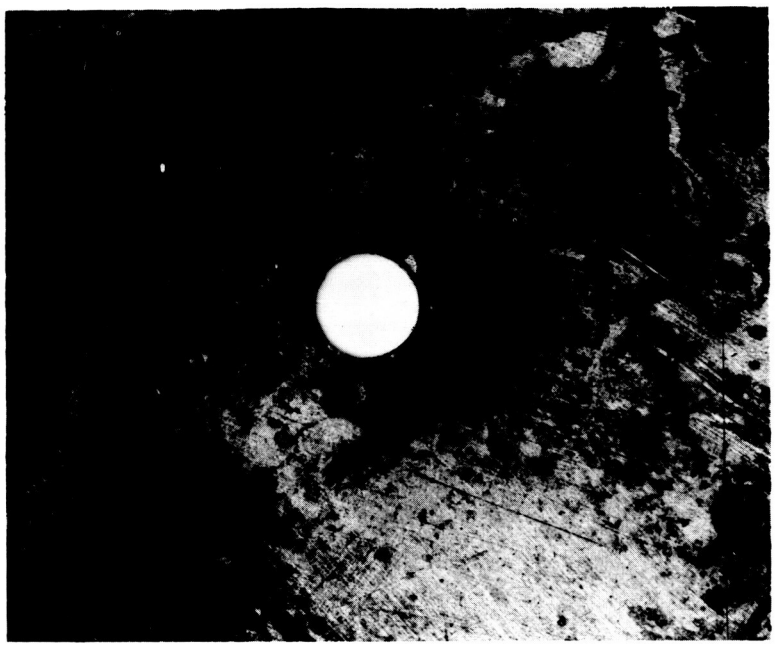
The Croloy 9M orifice was found to be relatively clean and contained only a small quantity of amalgam on the outlet side, Figure 28.

a) Inlet Approximately 10X

b) Outlet Approximately 10X

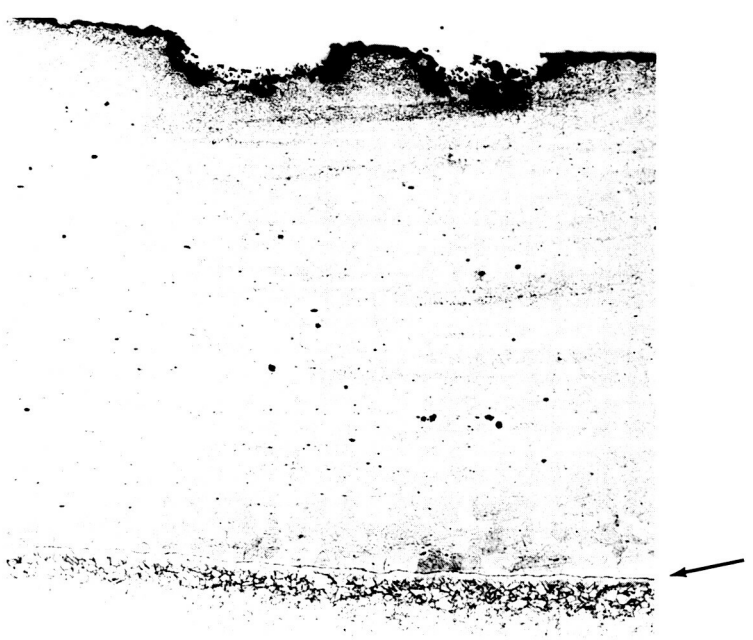
Figure 32. Intergranular Corrosion of Boiler Midsection.
Etchant - Carapella

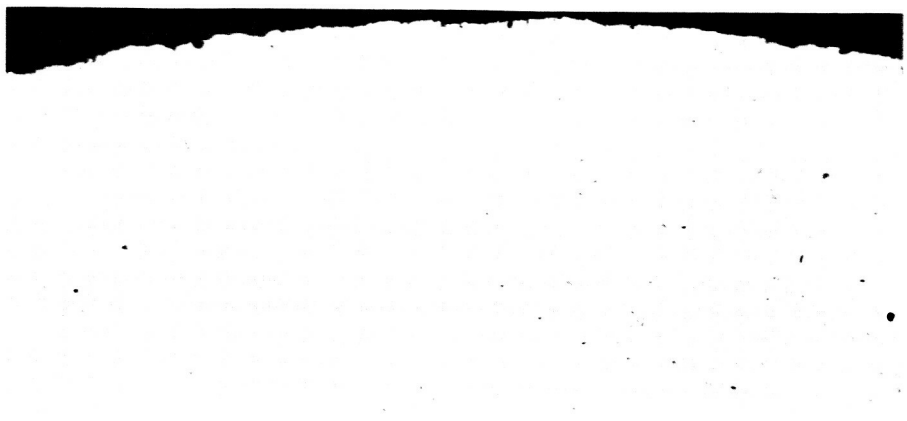
a) Intergranular Corrosion of Swirl Wire at Boiler Inlet

The intensity of the corrosive attack diminished near the boiler outlet. The tube wall exhibited a penetration of 1.1 mils (Figure 34). Metallographic examination of the swirl wire taken from the liquid/vapor interface revealed an intergranular type of corrosion of 0.6 mil penetration (Figure 33c). A similar intensity of attack was revealed in the inlet and midsection portions of the superheater. Intergranular corrosion (Figure 35 and Table 4) up to 1.7 mils penetration was measured. The swirl wire from these sections revealed 0.5 mil depth layer-type and 1.0 mil intergranular-type of corrosion at the superheater inlet and midsection, respectively, as shown in Figures 33d and 33e.

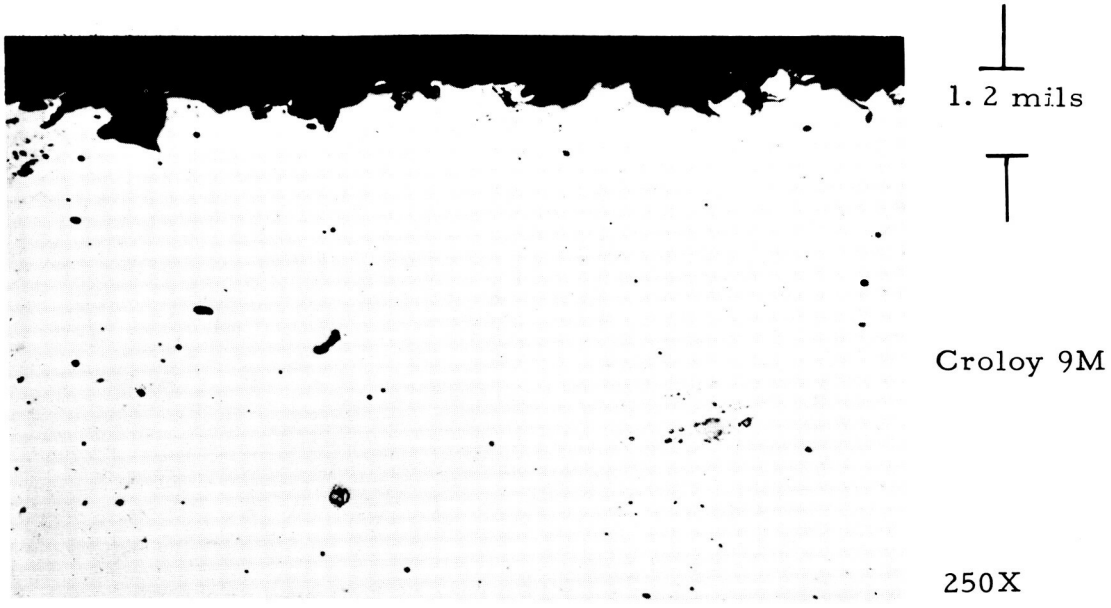
Figure 36. Intergranular Corrosion of Croloy 9M at Superheater Outlet.

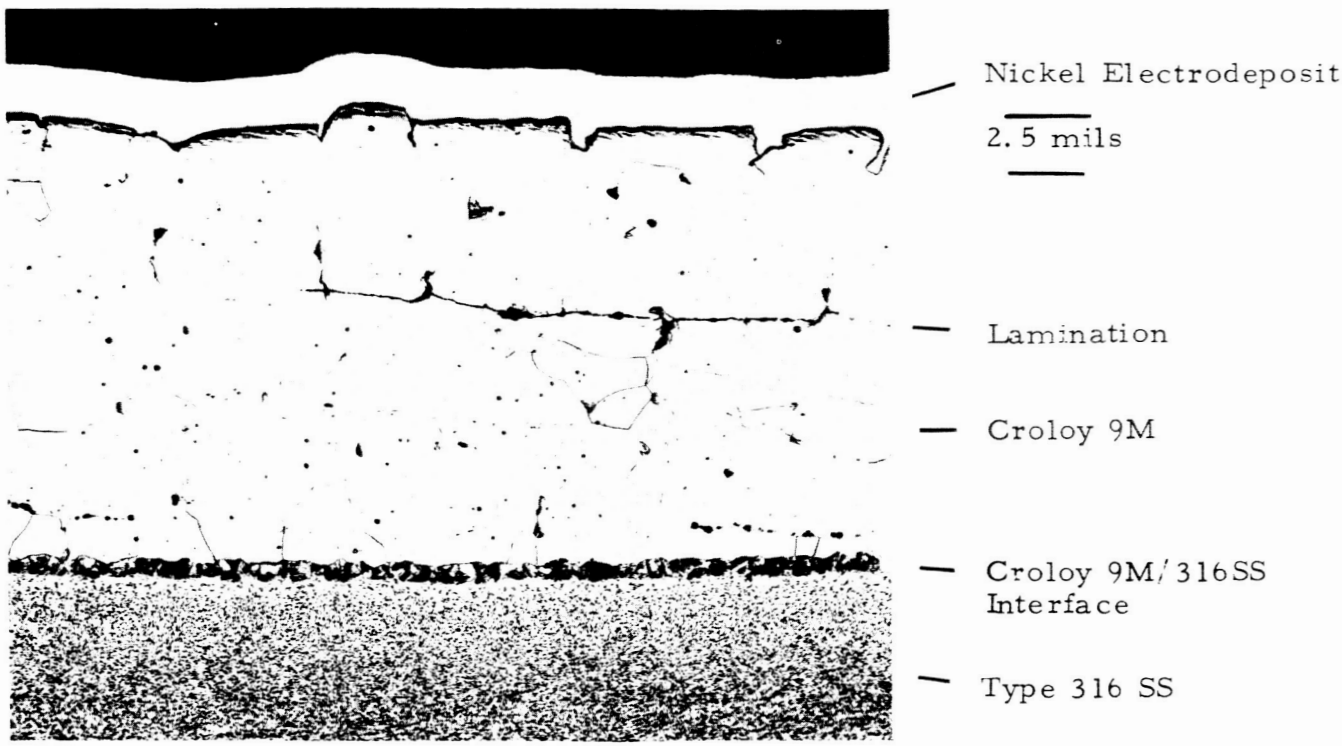
Figure 37. Intergranular Corrosion of Superheater Wall.

The microstructural change of the Croloy 9M in the superheater outlet section of this loop is clearly displayed in the photomicrograph of Figure 37. The normal grain structure of this ferritic steel has been replaced by an extremely low carbon, coarse grain ferrite. Apparently, long time elevated temperature exposure with intimate contact to Type 316 SS promoted the migration of carbon from the Croloy 9M to the austenitic stainless steel, accompanied by grain coarsening of the ferritic steel. The loss of carbon by the Croloy 9M did not change its original hardness (R_B85—96) significantly. The acquisition of carbon by the Type 316 SS cladding material was manifested by a profusion of carbides (Figure 37) and an appreciable change in hardness, R_B96 to R_C29. The electron beam microanalysis of this section of tubing revealed extensive molybdenum and chromium-rich precipitates in the Type 316 SS, which are probably carbides. The electron beam microanalysis also revealed a diffusion zone at the Type 316 SS—Croloy 9M interface of 1.7 to 2.2 mils in thickness (see Figures 54 and 55). This diffusion zone is also displayed in the photomicrograph of Figure 37. This extensive diffusion zone in the superheater outlet section (operated at 1405 ± 10°F) is compared with that observed in the boiler mid-section (operated at 1142°F and displayed in the photomicrograph of Figure 32). The diffusion zone in this lower-temperature region of the loop was found to be less than 0.3 mil in thickness, as revealed by the electron beam microanalysis (see Figures 56 and 57). The observed gross carbon diffusion and metallurgical structural changes of the Type 316 SS—Croloy 9M tubing in the 1405 ± 10°F temperature region is, of course, attributed to the excessive temperature.

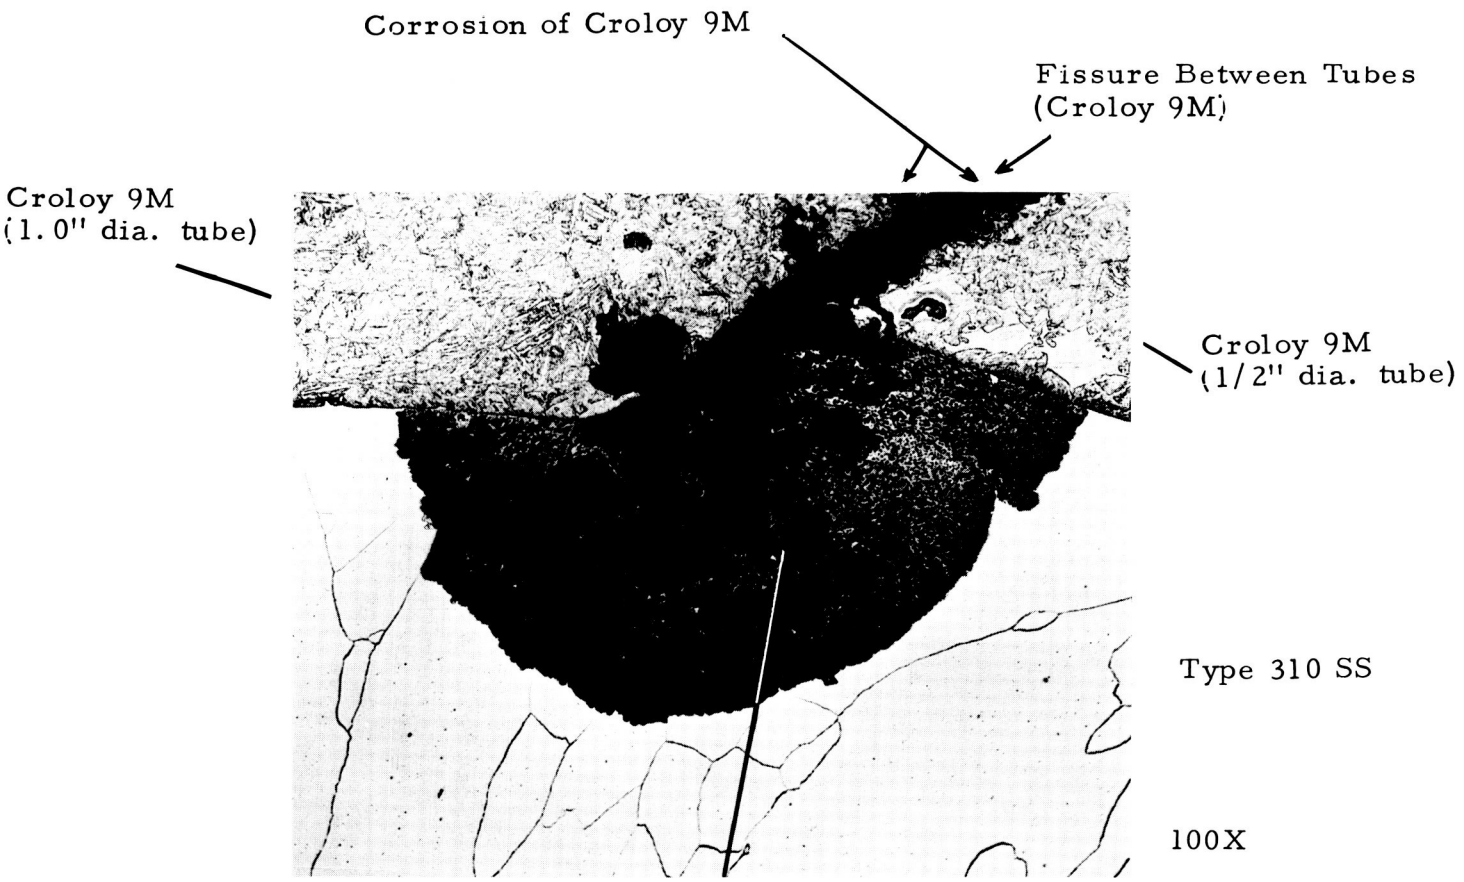
Figure 38. Leached Layer Corrosion of Type 310 SS Weld Metal and Croloy 9M at Weldment of 1/2 Inch Diameter Croloy 9M Tube to 1.0 Inch Diameter Duplex Tube (Croloy 9M/316 SS) in Boiler Section. Operating Temperature—1070°F. Etchant - Carapella.

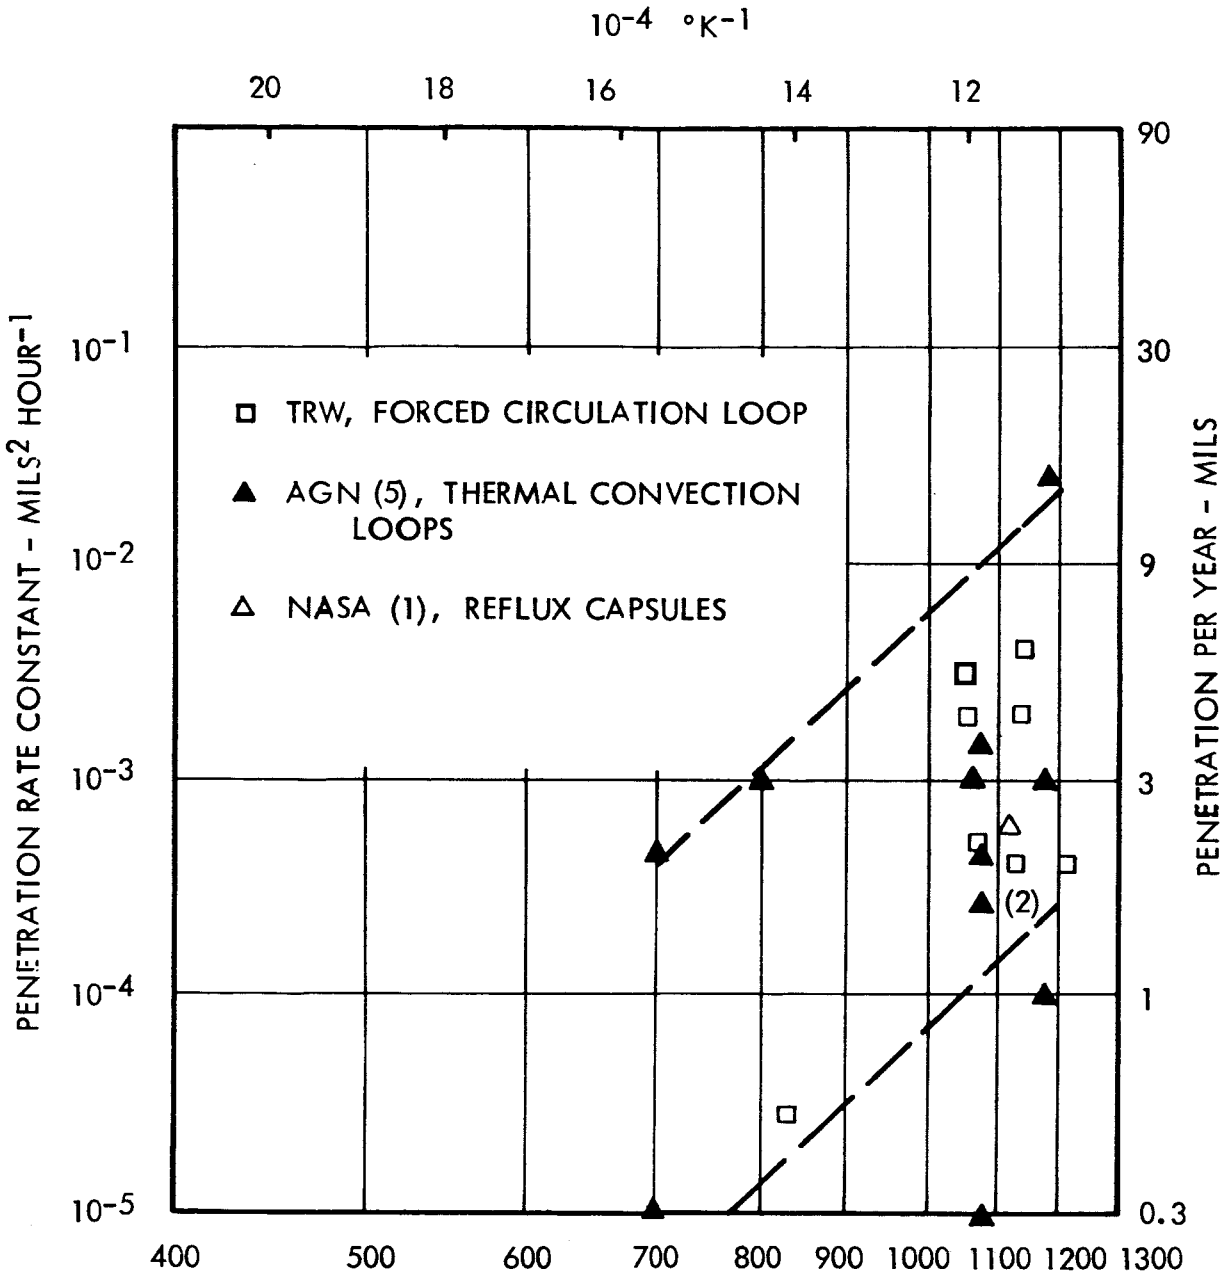
The corrosion capsule test results of other investigators[1] indicate that the corrosive attack by mercury of Croloy 9M is of the order of 0. 8 mil penetration after 1000 hours at 1100°F. Thermal convection loops operated for 1000 hours at a boiling and condensing temperature of 1075°F (7. 2 lbs/hr flow rate) revealed corrosive penetration of Croloy 9M to a depth of 1. 2 mils[5]. A comparison of the corrosion data obtained from the operation of this loop with the above referenced results was made. The data compare favorably, as shown in Figure 39, which is a plot of these data assuming diffusion control [8].

Figure 39. Plot of Corrosion Data for Croloy 9M Assuming Diffusion Control.

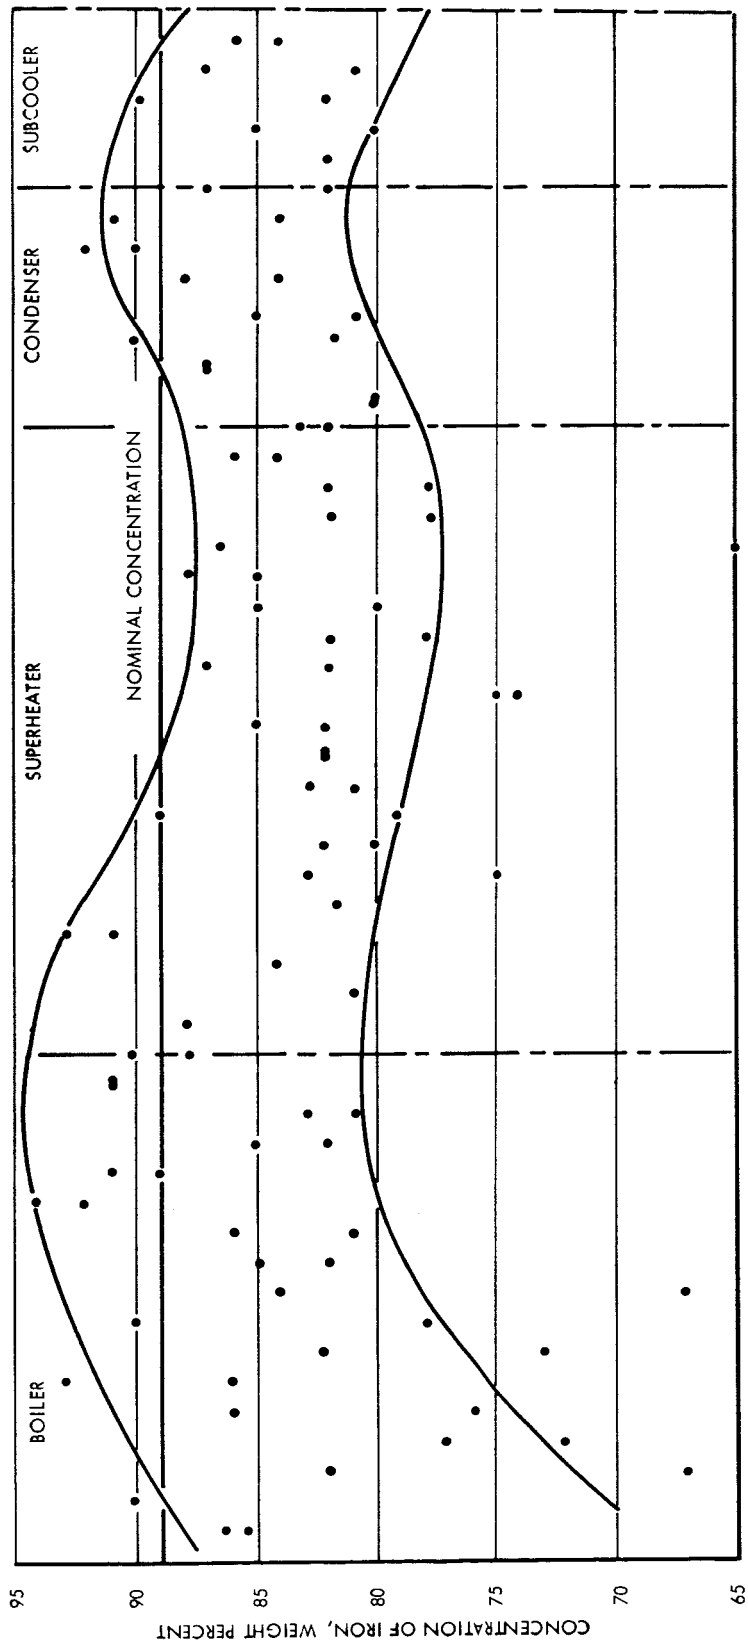
The ID surface of the loop was analyzed by x-ray fluorescent techniques, the results of which are semiquantitative. The values obtained for iron and chromium were plotted in an effort to determine any trends (Figures 40 and 41). The interpretation of these results is somewhat conjectural. Nevertheless, the plotted scatter-band indicates that the mean values for these elements are lower than the reported values of the Croloy 9M tube material given below:

This trend would indicate that corrosion of the general dissolution type does take place rather than selective leaching. The random high iron or chromium content of the deposits and several of the mercury samples also reflect this indication.

Figure 40. Variation of Iron Content of I. D. Surface with Loop Section.

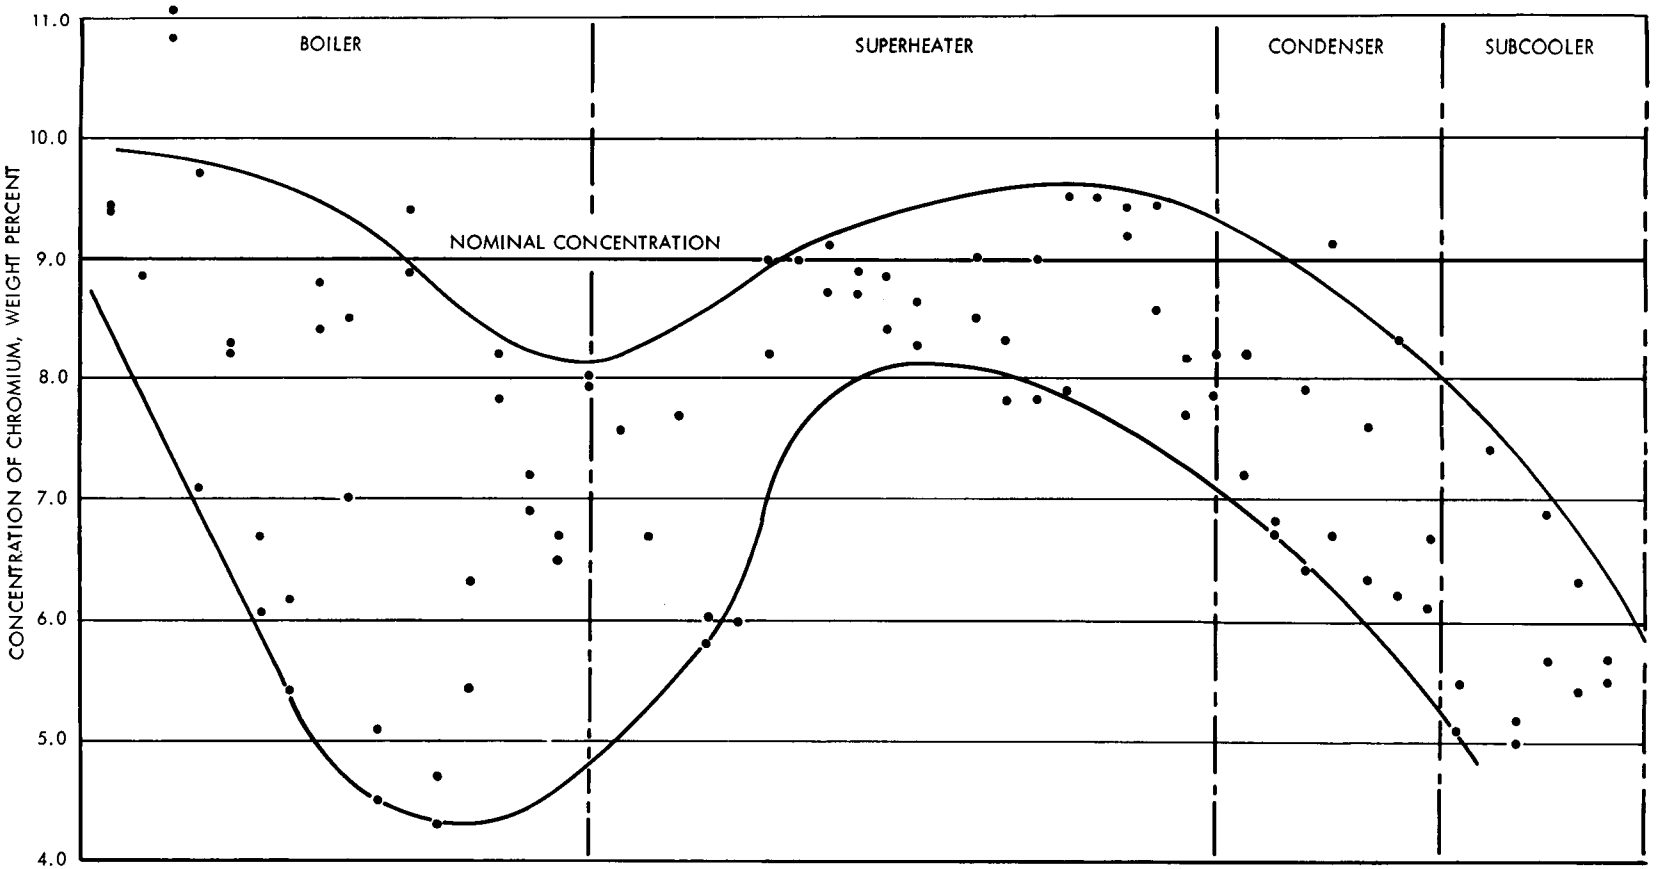
Two sections of the loop are indicated by this plot to have a depletion of chromium, the last half of the boiler, and the condenser and subcooler. The metallographic examination of the boiler revealed the severest corrosive attack by mercury and thus may substantiate this low chromium content. However, the low chromium content of

Figure 41. Variation of Chromium Content of I. D. Surface with Loop Section.

the condenser and subcooler ID surface cannot be explained by the metallographic results.

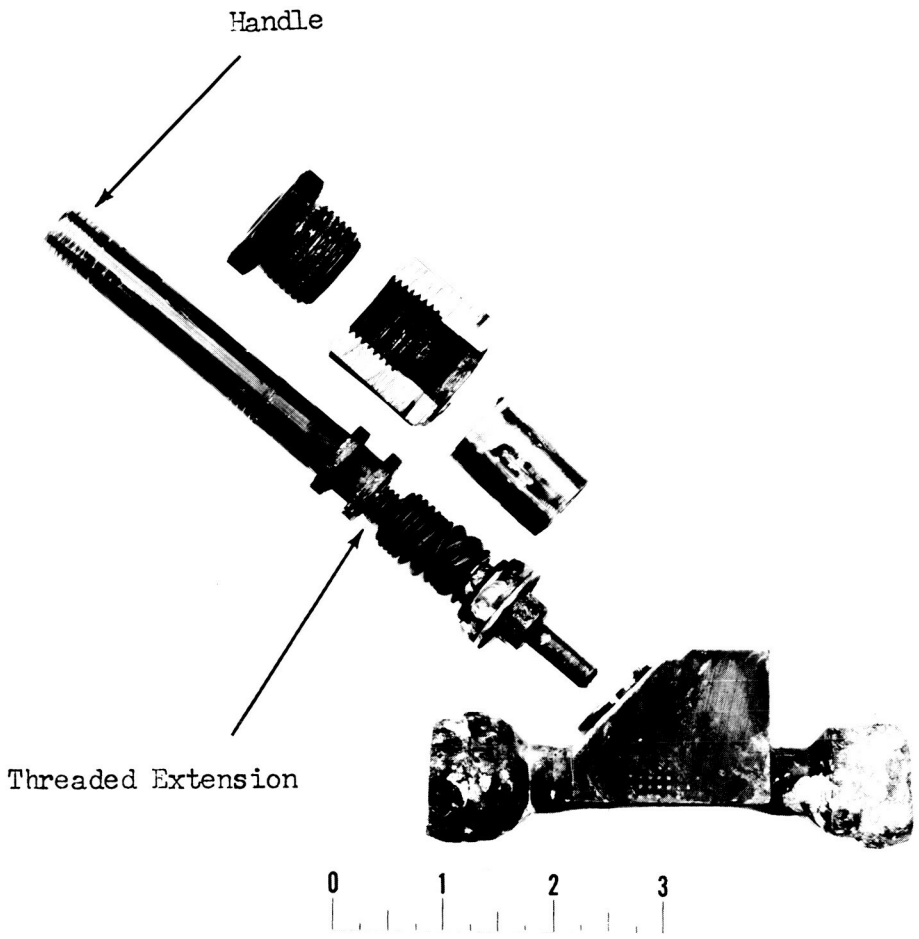
Deposition and corrosive and/or erosive attack were observed, after 448 hours of loop operation, in a Croloy 9M throttling valve located at the superheater outlet.

Figure 42. Disassembled Croloy 9M Throttling Valve.

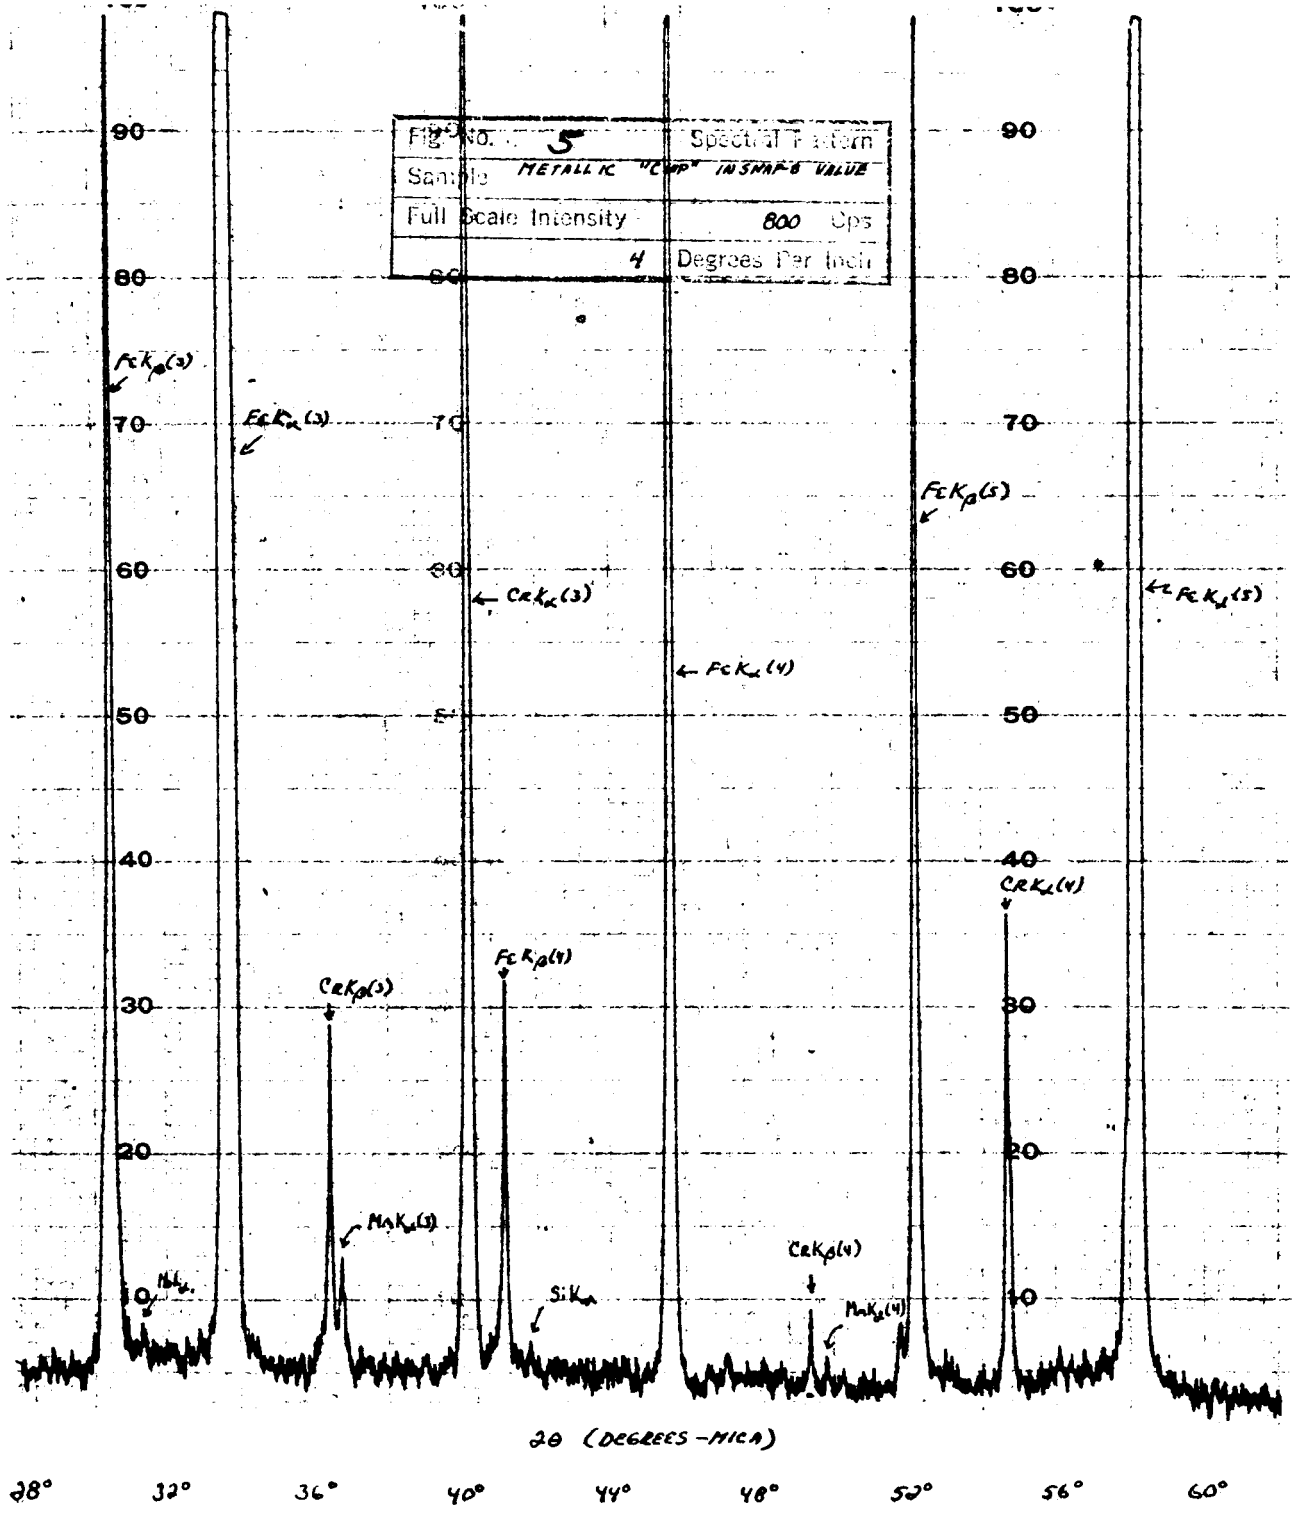
The valve was sectioned and mounted for metallographic evaluation. Examination showed that a deposit had formed on the outlet side of the orifice in the valve. Two foreign metallic chips were also found in this area of the valve. The combination of the deposit and metallic chips caused a considerable reduction in the flow passage in the valve. This explains the control difficulties experienced during initial loop operation when fine adjustment of the valve could not be obtained. A photomicrograph of this area of the valve is shown in Figure 44.

Figure 46. Spectral Pattern of the Metallic Chip Found in the Croloy 9M Throttling Valve.

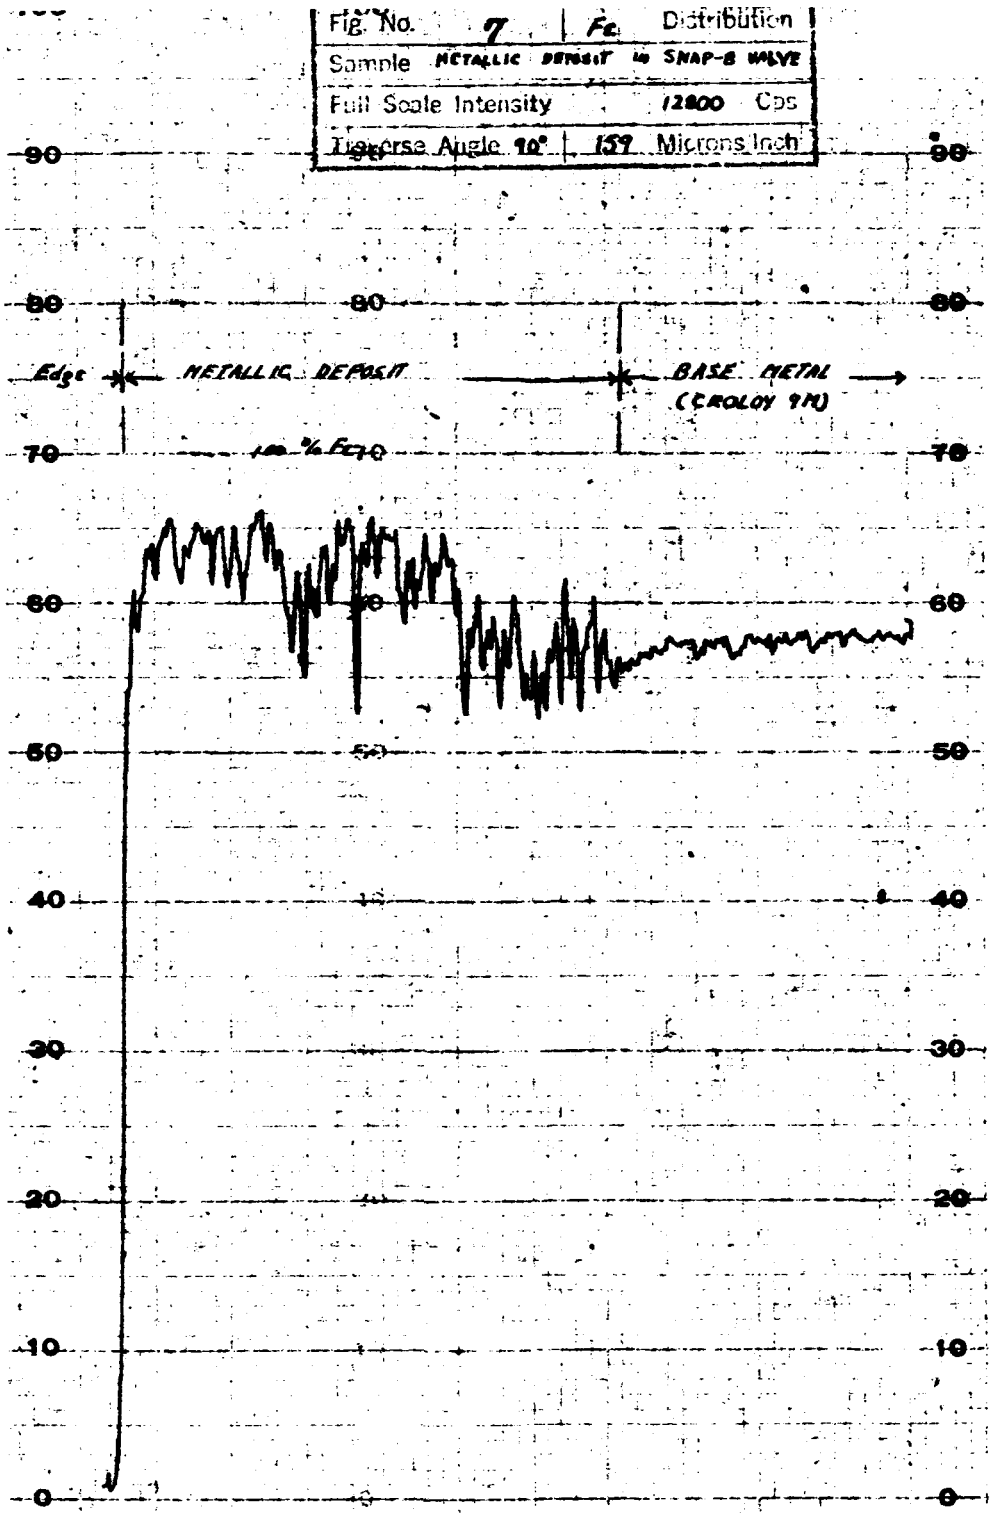
The iron, chromium, and molybdenum distributions in the deposit are shown in Figures 47, 48, and 49, respectively. It is seen here that the deposit is iron-rich and chromium- and molybdenum-poor. The chromium shows a small gradient in the vicinity of the deposit-base metal interface but rapidly falls to less than one percent. The molybdenum content drops abruptly to approximately zero percent at the deposit-base metal interface. The iron concentration rises to roughly 90 to 95 percent. Chromium-rich phases are present in both the deposit

Figure 47. Distribution of Iron in the Deposit Found in the Croloy 9M Throttling Valve.

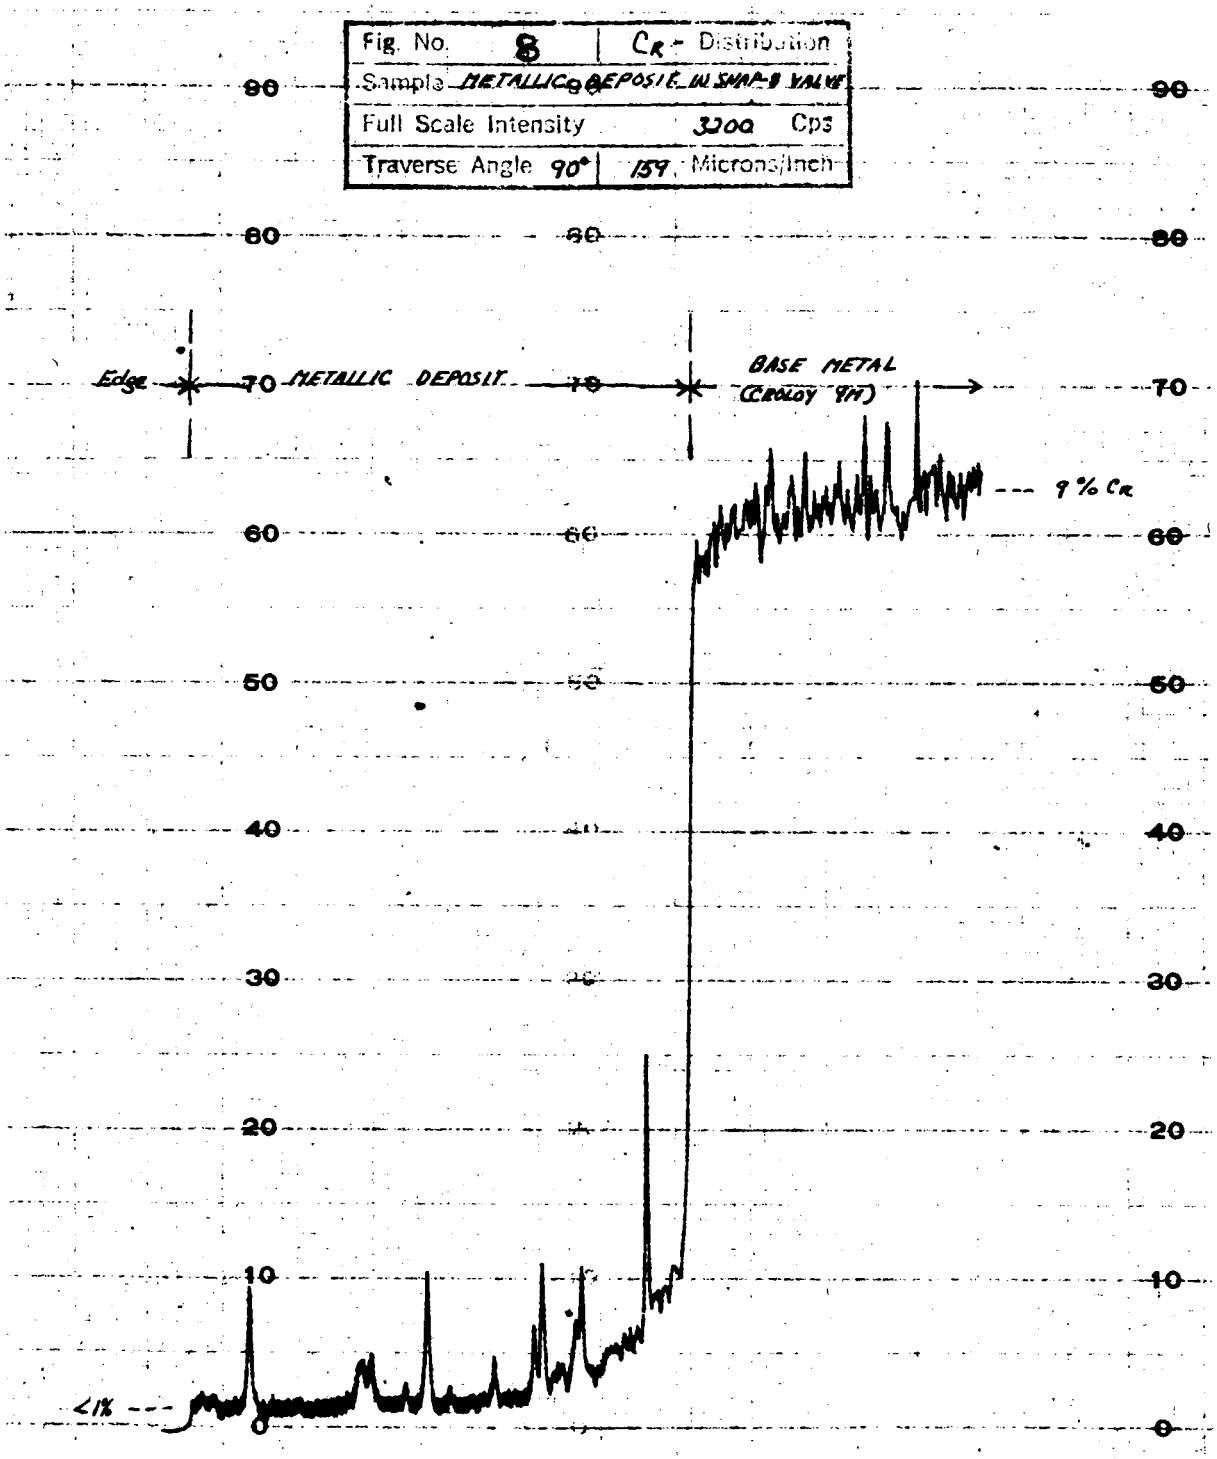
Figure 48. Distribution of Chromium in the Deposit Found in the Croloy 9M Throttling Valve.

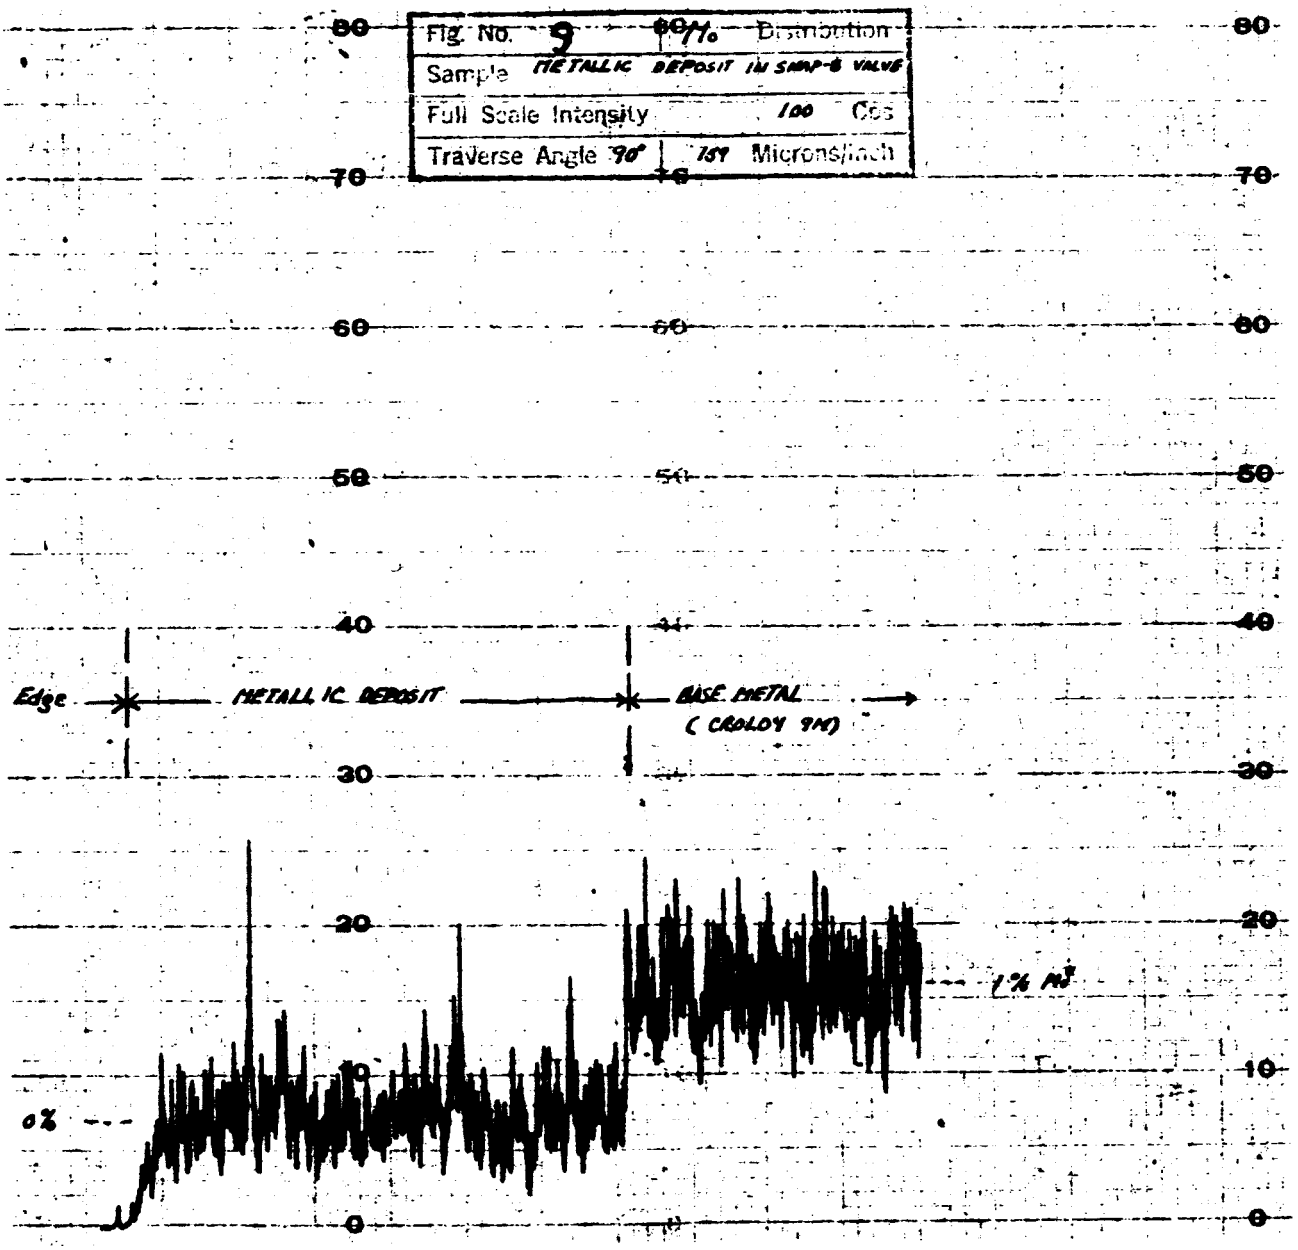
Figure 49. Distribution of Molybdenum in the Deposit Found in the Croloy 9M Throttling Valve.

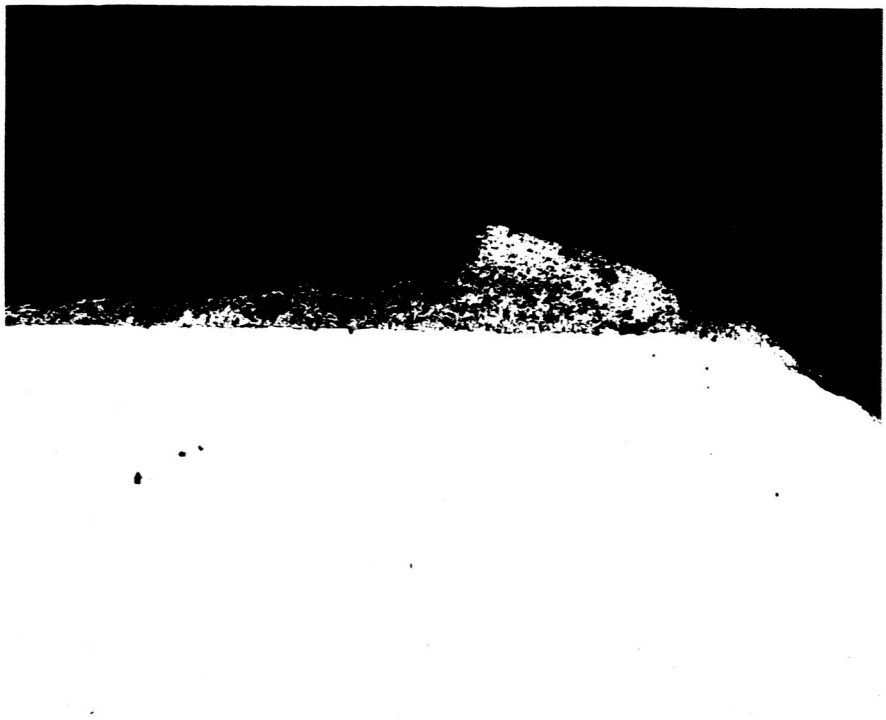
The stem (Croloy 9M) and the bellows (Type 321 SS) from the valve were also examined metallographically. As seen in Figure 50, some slight déposition was observed on the valve stem. The stem also suffered some corrosion and/or erosion damage as shown in Figure 51. The maximum depth of attack was approximately four mils. Some slight attack ($<$ one mil) was also observed on the Type 321 SS bellows, as shown in Figure 52.

Figure 50. Deposition on the Stem of the Croloy 9M Throttling Valve.

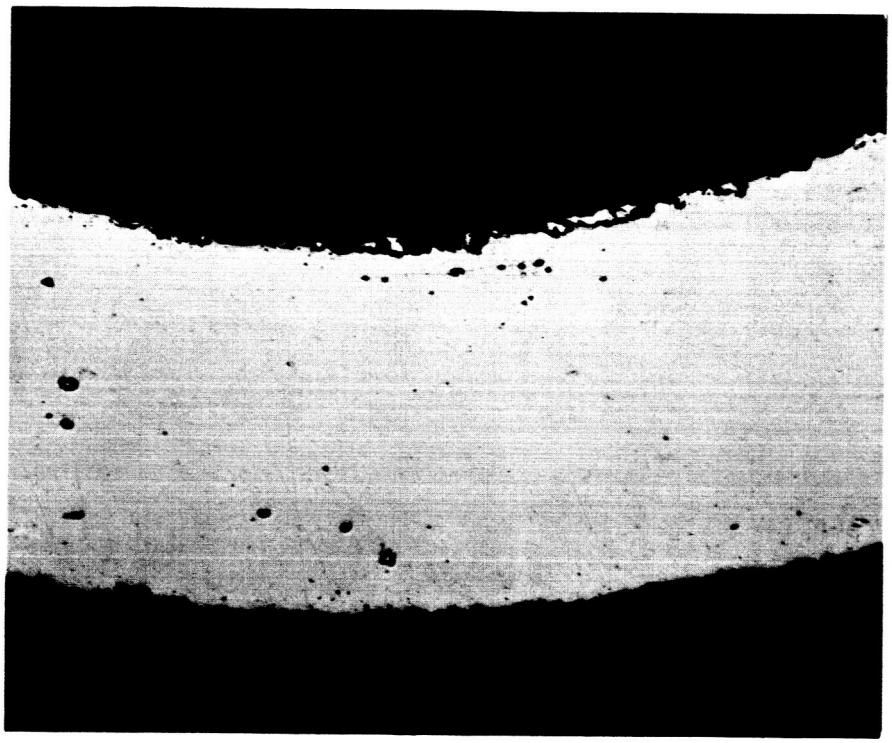
Figure 51. Attack on the Stem of the Croloy 9M Throttling Valve.
