NASA CR-217

OPERATION OF A FORCED CIRCULATION, CROLOY 9 M, MERCURY LOOP TO STUDY CORROSION PRODUCT SEPARATION TECHNIQUES

by D. B. Cooper and E. J. Vargo

A Croloy 9M, forced circulation, mercury loop was designed and operated for a total of 2918 hours at an average boiling temperature of 1074°F. Corrosion product separators were included in both the vapor and liquid sections of the system and were evaluated for their effectiveness in reducing problems associated with mass transfer in mercury systems. Corrosion data for this system were found to agree favorably with previously reported data for Croloy 9M. The greatest attack was found in the low vapor quality regions of the boiling section of the loop and in the superheater outlet where condensation is believed to have occurred. The dry portions of the superheater suffered negligible attack. The degree of corrosion which existed in the condenser and subcooler could not be detected metallographically because of the extremely rough surface of the as-received material.

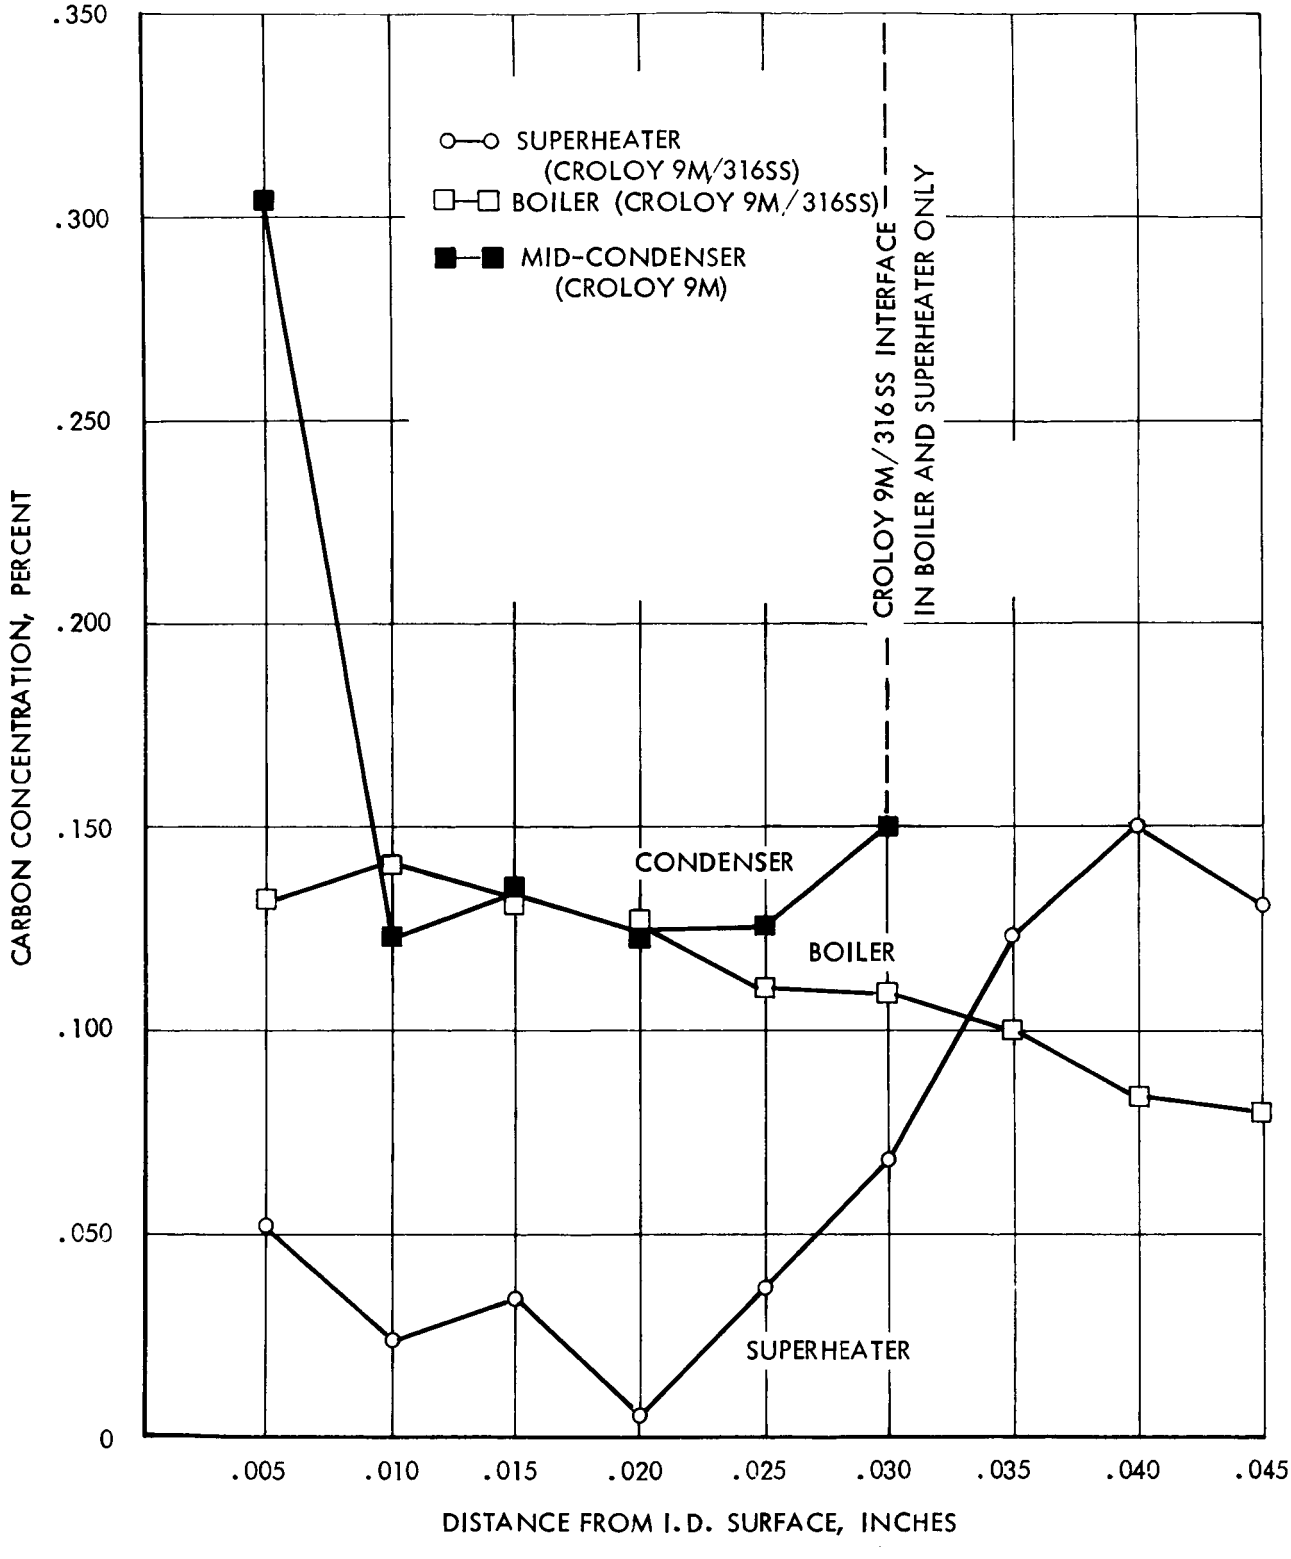
Figure 53. Carbon Content of Loop Wall at Various Distances from the I.D. Surface.

It is apparent from these carbon analyses that the Type 316 SS—Croloy 9M composite tubing is subject to metallurgical changes because of carbon diffusion at temperatures above 1200°F. Furthermore, it is indicated from these results that carbon is lost by the Croloy 9M by diffusion to the Type 316 SS cladding.

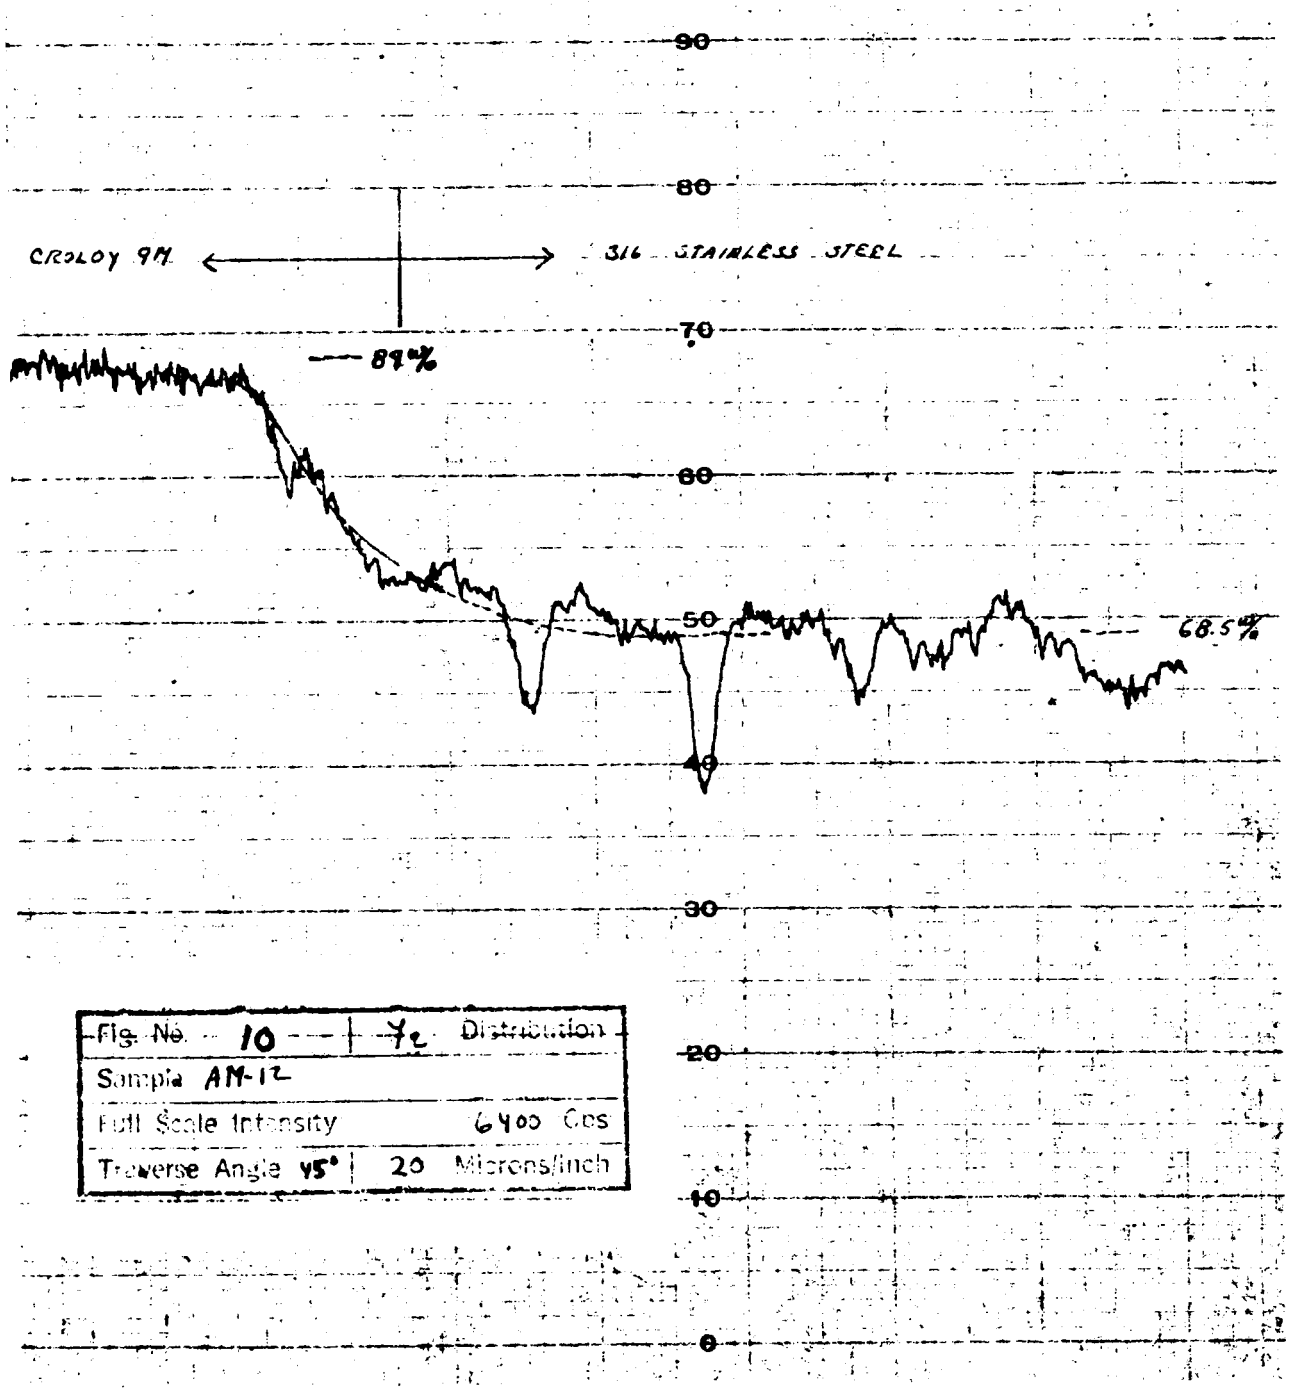
Figure 54. Distribution of Iron at the Type 316 SS-Croloy 9M Interface in the Superheater Outlet.

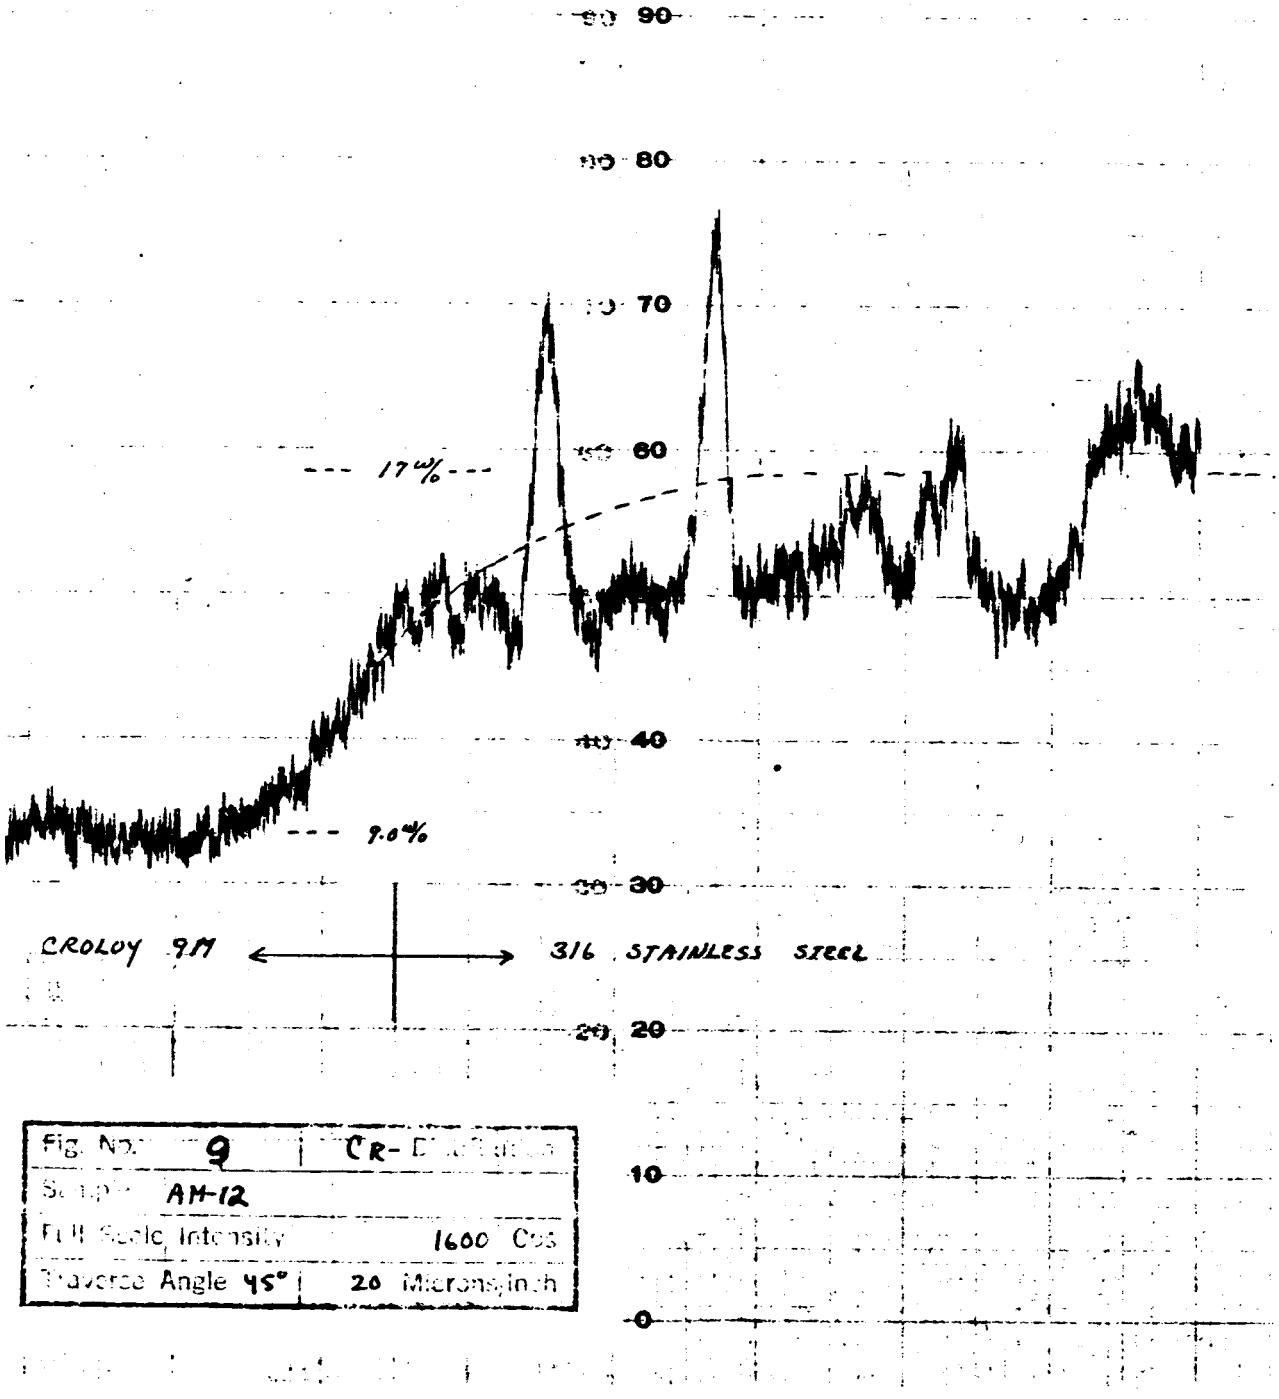
Figure 55. Distribution of Chromium at the Type 316 SS-Croloy 9M Interface in the Superheater Outlet.
