Technical Report No. 32-832

Mariner IV Science Platform Structure and Actuator Design, Development and Flight Performance

JET PROPULSION LABORATORY
CALIFORNIA INSTITUTE OF TECHNOLOGY
PASADENA, CALIFORNIA

November 15, 1965

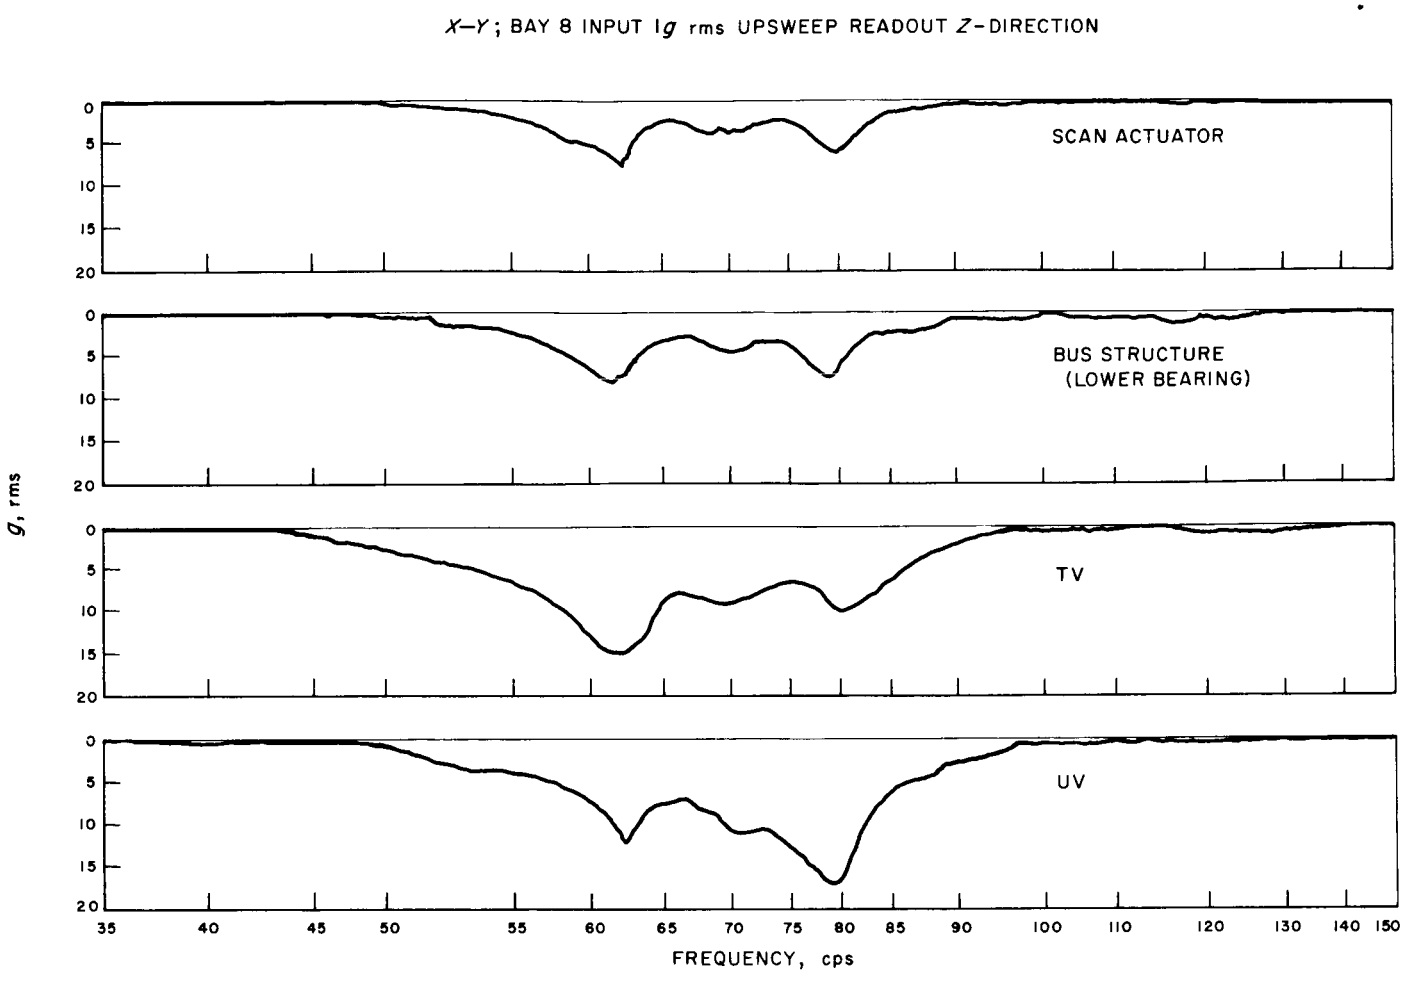
Fig. 4. Vibration response curve

As an example of the response to a typical low frequency sweep, Fig. 4 is a plot of g-load vs frequency for locations on the bus structure upstream of the bearings and at science instrument locations for a 1-g input at the separation joint. It can be seen that the response indicates that the majority of the gain is a result of the entire bus structure and platform being driven with only small increases across the scan joint. The load peaks can be correlated with expected primary modes of the structure; the 60-cps resonance is related to the primary bus mode

with the 78-cps point coincident with the calculated first bending mode of the cantilevered platform.

No failures in the platform structure occurred during any series of tests. The conclusion reached was that a satisfactory environment was achieved for the science instruments. If it had been necessary to reduce the overall gain in the system, it was evident that modification to the bus itself would be required. To further qualify the platform structure, a separate test was conducted on a scan platform held in rigid bearing supports and fully ballasted with simulated science instruments. Some 2 to 3 hr of accumulated test time at 20-g sine sweep and complex wave input produced no structural failure.

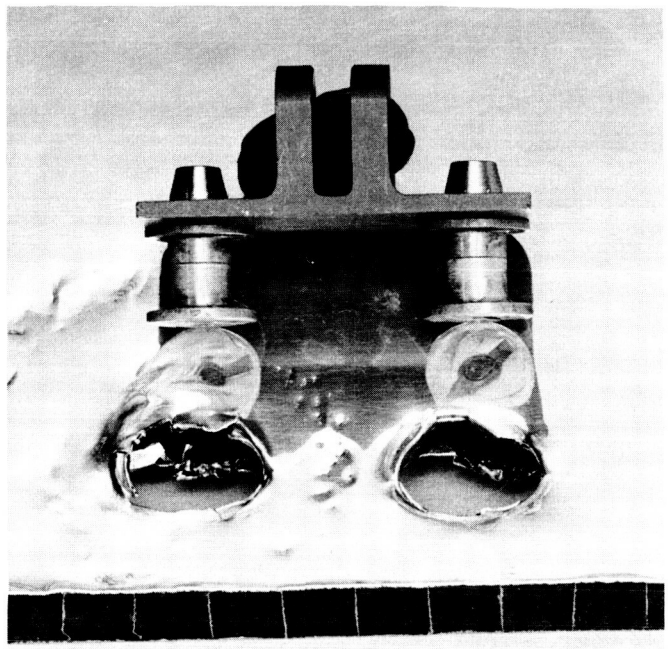
Fig. 10. Cover honeycomb insert failure

During initial vibration tests of the science cover assembly, both as a separate unit and as assembled on a complete test vehicle, catastrophic failure occurred when the latch attachment fittings in the cover plate pulled through. Upon inspection, it was noted that core fill and insert bonding were not done as specified; in fact, they were not done at all. An example of this failure is shown in Fig. 10. A check of the cover plates on hand revealed that the entire lot had not been fabricated per print. An alternate vendor was selected and increased quality control measures were introduced to insure proper fabrication. As a backup, minor changes were incorporated in the attach fittings and support structure to provide a safety margin on the inserts' load-carrying ability.

Performance of the assembly during the initial qualification tests was hampered by the previously mentioned fabrication problem with the honeycomb plate. The lack of proper insert bonding exhibited itself during the first high-frequency complex wave vibration where the inserts proceeded to work loose, allowing high excursions and eventual destruction of the cover hinges and latch fittings. Following the incorporation of properly fabricated hardware, qualification proceeded with no failures noted in any developmental or flight hardware test.

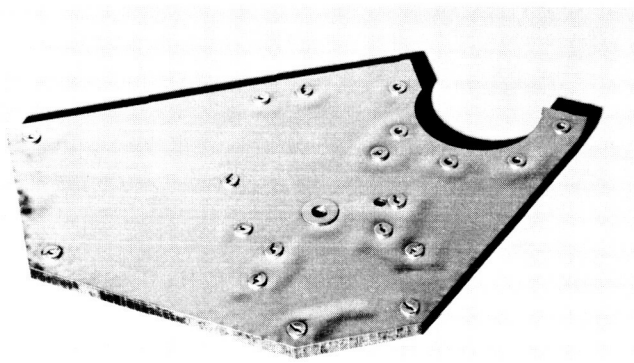
Fig. 11. Cover skin delamination

One improvement incorporated for the second run of covers consisted of an adhesive call-out change to one capable of withstanding higher temperature. This was felt necessary after a check on the possible transient solar heat input as a result of a midcourse maneuver. The revised adhesive curing procedure resulted in internal pressure capable of producing skin delamination as illustrated in Fig. 11. Judging by the location of the damaged area, it appeared that the insert fill adhesive was outgassing at a sufficiently high rate during cure that the pressure could not be adequately vented through the perforated core. After some revision in the method of heat application, this problem was resolved.
