NASA TECHNICAL NOTE

REVIEW OF CAUSES AND ALLEVIATION
OF LOW TIRE TRACTION ON WET RUNWAYS

by Walter B. Horne, Thomas J. Yager, and Glenn R. Taylor

Langley Research Center
Langley Station, Hampton, Va.

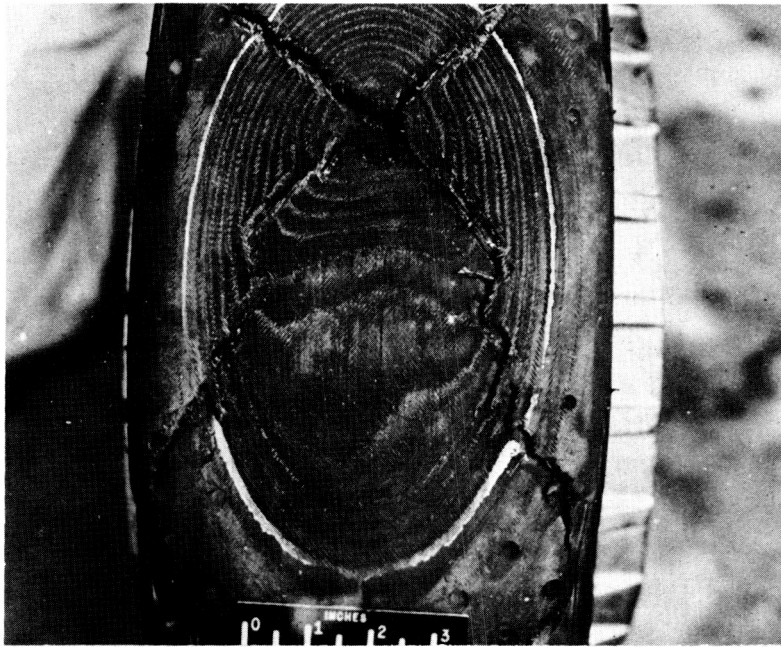
ways. Shown in figure 3 is a tire which blew out after sliding only 60 feet (18.3 meters) at a ground speed of 100 knots on a dry concrete runway under a vertical load of 10 000 pounds (44.5 kilonewtons). Calculations show that while the tire was sliding, the contact patch of the tire, with an area of approximately 40 inches^2 (258.0 centimeters^2), was absorbing 460 horsepower (343.0 kilowatts). During this time, 1 inch (2.5 cm) of tread rubber and carcass cord was melted and eroded away in less than 0.36 second, the duration of the locked wheel skid in this case. One way to avoid such situations of

L-2551-3
Figure 3.- Blowout with 32 × 8.8 aircraft tire after skidding 60 feet (18.3 meters)
on dry concrete at ground speed of 100 knots.

excessive tire wear is to provide an antiskid system which prohibits wheel lockup and simultaneously forces the tire to brake under conditions of favorable slip ratio.

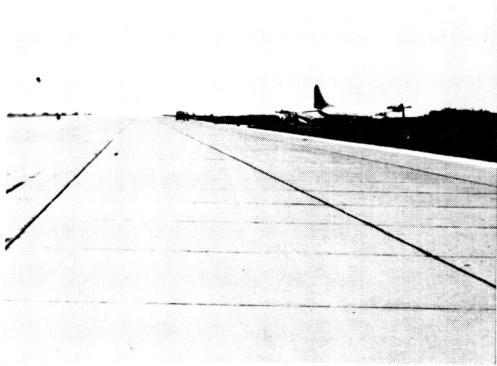
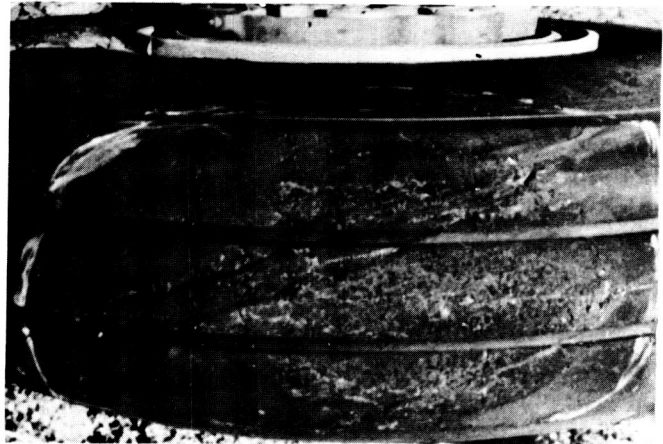
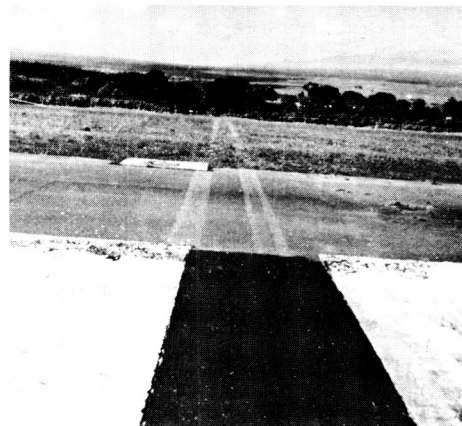
Evidence from skidding accidents.- A recent survey of conditions that prevailed during landing accidents on wet runways showed a very interesting correlation. In numerous documented cases on wet runways involving aircraft departure off the side of the runway or in an overrun (both types of accidents indicate drastic loss of tire traction), the runway surface was found to have developed white streaks in the tire paths. The aircraft tires showed evidences of prolonged locked wheel skids with indications that the rubber in the skid patches had reverted to an uncured state. Examples of the two types of accidents made available to NASA are shown in figures 17 and 18. In figure 18, where effects of an overrun accident are shown, the white streaks persisted down to the point that the aircraft stopped.

White tire streaks on runway

Reverted-rubber skid patch

Figure 17.- Hydroplaning accident with four-engine prop jet on flooded runway during heavy crosswind.   L-2551-17

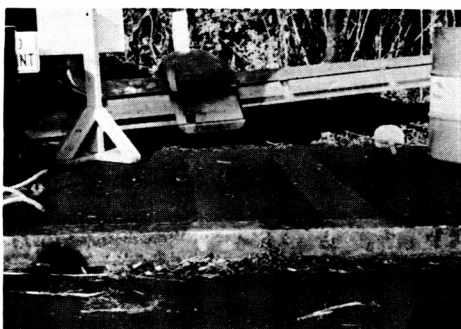
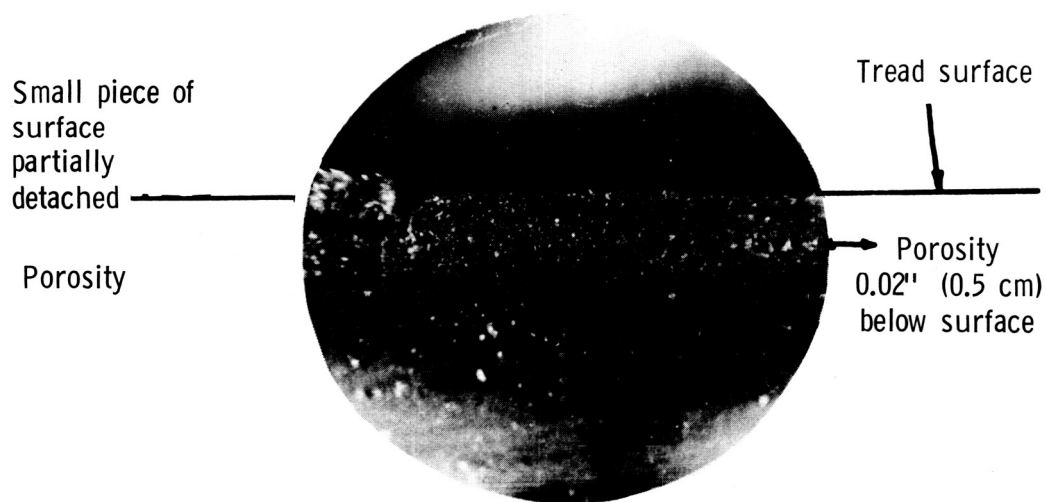
White streaks on runway
≈70 knots

White streaks on over-run
≈5-10 knots

In contrast, if the wheels lock on dry runways at speed, black streaks from molten rubber eroding from the tire are immediately deposited in the tire paths. Although friction decreases under this condition, at least one-third of the maximum dry friction coefficient is still available for stopping the aircraft, as was illustrated in figure 2. It thus appears that some mechanism other than viscous or dynamic hydroplaning must be at work to prevent the skidding tire from developing traction on wet textured pavements even at very low ground speeds as indicated in figure 18.

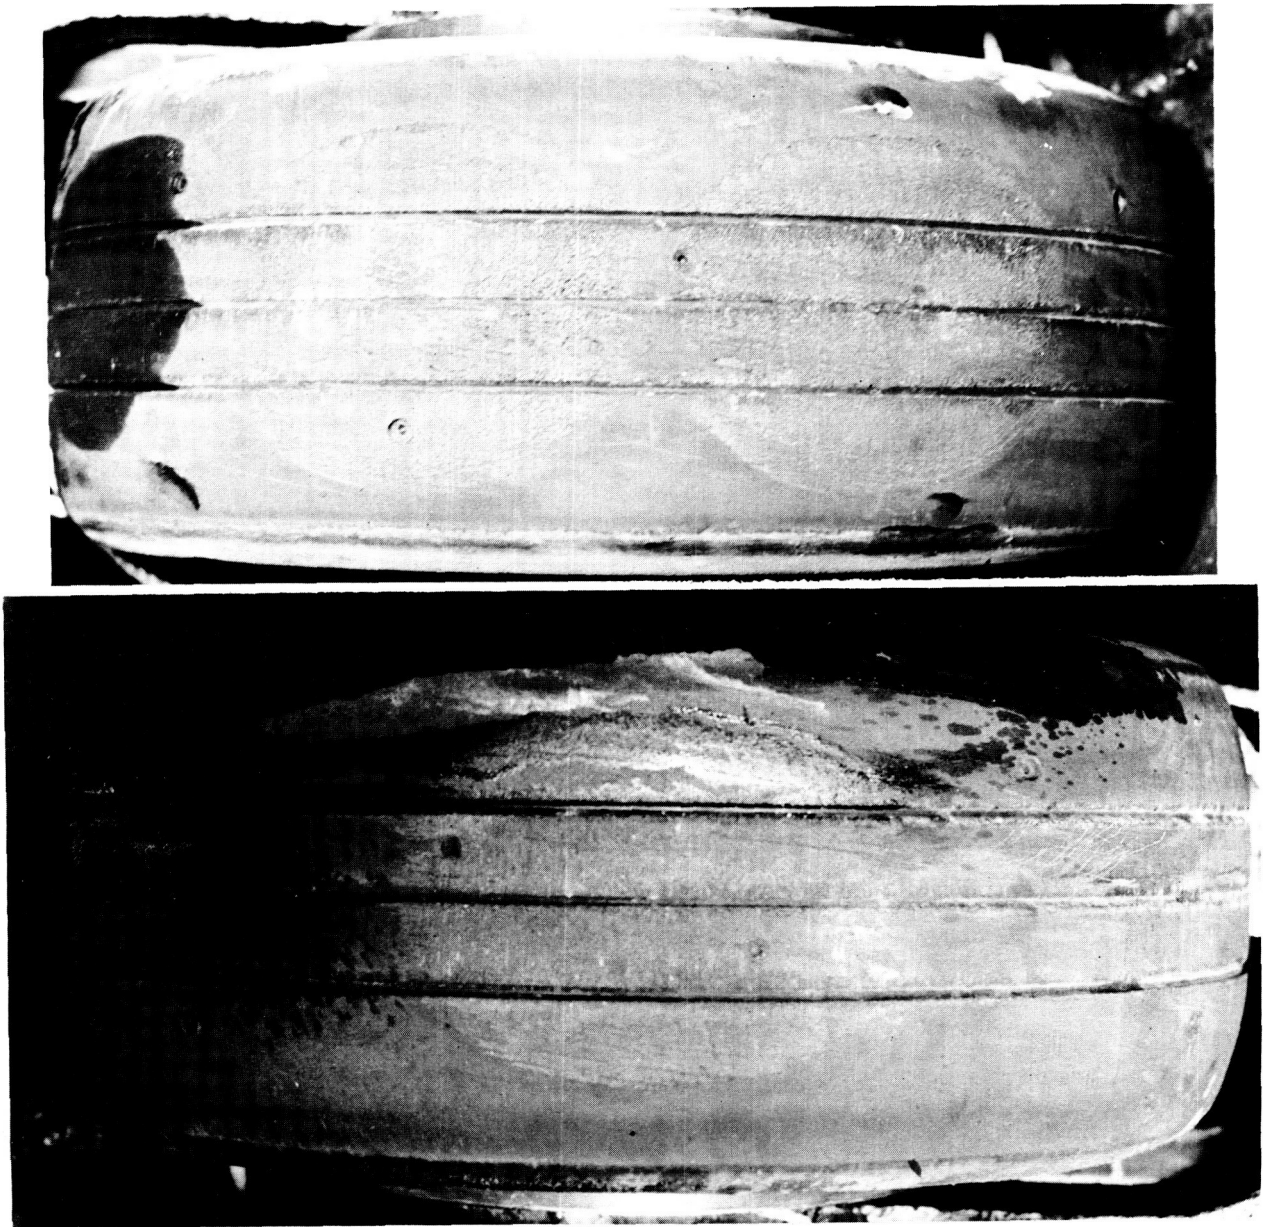
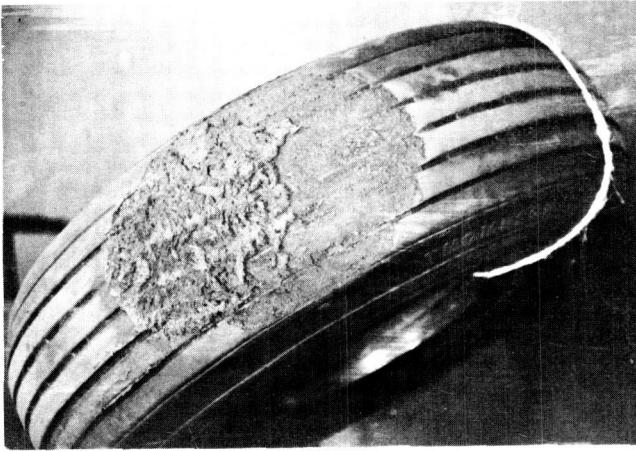
Figure 21.- Reverted-rubber skid patches. Hydroplaning accident with supersonic fighter on wet runway with isolated puddles.   L-2551-21

Multiple reverted rubber skid patches.- Numerous instances have been observed where multiple reverted rubber skid patches such as those shown in figure 21 develop around the tire circumference. For these cases, it is believed that intermittent wheel lockups from braking, actuated either by the pilot or by antiskid

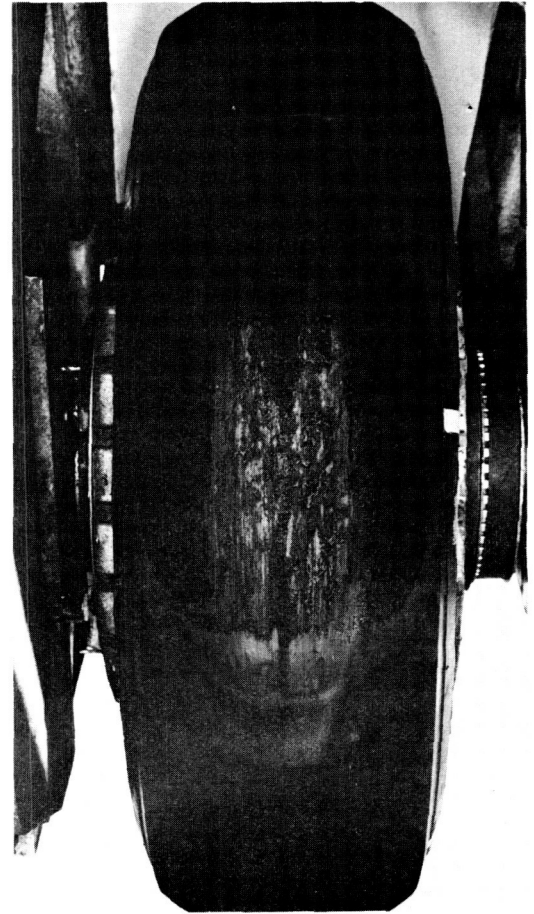
L-2551-22
Figure 22.- Reverted-rubber skid patch obtained with four-engine prop jet on wet runway.
