NASA TN D-5000

HOT-SALT STRESS-CORROSION OF TITANIUM ALLOYS: GENERATION OF HYDROGEN AND ITS EMBRITTLING EFFECT

by Hugh R. Gray

Lewis Research Center

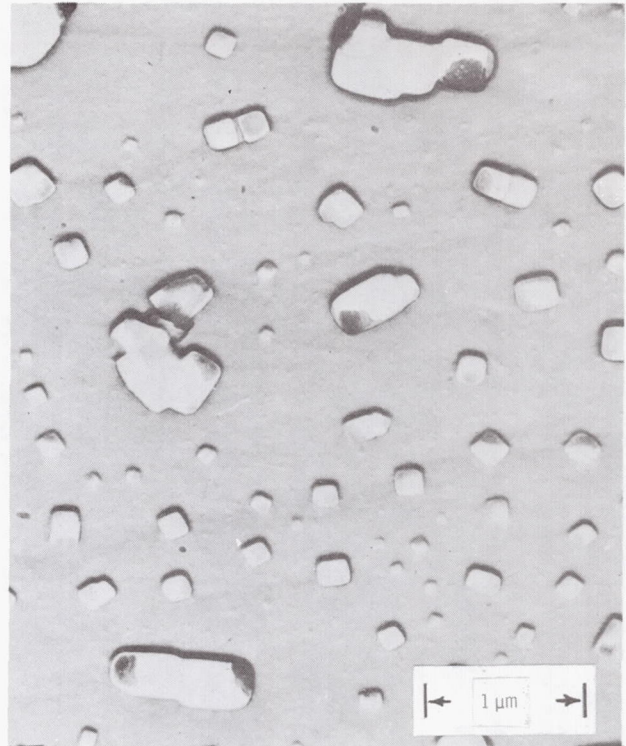
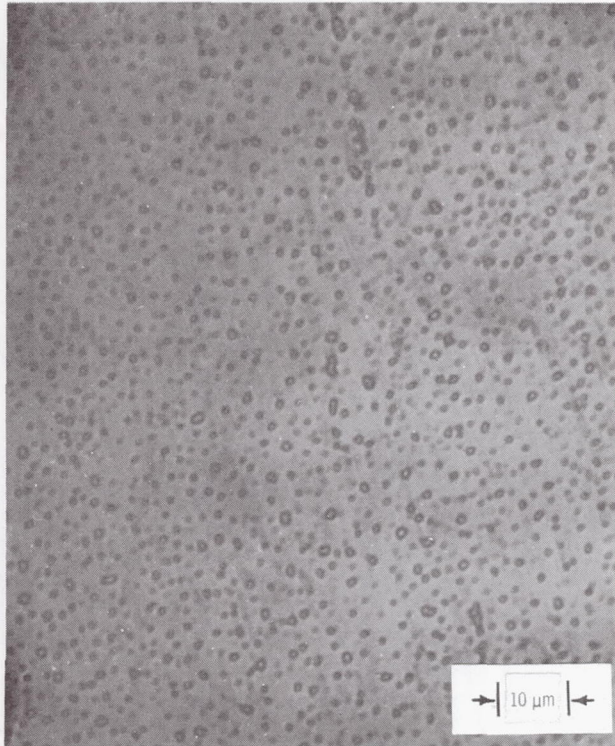
Salt coating. - Before high-temperature exposure, all specimens to be salted were coated with an average salt (chemically pure NaCl) coating of about 0.2 milligram per square inch (0.03 mg/cm^2). This average concentration was achieved with the rig described by exposing unstressed specimens for 1 hour to a salt-in-air concentration of 40 parts per billion at an air velocity of 1000 feet per second (300 m/sec), an air temperature of 400° F (205° C), a dewpoint of -120° F (-85° C), and a pressure of 30 psia (0.2 MN/m^2). This technique provided a uniform dispersion of salt particles on the bore of the specimen, as may be seen in figure 3. It is evident that the crystals are cubic in symmetry and submicrometer in size.

Figure 3. - Salt crystals deposited on hollow titanium alloy specimens at 400° F (205° C).

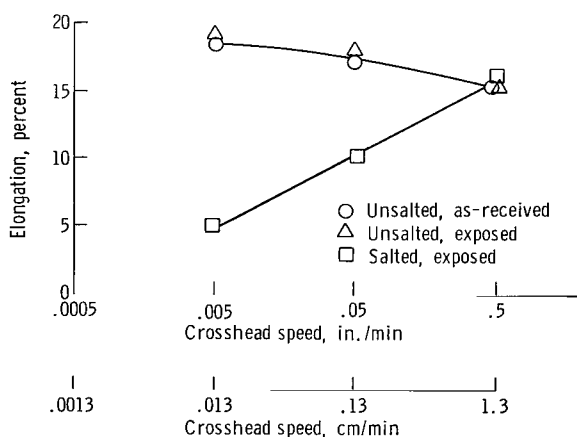
Tensile testing speed has a dramatic effect on the postexposure ductility of salted Ti-8Al-1Mo-1V alloy specimens, as may be seen from figure 5. Specifically, elongation decreased as the testing speed decreased. At a fast crosshead speed of 0.5 inch per minute (1 cm/min) salted-exposed specimens exhibited no loss of elongation when compared with the elongation of similarly exposed nonsalted specimens. However, the elongation of salted-exposed material, which was about 17 percent at the fast testing speed, decreased to 5 percent at the slowest testing speed of 0.005 inch per minute (0.01 cm/min).

Figure 5. - Effect of tensile testing speed on the ductility of Ti-8Al-1Mo-1V alloy specimens after salting and exposure at 800° F (425° C) for 100 hours at 50 000 psi (350 MN/m^2). Test temperature, 72° F (22° C).

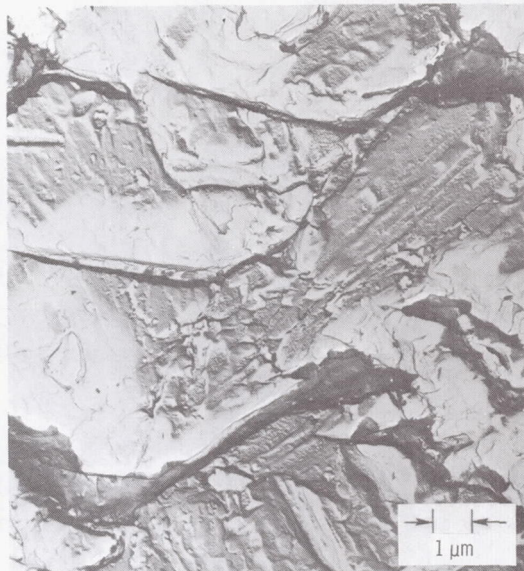
Figure 6. - Electron fractographs of typical fracture surfaces of tensile tested Ti-8Al-1Mo-1V alloy specimens previously exposed at 800° F (425° C) for 100 hours at 50 000 psi (350 MN/m2).

presented in figure 6. It is immediately evident that the primary fracture mode has changed from the dimple formation in the ductile material to a cleavage mode in the brittle material. Evidence of cracking is also visible on the fracture surface of the embrittled specimen.

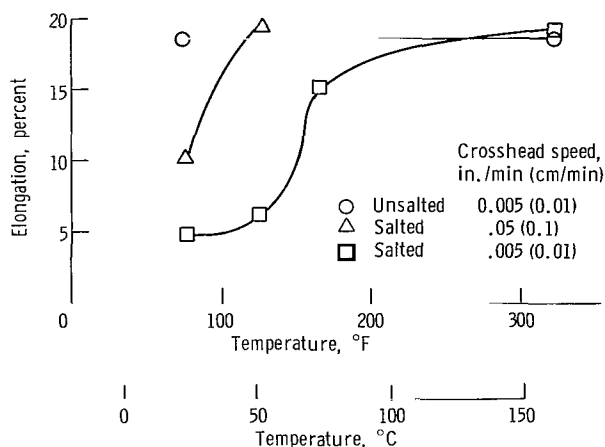
Tensile-test temperature, as well as strain rate, markedly influenced ductility. As is evident from figure 7, embrittlement was more pronounced at lower temperatures for a constant testing speed. For example, at 0.005 inch per minute (0.01 cm/min) embrittlement was quite severe at room temperature, as indicated by an elongation of only 5 percent. However, ductility gradually improved with increasing temperature until a maximum elongation of 19 percent was observed in the vicinity of 300° F (150° C). Similar temperature sensitivity was observed at the intermediate testing speed of 0.05 inch per minute (0.1 cm/min). These observations are remarkably similar to the mechanical behavior resulting from the well-known phonomenon of slow-strain-rate hydrogen embrittlement in titanium alloys and steels, which is discussed in the following section. Limited data reported by the General Electric Co. (private communication from L. P. Jahnke) indicated some apparent strain-rate and temperature sensitivity after exposure

Figure 7. - Effect of tensile testing temperature on the ductility of Ti-8Al-1Mo-1V alloy specimens after salting and exposure at 800° F (425° C) for 100 hours at 50 000 psi (350 MN/m²).
