NASA CR-1575

EVALUATION OF TANTALUM/316 STAINLESS STEEL BIMETALLIC TUBING

by J. N. Kass and D. R. Stoner

7. Author(s) J. N. Kass and D. R. Stoner	8. Performing Organization Report No. WANL-PR-PPP-001

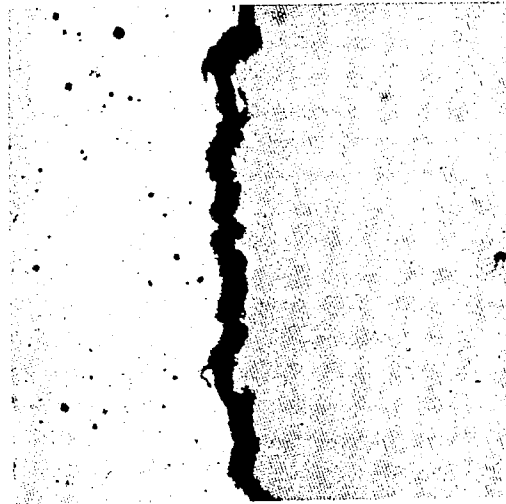
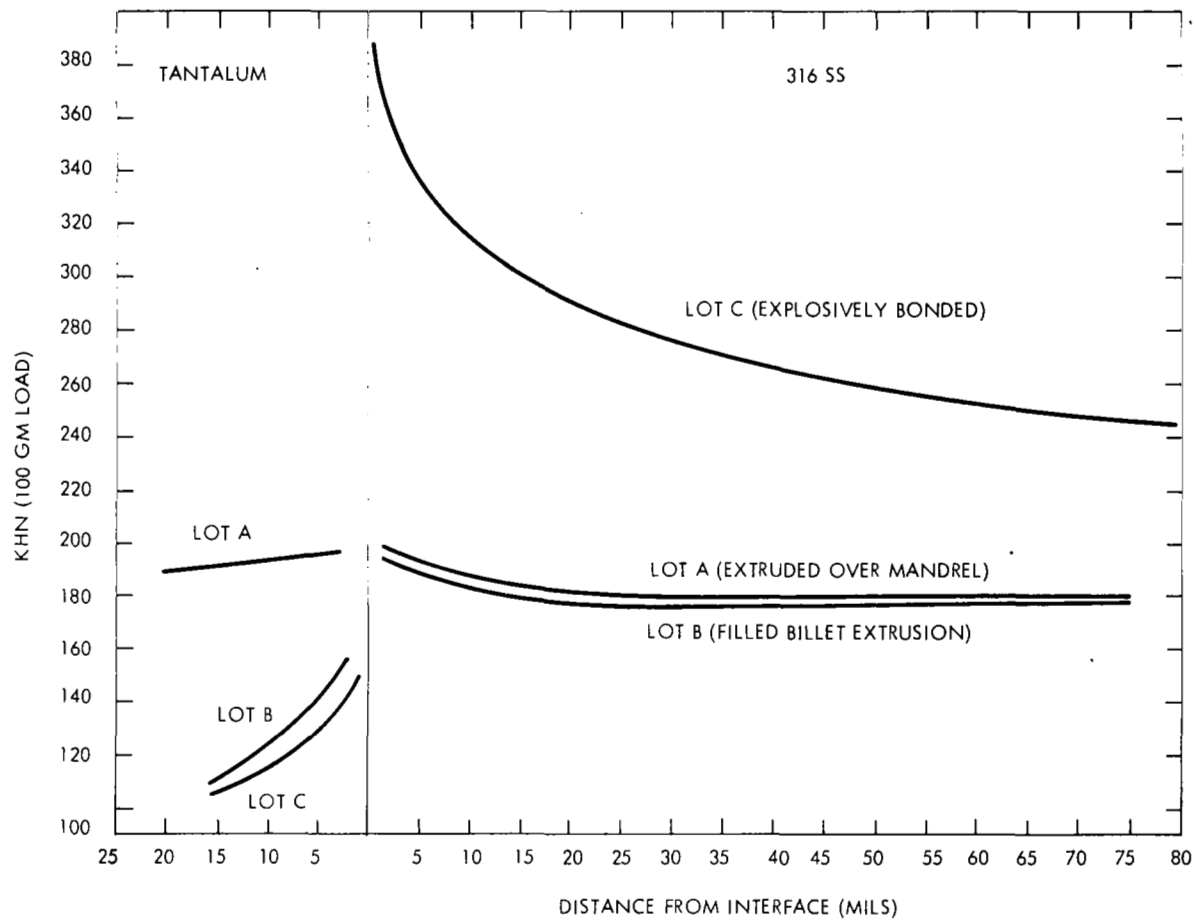
FIGURE 8 – Unbonded Area in Type B (Filled Billet Extrusion) Tubing

Ultrasonic Test Results.   The ultrasonic inspection results are summarized in Table 8. The presence of unbonded areas, as determined by ultrasonic testing, was corroborated by metallography. An example is shown in Figure 8.

The extruded-to-size tubing, Lot A and B, had bond integrity superior to that of the explosively bonded-to-size tubing, Lot C. The explosively bonded tubing has unavoidable unbond areas at the spacing protrusion areas. In addition to these built in unbond areas, an unbonded area was found near the end in the 9 foot tube of this lot. In contrast, only a few small unbonded areas were found in Lot B and none in the Lot A tubing.

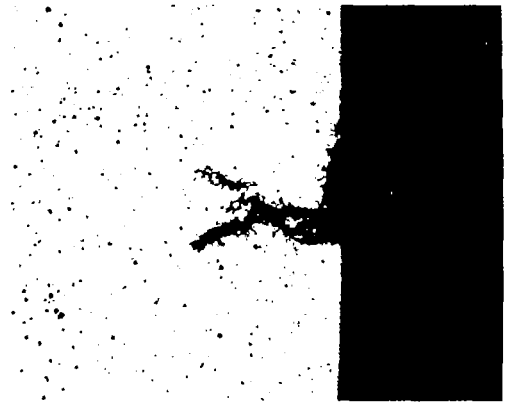
A nearly continuous intermetallic layer was observed at the bimetal interface of the as-explosively bonded tubing. Transverse cracks were observed in the intermetallic layer which occasionally propogaged into the tantalum as shown in Figure 15.

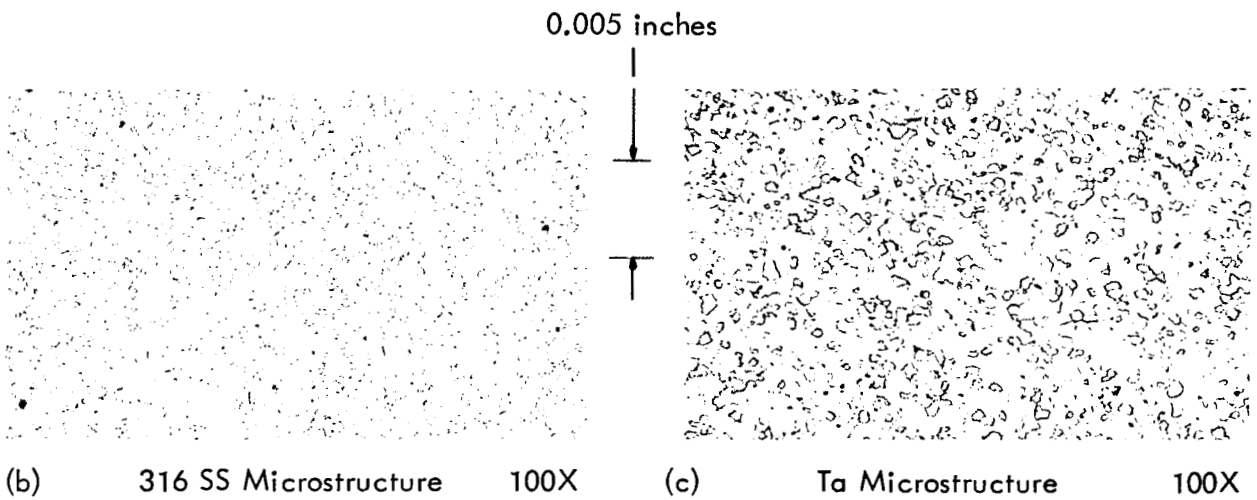
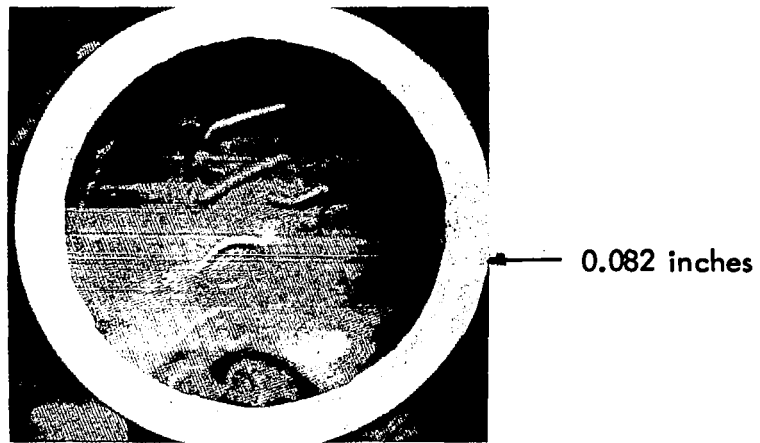
Lot B (Filled Billet Extrusion). The ID surface was rough and was formed of striations 2-3 mils deep as shown in Figures 12a and 13a. The OD surface was smooth. Both the OD and ID surfaces contained fissures of varying depths as shown in Figures 12b and 12c. The majority of ID cracks were about 2-3 mils deep. The 316 SS and Ta were fine grained and recrystallized as shown in Figure 13b and 13c.

(b) ID Crack ~2 Mils Deep 100X

(c) OD Crack ~7-1/2 Mils Deep   100X

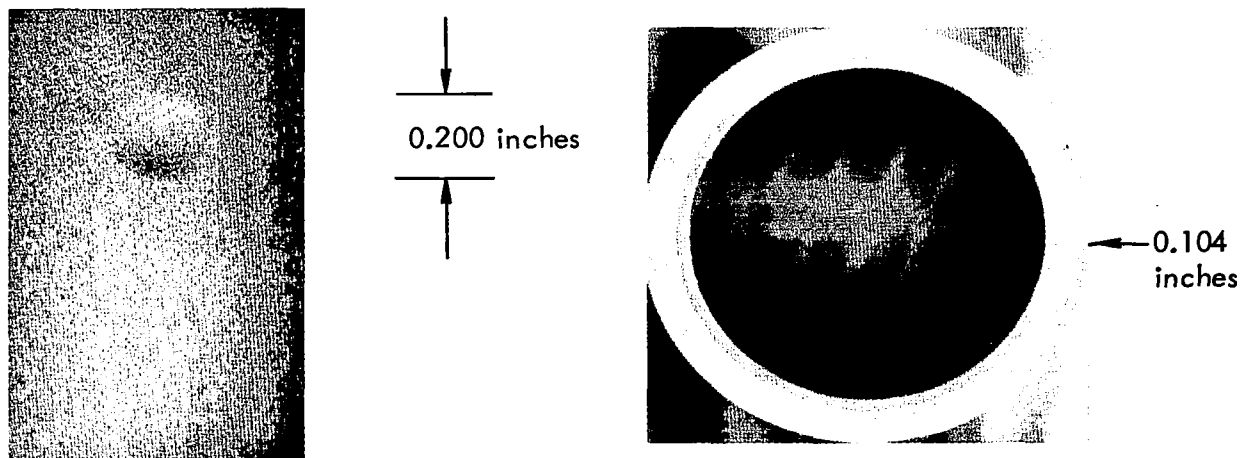
FIGURE 14 – Sections of Lot C Explosively Bonded Bimetal Tubing

Lot C (Explosively Bonded). All exterior surfaces of the tubing were smooth and crack-free. Unlike the extruded tubing Lots A and B, the transverse section of the bimetal interface is ripple free as shown in Figure 14c. The original spacing protrusions required for explosive bonding are retained in the bonded tubing as shown in Figure 14a. The protrusions are the only disturbance to the very uniform bimetal layers. An ID surface view of a spacing protrusion is shown in Figure 14b.

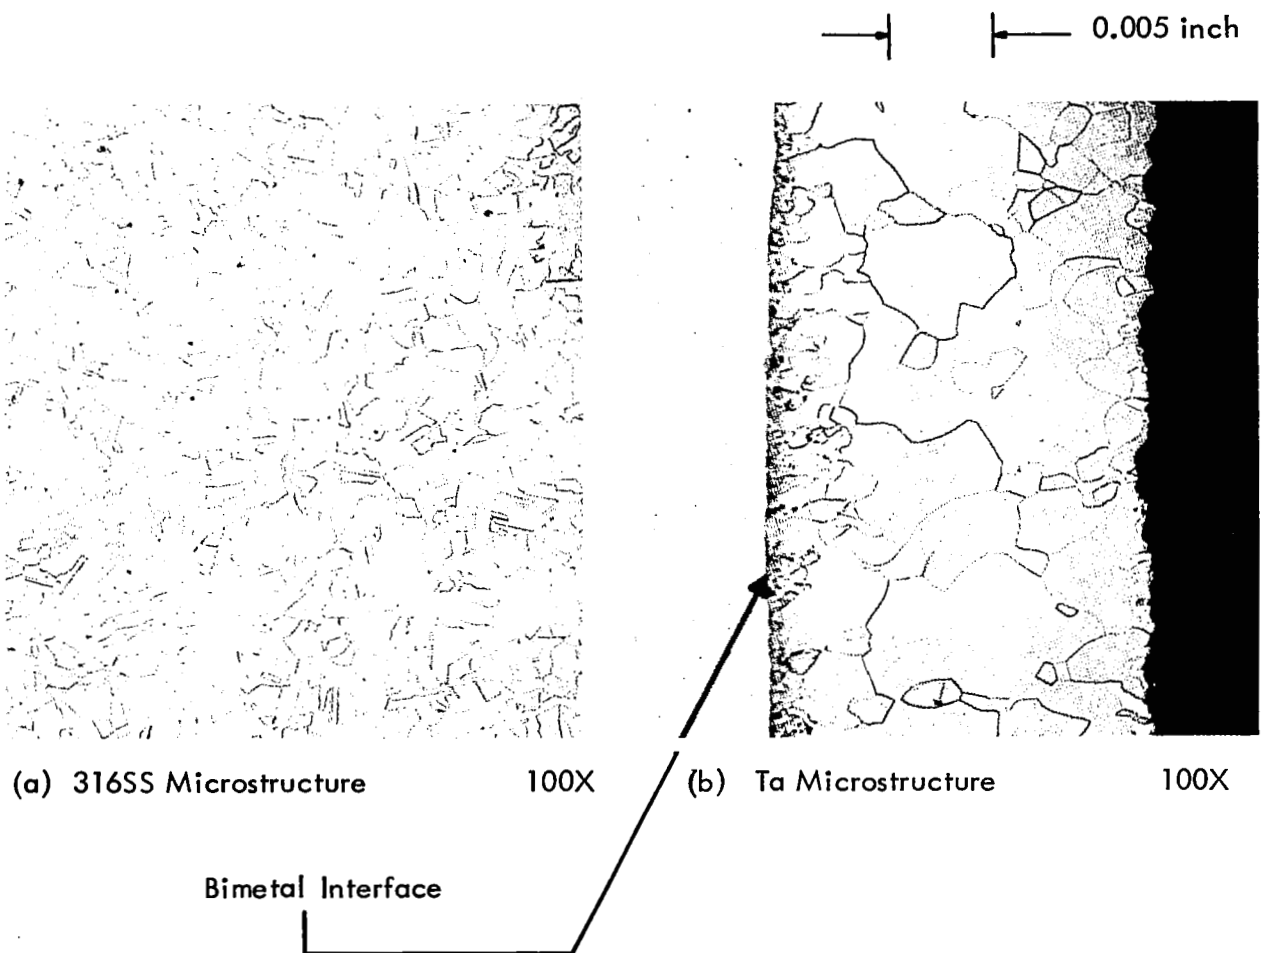
FIGURE 16 – Microstructure of Type C Explosively Bonded Bimetal Tubing

As shown in Figure 16, the tantalum and 316 SS components exhibit uniform equiaxed grains except near the interface which corresponds to the sharp increase in hardness shown in Figure 9.

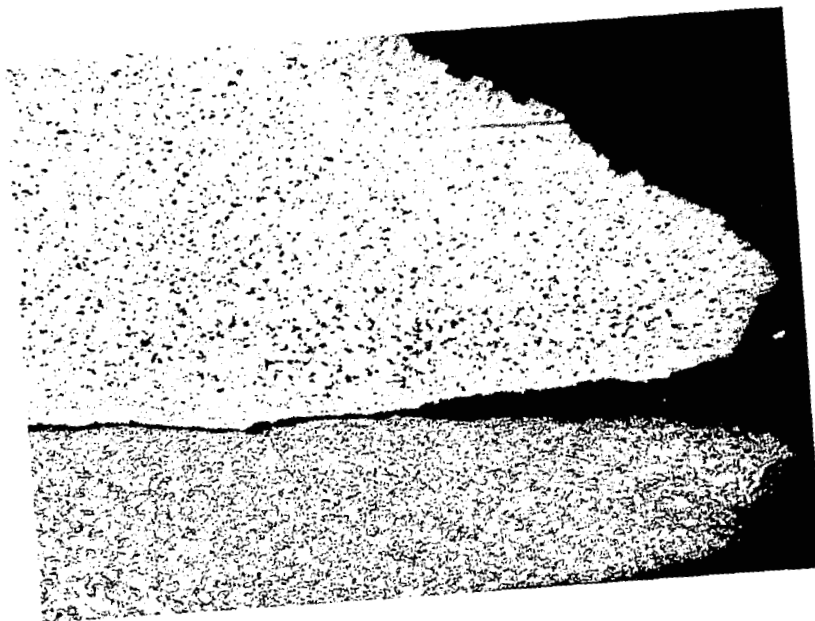
FIGURE 24 – Fracture Edges of Burst Tested Lot A, Mandrel Extruded, Bimetal Tubing

The Lot A and Lot B specimens exhibited over 5% diametral strain before failure. As shown in Figure 24, a fracture section of the Lot A tubing, the reduction in area of the tantalum component exceeded 90%. The 316 SS generally exhibited less than 50% reduction in area and intergranular failure.

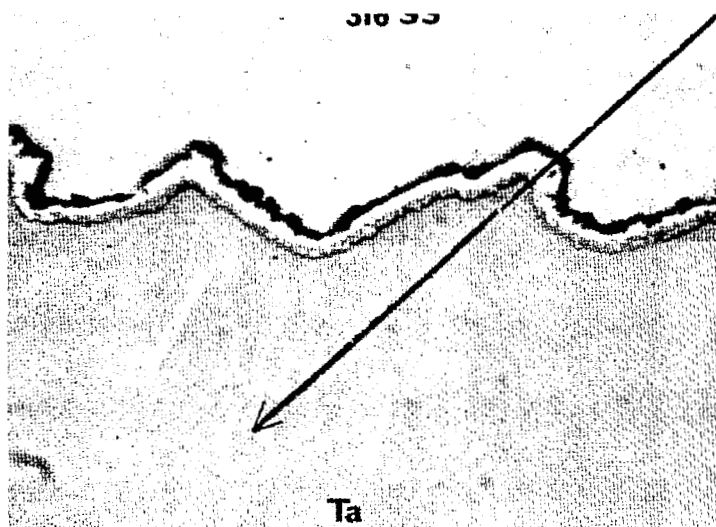
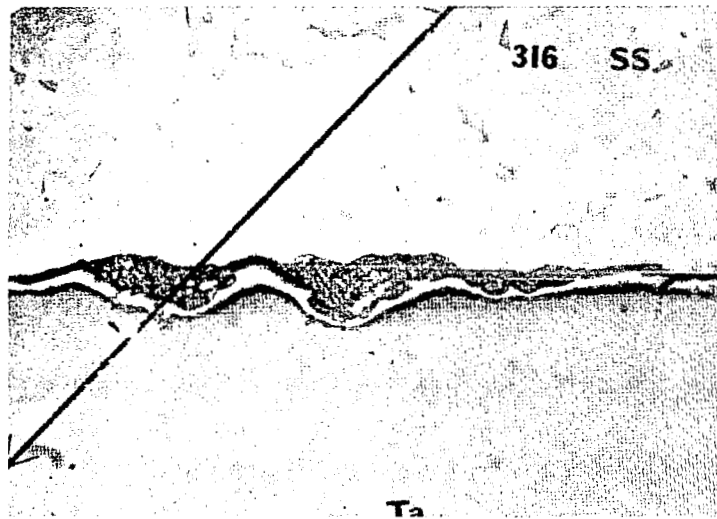
The explosively bonded tubing, Lot C, showed a significant growth in the spacer unbond areas after the thermal cycle test both in the as-received and heat treated conditions. Neither type of spacer design, the three spacer single plane or the helical spiral was effective in preventing additional unbond propogation during thermal cycling. The section of

(a) Lot C Explosively Bonded Tubing, Heat Treated at 1650°
for 300 Hours.

explosively bonded tubing which was free of all spacing protrusions did not unbond during thermal cycling. The intermetallic layers present in the as-fabricated and heat treated specimens were fractured extensively in both longitudinal and transverse directions during thermal cycling.

The test results indicate that either type of extruded tubing has good bimetal bond durability during thermal exposure and thermal cycle testing. Explosively bonded tubing, conversely, suffers significant unbonding unless the "built-in" defects at the spacer protrusions are eliminated.

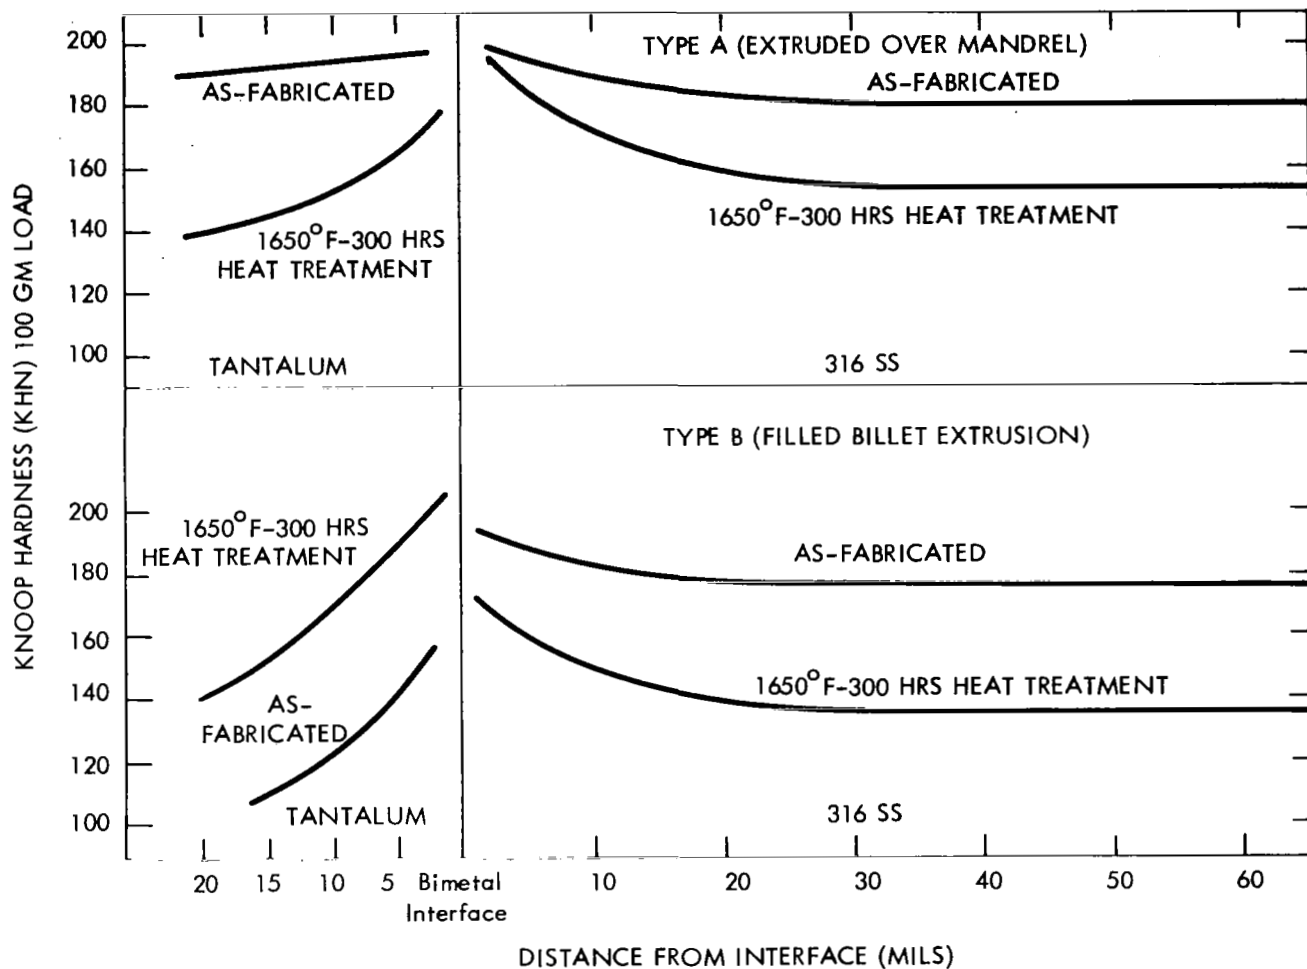
FIGURE 31 – Hardness Traverse Comparison of Heat Treated Lots A and B,

Hardness Changes. A comparison of the before and after heat treating hardness traverses of the tantalum and stainless steel is shown in Figures 31 and 32. In general the tantalum increased in hardness following the thermal exposure with an increasing hardness gradient towards the bimetal interface. The hardness gradient may be assumed to follow an interstitial content gradient although this was not confirmed by chemical analysis. The Lot A tubing showed a drop in tantalum hardness, but this is due to stress relieving of the worked tantalum. The 316 SS decreased in hardness following heat treatment especially the explosively bonded tubing in which the stainless steel was severely hardened by the explosive deformation process.
