NASA TN D-5864

VACUUM LEAKAGE TESTS OF A SIMULATED LIGHTWEIGHT SPACECRAFT AIR LOCK

by Otto F. Trout, Jr.

Langley Research Center
Hampton, Va. 23365

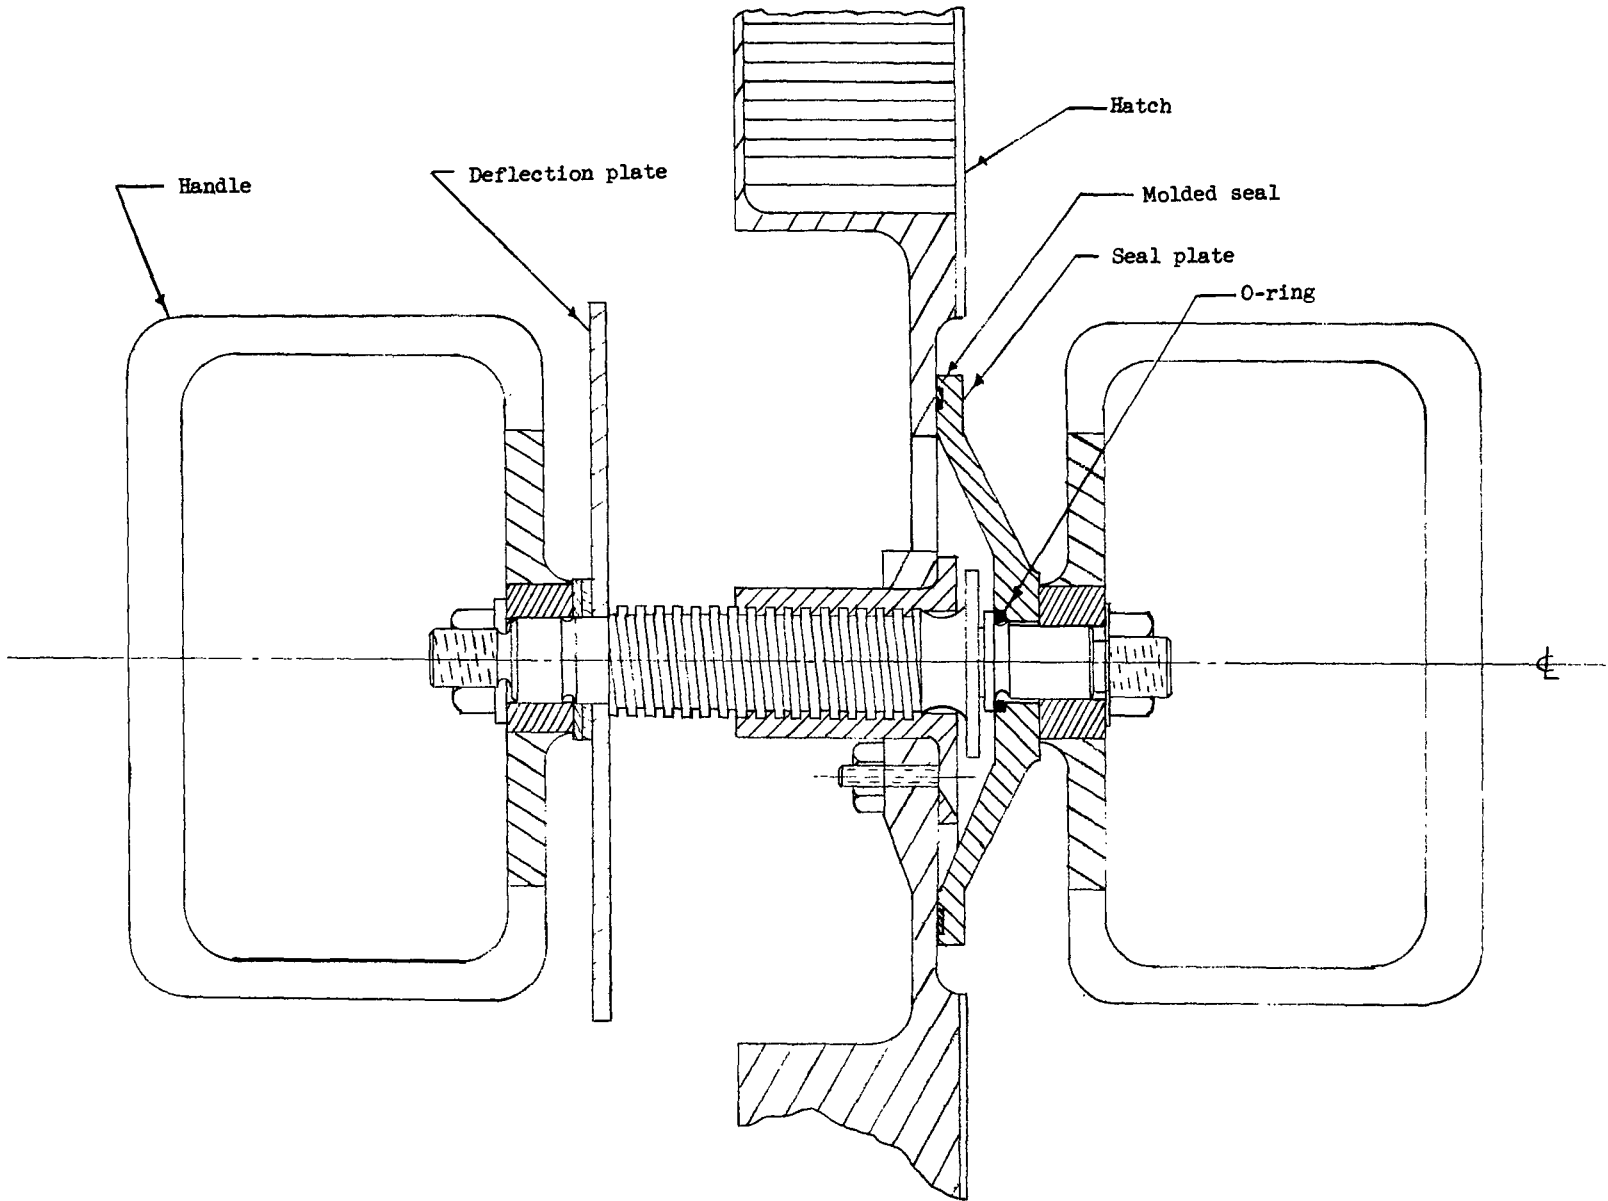
Figure 4.- Pressure-equalization valve for hatch A and hatch B.

An additional problem was encountered with the pressure-equalization valves (fig. 4) which could not be opened by hand after being sealed for several days with a pressure differential across the valves of 1 atmosphere (1 atmosphere = 1×10^5 N/m^2). It was necessary in this case to insert a hammer handle or other means to provide additional leverage to open them. This problem could possibly be alleviated by making the valve seat smaller or by designing a different type of valve mechanism. Equalization time to reduce the pressure from 1 atmosphere to vacuum with the present valves was approximately 9 seconds. If this time were increased to approximately 1 minute, the valve seat would probably be small enough to be opened manually even after extended periods of time.

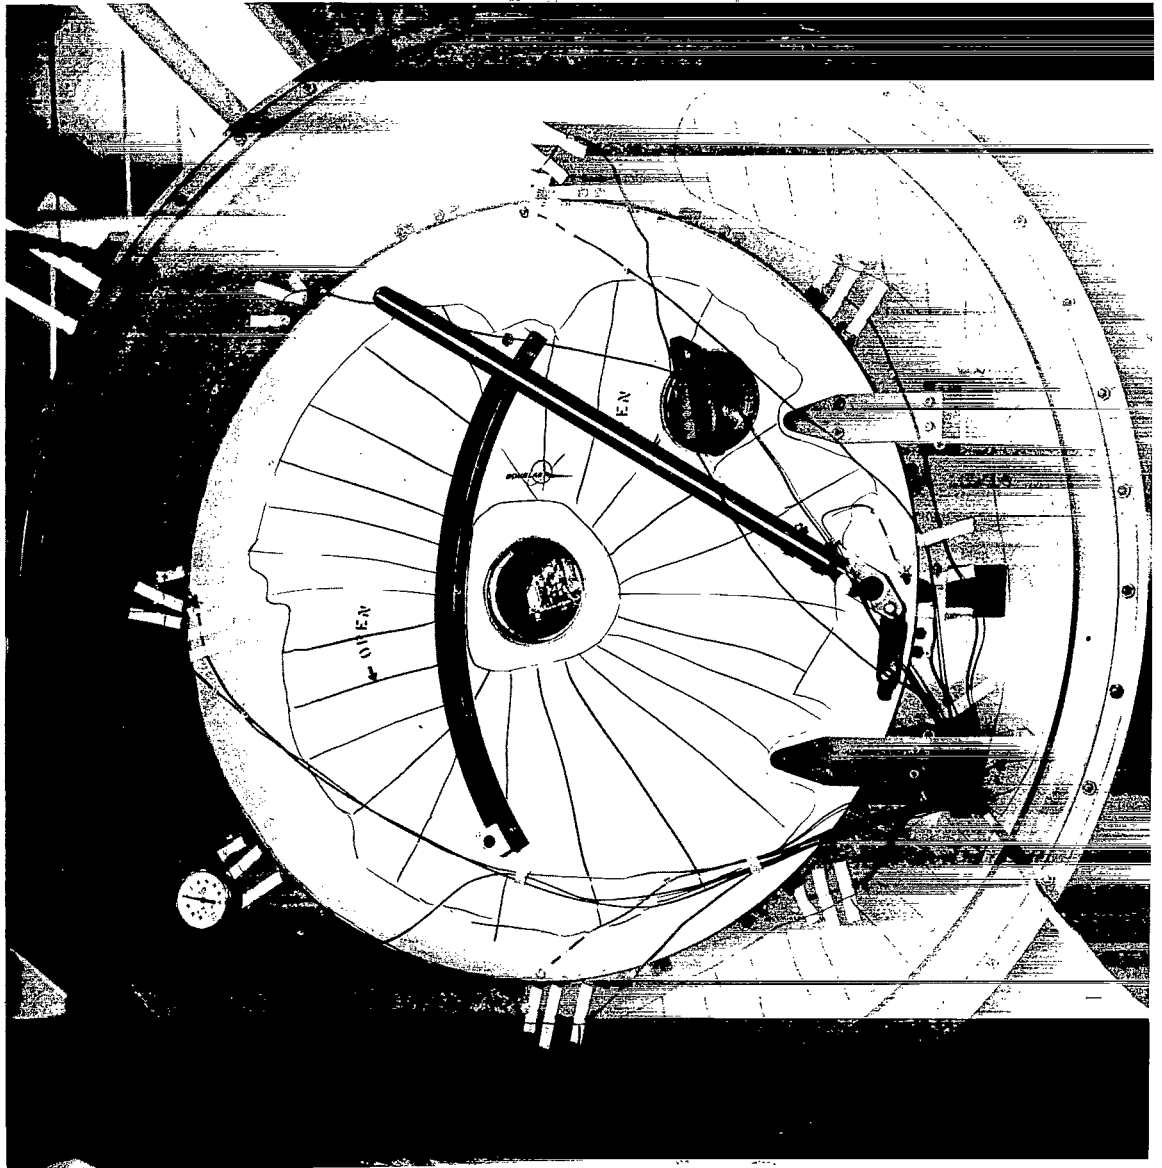
Figure 31.- Failure areas of hatch A and frame.

During the third higher temperature test on hatch A, the hatch failed structurally while being heated to 250° F (121° C). Leakage measurements had not been started at the time of failure; however, the interior of the air lock was under vacuum and the exterior at atmospheric pressure. Figure 31 shows the areas in which the metal skin parted from the honeycomb core. At the time of failure the seal continued to retain the vacuum inside the air lock. Further testing of hatch A was terminated after this damage. A possible cause of the failure may have been the pressure buildup from the bonded honeycomb sealed within the structure. The honeycomb was vented between cells but not vented to the outside of the structure.

It is recommended that problems of structural integrity of the honeycomb structure, uneven structural deflection, and leakage rates at lower temperatures be investigated in greater detail in future research.

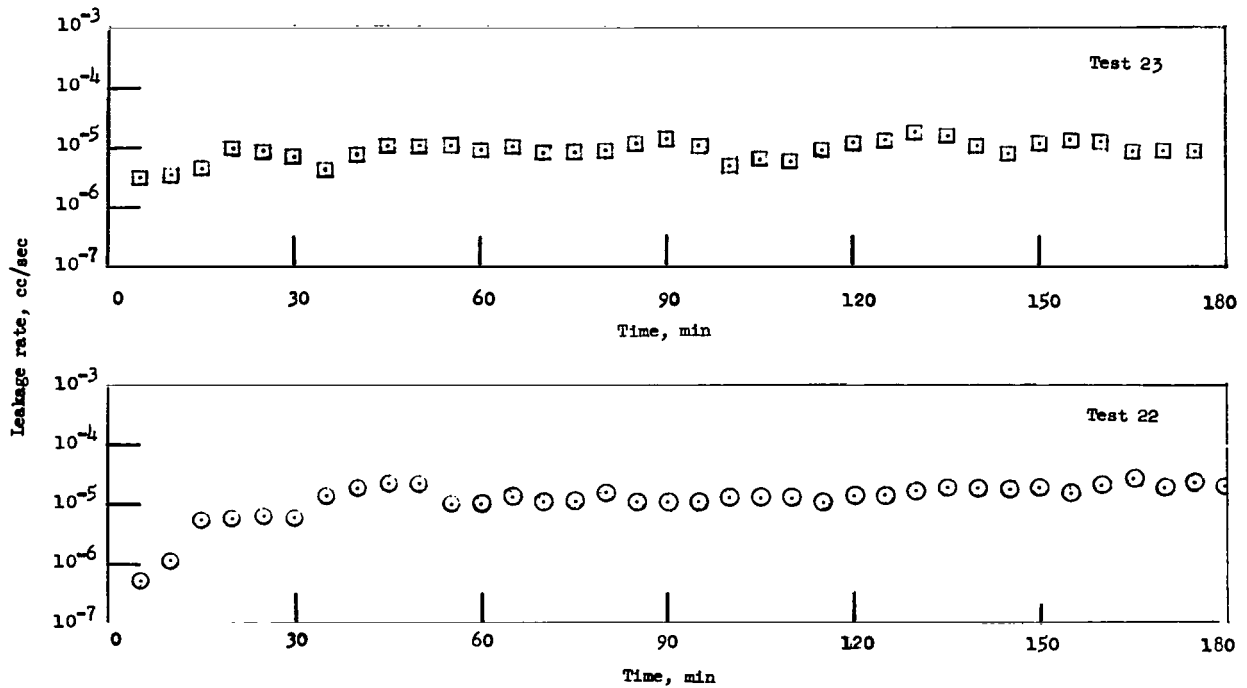
Figure 33.- Leakage rate as a function of time for hatch C with pressure loading toward the closed position during the heating tests.

Figure 33 shows the leakage rate of hatch C with the hatch at average temperatures of 150° F (66° C) and 177° F (81° C) and for the hatch pressure loaded toward the closed position. The maximum measured leakage was 2.4×10^{-6} cc/sec. Leakage for hatch C was almost an order of magnitude less during these tests than for tests at room temperature. This effect is exactly opposite to that which occurred on the O-ring seal on hatch A and the molded seal on hatch B. The reason for this lower leakage rate is not apparent and should be investigated further.
